**IEEE SW Test Workshop**  
Semiconductor Wafer Test Workshop

**Eddie McClanahan and Al Wegleitner**  
Texas Instruments

# **The Influences of Signal Matching During Multi-site Testing**

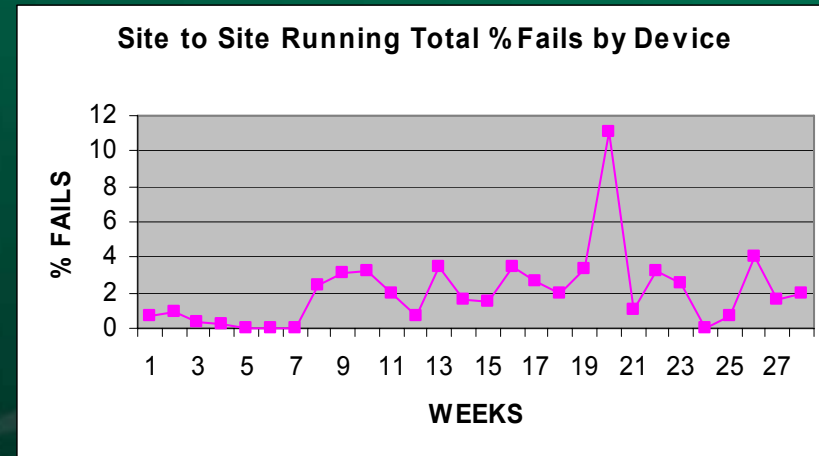
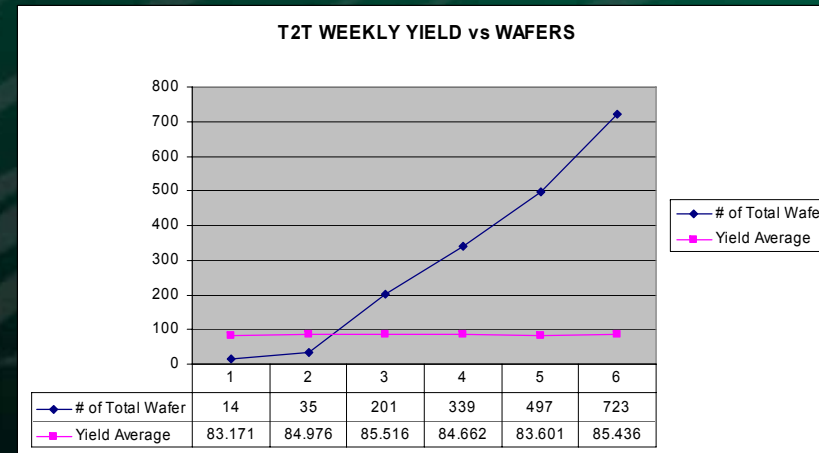
# Yield Analysis S2S vs. T2T

- Yield Variability
  - Site to site monitoring of this device indicate an increasing yield delta between sites. Average 2.95 %
  - Tester to tester yield performance data did not identify isolated tester issues but did support site to site failure mode

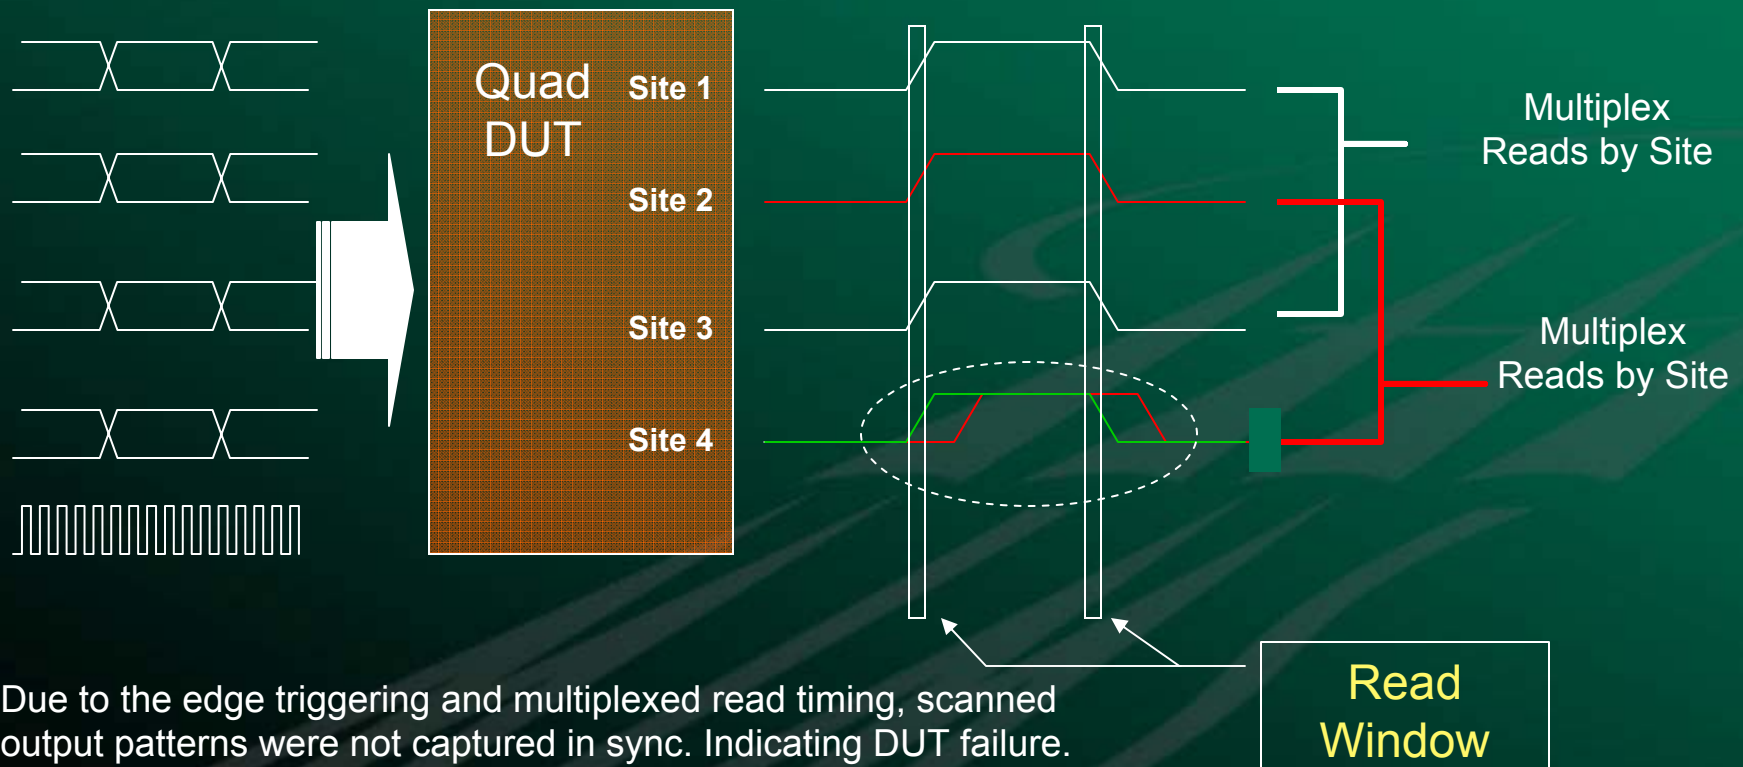
# Signal Timing Issue

Due to the edge triggering and multiplexed read timing, scanned output patterns were not captured in sync. Indicating DUT failure. Individual retesting of the failed DUT returned good GEC. Timing adjustment in program resulted in adjacent site function failures which also were recovered on reprobe. Suspect signal trace or timing issues between tester and DUT by site.

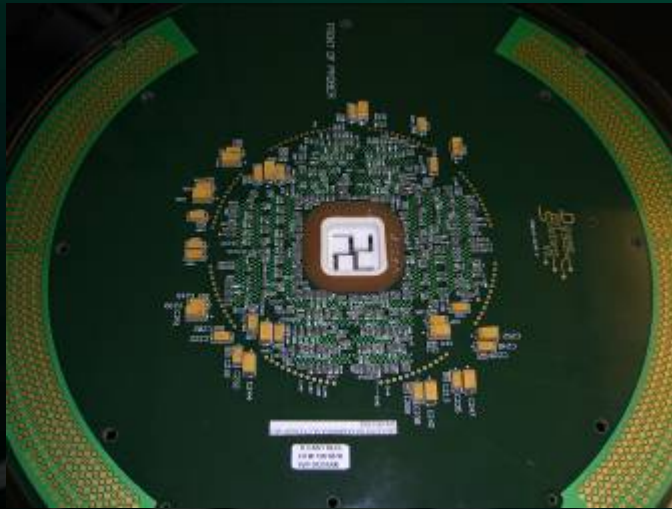
**PC #1**

Probe card wo/ Site Matching Considerations

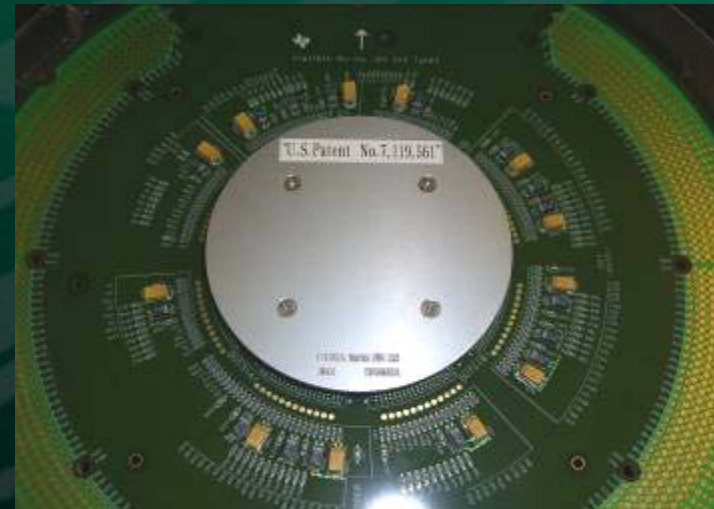
**PC #2**

Probe card w/ Site Trace Length and Component Layout Matching

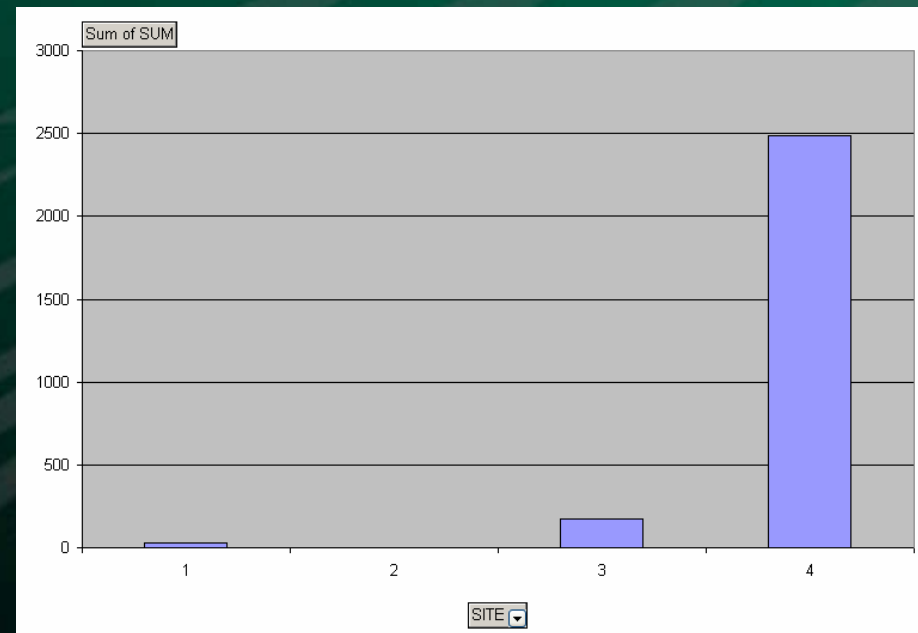
- Probe parameters
  - Tester platform – VLCLT UF 3000
  - Probe Card – Cantilever
  - Quad Site
  - Probe Points – 592
    - 148 points per site
- Issue:
  - Fuse Farm accumulators value and Fuse blown shows different blowing performances across sites
  - Site#4 needs more iterations to blow correct eFuse chain than the other sites
- Critical signal traces:
  - VPP Power
  - VPP Sense

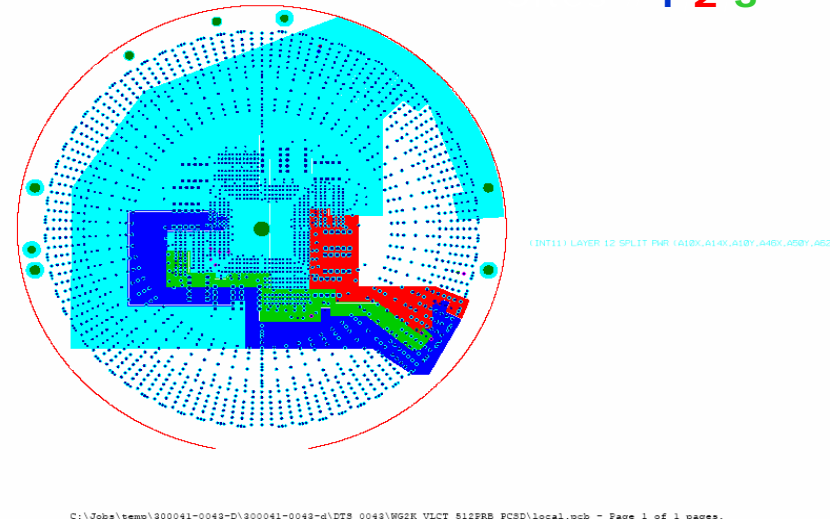
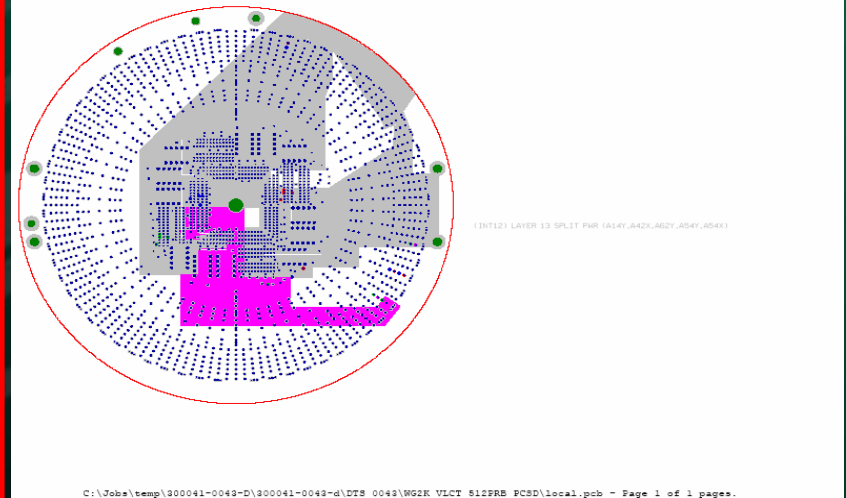
## VPP Connections

- Suspect contact issue at contact pads or traces resistance and length (capacitive coupling) causing reduced current on fuse blow pulse.
- TDR trace comparisons of both VPP Power and Sense indicated an additional length between sense and power trace different than sites 1 thru 3.
- Fuse blow test performed after adding a jumper between the force and sense traces eliminated issue.

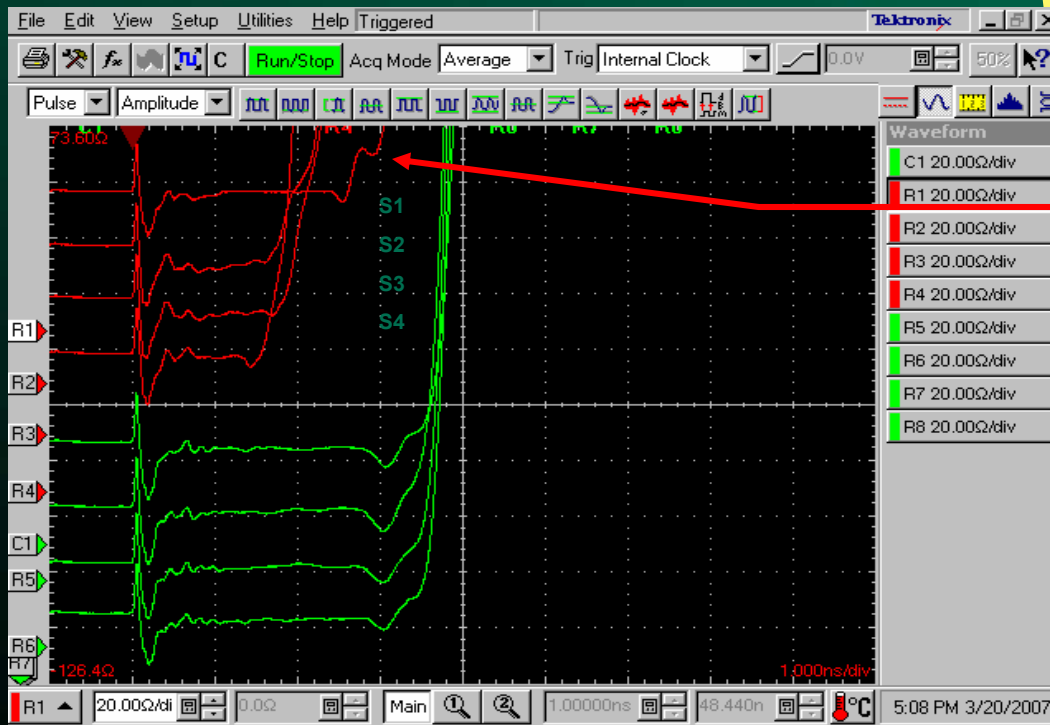
This area of the trace for site 1 indicates high impedance contact. (+17Ω specification requires <10Ω)

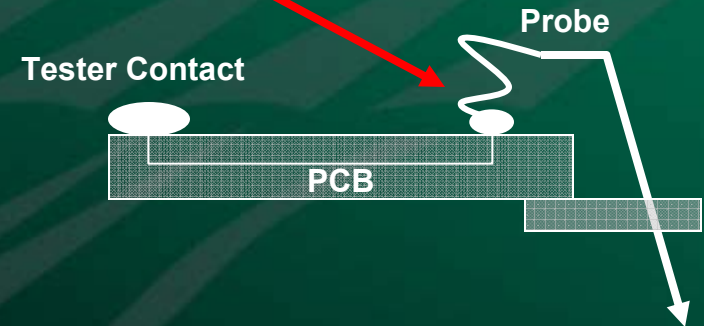
Further examination of the TDR trace can identify contact issues by indicating impedance measurement changes. In this case, poor probe wire contact to the PCB is indicated.
