# Analysis for Pre-Mature Worn-out of Vertical Probe Needle

**Wiljelm Carl K. Olalia**  
Process Engineer II  
Probe and Die Sales Department  
ON Semiconductor Philippines  
June 5-8, 2016

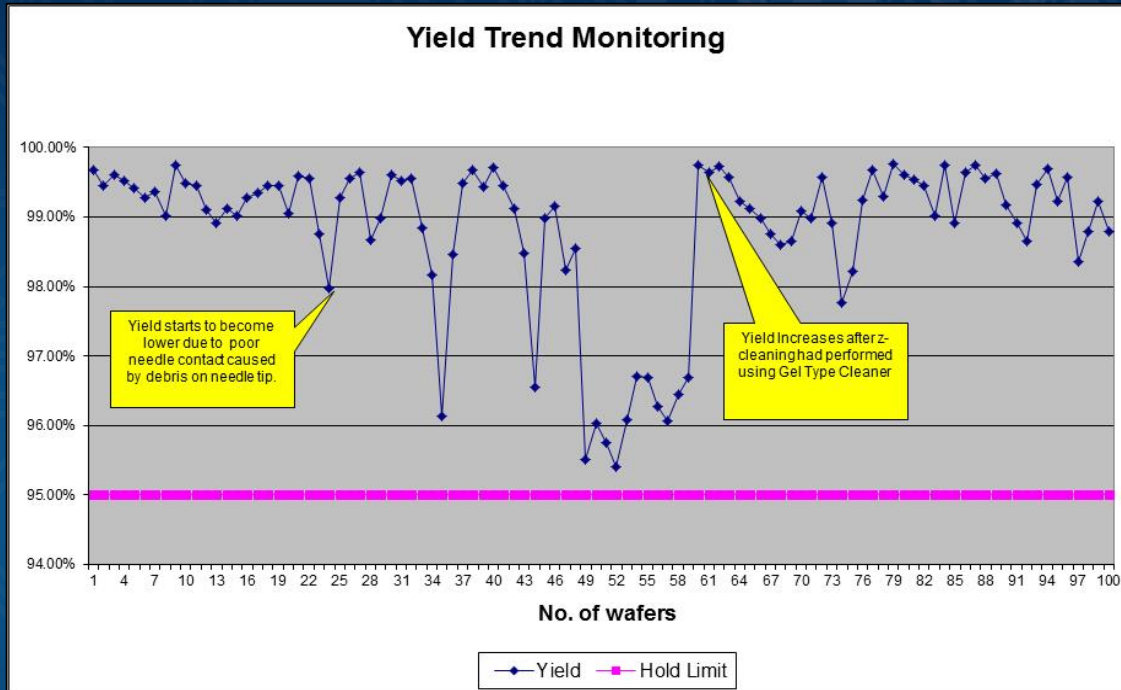
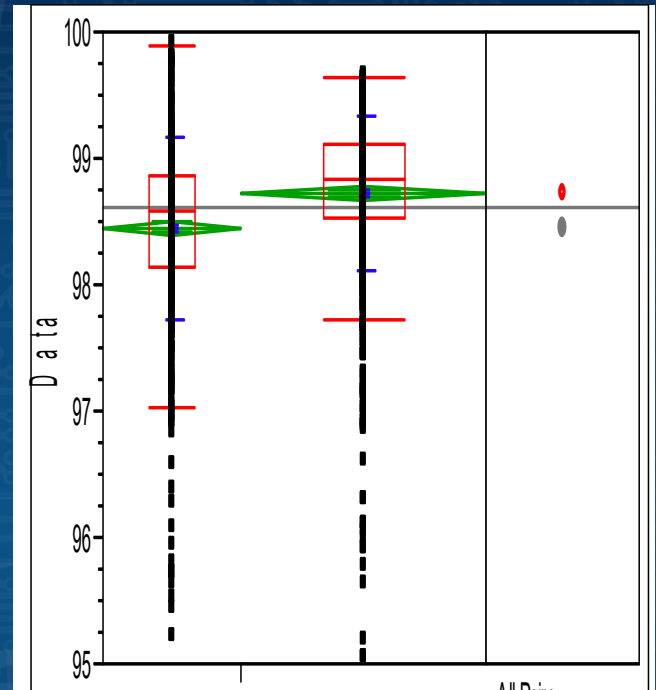
- As shown in the graph below, yield started to go below 95% after the 13th wafer.
- Yield becomes more inconsistent on wafer #24 to #59.
- Yield improve on the 60<sup>th</sup> wafer after z-cleaning perform using Gel Type Cleaner

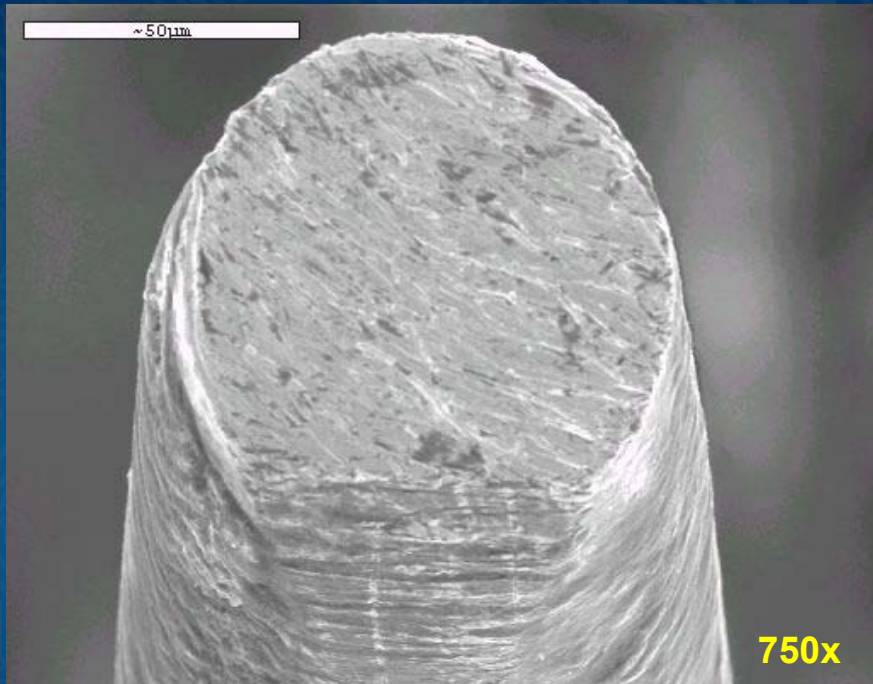
**Used Probe Needle**

- Vertical needle verified to have a performance deterioration which is evident on the wafer yields.
- This deterioration is caused by needle tip deformation and debris accumulated on the needle tip which is not been removed by brush alone.
- Brush can only remove the cloudlike dirt but cannot re-shape and remove the debris on needle tip
- Yield deterioration is due to poor probe tip condition.

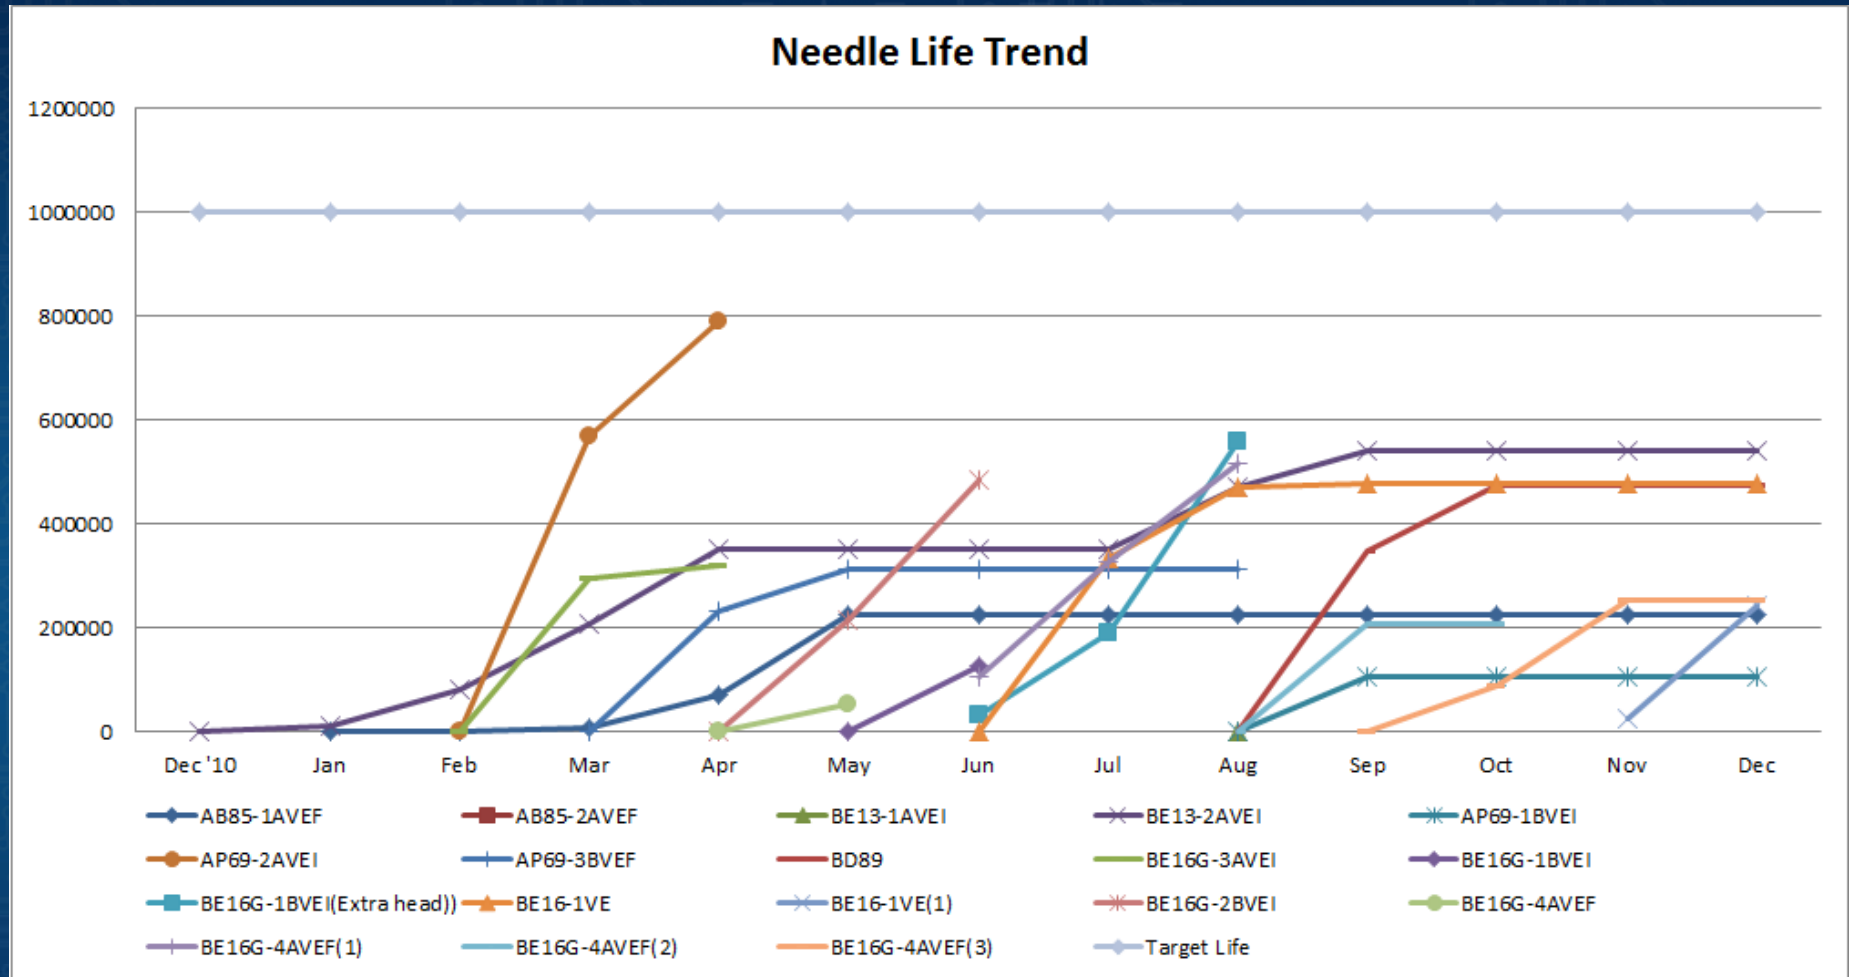
Maximum needle life recorded so far for Vertical Needle is ranging from 57,063 to 790,022 TD Count.

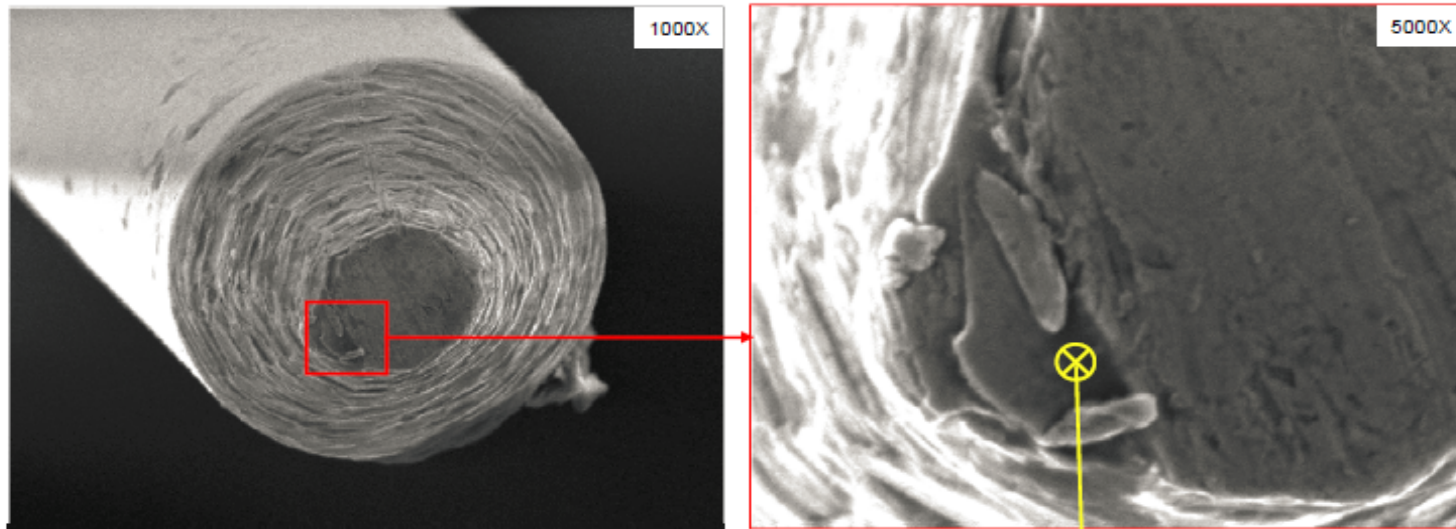
Figure 2. SEM+EDX results on Pin 4

SEM morphologies results on Pin site 4 showed no early wearing problem. EDX spectroscopy showed elemental composition of Copper (Cu), Palladium (Pd), Silver (Ag) and Carbon (C).

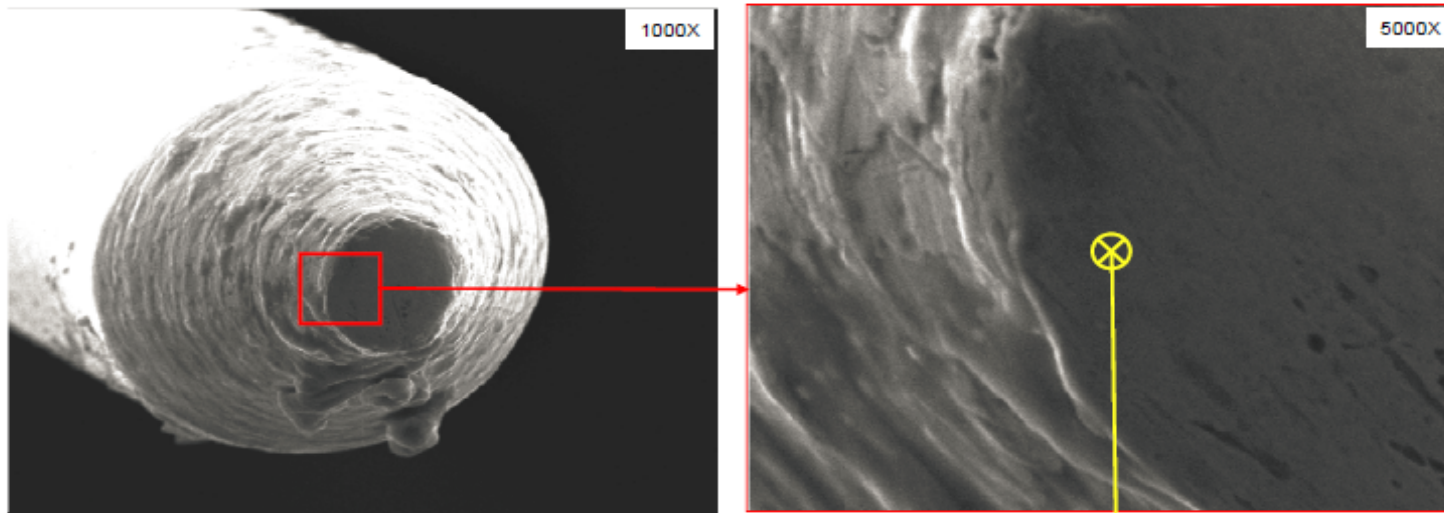
Figure 2. SEM+EDX results on Fresh Pin 7

SEM+EDX results on Pin site 7 also showed no early wearing problem. EDX detected also Copper (Cu), Palladium (Pd), Silver (Ag) and Carbon (C). Traces of Aluminum (Al) were also found w/c may come from the bonding pads.

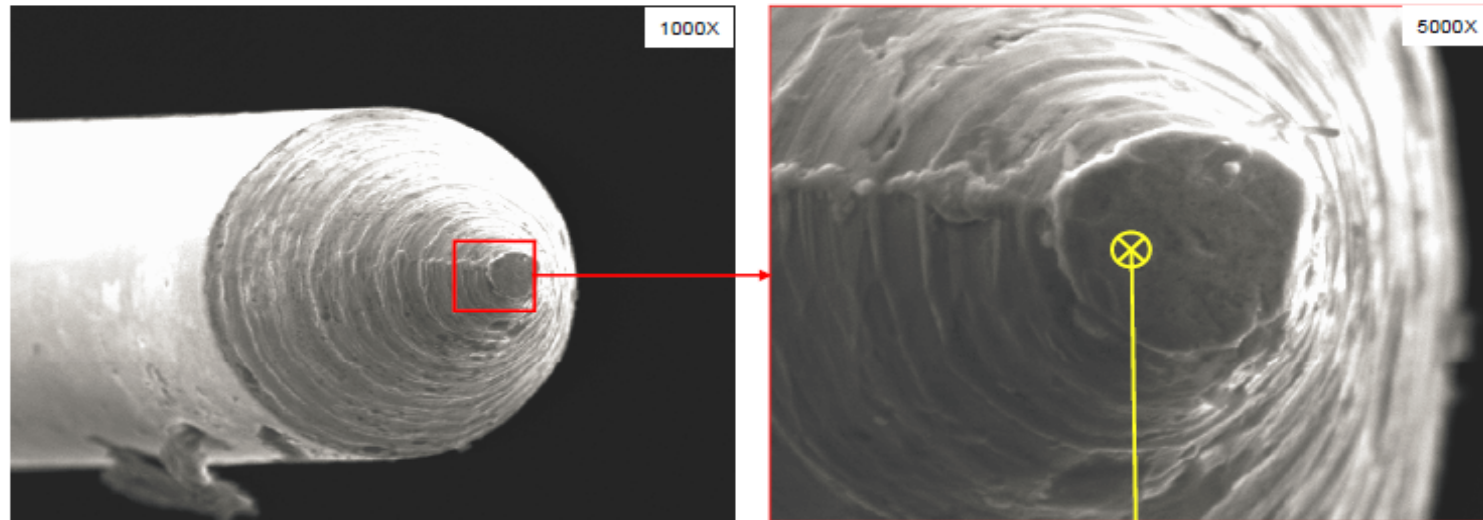
Figure 2. SEM+EDX results on Fresh Pin

SEM+EDX results on Fresh Pin showed elemental composition of Copper (Cu), Palladium (Pd), Silver (Ag) and Carbon.

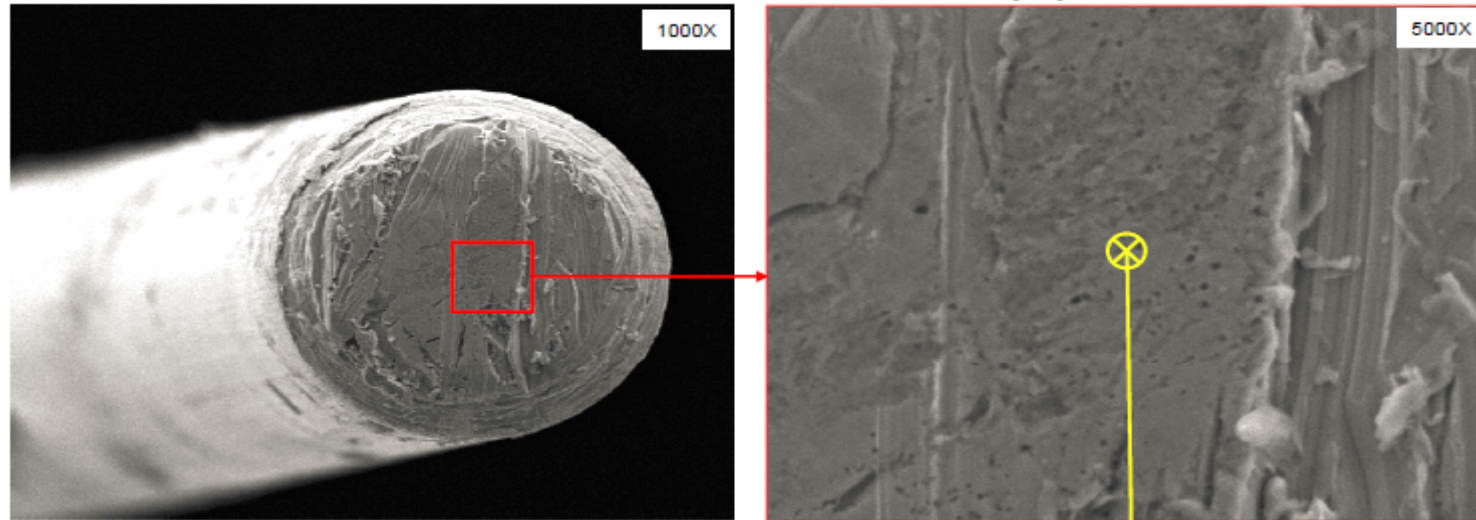
Figure 3. SEM+EDX results on Site 1 Pin

SEM+EDX results showed wear on Site (1) Pin. EDX detected presence of Aluminum (Al) and Silicon (Si) on the contact area of the pin.

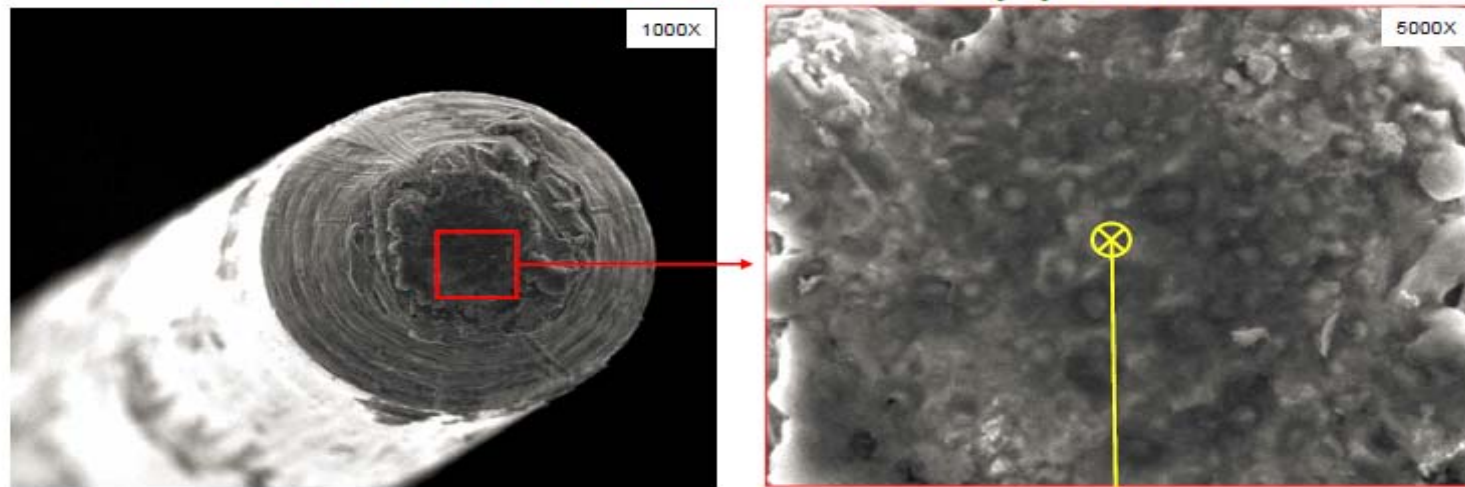
Figure 3. SEM+EDX results on Site 2 Pin

SEM+EDX results also showed wear on Site (1) Pin. Aluminum (Al) and Silicon (Si) are also present. Silicon in the form of passivation/glass ( $\text{SiO}_2$ ) is a harder material comparing to the metallic pins. The passivation can cause wear on the pins during contact.
