Practical Method For Detecting Hot-Stepping, Micro-Arcing Or Hot-Switching During Wafer Probe

Enrique Guerra (Author) Imran Ahmed (Presenter) Texas Instruments Inc.

June 2-5,2019

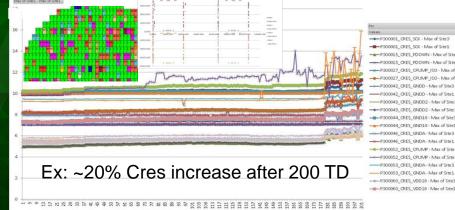
Accumulation of debris and non-conductive

Cres increase over time with hot-stepping

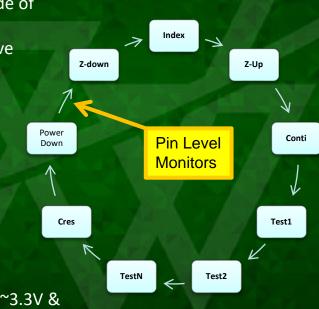
- Test Case #1:
- Device suffered from yield stability problems including Cres/Continuity failures & Prober misalignment failures
 - Upon probe card visual inspection found blobs build-up on side of probe tips.
 - Probe tips affected were connected to voltage reference active components.

- Added Monitor Routine at EOF and found some pins keeping ~3.3V &
 2.5V due to PS on Volt Reference IC left on and not mapped to a site
- Fixed by mapping Ref32xx PS (or Enable pin) to each site allowing power down by site.

Monitor Levels Before Fix: VREFXXPS~5V, VR3233~3.3V & VR3225~2.5V @ EOF

Monitor Levels After Fix: VREFXXPS~0V, VR3233~0V & VR3225~0V @ EOF

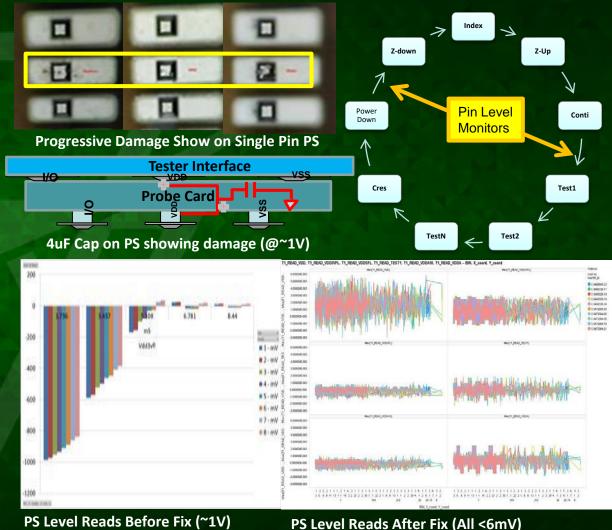
- Test Case #3:
- Device Premature Continuity failures & Card Required Probe Tip Replacement after regular prolonged use.
 - Upon visual inspection found one PS pin being damaged by Micro-arcing with evidence of craters and pin alloy missing causing premature continuity failures after a prolonged continuous use (Ex: One Month).

- Main Probe tips involved was single pin Power Supply connected to a 4uF decoupling capacitor.
 - Added Monitor Routine for all PS pins at end of every test and found PS involved measuring ~1V at EOF when failing continuity.

- Found power down routine not having enough current and discharge times for this power supply after a continuity failure, thus, leaving ~1V charge on this pin after an Open failure.

- Added correct amount of discharge time and current.
 - After fix, reads for all PS pins on a production run sample did not show voltage spikes at EOF for any bin conditions and levels below <6mV.
