# Evaluation of Cantilever Probe-Induced Dielectric Cracks in Cu/Low-k Devices

C.D. Hartfield, D. Stillman, J. Aronoff  
Texas Instruments, Dallas, TX

**SouthWest Test Workshop - 2004**

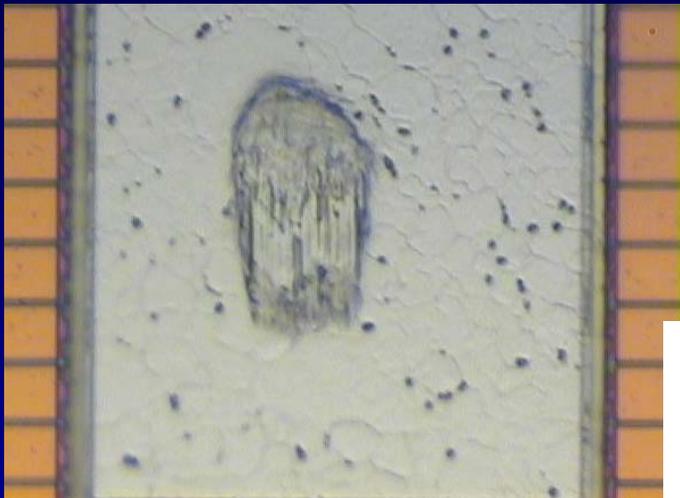
- Scrub marks indicate different “kicking action”

Horseshoe  
crab  
similarity

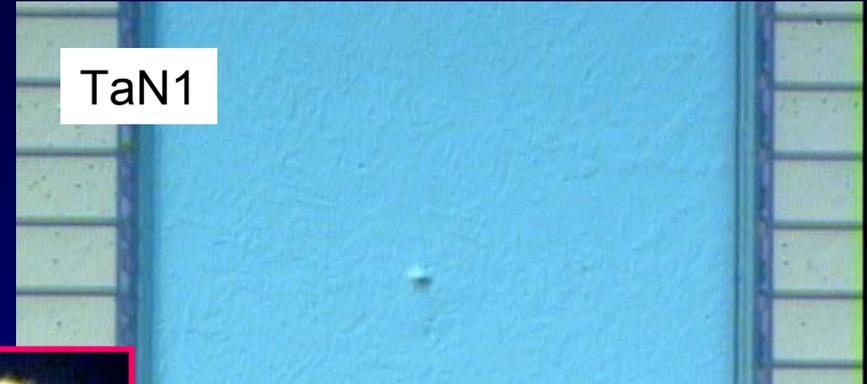
**All other needles break at  
6x or 7x TD**
