Eliminating Dielectric Cracking of Cu/Low-k Devices During Cantilever Probing

D. Stillman and C.D Hartfield
Texas Instruments, Dallas, TX

June 6th 2005

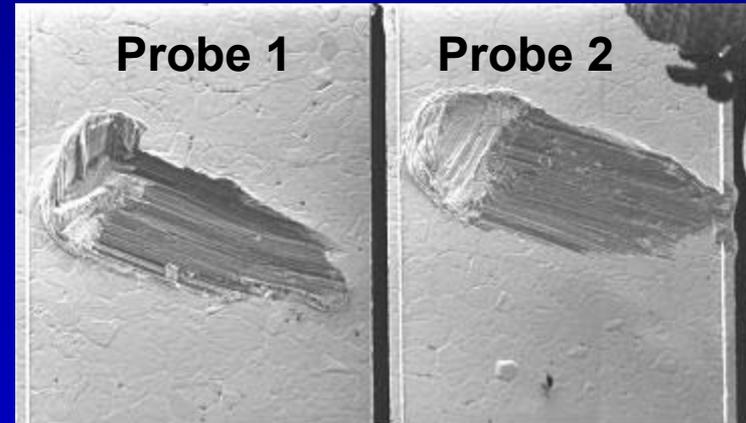
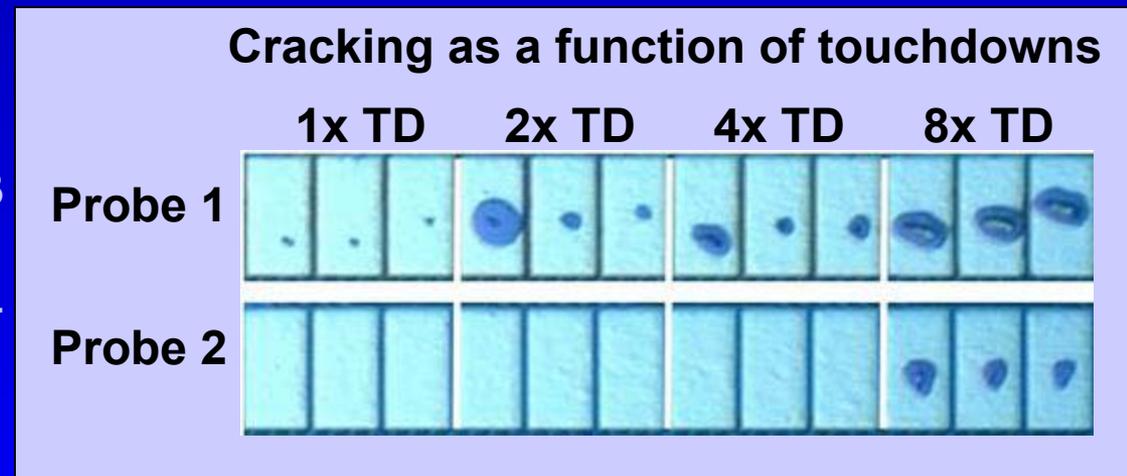
- Experiments show that probe force is not the only leading factor causing cracking.

- Two needles
- Identical force
- Different scrubs and cracks results

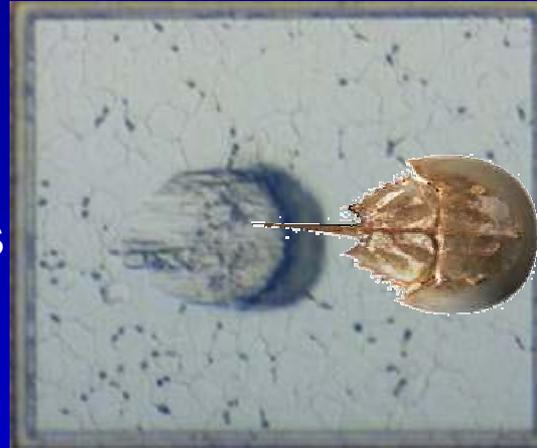
Horse shoe crab scrub marks- no cracking

- BCF was a key factor in cracking in past technology nodes.
- Different vendors showing different results in scrub marks and cracking.
- Scrub mark shape correlates to cracking of low-k dielectrics.
- Scrub shape correlates with probe tier.
- **Majority of dielectric cracking is induced by needles on tiers one and three on a 6 tier quad site shelf probe card**

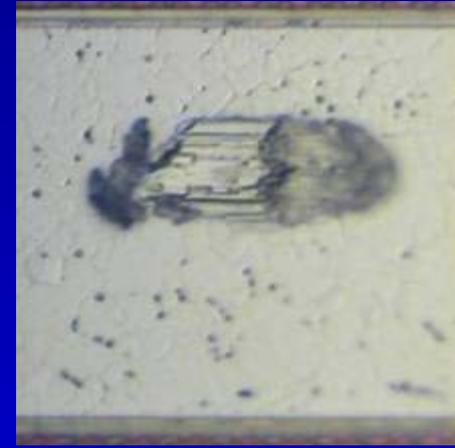
Comet scrub marks- cracking

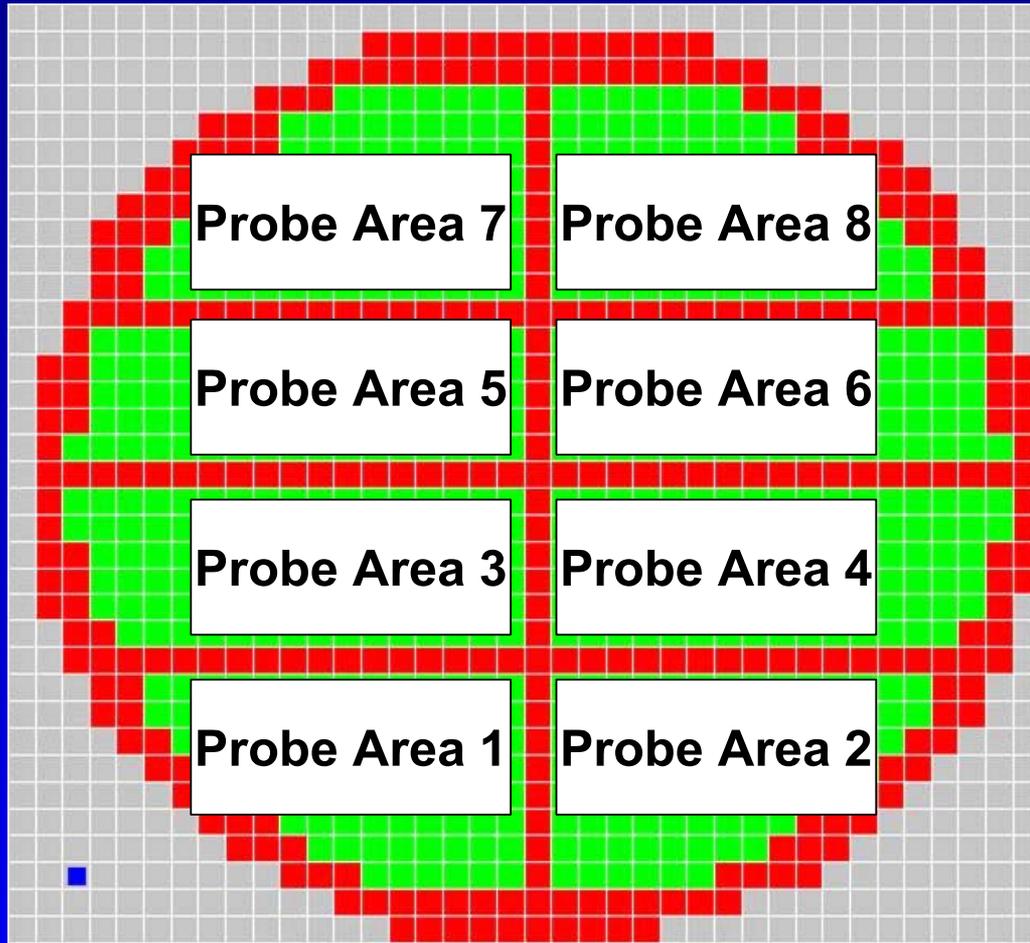
Approach Probing

Probing Settings

- Full production over-travel
- Cleaning of the probe needles at the beginning of the wafer only

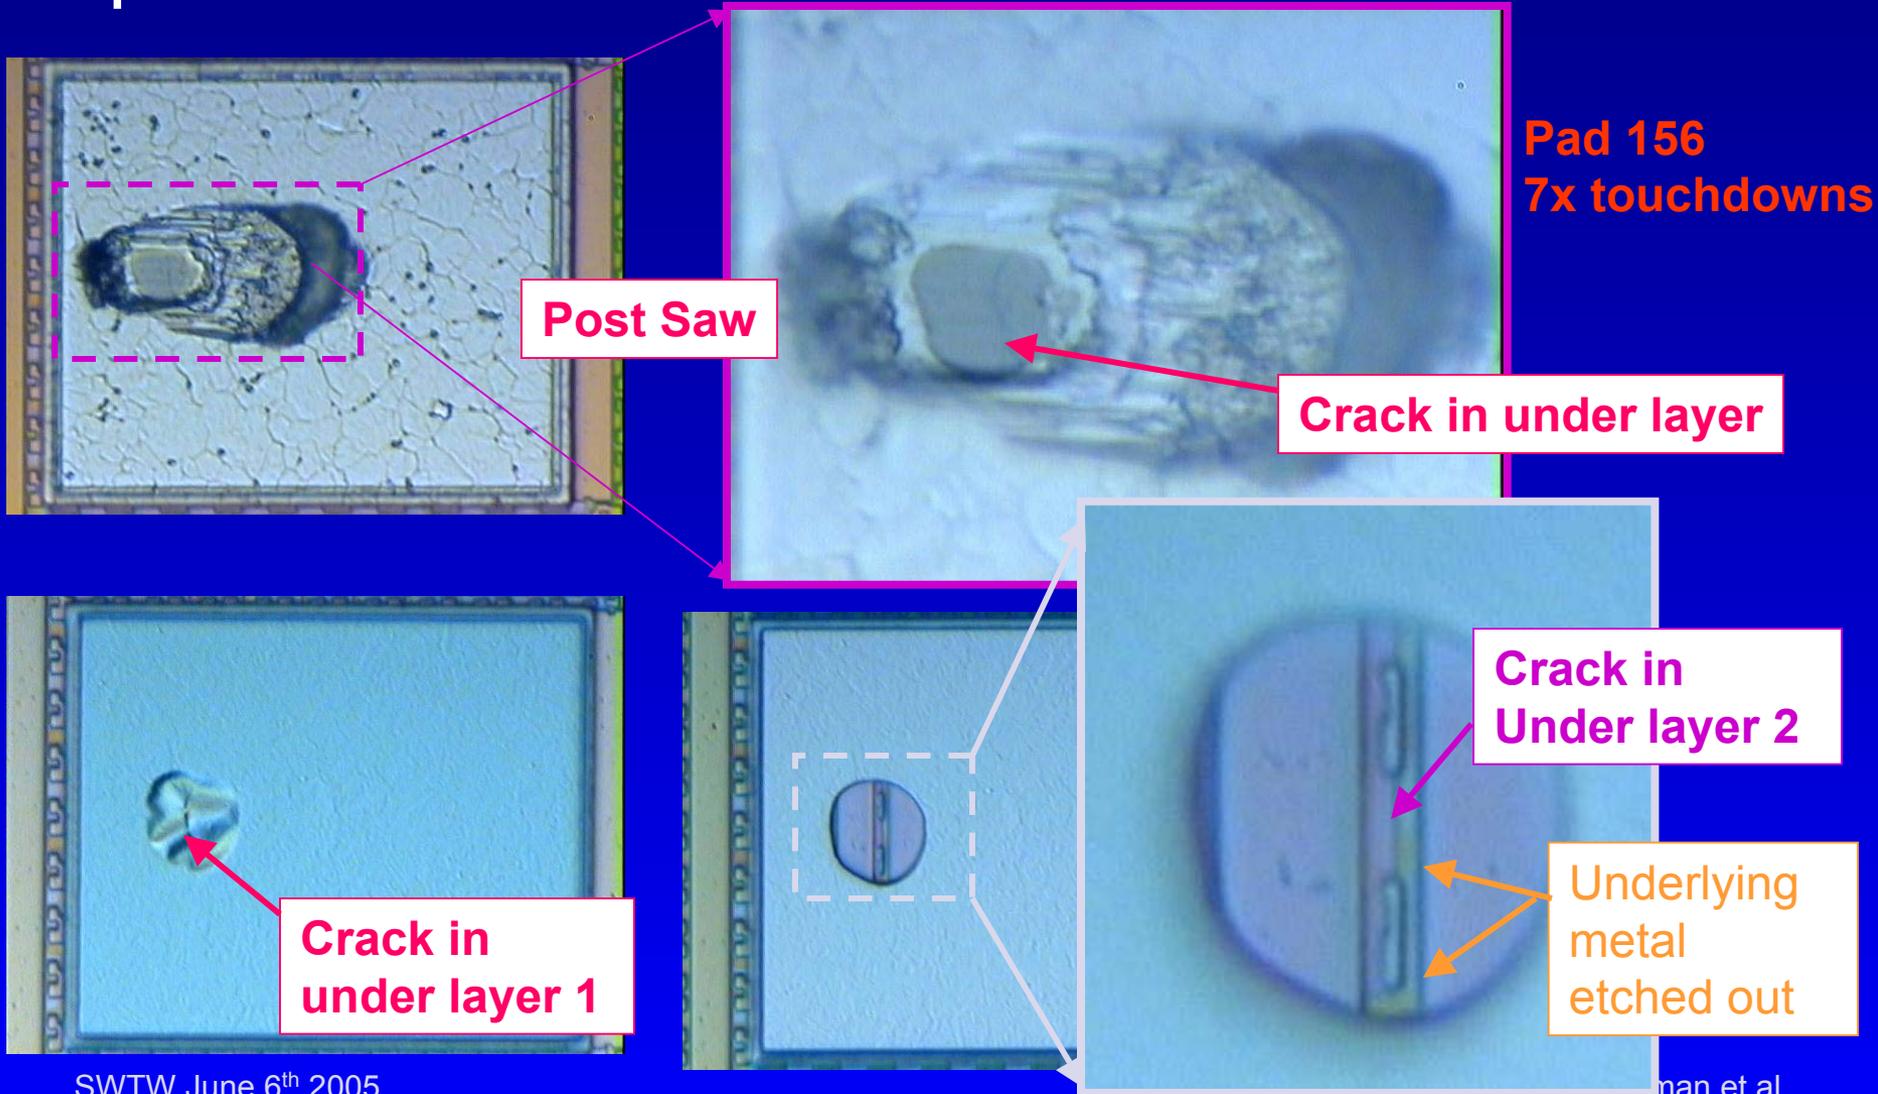
Inspection/Documentation

- Incoming scrub marks
- Post wafer saw
- Post wet etch

- Cracked pads
- Repeating pins
- Needle number, site and tier.

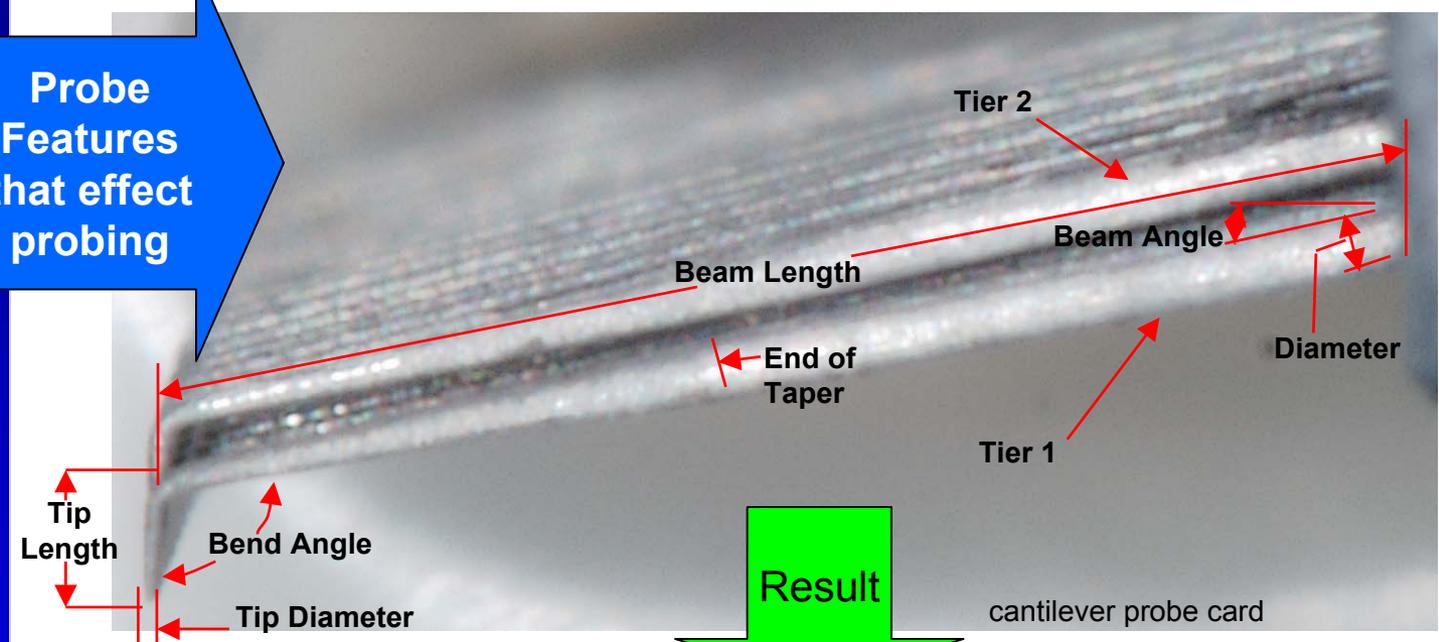
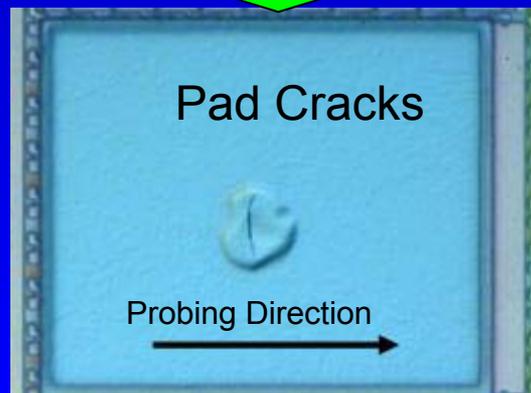
Probe Features that effect probing

- ~~Tip Shape~~
- ~~Tip Diameter~~
- Approach Angle
- ~~Beam Angle~~
- ~~Wire Diameter~~
- ~~Under Layer Roughness~~
- Beam Length
- ~~Taper Method~~
- Tip Length
- Knee Diameter
- ~~Difference in vendors~~
- ~~Wire Material~~
- ~~Probe Force~~
- ~~Probe Chuck Impact~~
- Taper Length

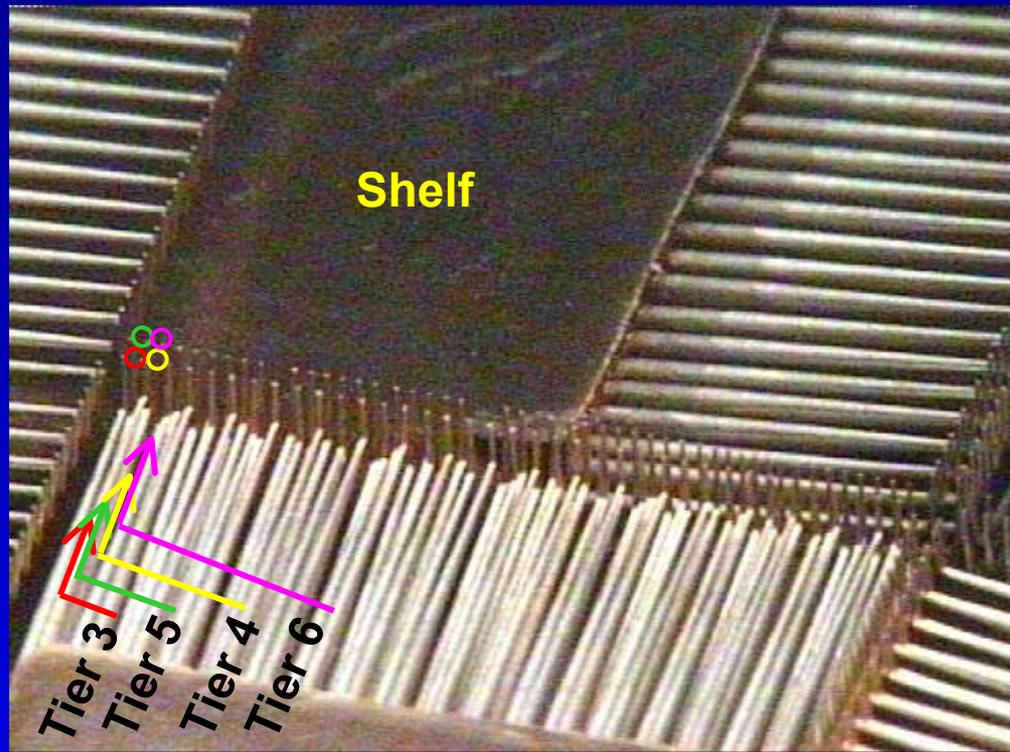
Bottom View of probe card

Needle Modification Tier and Shelf Design

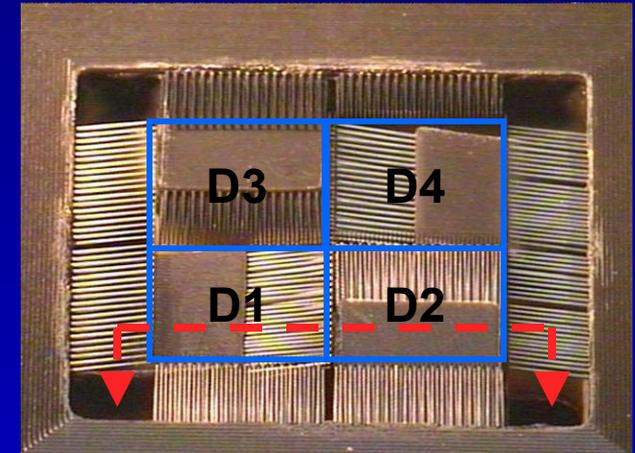
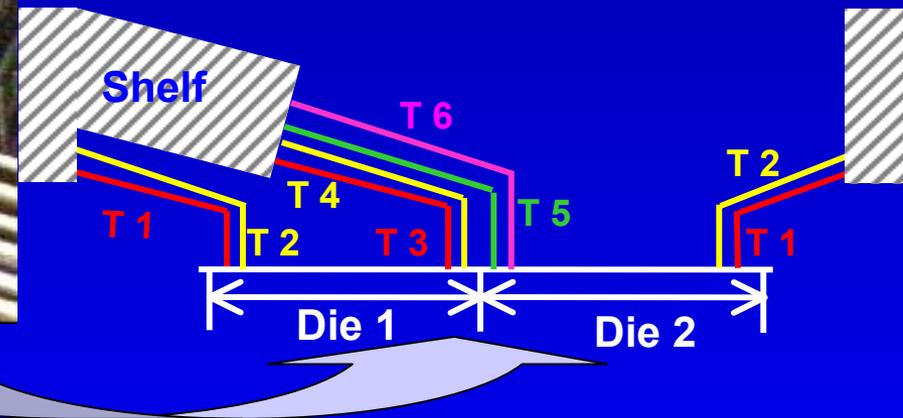
Rigid needles = Short beam length + Short tip lengths + Short taper lengths = Cracking

Tier 1 = Tier 3 = Short beam length + Short tip lengths + Short taper lengths = Rigid needles = Cracking

- Rigidity of the probe needles cause deep scrub marks and cracking of low-k dielectrics
- Tier 1 and tier 3 are the most rigid needles in a 6 tier quad site design
- Increasing the Beam, Tip and Taper length of the probe needles reduces the severity of scrub damage and ultimately eliminates cracking of the low-k dielectrics

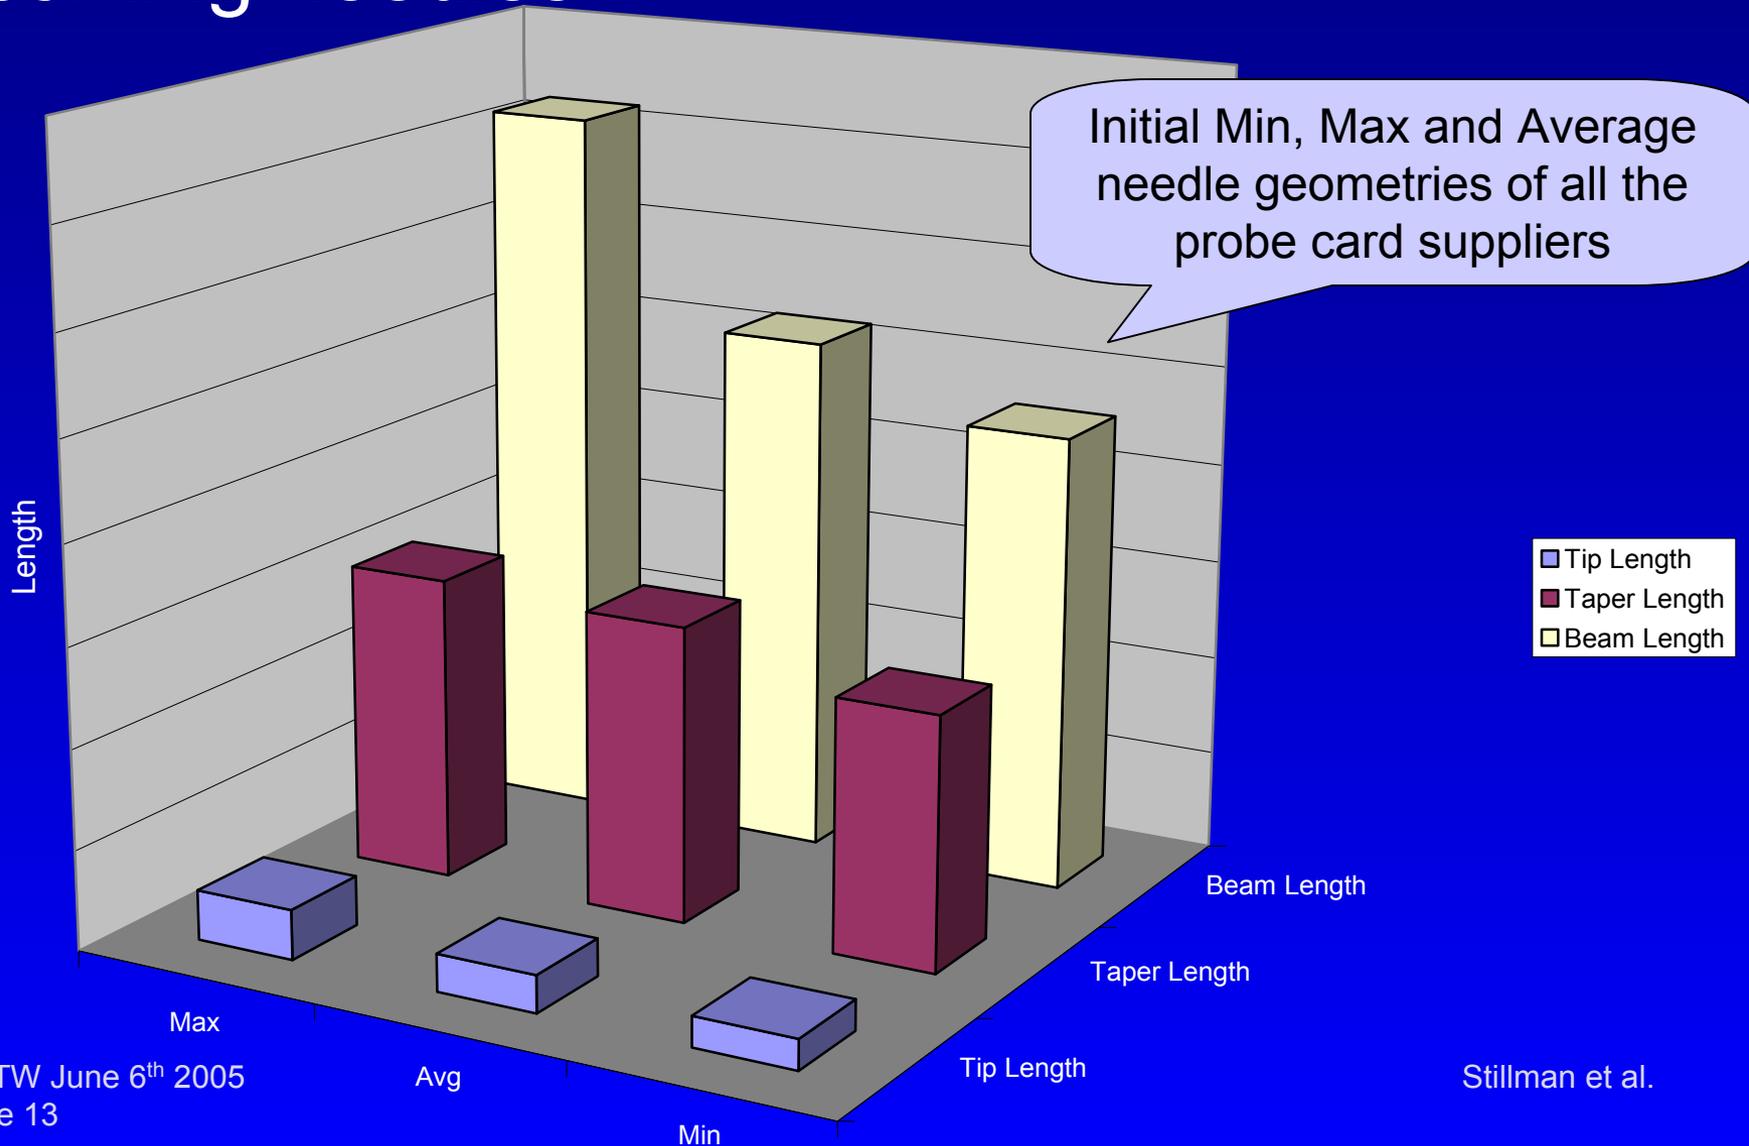
Incoming needles

- Worked with different probe card suppliers
- All suppliers have different:
 - Needle geometries
 - Build practices
 - Cracking results
