The „probe card signature“ – syndrome
or who has the “old maid”

Frank Pietzschmann (IFX)
James Andersen (APLLC)

Dresden,
June 2005

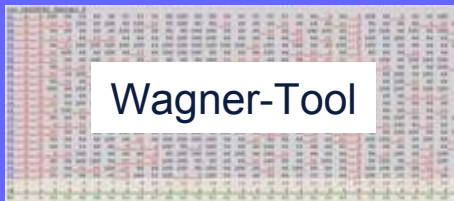
Cres online Monitoring

... detect WT yield drops < 1%

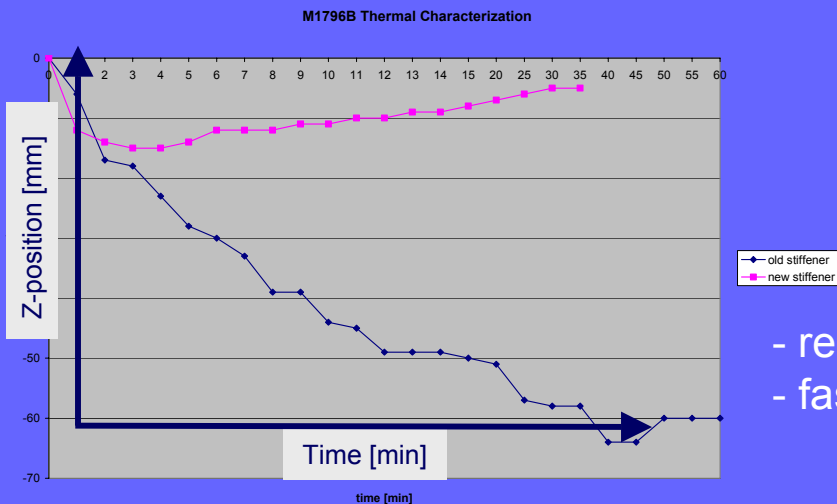
Comparison Major Scrub Lengths

- reduced scrub length
differences $\times 1,6 \dots \times 4,3$
- faster recovery time
up to $\times 3$

- reduced z-movement range $\times 4,3$
- faster return point $\times 10$

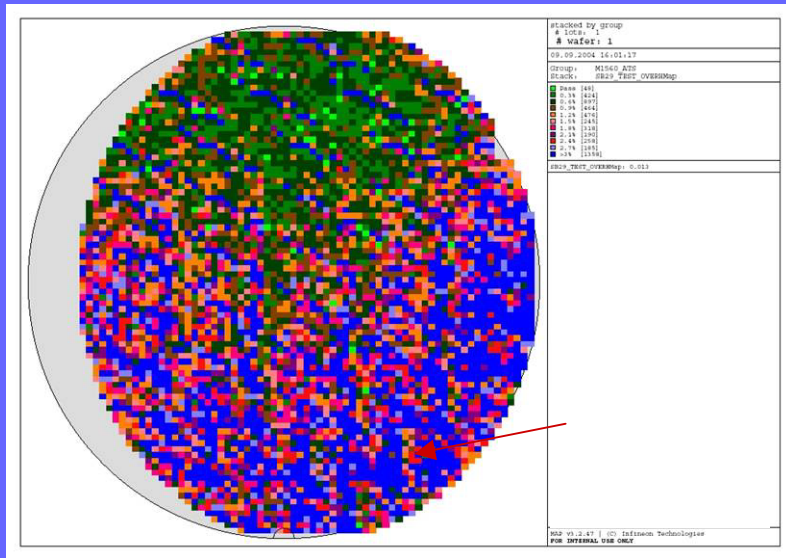
yield stacked map 23 wafers

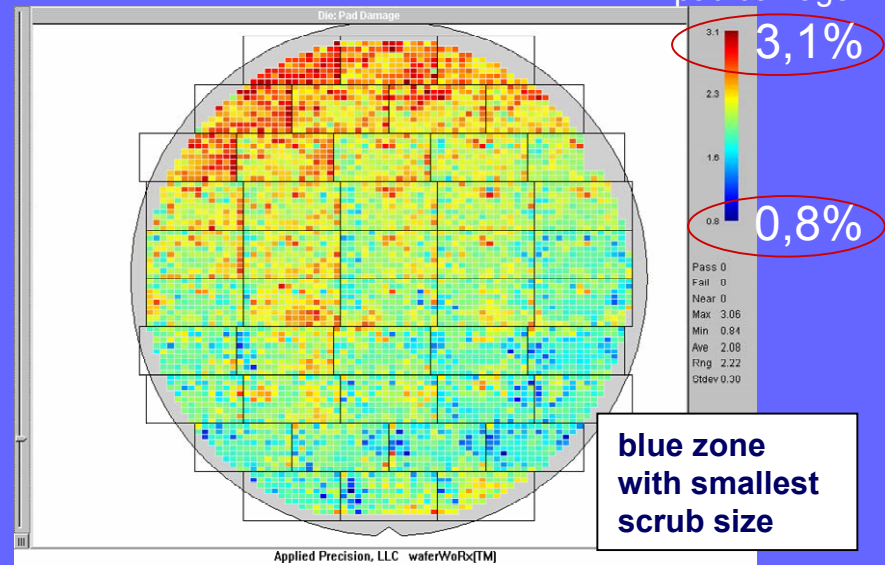
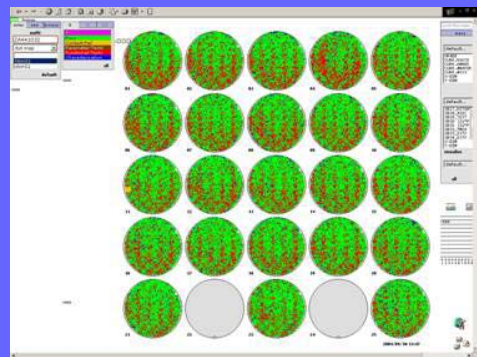
scrub mark analysis 1 wafer

matched pattern!

same pin with different scrub sizes over the wafer!

Failure Signature Example – chuck movement (shift)

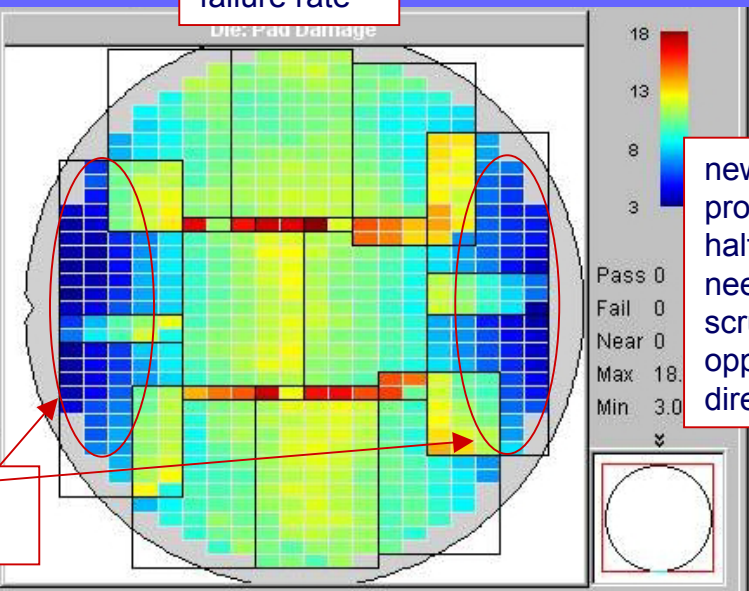
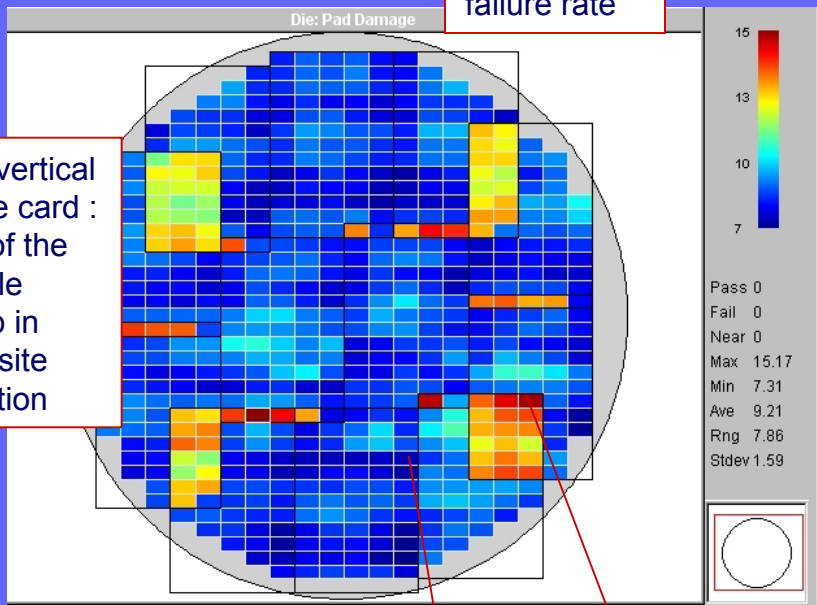
Inconsistent pad damage = higher failure rate

Consistent pad damage = lower failure rate

standard vertical probe card : all needles scrub in one direction

new vertical probe card : half of the needle scrub in opposite direction

highest failure rate

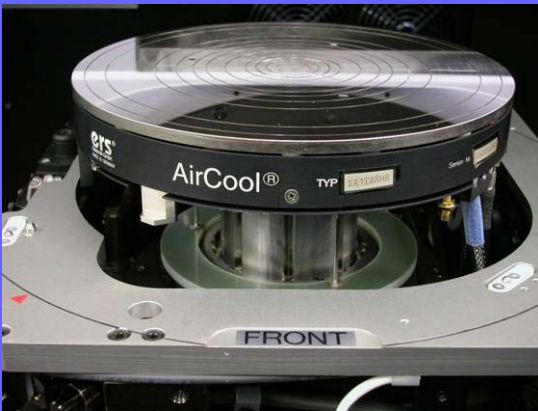
This movement reduces the scrub length = online cleaning necessary

problem overlap zones

Failure Signature Example – chuck movement (theta)

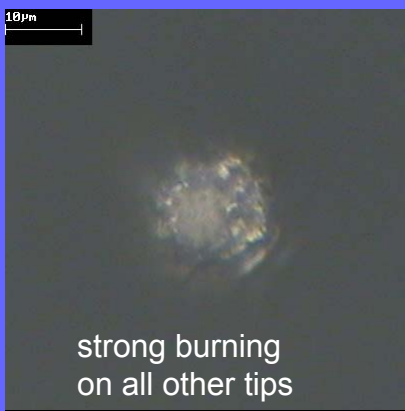
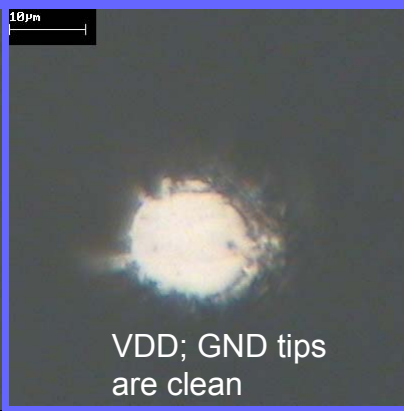
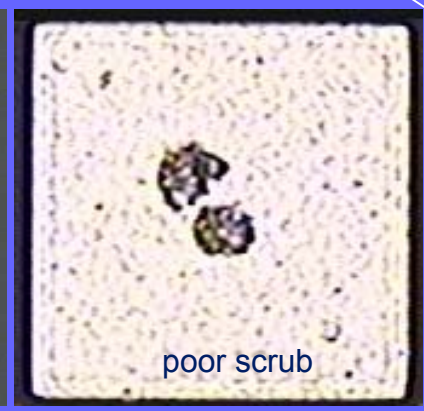
burned beam

Implemented test:
Test forces -5mA pin-by-pin at every BPMU card. The forcing voltage can reach -24V. Number of simultaneously forced pins is equal to BPMU cards attached to device. On contact problem first the Al2O3 is electrically broken, than small current is forced to clean the contact and decrease the contact resistance.
! IMPORTANT ! GND and all supply voltages must be forced to 0V.
