# Controlling BP Damage at 129C Probing

Daniel Fresquez, Eddie McClanahan and Al Wegleitner  
Texas Instruments, Dallas, TX

June 11<sup>th</sup> 2006

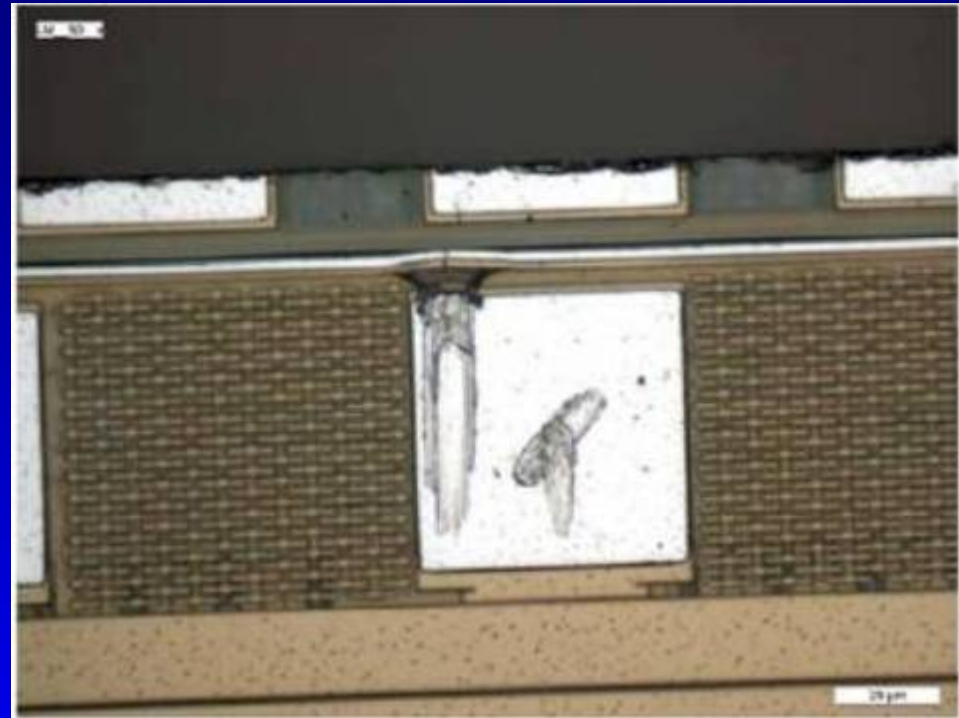
# BP/MA Sources Probe at 125C

Bond Pad Surface  
Test Times  
Cleaning Time  
Cleaning Frequency  
Chuck Temp  
Camera Heating  
Z-Axis Travel  
Interface design  
Interface Materials  
Calibration Settings  
PC Materials  
Needle Tip Size  
GPIB Communication  
Gravity Programming

**Conditions  
that effect  
MA/Damage**

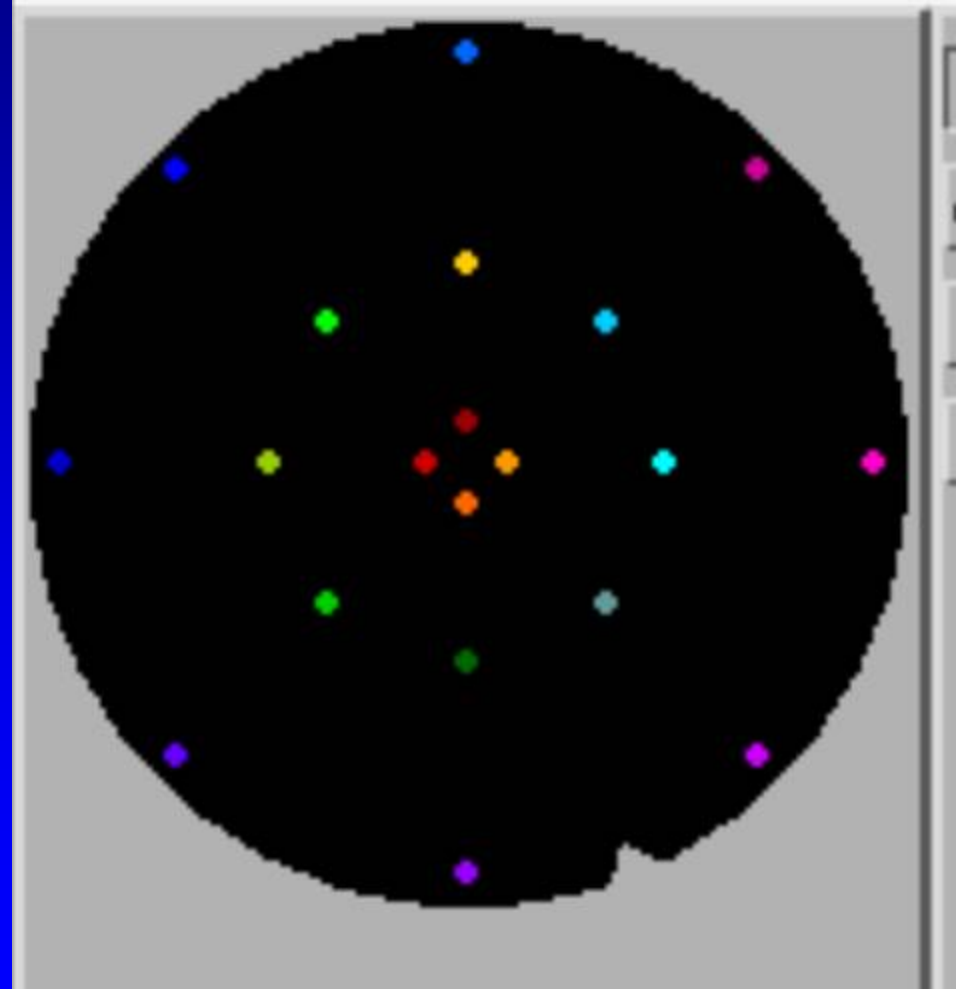
# SensArray Integrated Wafer

- Enabled 17 sensors
- Set sample rate at 1/sec after a 3 min delay
- Started the data collection sequence
- Loaded the wafer on the chuck for approx. 7 min

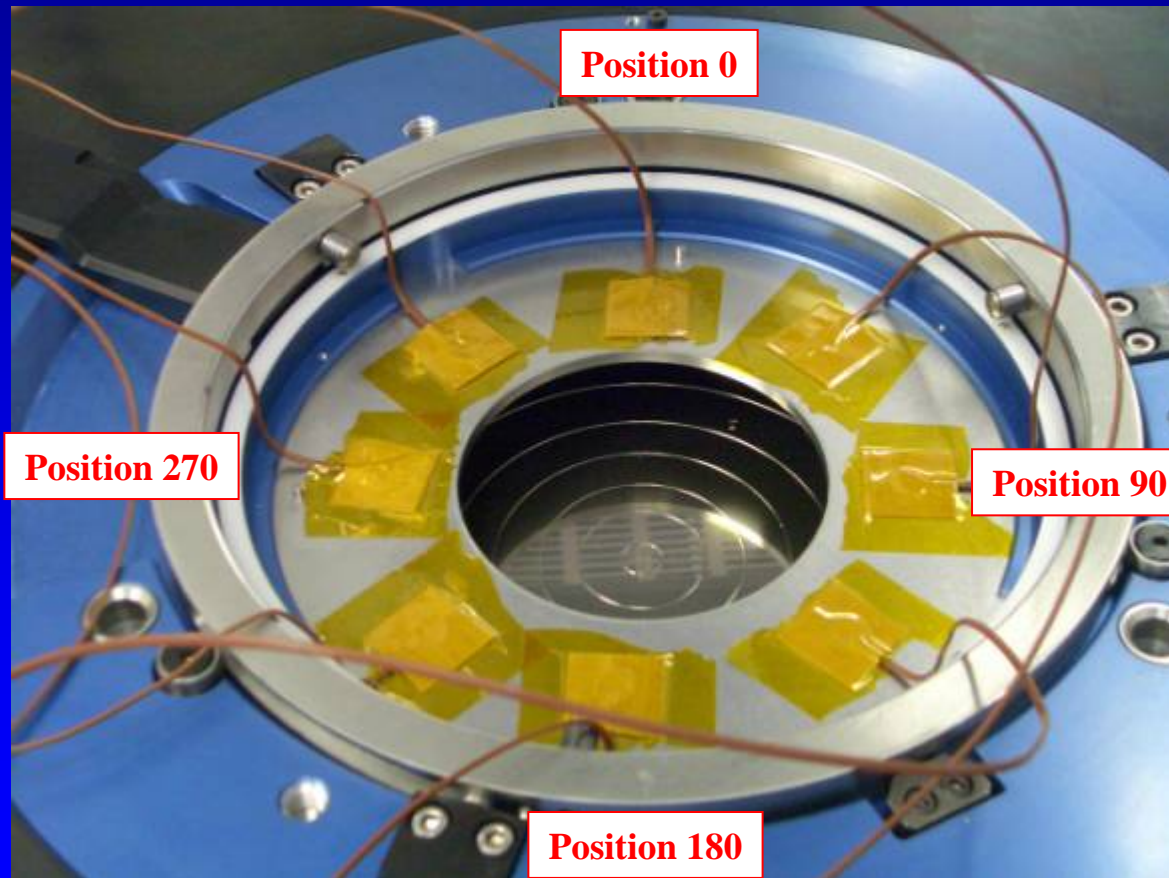
### Thermocouple Setup & Location

# TKB 197 Thermal Profile

## Standard Steel VLCT Ring

**Prober Rear**

**Prober Front**

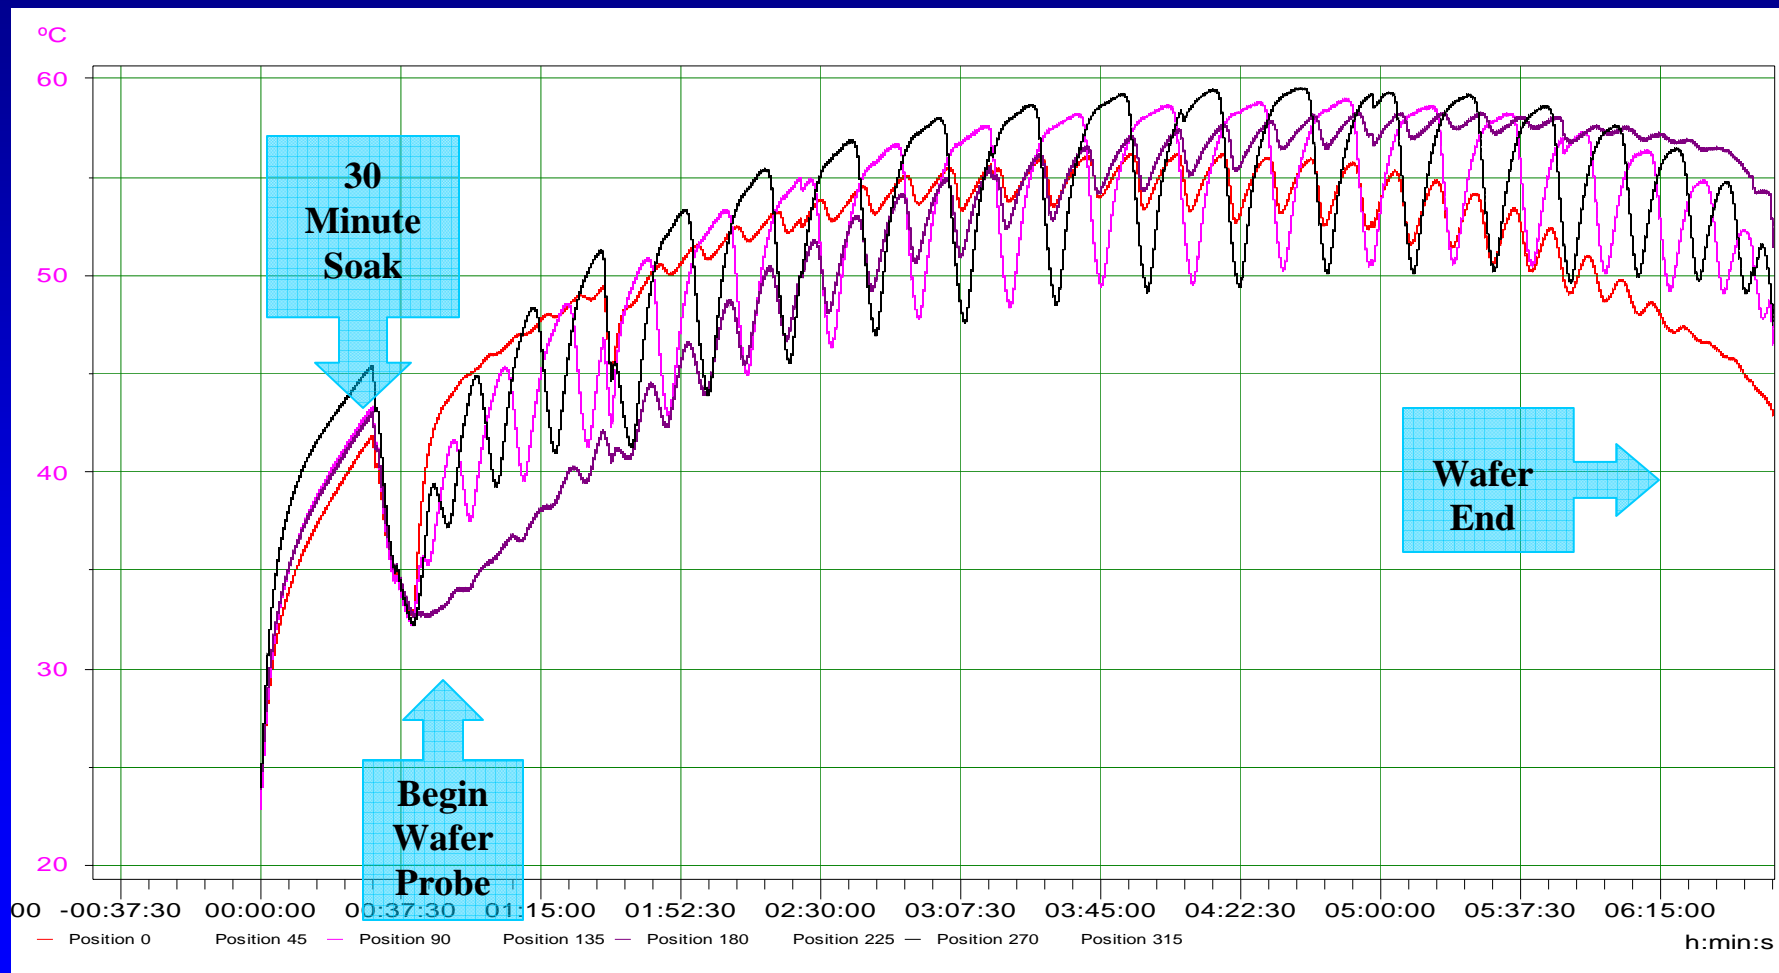
Complete wafer probe

# TKB 197 Thermal Profile

Standard Steel VLCT Ring

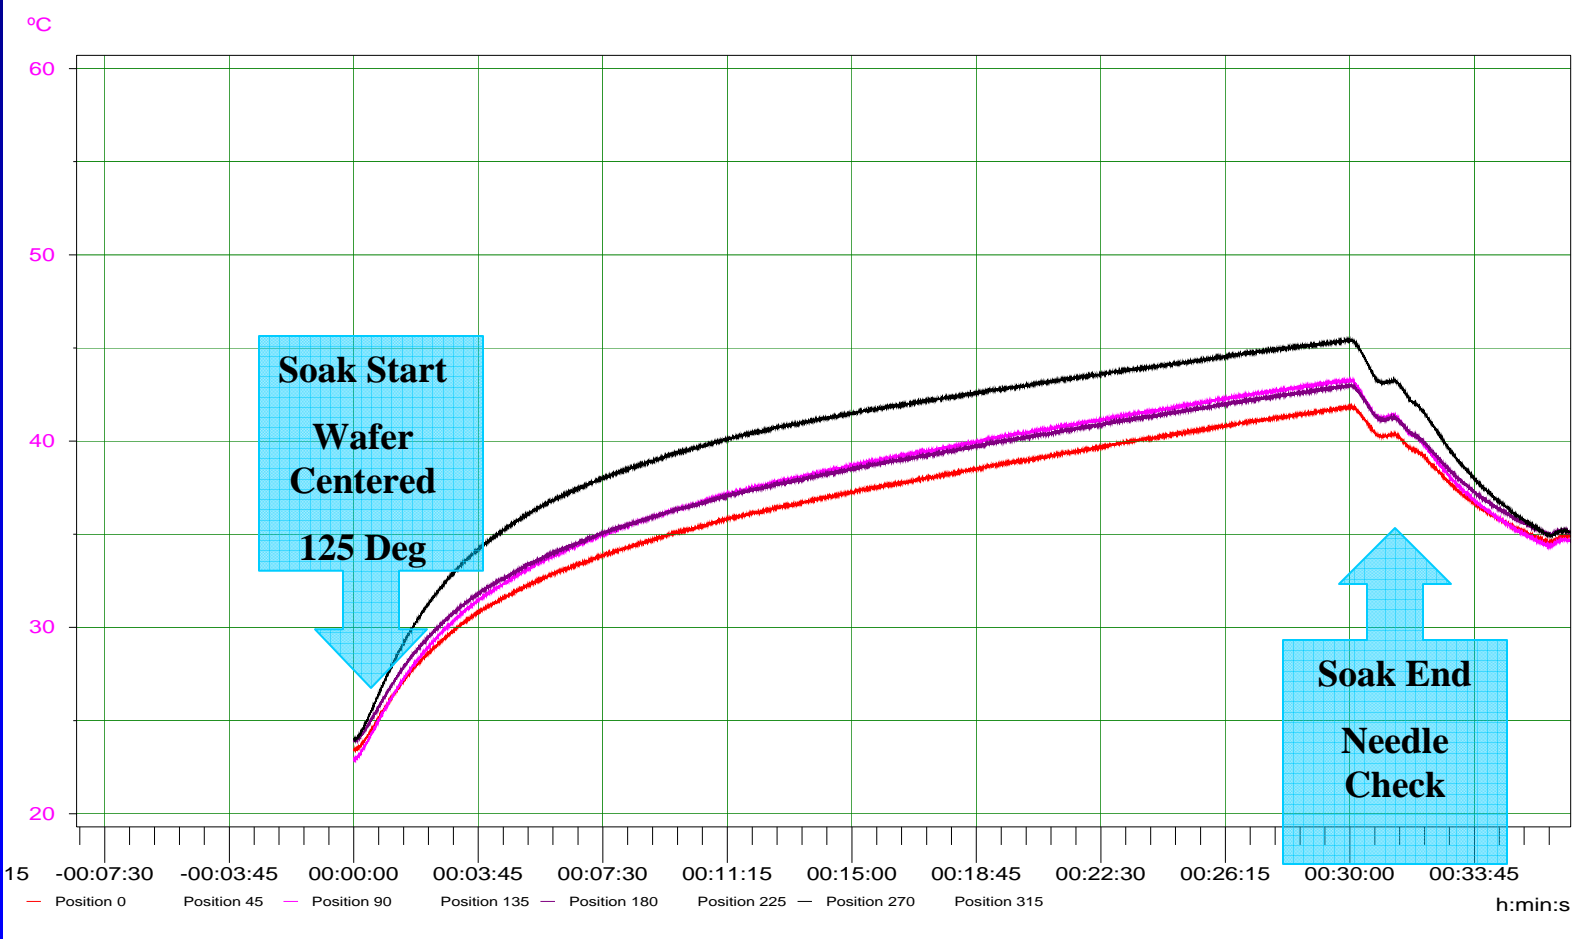
### 30 Minute Soak

# TKB 197 Thermal Profile

## Standard Steel VLCT Ring

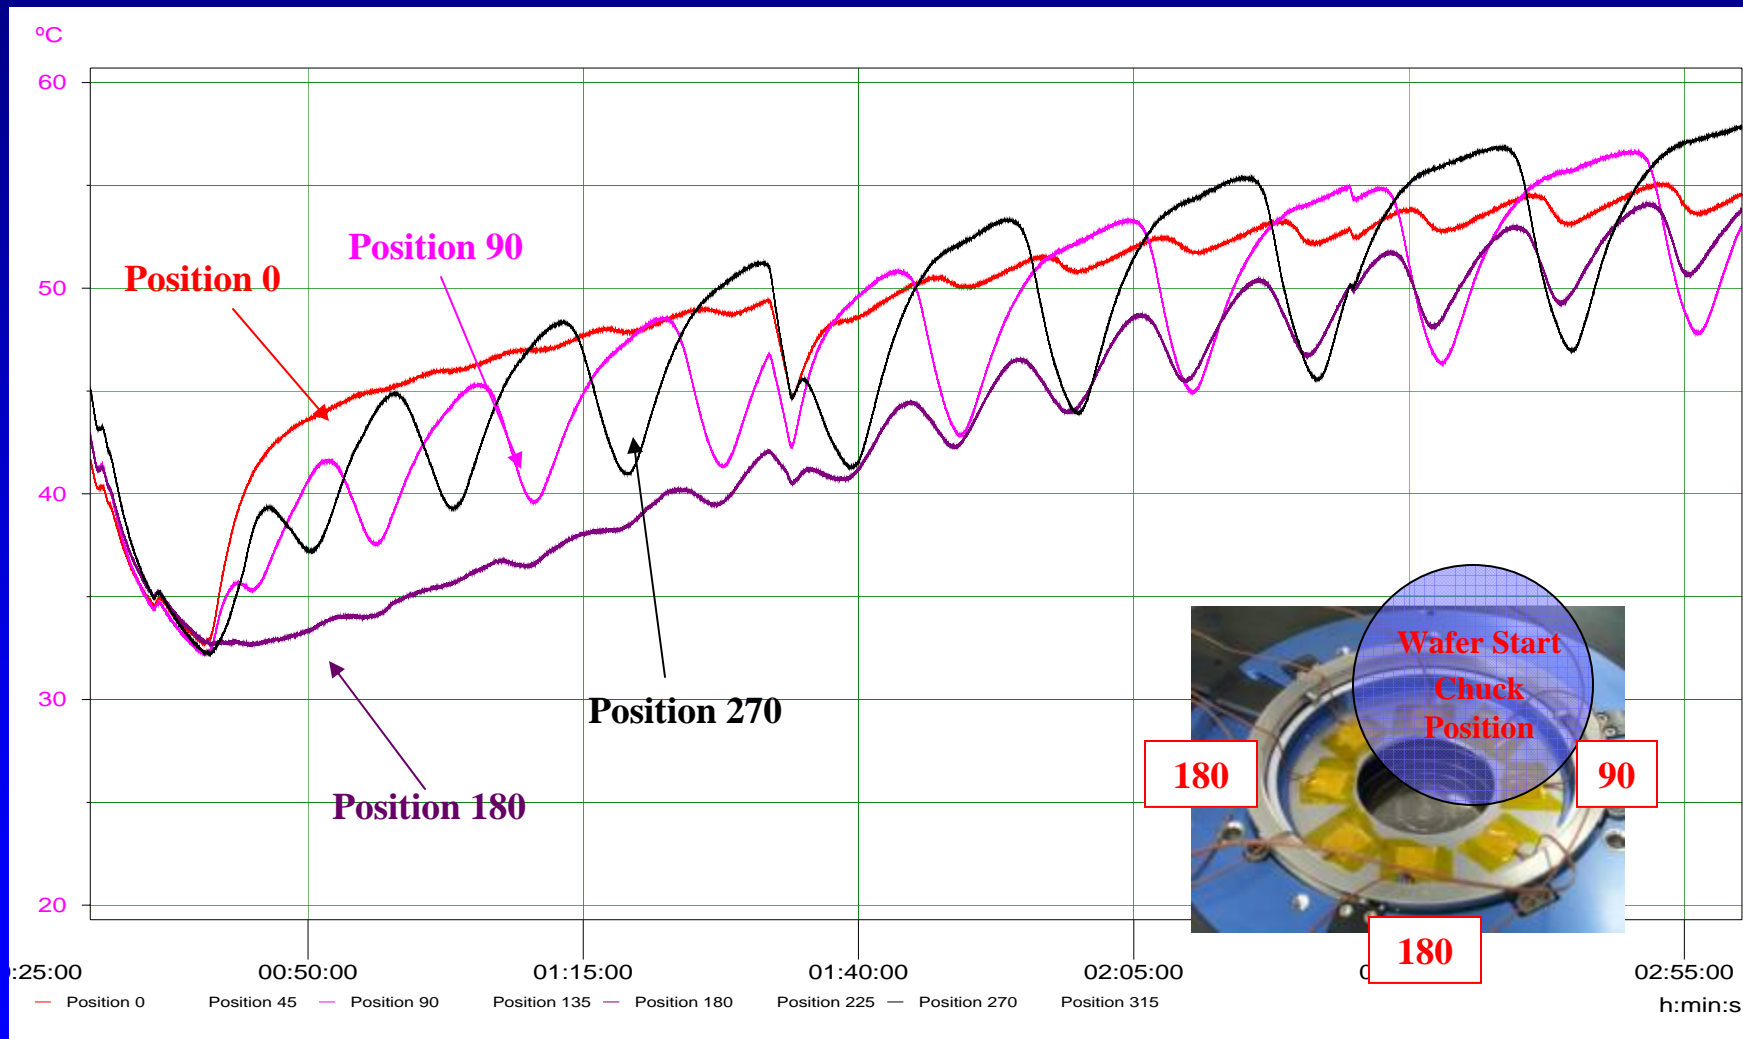
### Beginning of wafer

# TKB 197 Thermal Profile

## Standard Steel VLCT Ring

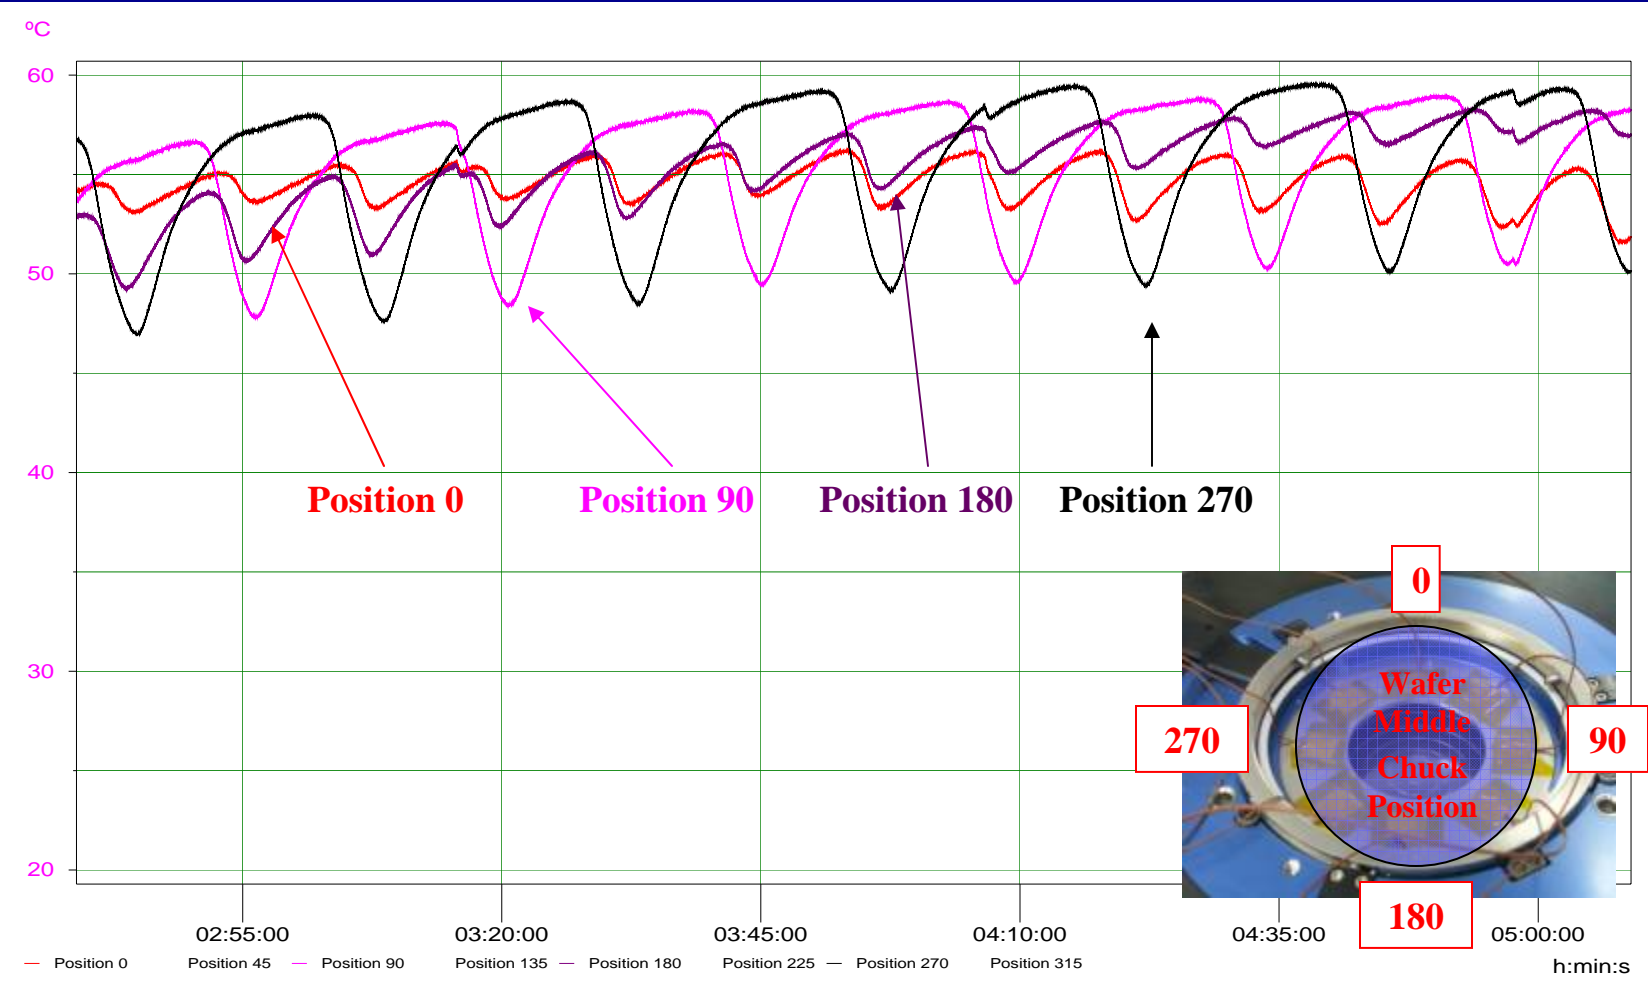
Middle of wafer

# TKB 197 Thermal Profile

## Standard Steel VLCT Ring

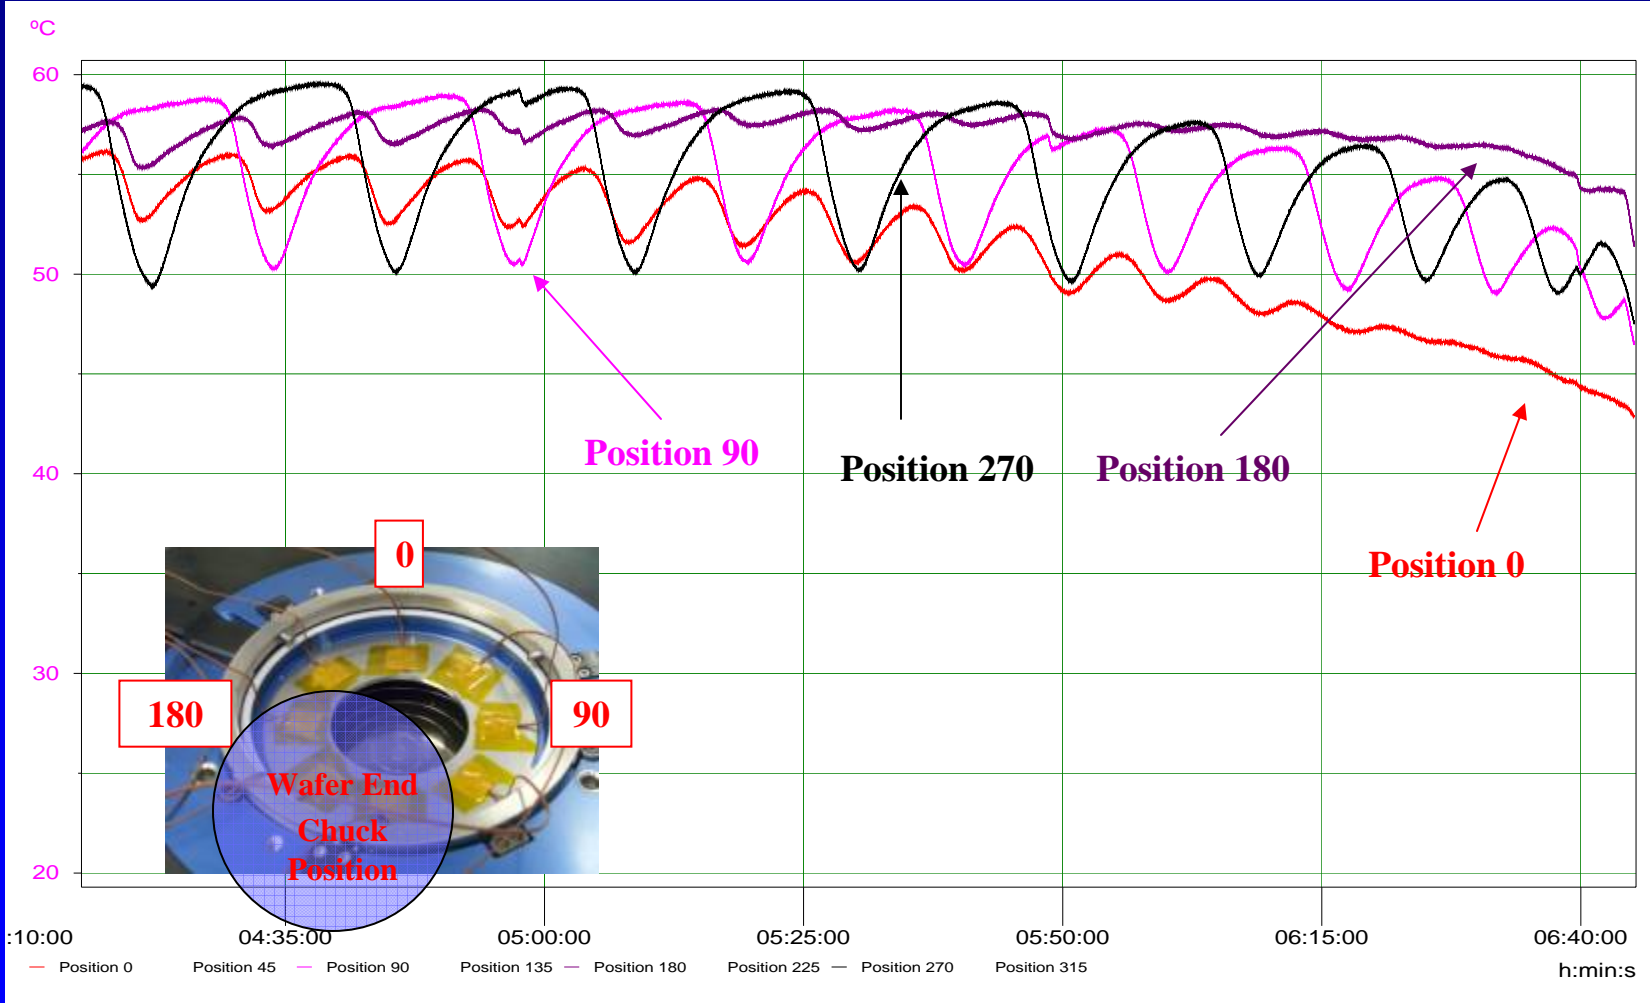
End of wafer

# TKB 197 Thermal Profile

## Standard Steel VLCT Ring

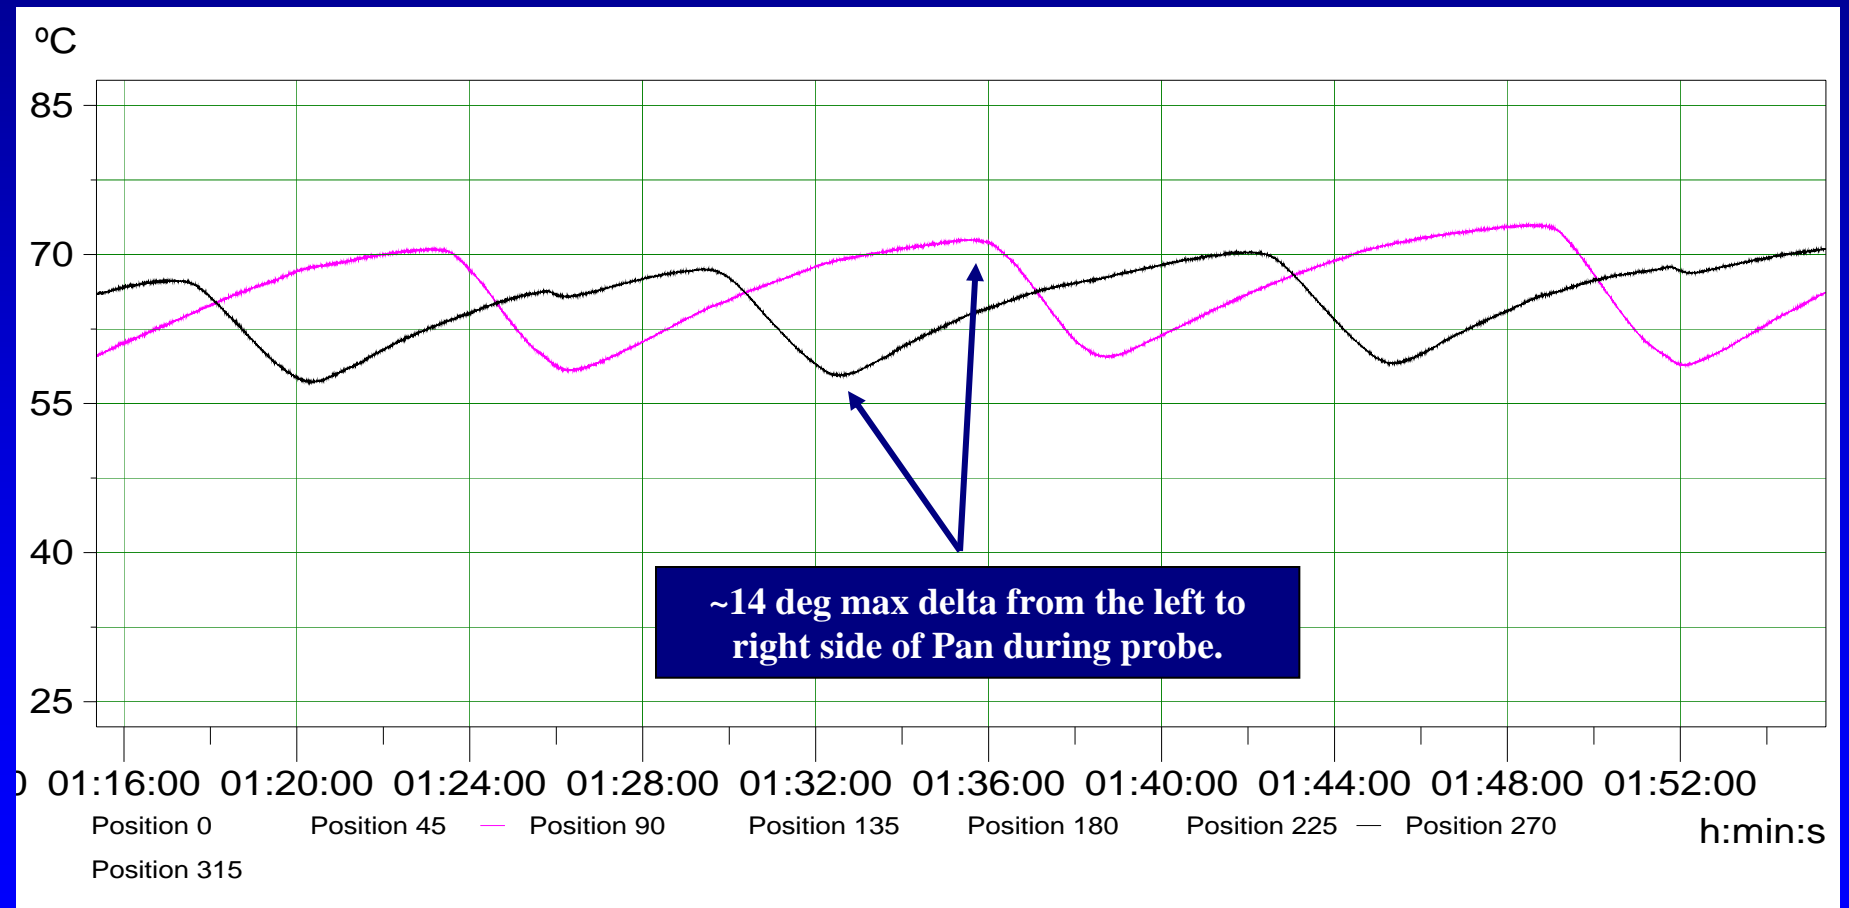
Position 90 & 270 Temperature Track

# TKB 195 Thermal Profile

## Standard VLCT Ring with Ceramic Pan

Center of Wafer

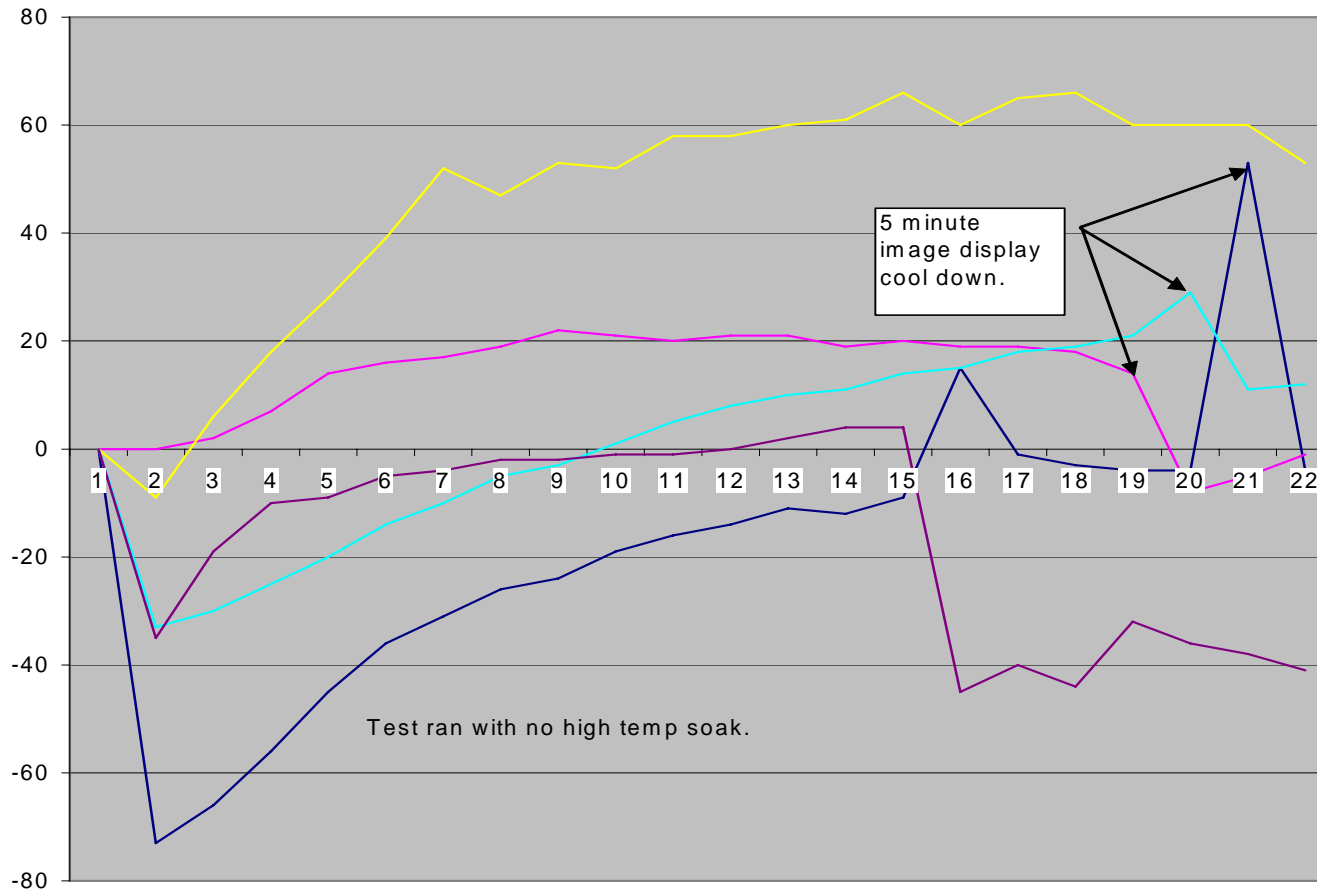
Alumina / Blue Ring

# Interface Movements

All test were ran with CE 8" UPP8Meg probe card except for Alumina 12" UF200 where a non-high temp leveling card was used.

- 410 (no pockets UF3000)
- Alumina RASP 8" (UF3000)
- Natvie Blue Ring (UF3000)
- Alumina (Pockets 8" UF200)
- Alumina (Pockets 12" UF200)

Note: Blue Ring has an 8" pan. All others were with an 12" pan.

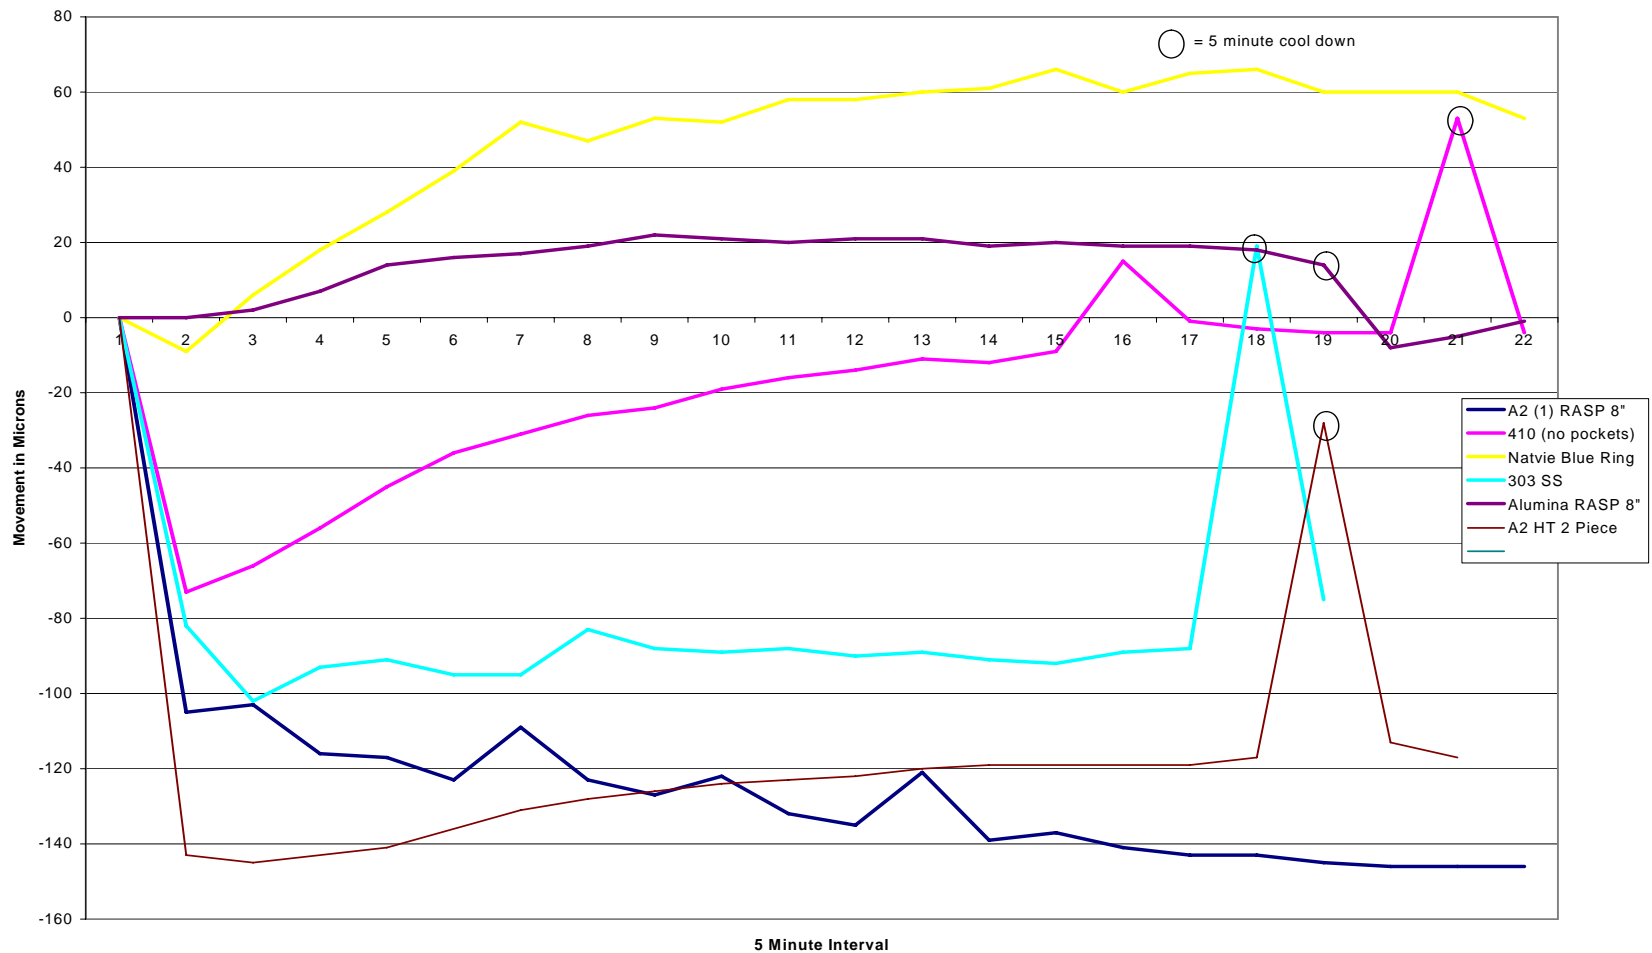
Auto-Z Movement @ 125

# Interface Material

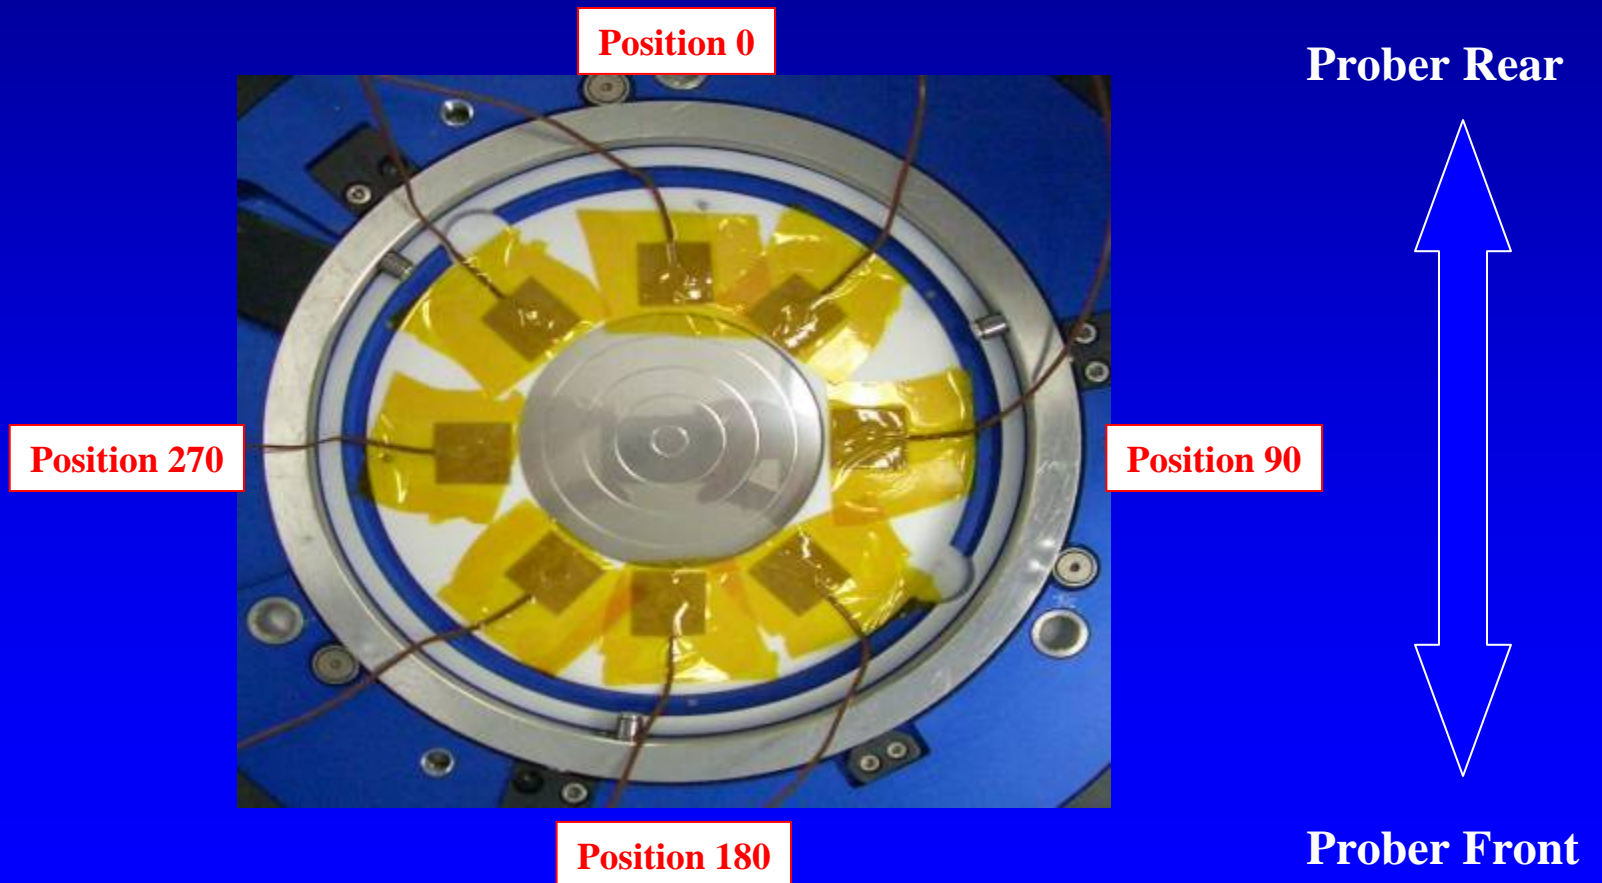
### Thermocouple Setup & Location

# TKB 195 Thermal Profile

## Standard VLCT Ring with Ceramic Pan

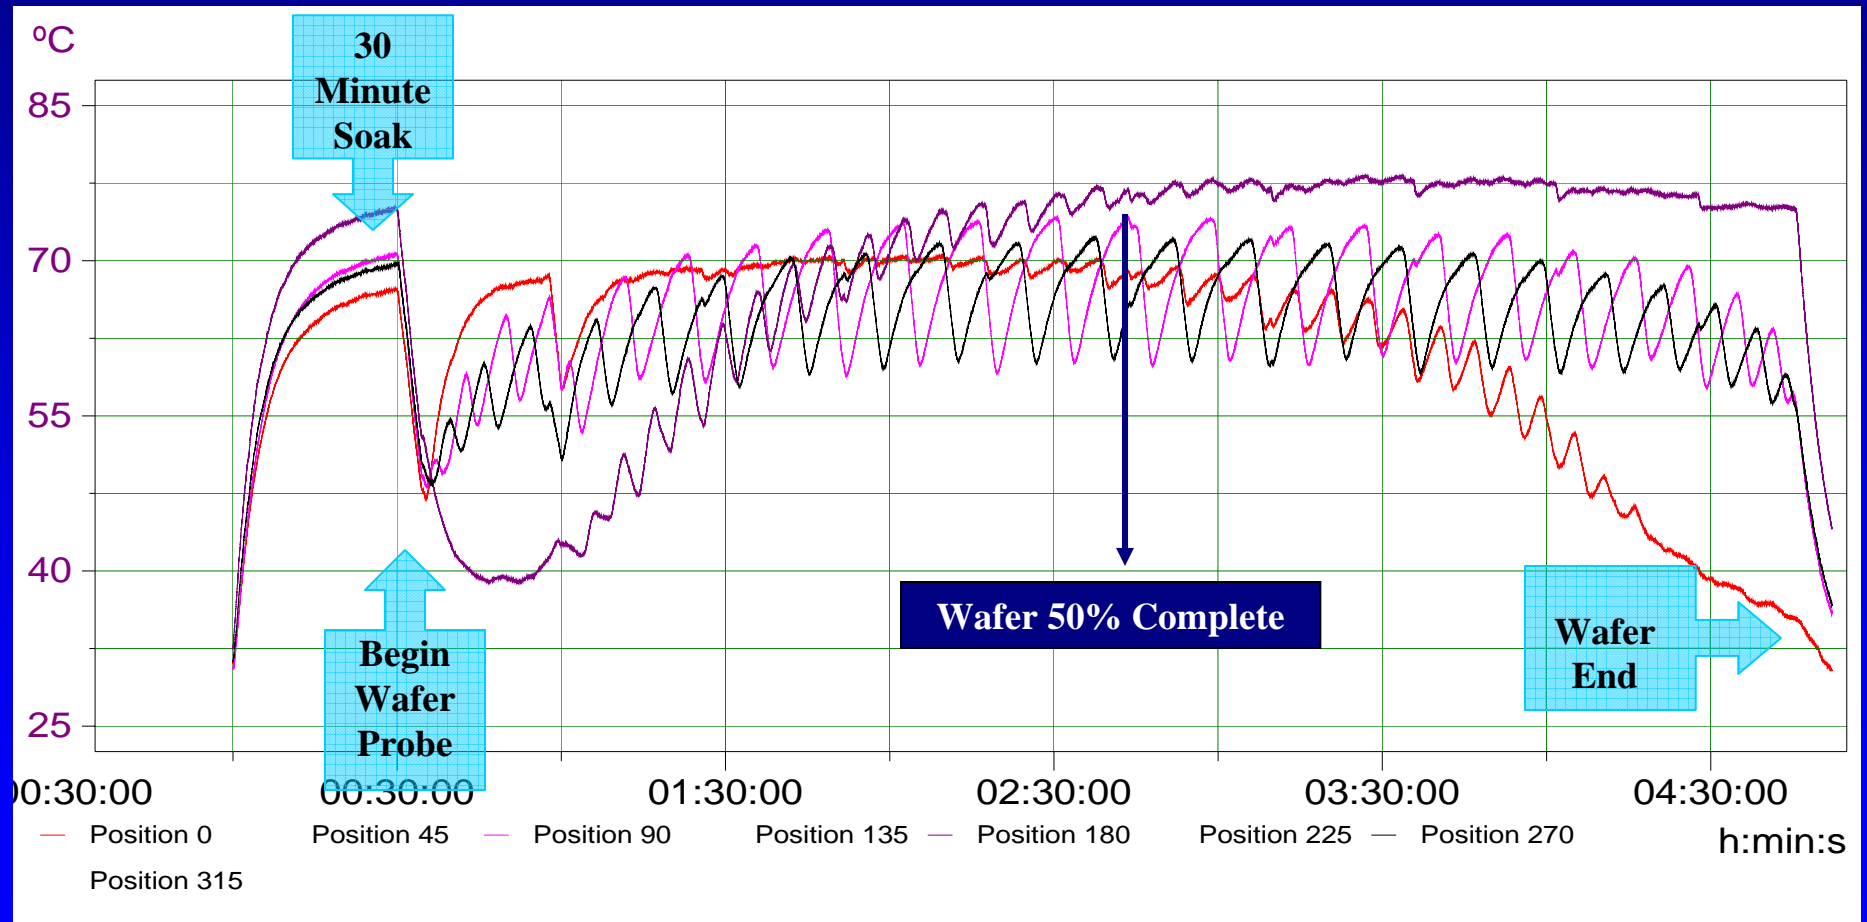
Complete wafer probe

# TKB 195 Thermal Profile

## Standard VLCT Ring with Ceramic Pan

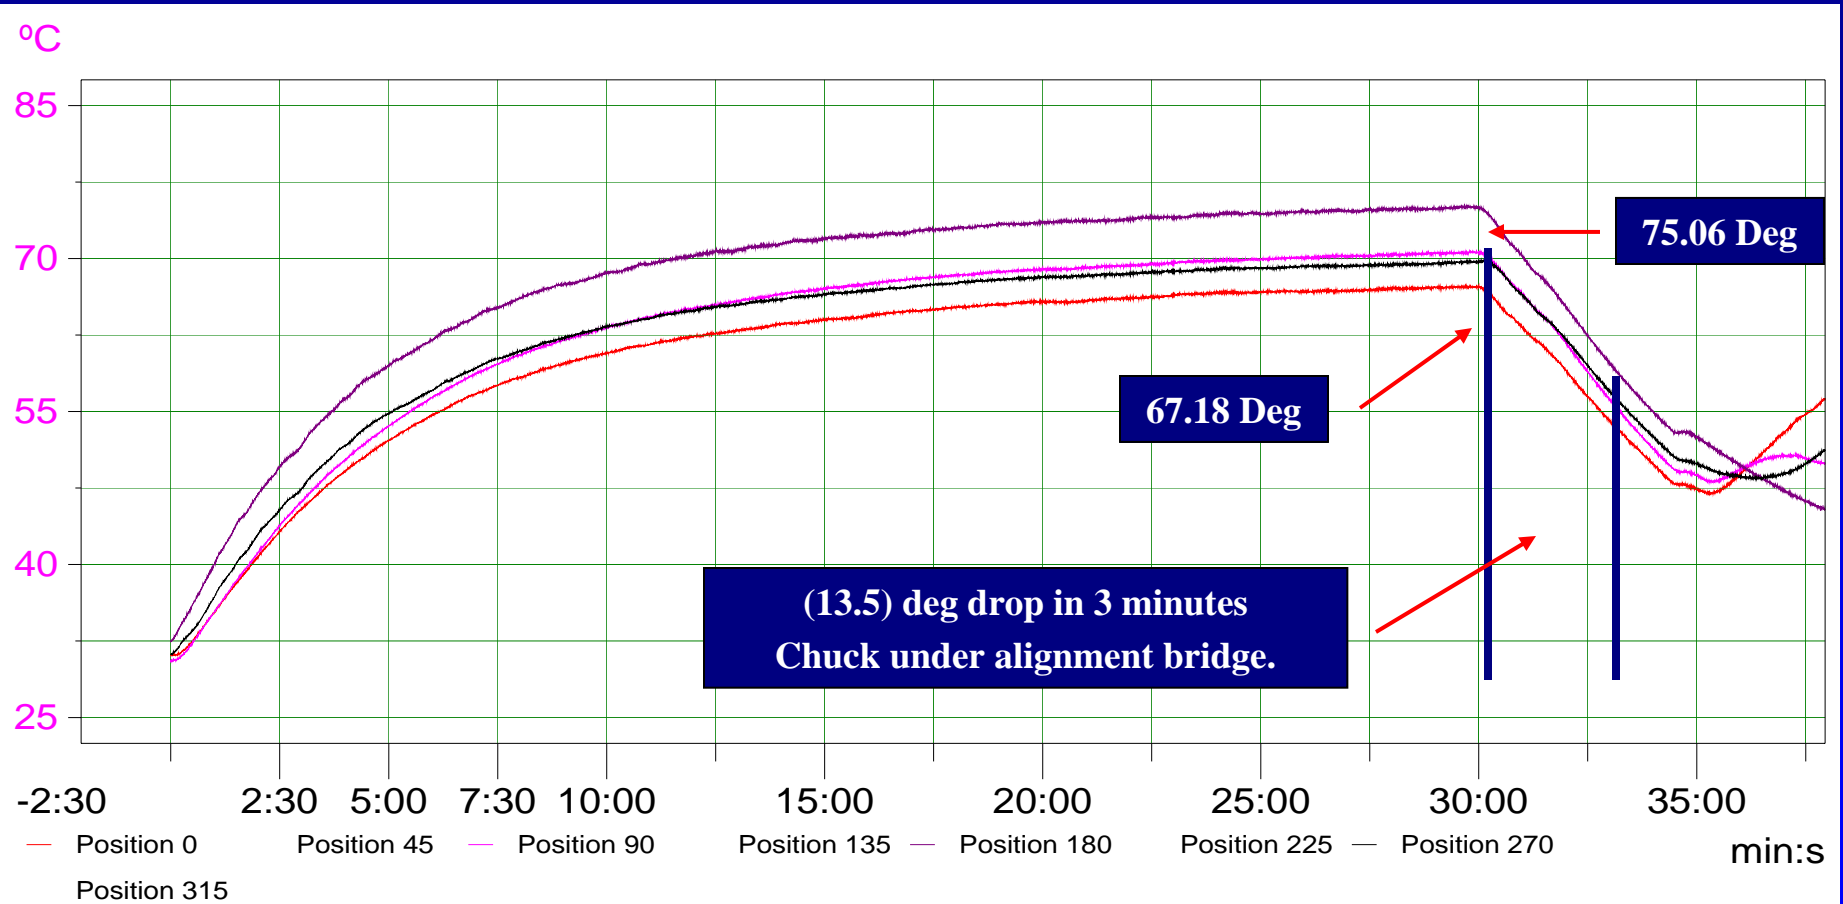
30 Minute Soak

# TKB 195 Thermal Profile

## Standard VLCT Ring with Ceramic Pan

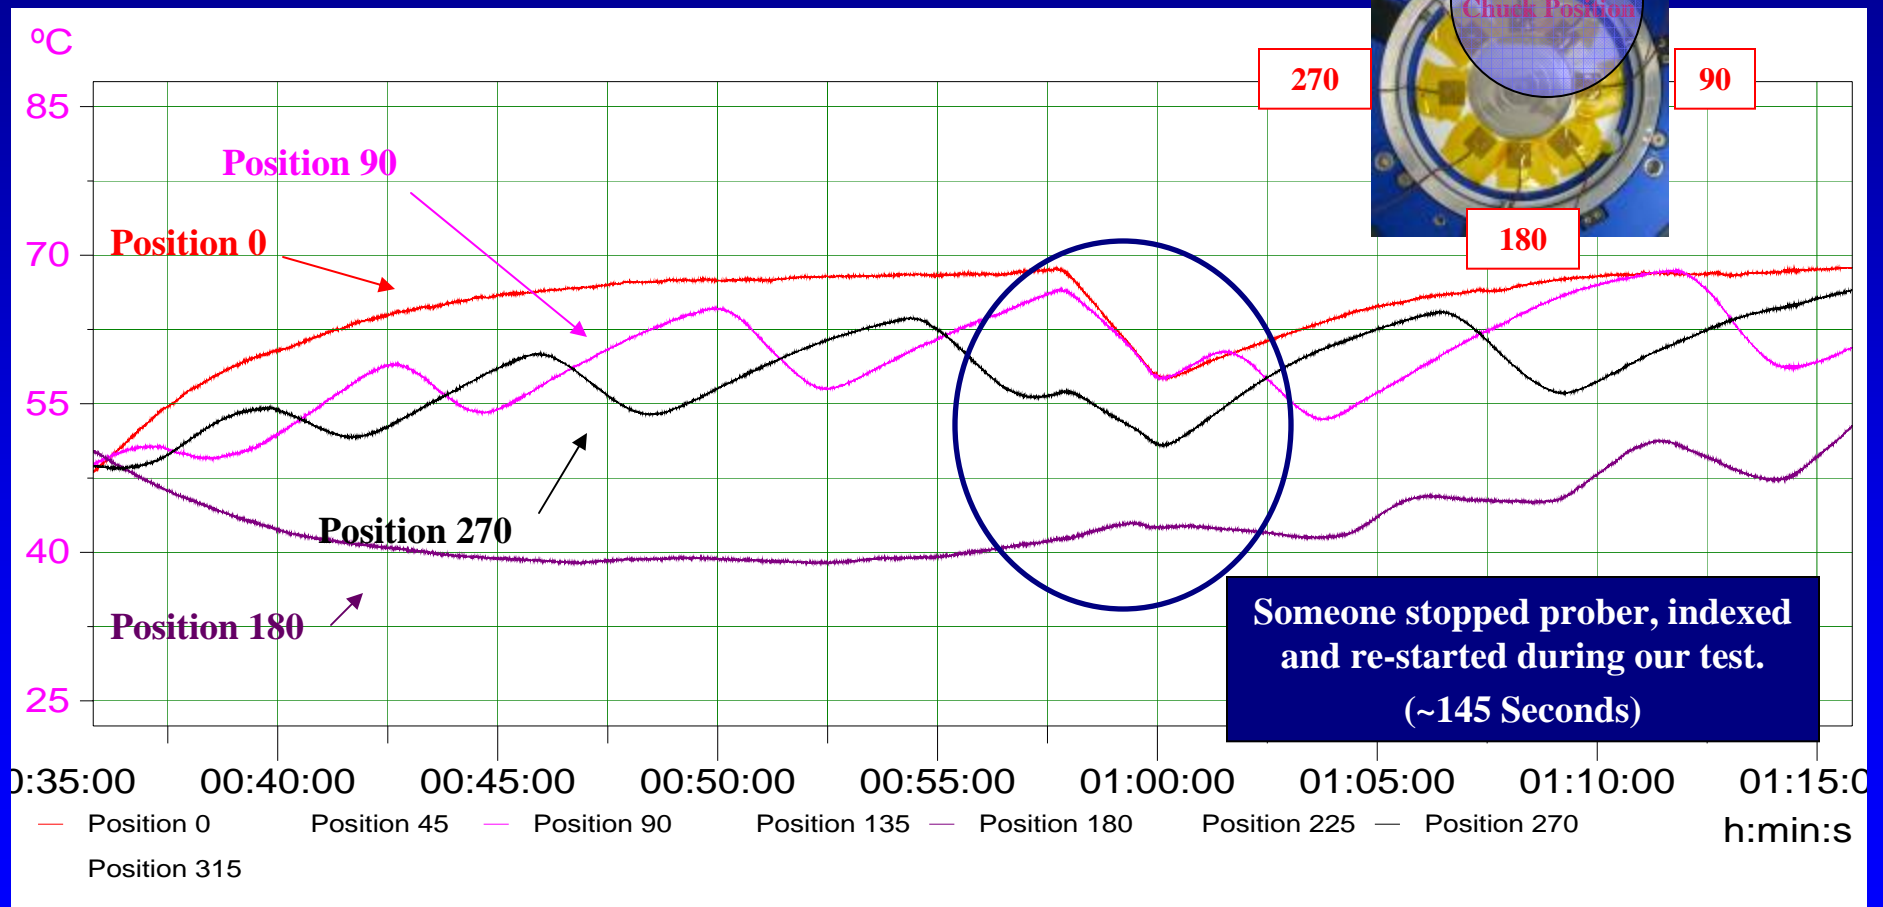
Beginning of wafer

# TKB 195 Thermal Profile

## Standard VLCT Ring with Ceramic Pan
