# Controlling BP Damage at 129C Probing

Daniel Fresquez, Eddie McClanahan and Al Wegleitner  
Texas Instruments, Dallas, TX

June 11<sup>th</sup> 2006

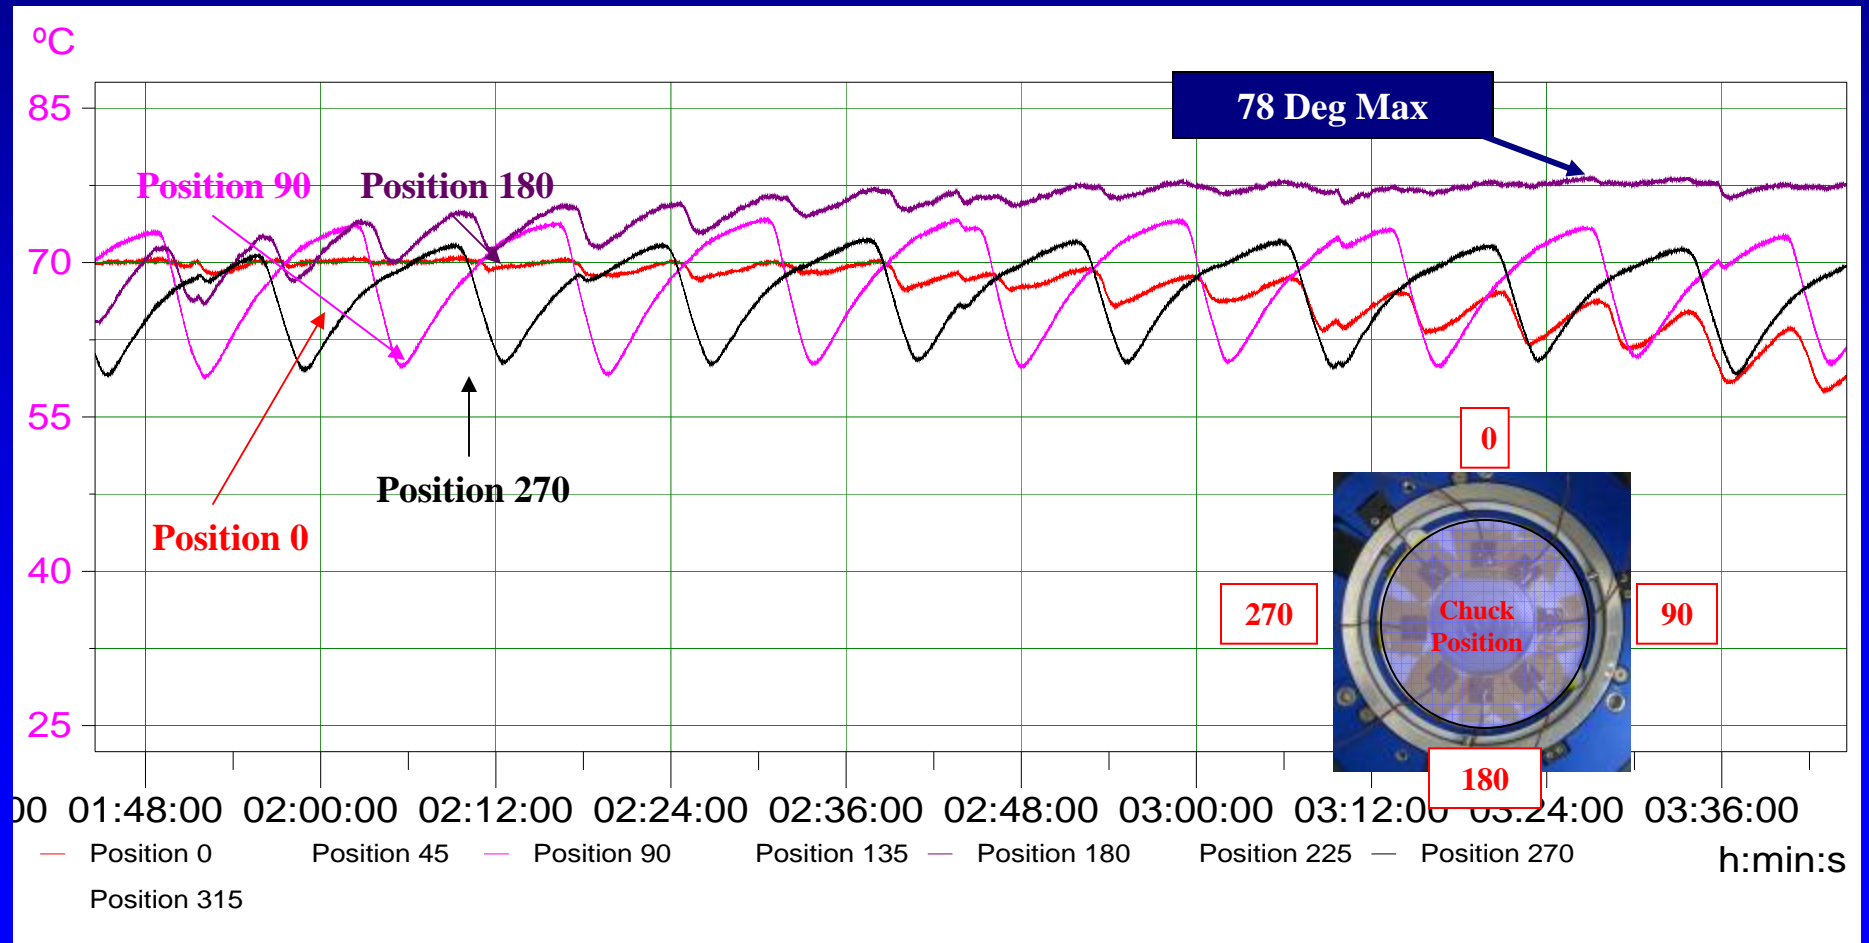
Middle of wafer

# TKB 195 Thermal Profile

## Standard VLCT Ring with Ceramic Pan

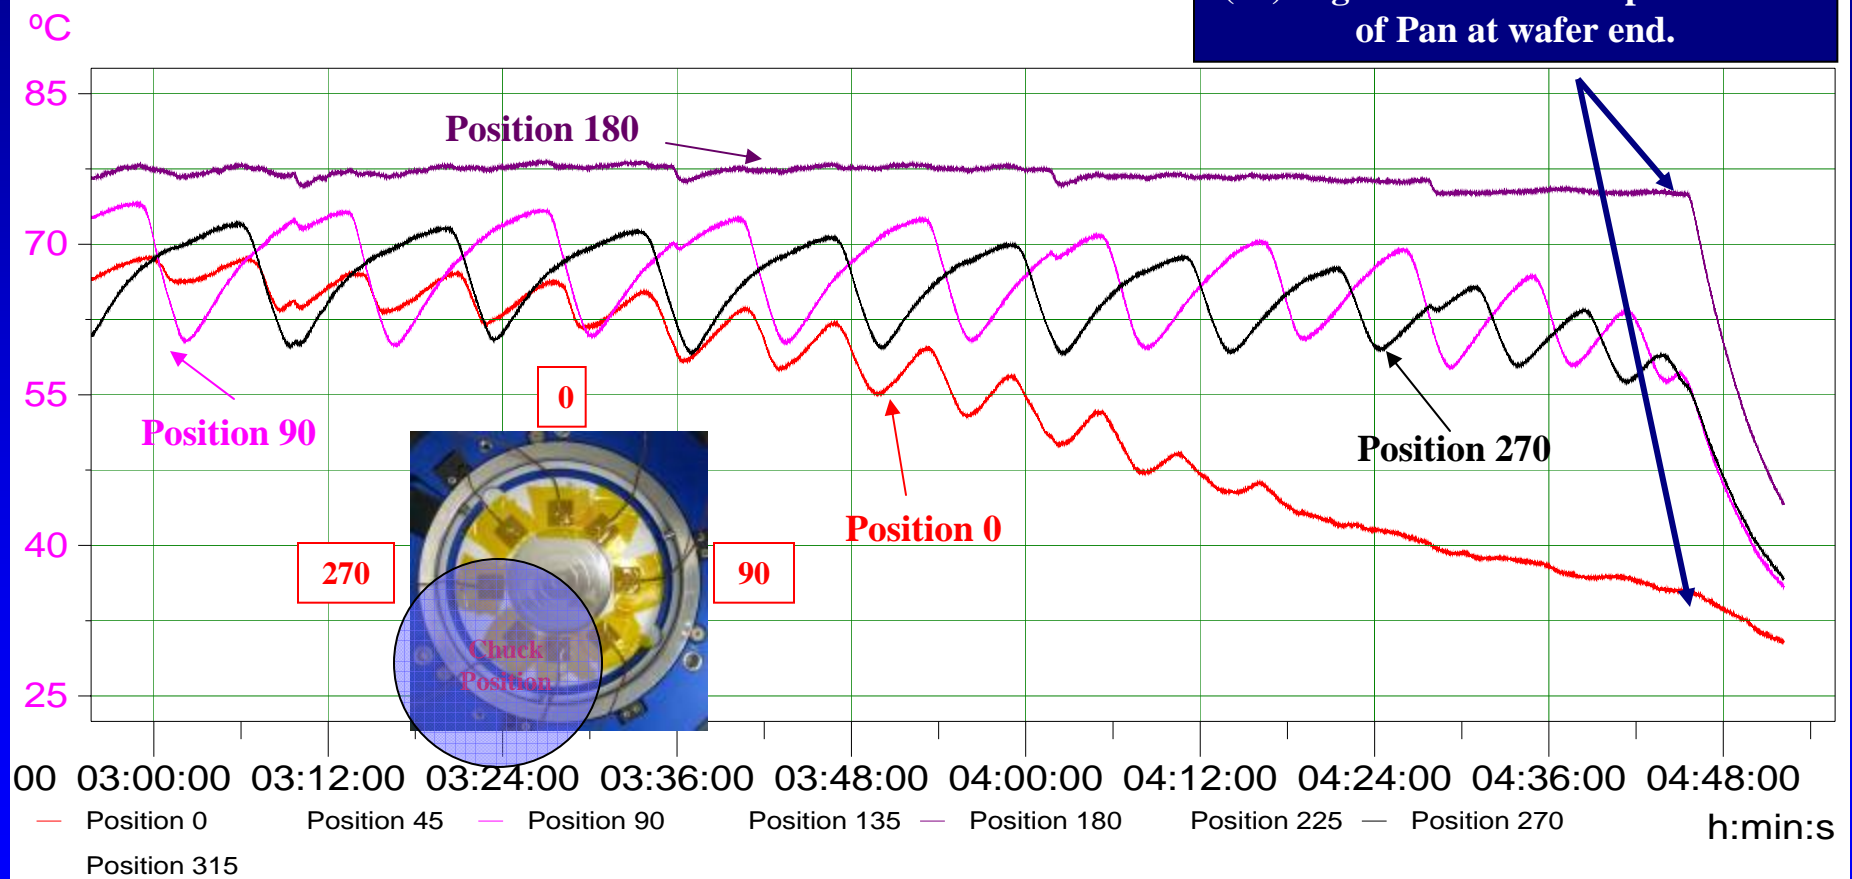
End of wafer

# TKB 195 Thermal Profile

## Standard VLCT Ring with Ceramic Pan

(40) deg delta from the top to bottom of Pan at wafer end.

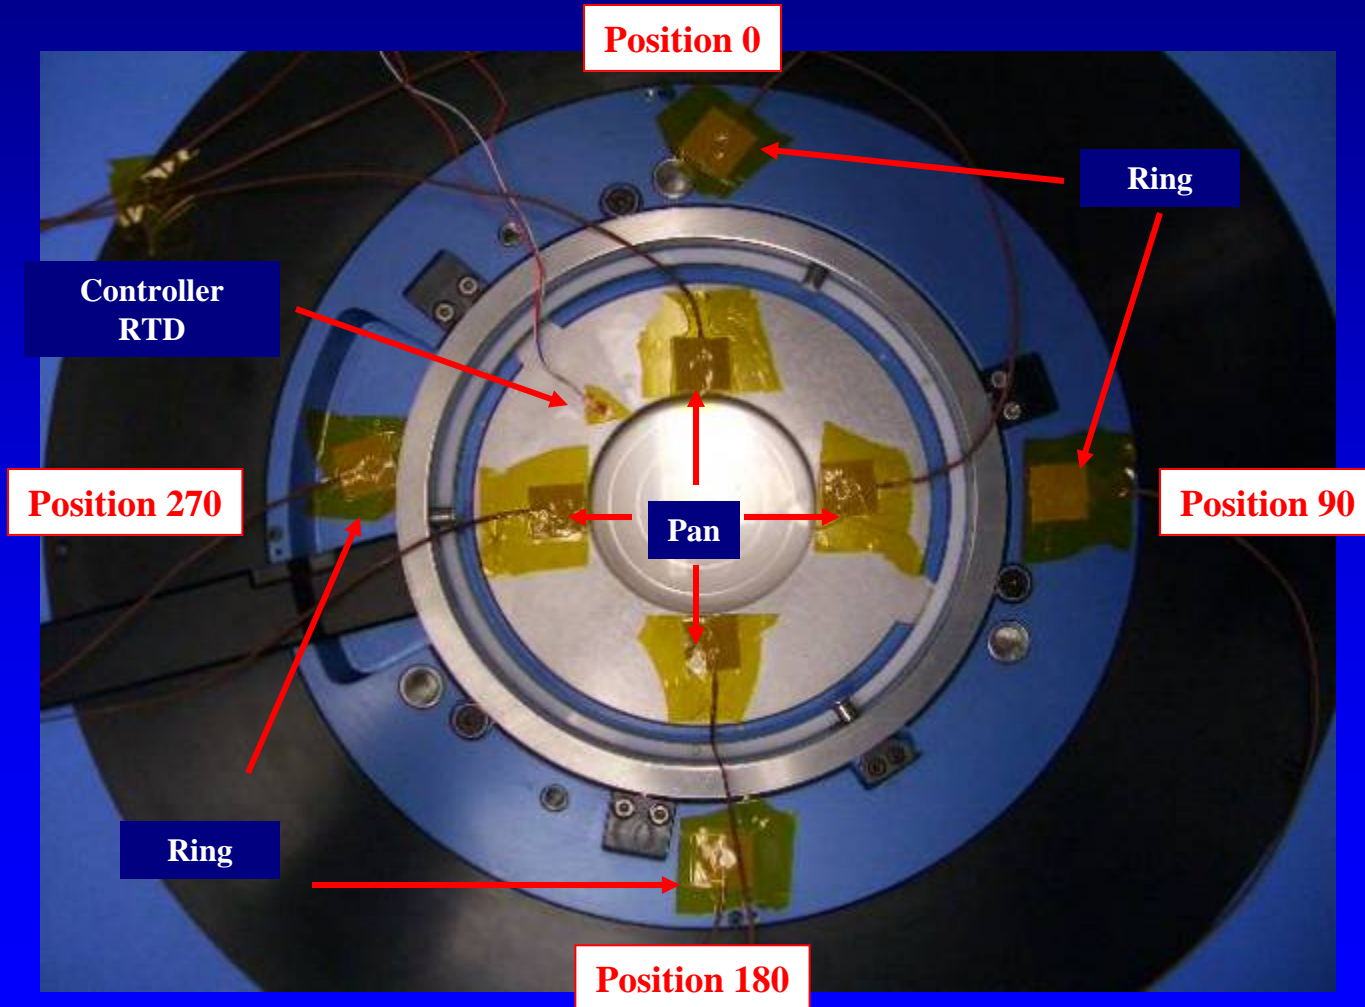
# Thermal Profile

Standard VLCT Ring with Thermofoil Heater  
TKB 196 Sensor Positions

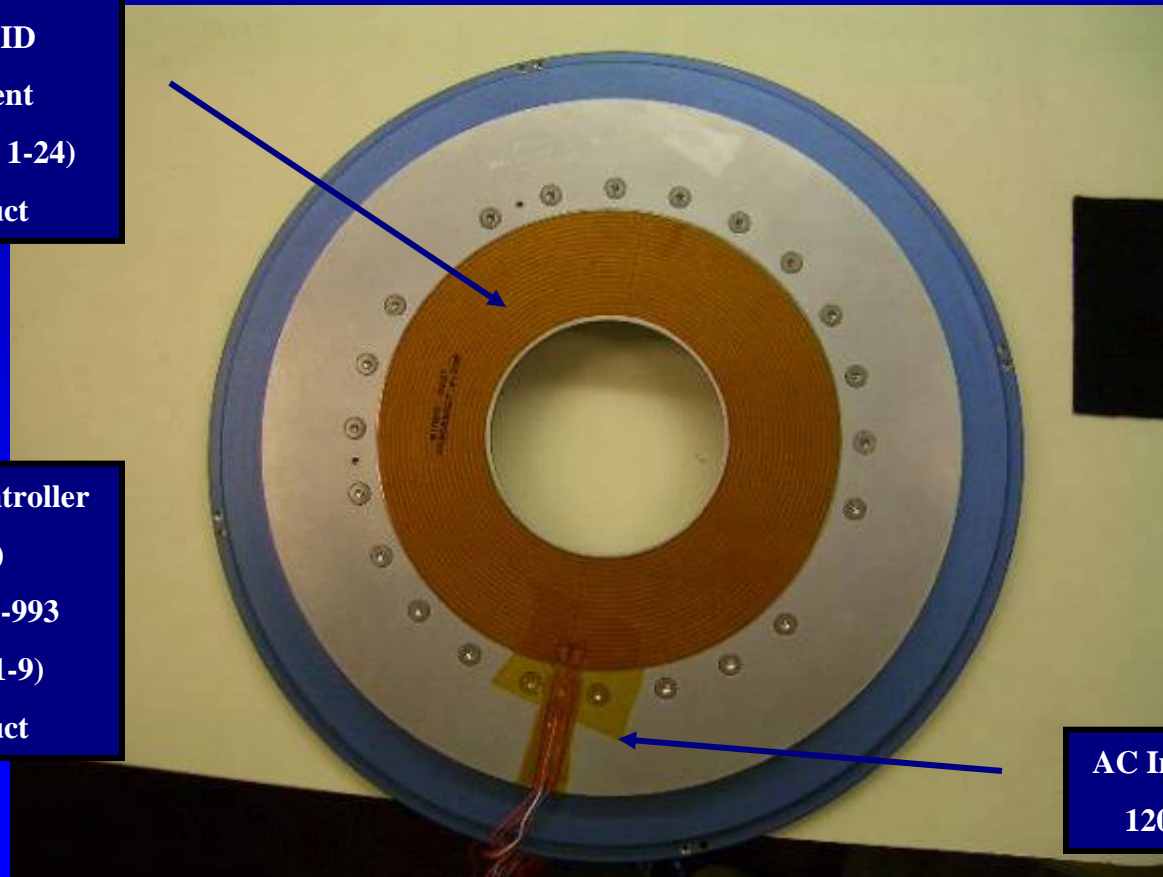
# Heater Setup

## Standard VLCT Ring with Thermofoil Heater

### Bottom side of VLCT Pan

**Minco Thermofoil Heater**

**Part# HK5556R97.4L36B**

**8.25" OD, 4.32" ID**

**97.4 Ohm Element**

**AC Inputs From Controller**  
**120 VAC, Max 3 Amps**

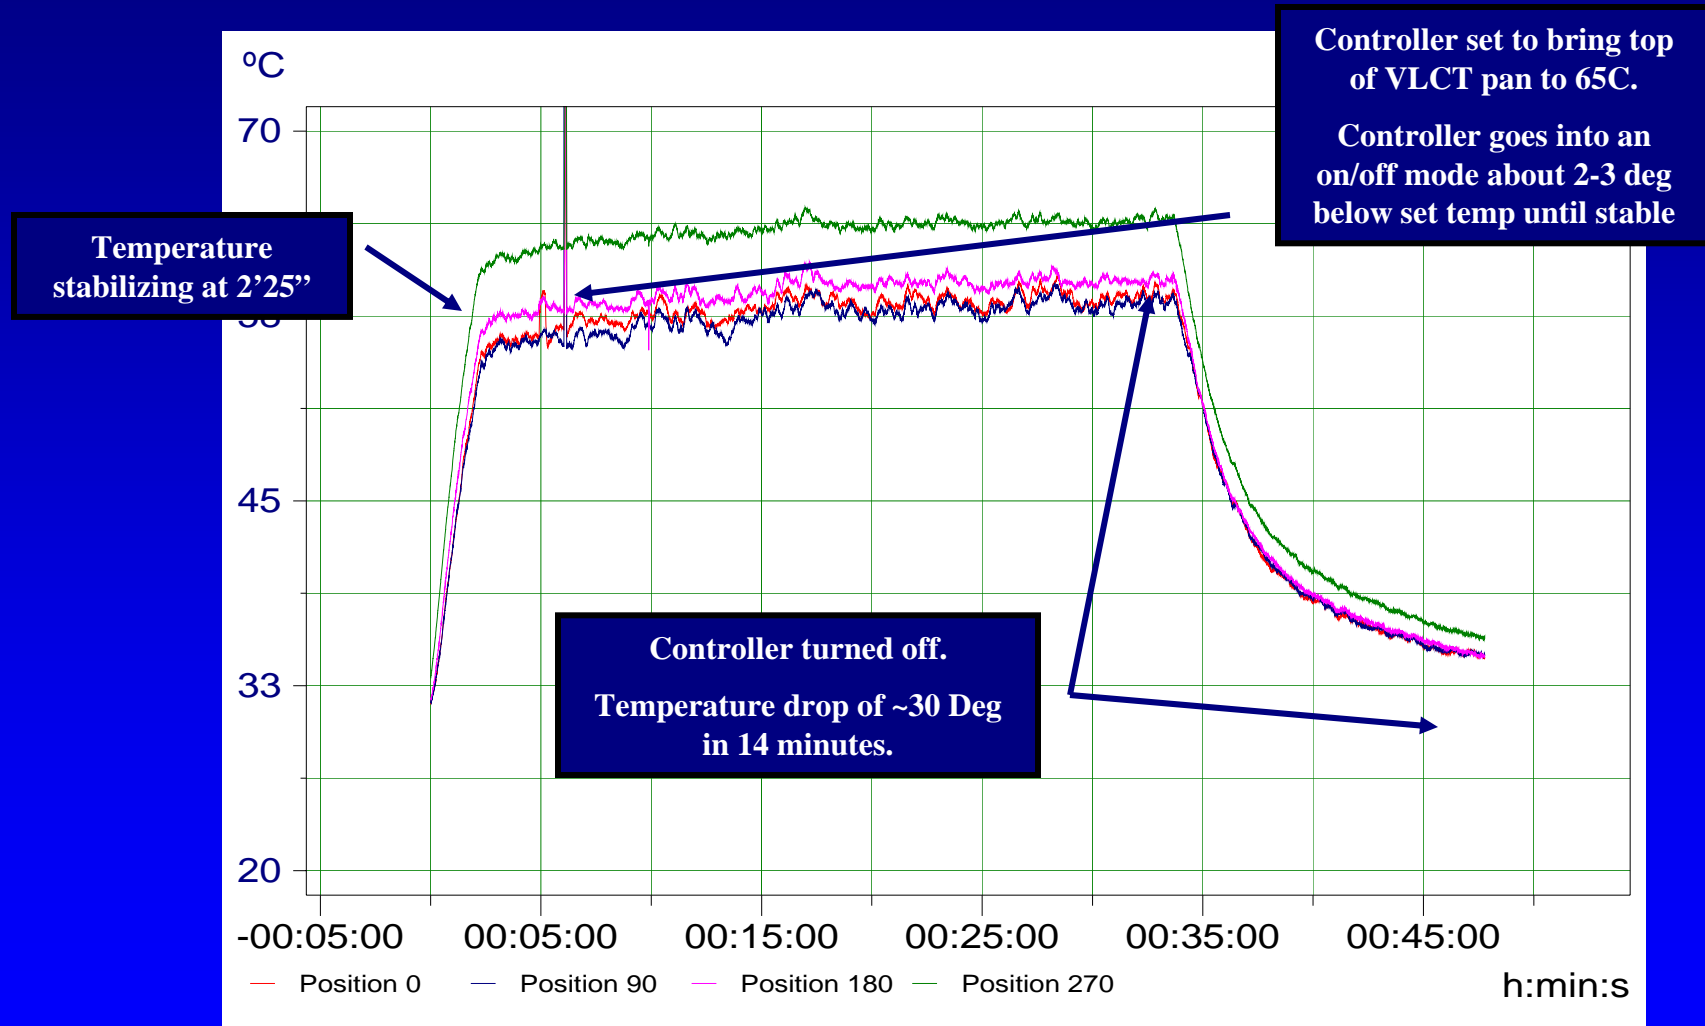
# Thermal Profile

## Standard VLCT Ring with Thermofoil Heater Stand Alone Test

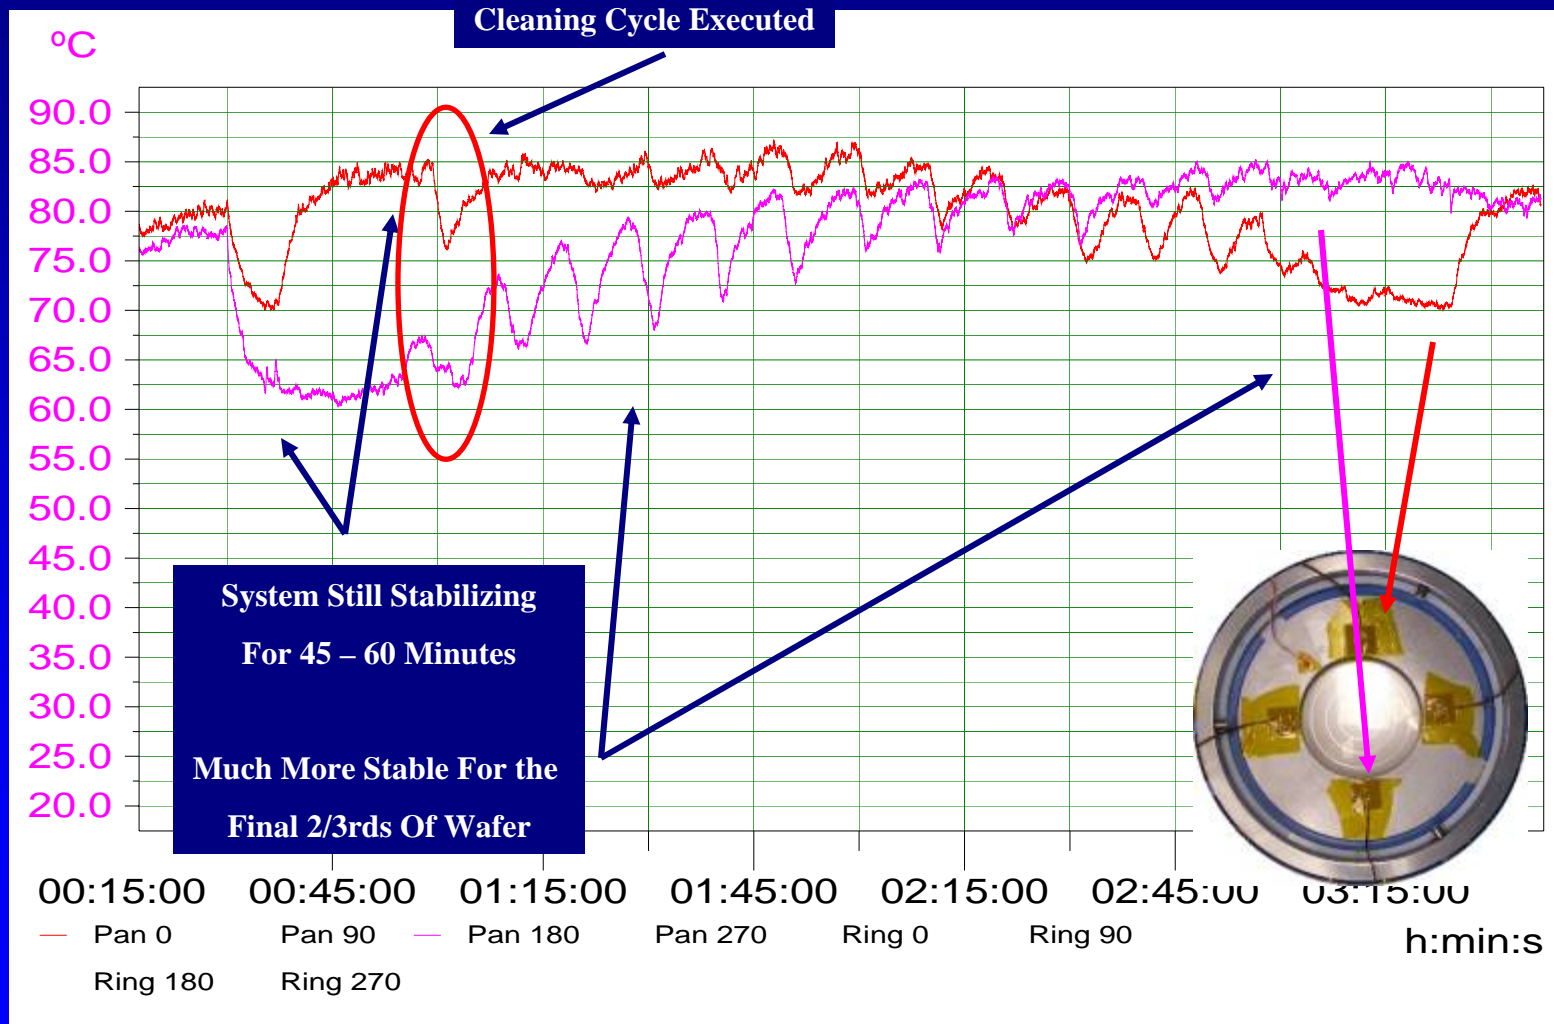
# Thermal Profile

## Standard VLCT Ring with Thermofoil Heater Complete Wafer Probe

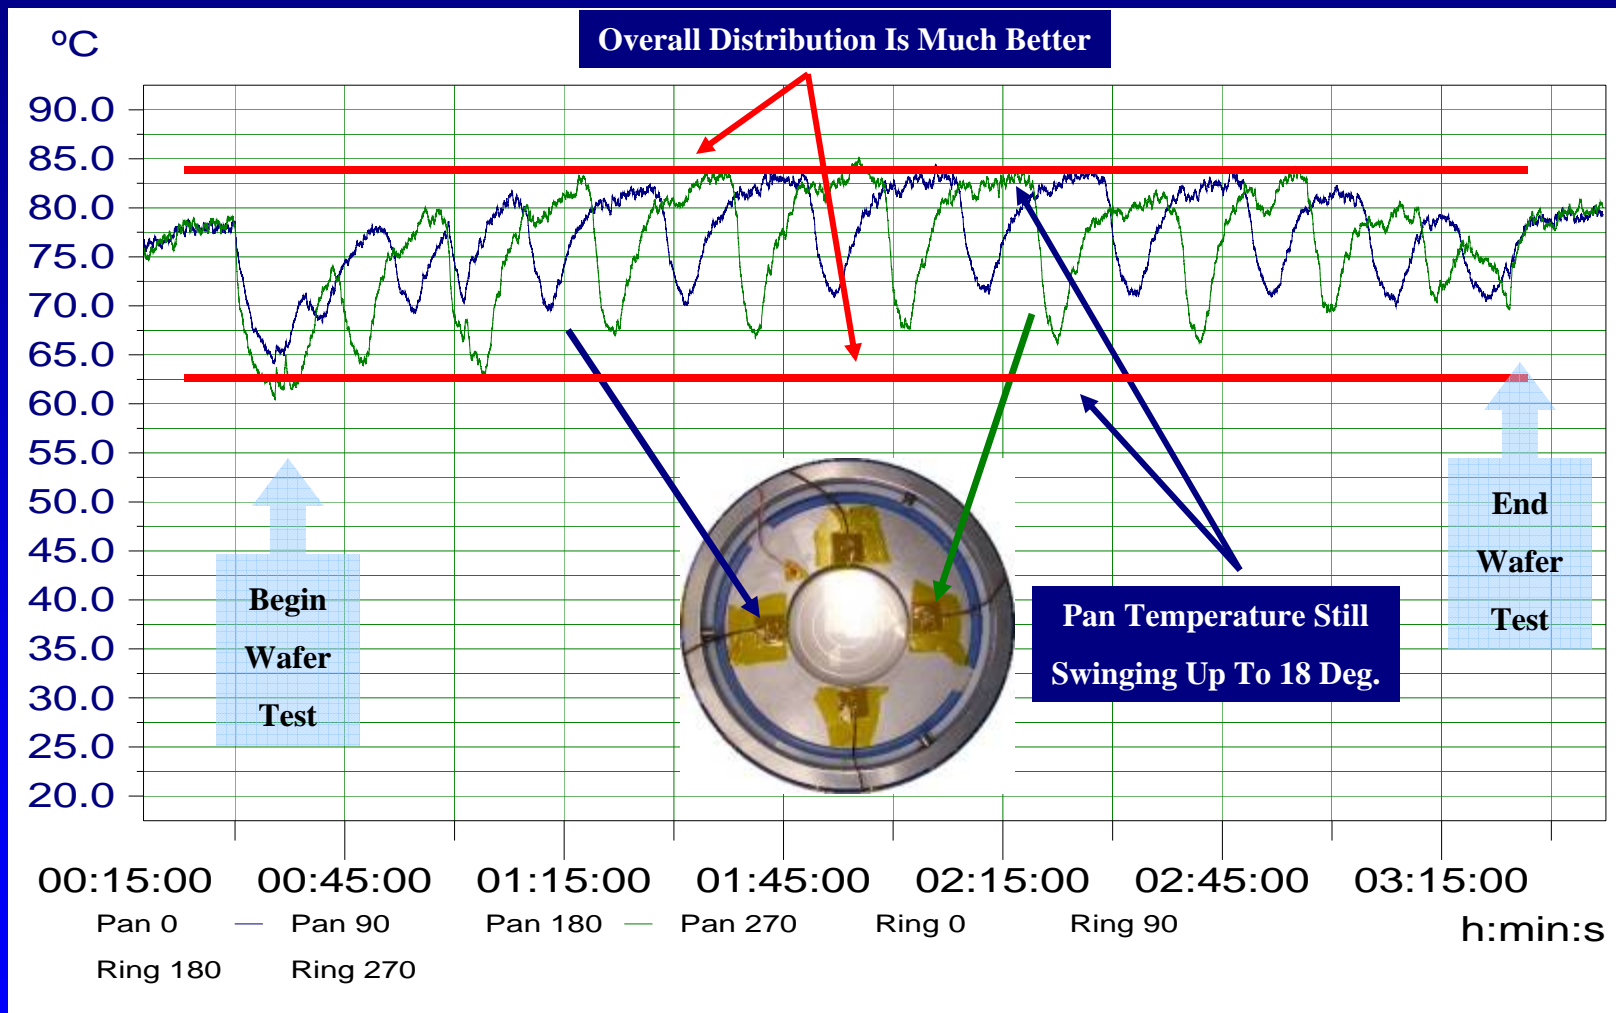
# Thermal Profile

Standard VLCT Ring with Thermofoil Heater  
Complete Wafer Probe

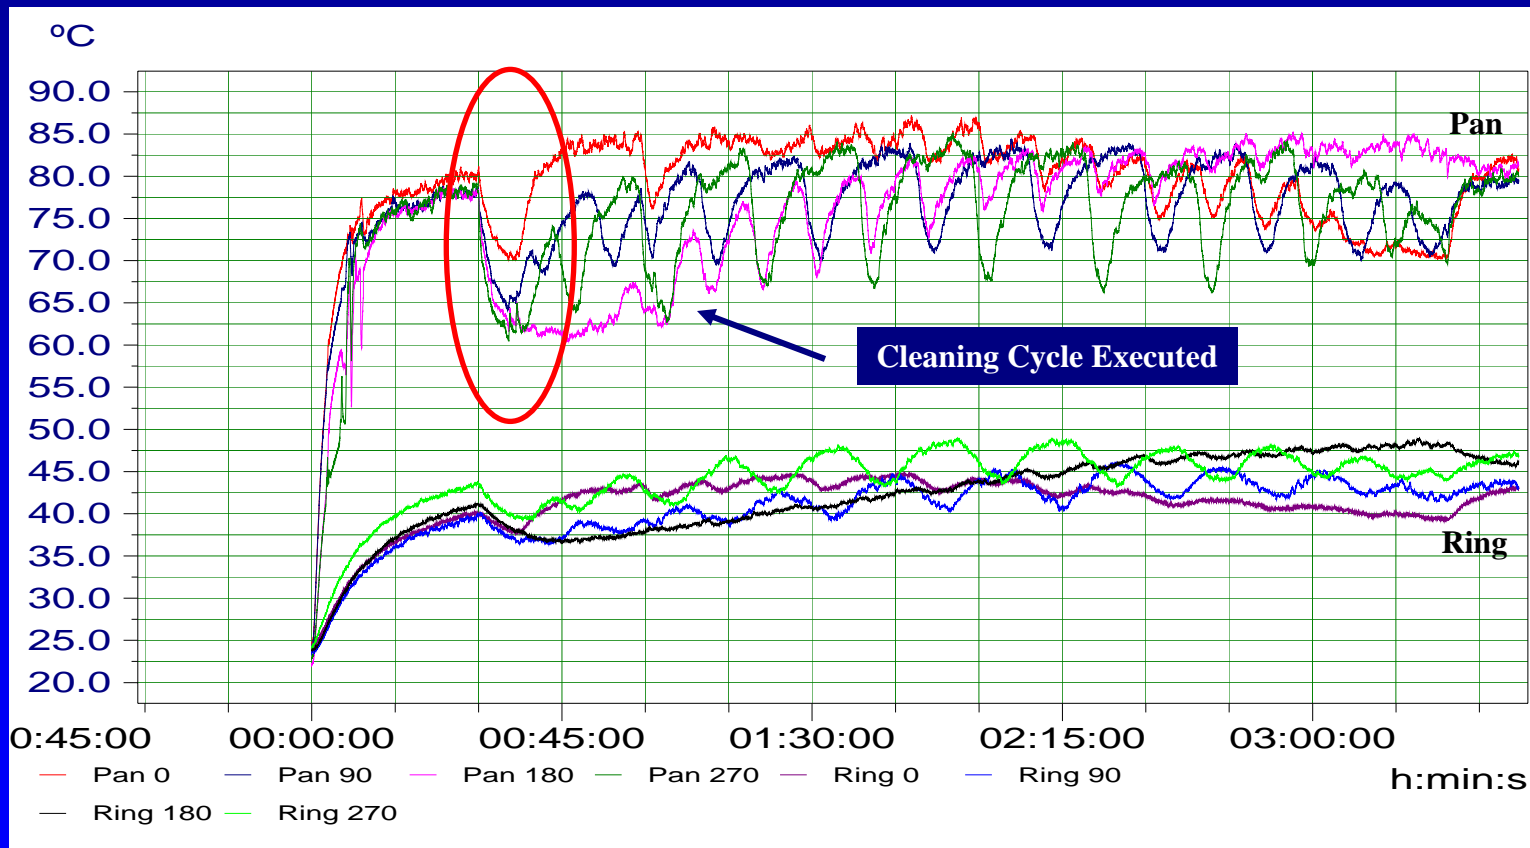
# Thermal Profile

## Standard VLCT Ring with Thermofoil Heater Complete Wafer Probe

Thermofoil heater was on 100% of the time.

Max output for this setup.

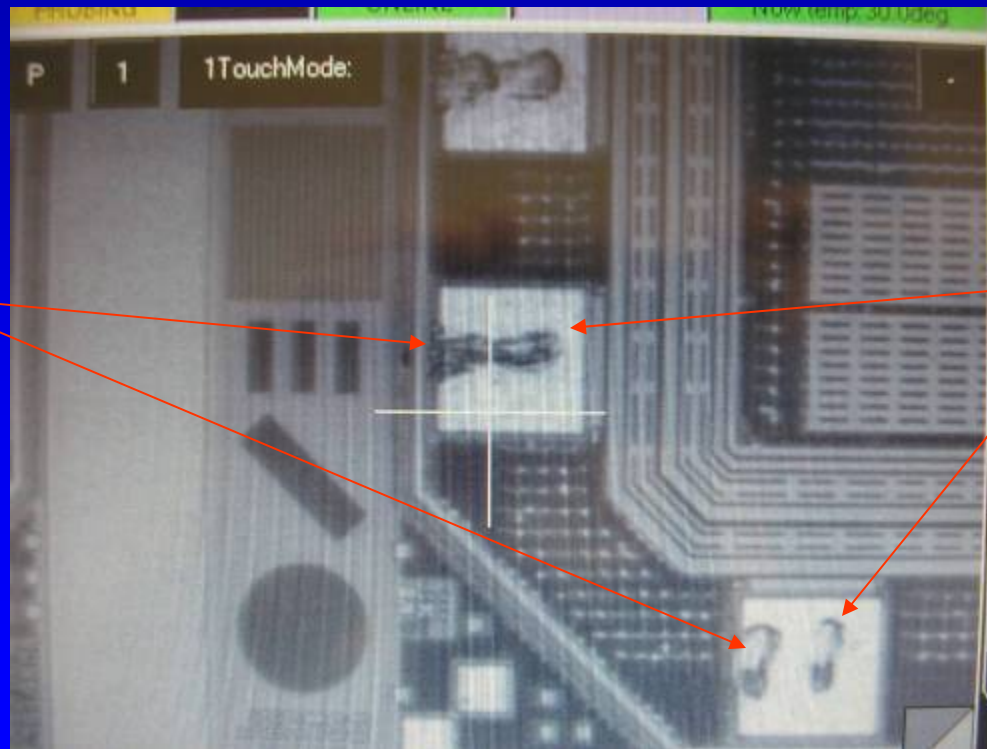
# Camera Calibration

- Needles were landing on the edge of the pad on initial setup.

Marks after  
initial setup

Marks after  
correction

This tester aligned 10 times on the edge of the pads. A PE redid the setup and verified that there was a problem. EE corrected the problem based on PE input and data. (Focal X beam position had values corrected).

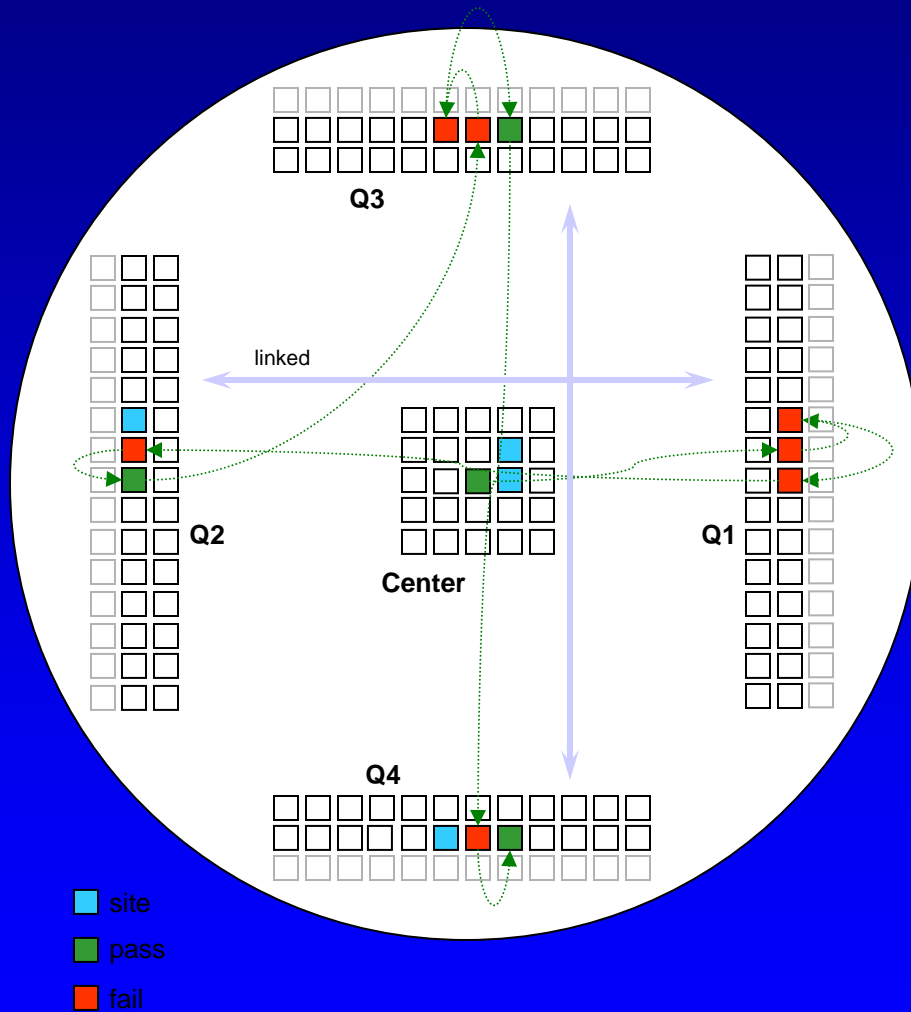
# Automated PMI

## Intra-group

**Rule 1:** If PMI passes for a site, then the PMI for the group passes; Else inspect the next site within the group

**Rule 2:** If PMI fails for all sites within the group, then PMI for the group fails.

## Center Group

**Rule 3:** If all dies in the group in the Center fail (ie. rule 2), then the Probe-PMI fails immediately. If Center passes, then inspect the next 2 opposing quadrants.

## Group-to-Group

**Rule 4:** If two opposite Quadrants fail, then Probe-PMI fails immediately.

**Rule 5:** If any 2 of the 4 Quadrants fail, then Probe-PMI fails; For Probe-PMI to pass, only 1 quadrant must fail.
