Semiconductor Wafer Test Workshop

June 7-10, 2009
San Diego, CA

Controlling CRES

Clean the Wafer,
Not the Probe Card!

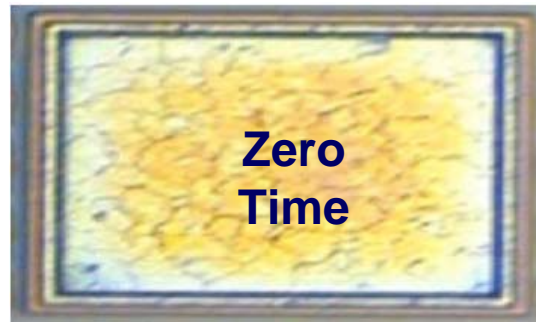
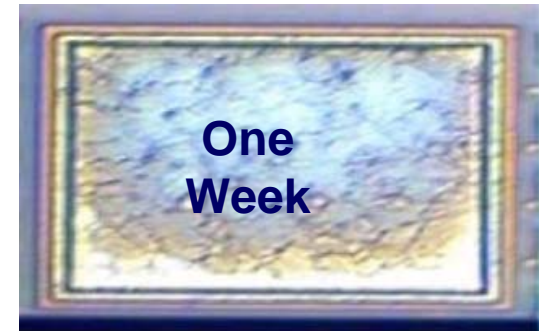
AI Bond Pad Analysis Over Time

Dry Box Conditions - Fluorine contamination is apparent at time zero as received. As time continues the pads become more corroded. Conditions of these pads are typical and are the root of poor contact resistance. If the pads are not cleaned then poor yield is likely as well as die and hardware damage.

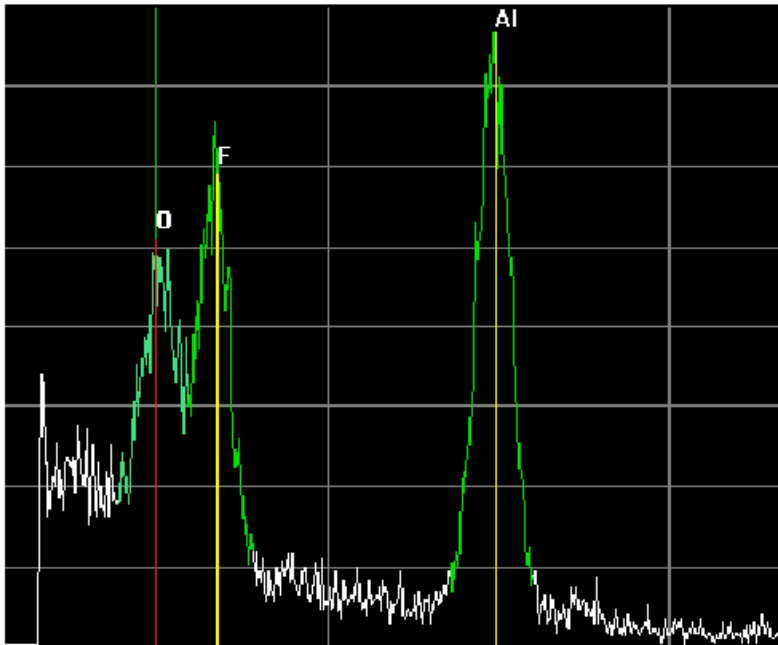
Downstream corrosion – fails wire bond

EDX results show OF covers more of the surface than Al

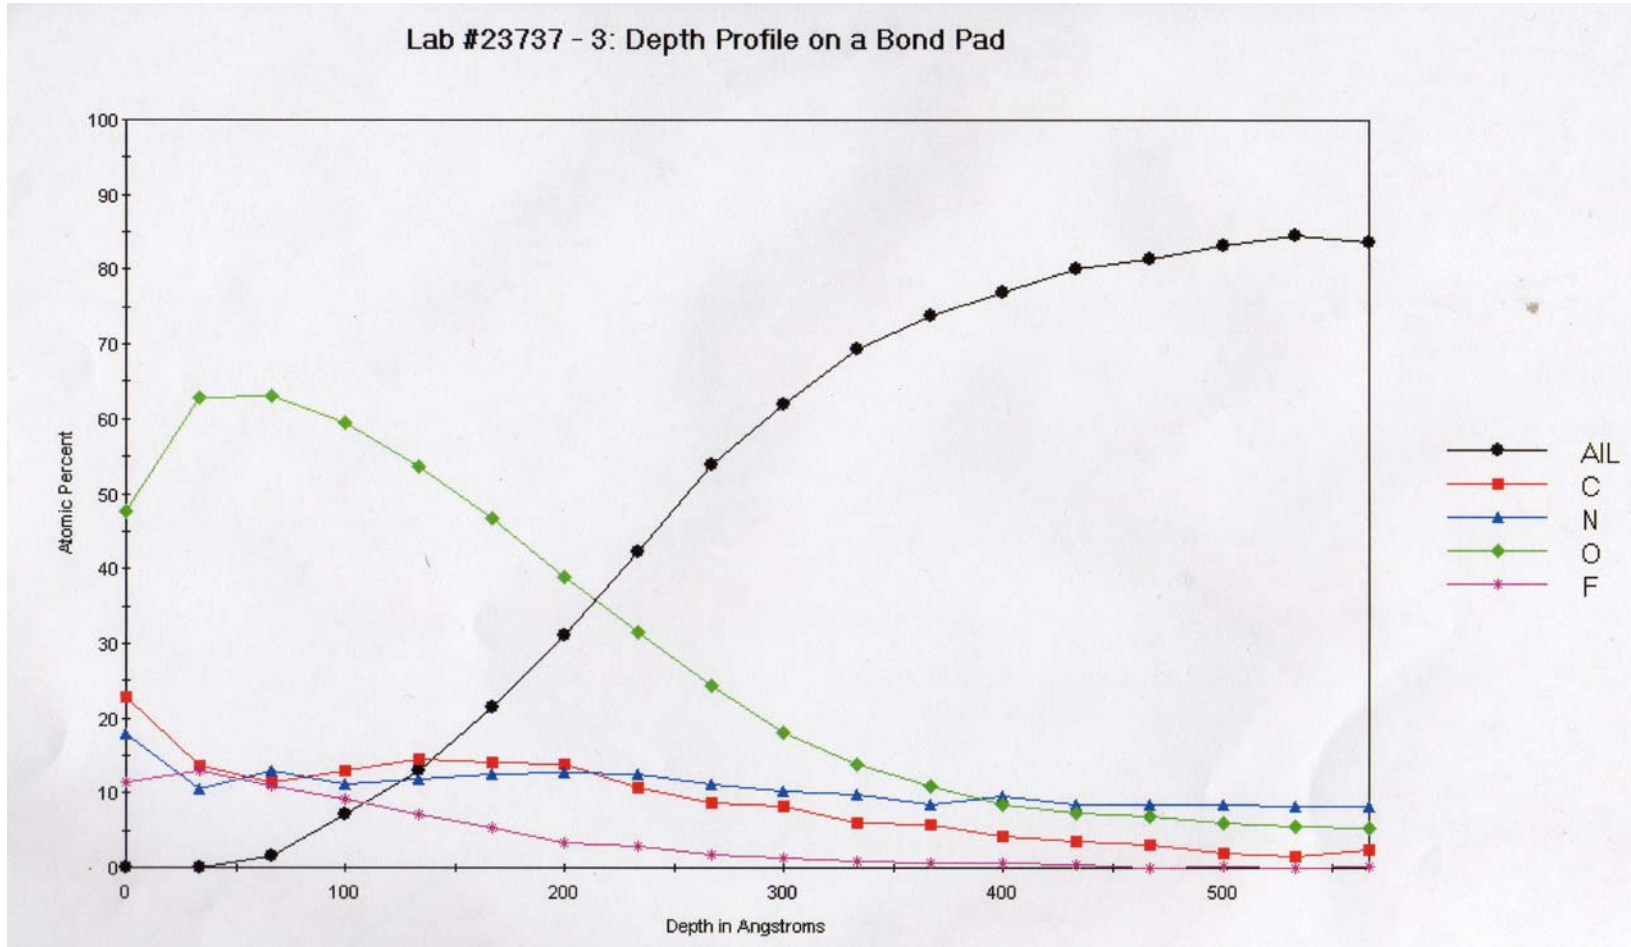
Lab #23737 - 3: Depth Profile on a Bond Pad

Fresh from the CF4 Plasma

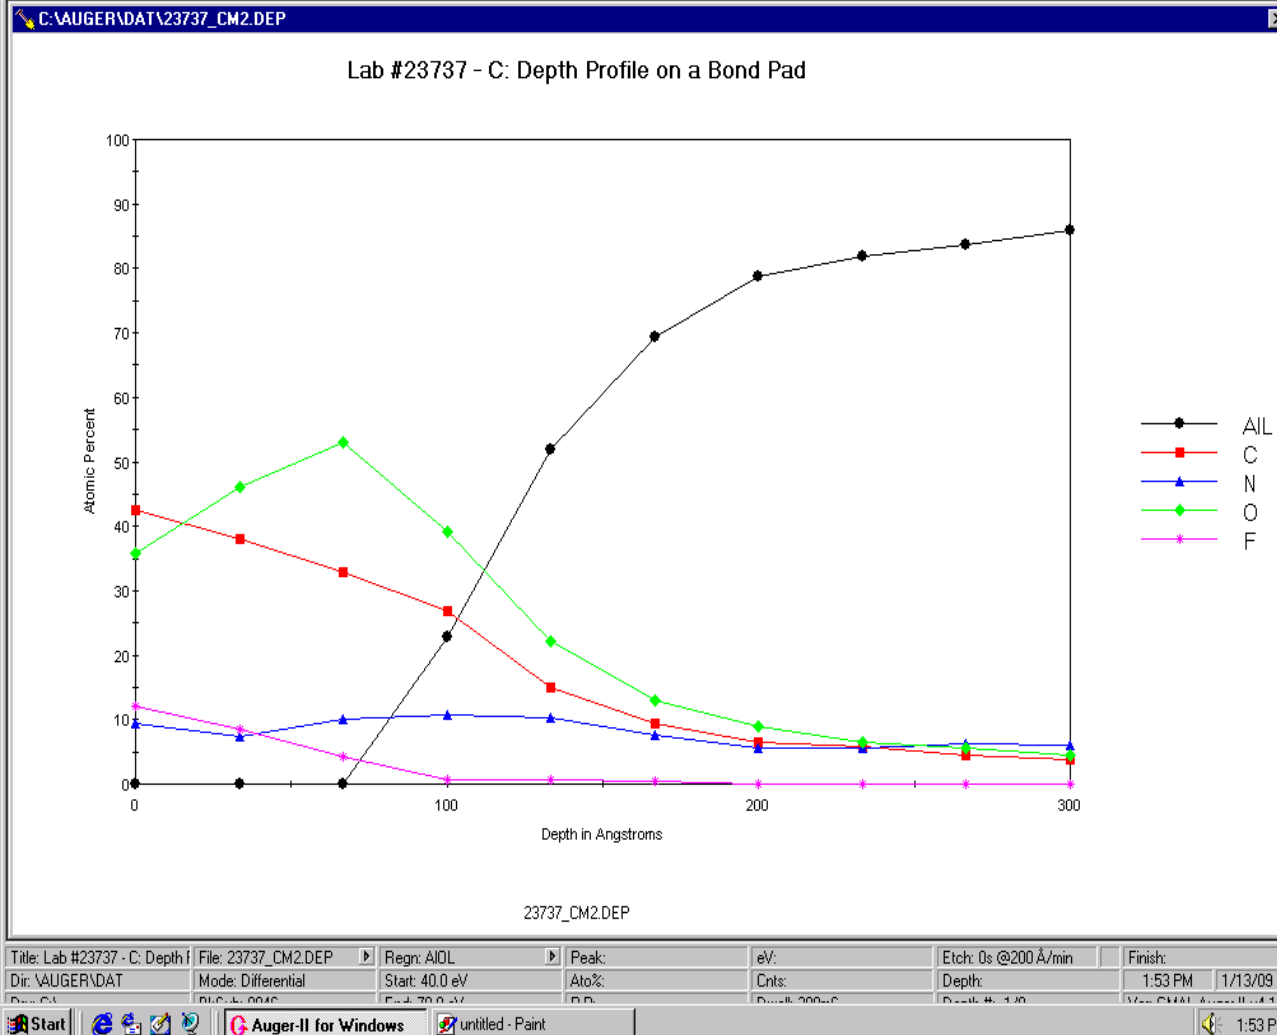
Post BPS100 Clean

- AI detected prior to 300A
- F drops to zero at 100A
- C drops to under 10%
- O drops to below 10%
- AlO species removed

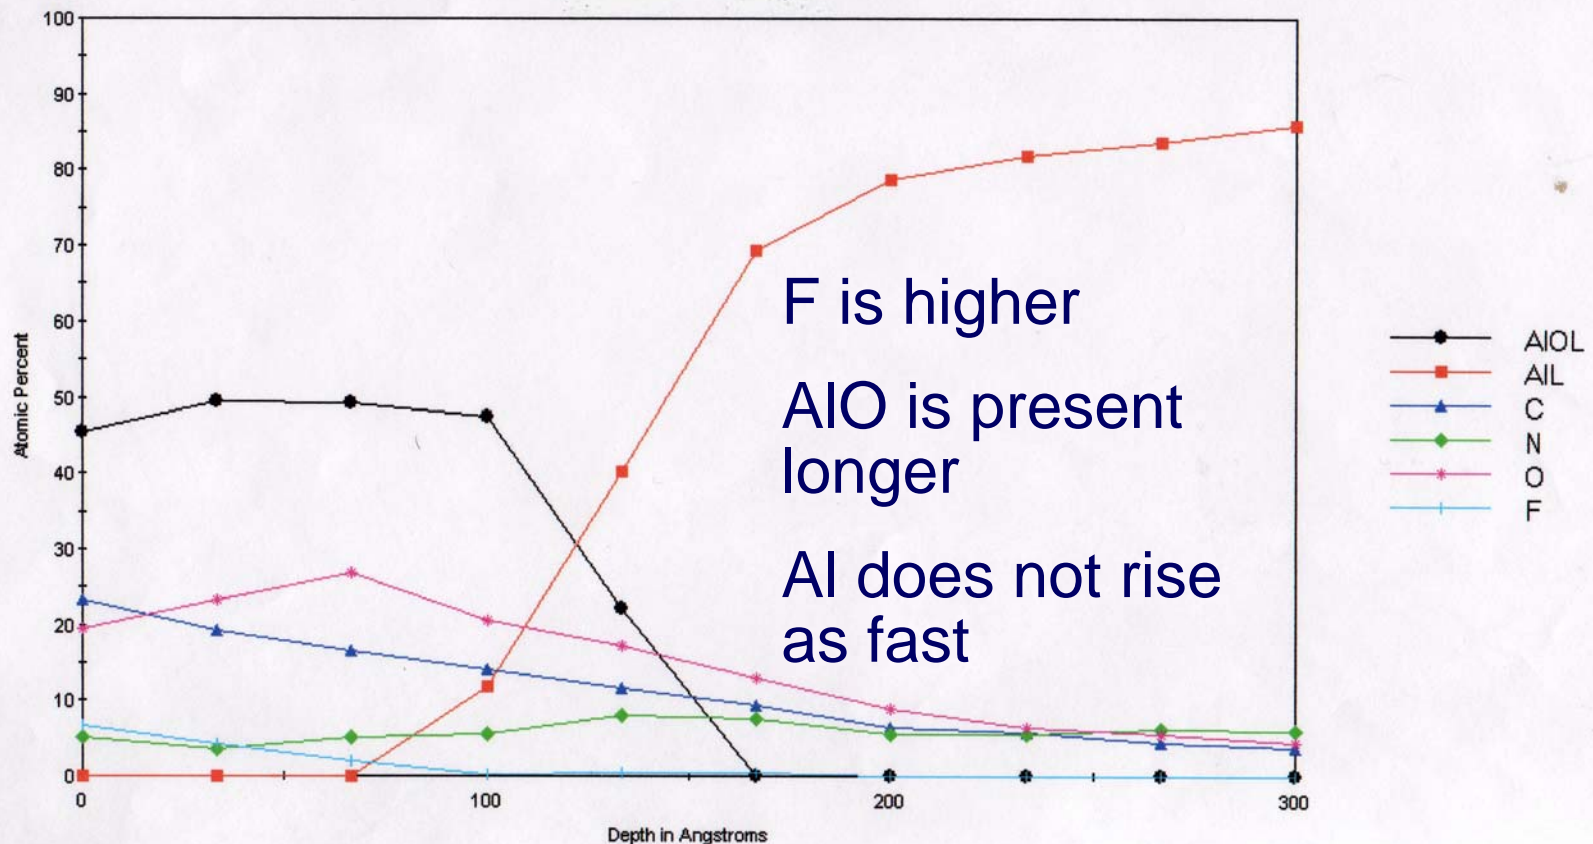
Lab #23737 - C: Depth Profile on a Bond Pad

Clean Rate Changes

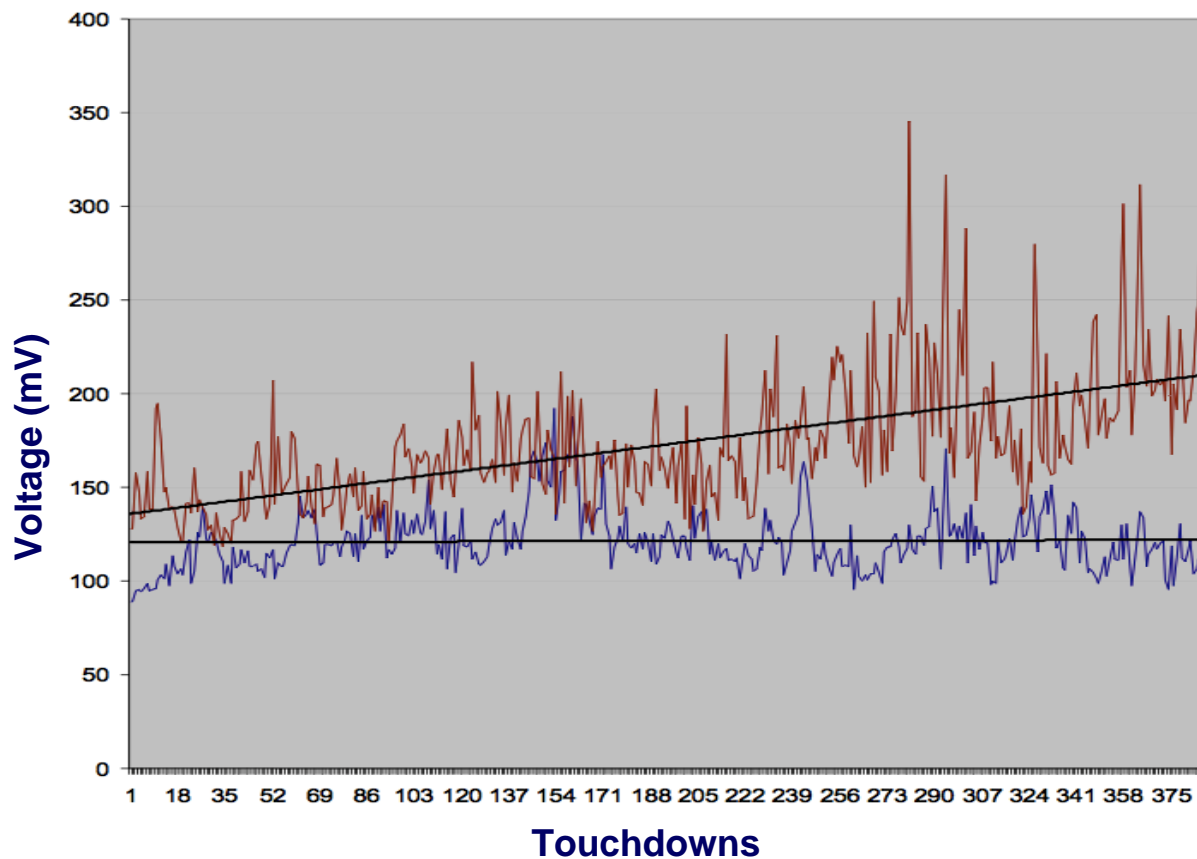
Dramatic Results After BPS on AI

- Lower CRES
- Less Noise
- Fewer false fails
- Less CRES increase over touchdowns

Before BPS

After BPS

Real resistance between two pins on the pad at 10um overtravel

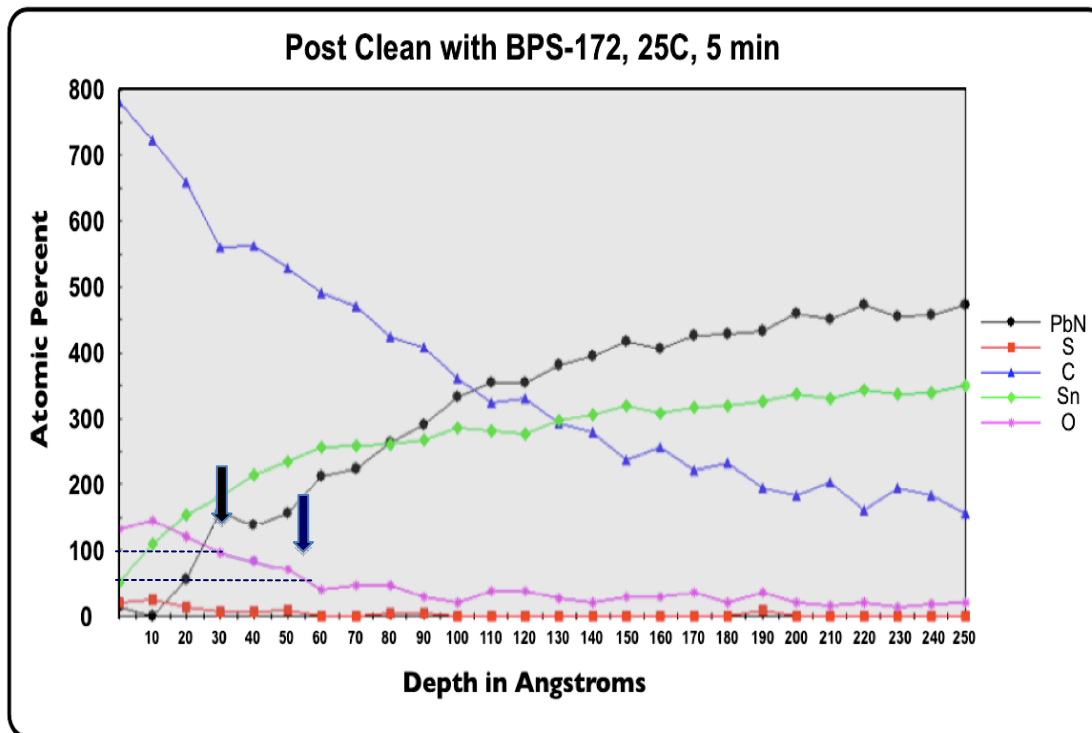
BPS 170/172 for SnPb Bumps

Wafers cleaned with BPS-172:

10% level reached at 30 Å and
5% level around 55 Å
Oxygen levels lowered by 70%!

5 minutes in BPS170/172 reduces oxide and can eliminate the need for flux during assembly

Oxide levels determined by Auger milling to 250 Å depth
