Semiconductor Wafer Test Workshop

*Rocky J.M.Lee, J.S.Choi, IMT Co Ltd, Korea

Probe Card Cleaning by Laser

June 6 to 9, 2010
San Diego, CA USA

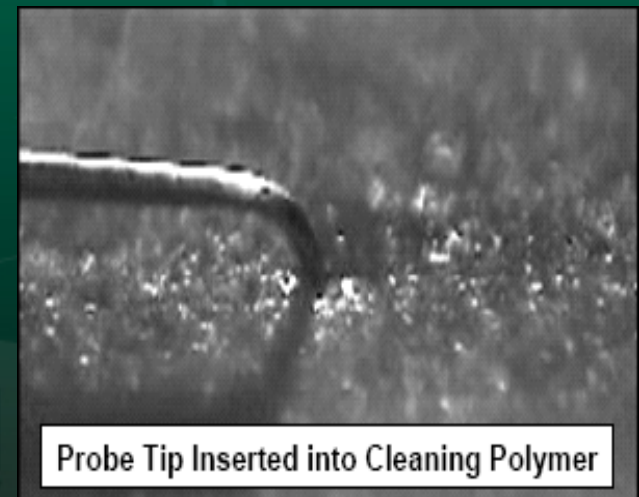
Conventional PC cleaning

: Mechanical contact using abrasive pad at Prober

1. Difficult to clean the probe sides
2. Probe wear due to contact cleaning => PC Lifetime reduction
3. PC Alignment & planarity change due to contacts => Lifetime red.
4. Consumable Abrasive pads => Extra cost
5. No cleaning solutions for MEMS PC due to delicate structures

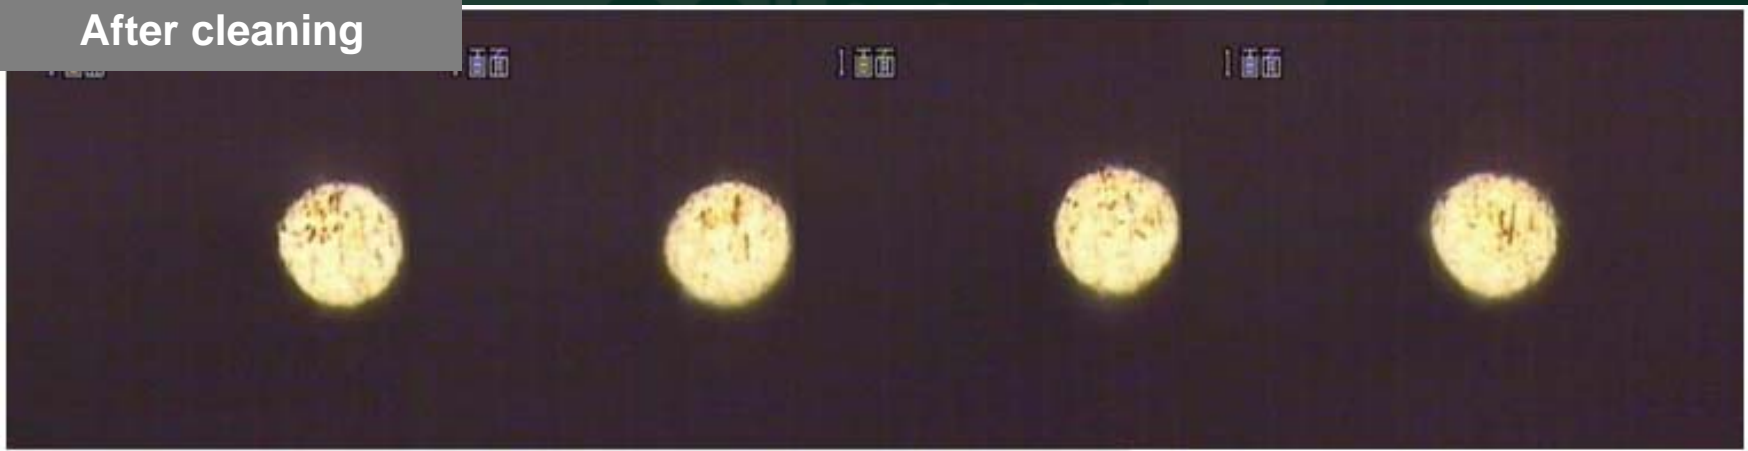
- Magnified Tip Surface (x200)

Before cleaning

After cleaning

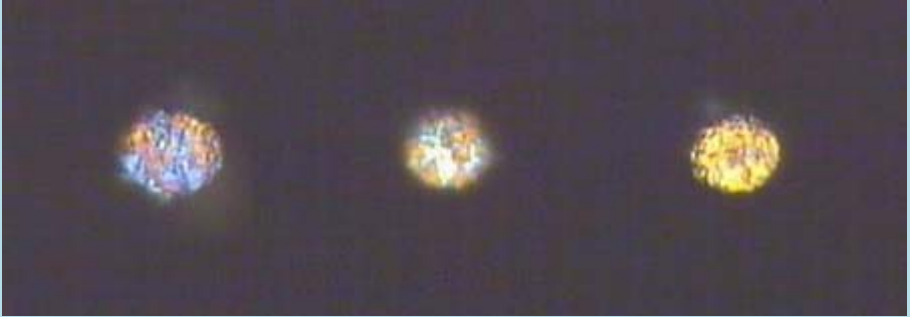
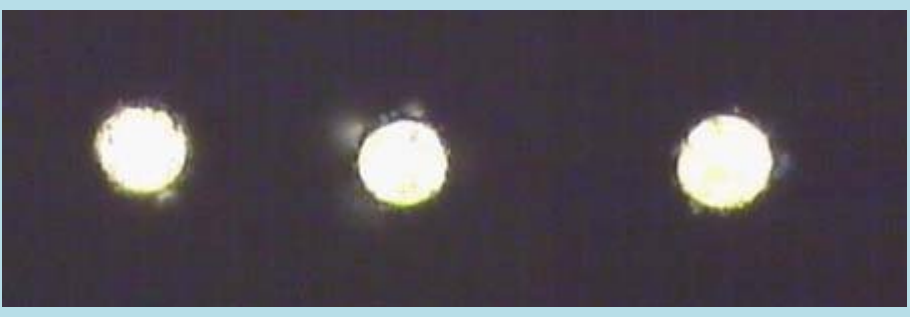
구분 Item	단면상태 Tip surface			PRVX3 Test [Contact Resistor]		
Before Laser Cleaning

Passed Failed Not Found	- - -	96 879 0
After Laser Cleaning

Passed Failed Not Found	- - -	577 398 0
Needle Diameter	Ø 80 μ m	Tip Diameter	7 \pm 1 μ m	Needle material	REW	
Laser 효과 effectiveness	Passed Channel 증가. C/R 저항 값 하락 Value decreased	PRVX C/R (Before cleaning)	1회 1.93~36.9 Ω 2회 0.10~31.1 Ω 3회 0.10~49.2 Ω	PRVX C/R (After cleaning)	1회	0.10~10.2 Ω
Laser	Power- 532nm Energy- 280mJ	Overtravel	Gold Plate - 20 μ m	PRVX C/R allowance	5 Ω

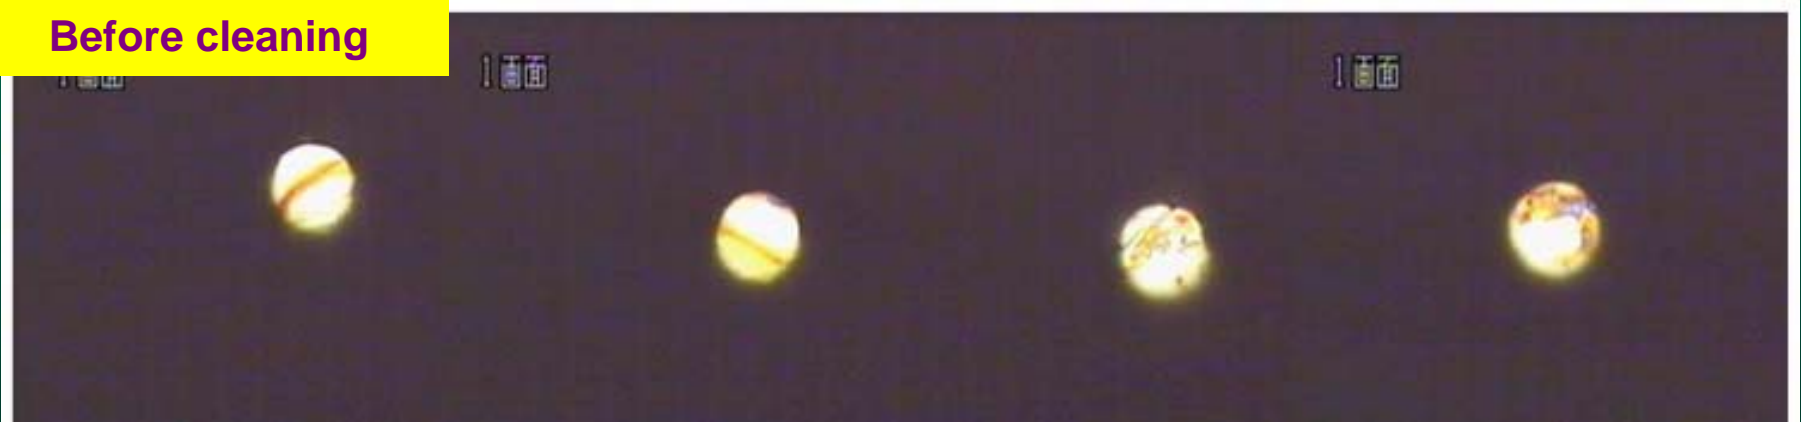
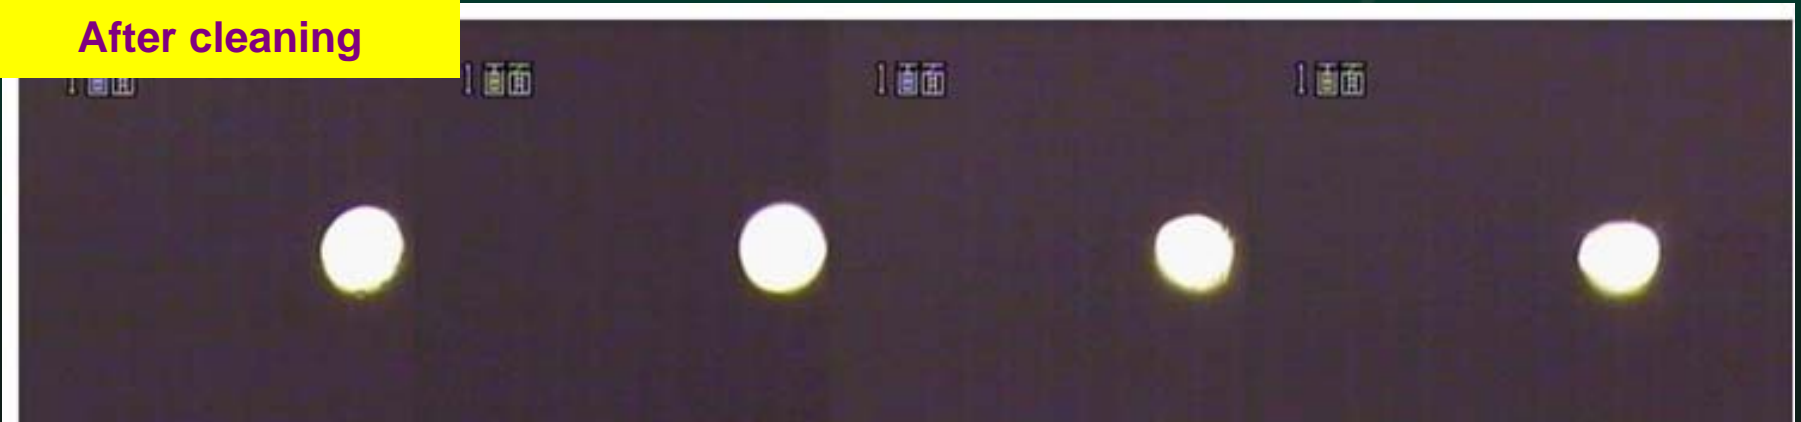
Before cleaning

After cleaning

*** The original contamination on the tip such as organic and native oxide were successfully removed by laser cleaning.

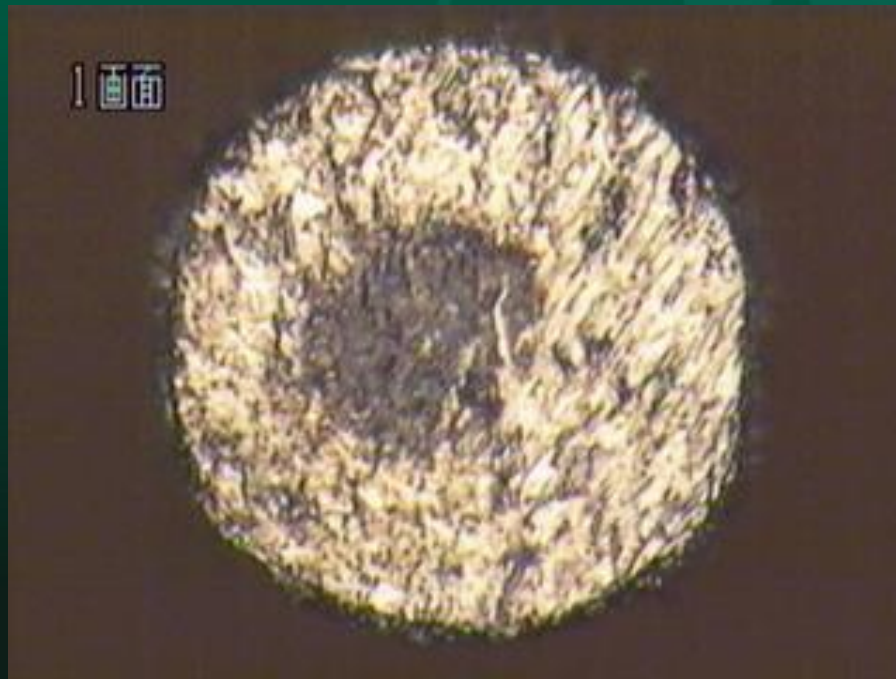
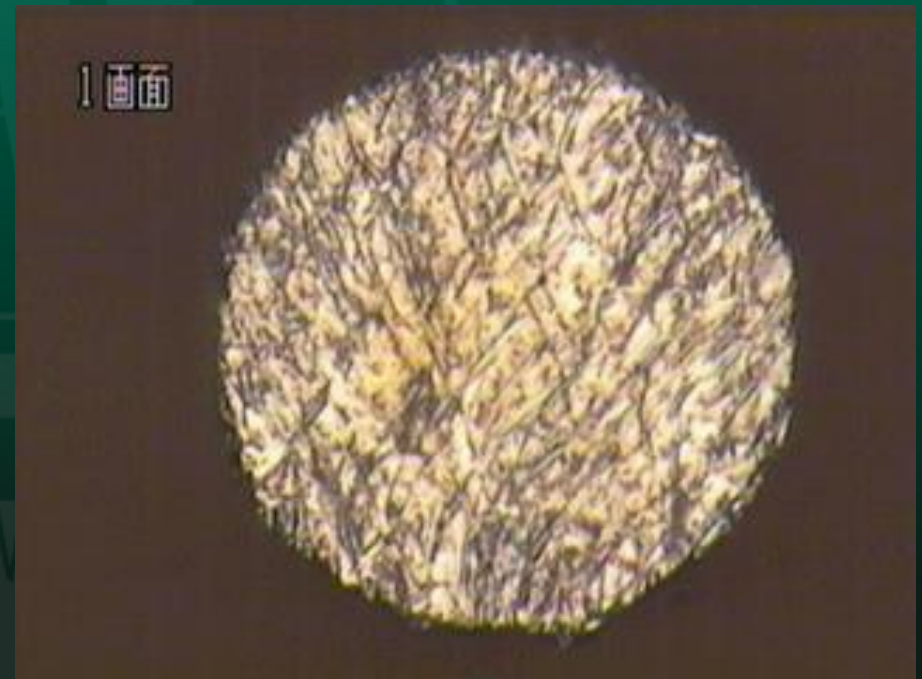
- Probe Surfaces Before & After Cleaning (x50)

Before Cleaning

*After Cleaning
=> Well cleaned*

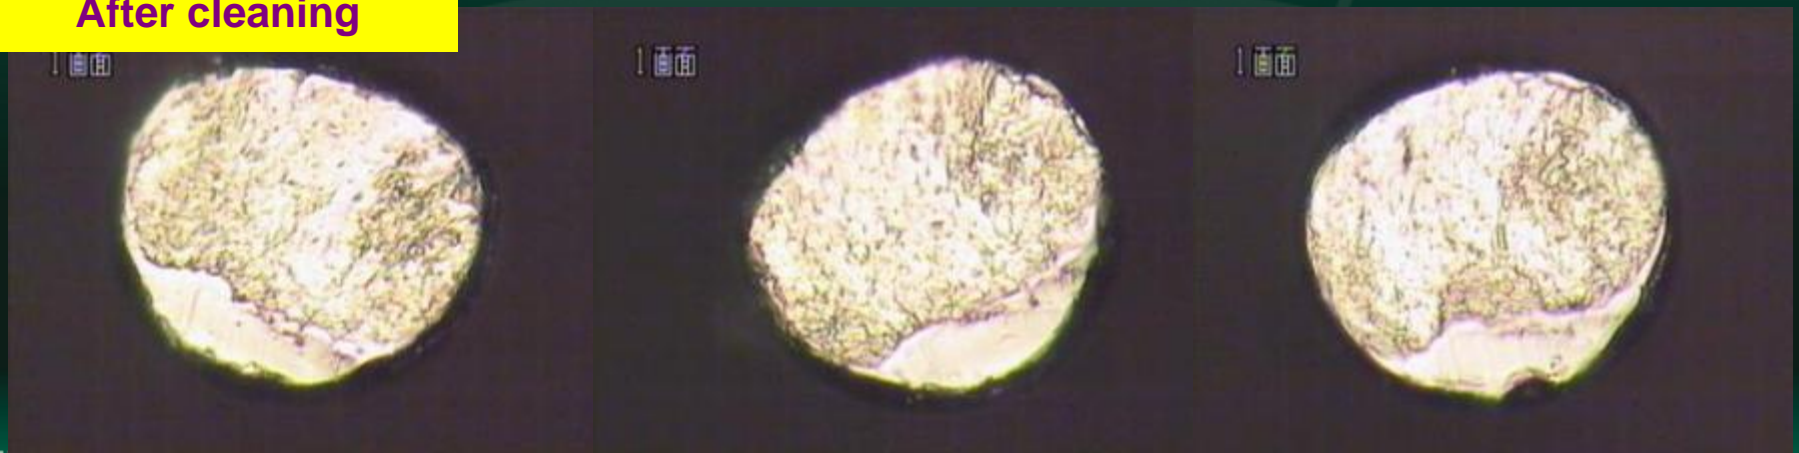
Cobra Needle Cleaning (Pt)

Before cleaning

After cleaning

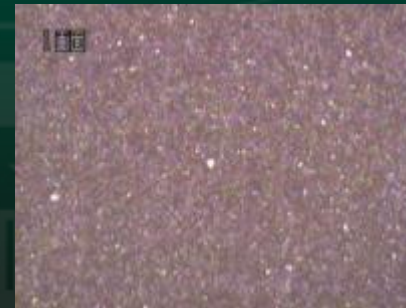
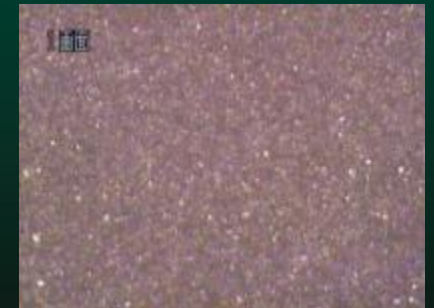
- ◆ Substrate & Parts before & after 100 laser shots at 350mJ

Before treatment

After treatment

*** There was no any surface changes after the harsh 100 laser treatment => No physical damages by laser cleaning

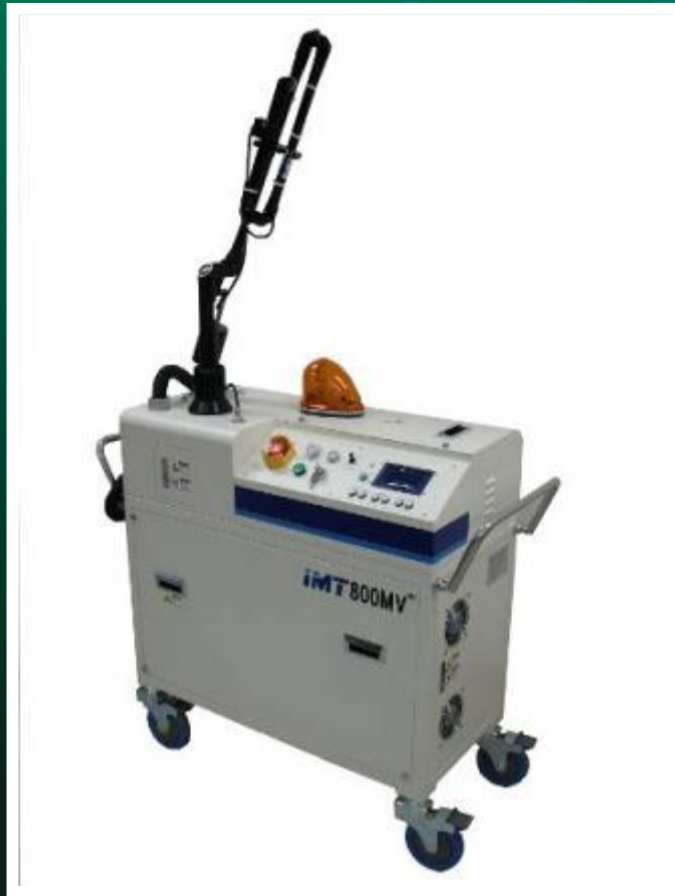
*** Mobile & Manual
For on-line cleaning

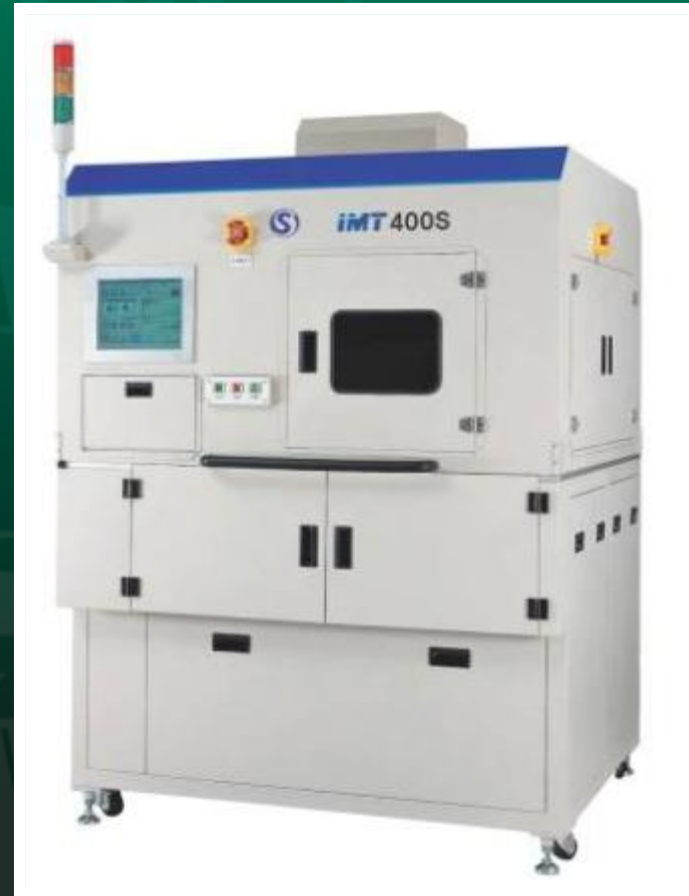
*** Fully Automatic
For off-line cleaning

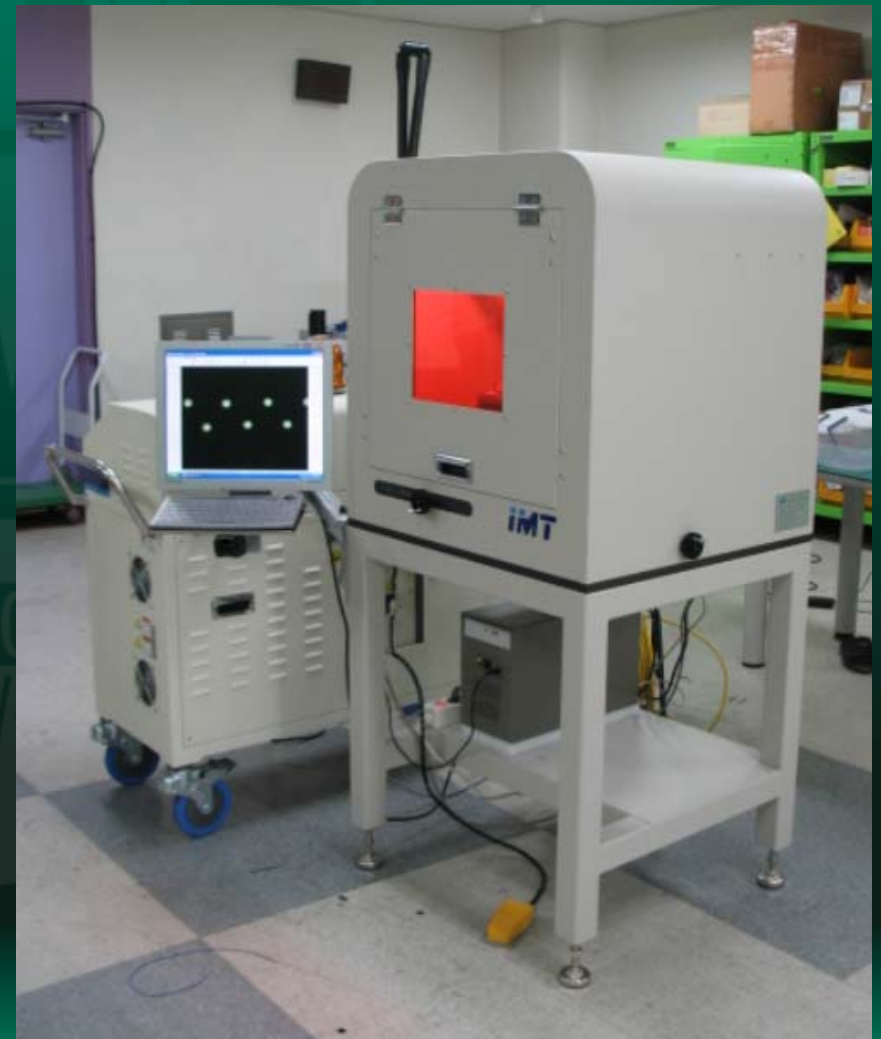
Real Application – X-Y Cleaning Stage

- * Off-line Cleaning Stage
- Manual operation
