Comparison of Bond Pad Cracking in Harsh Probing with Three Different Probe Cards

IEEE SW Test Workshop
Semiconductor Wafer Test Workshop

June 10 - 13, 2012 | San Diego, California

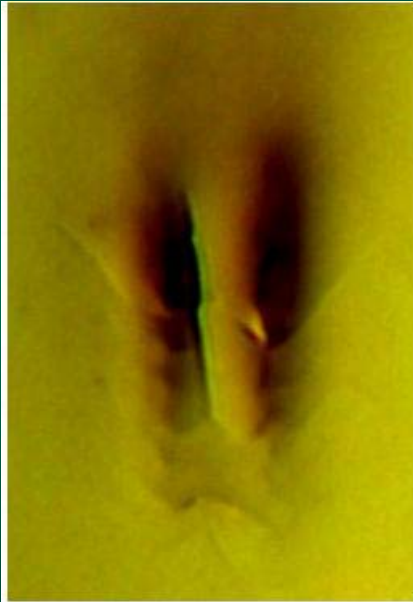
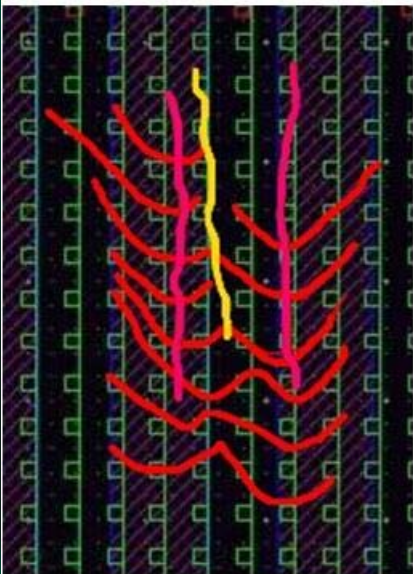
High Force Cracking Example

Probe
direction

- “Regular” probe cracks are split, accompanied by a perpendicular crack corresponding to the MT(-2) pattern

- Red: cracks relate to the array of holes in MT(-1) but split where no MT(-2)
- Pink: valleys above MT(-2) metal
- Yellow: Crack along the ridge, transition between MT(-2) metal and SiO₂
