Improved Cantilever Probing - Minimizing Scrub Marks

IEEE SW Test Workshop
Semiconductor Wafer Test Workshop

June 10 - 13, 2012 | San Diego, California

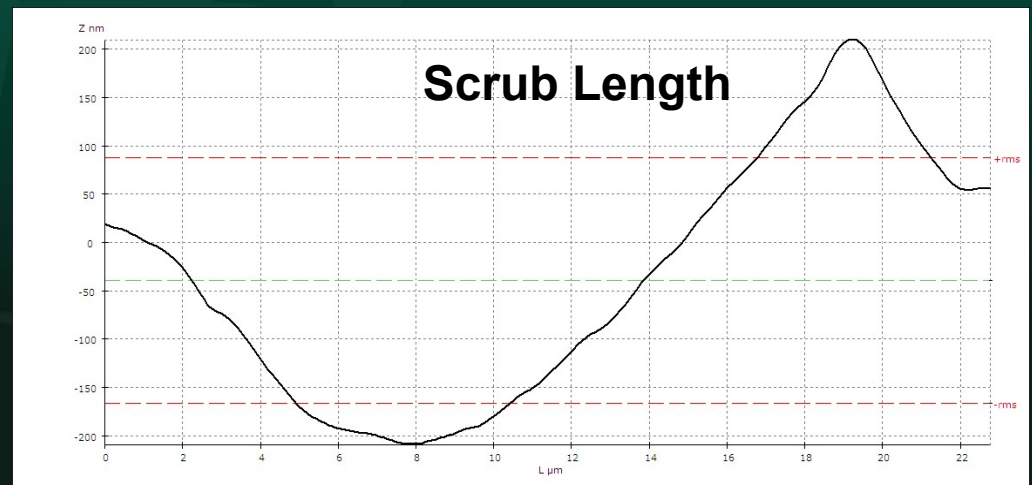
Scrub Analysis

- Typical Scrub at OT = 50 μm 1TD

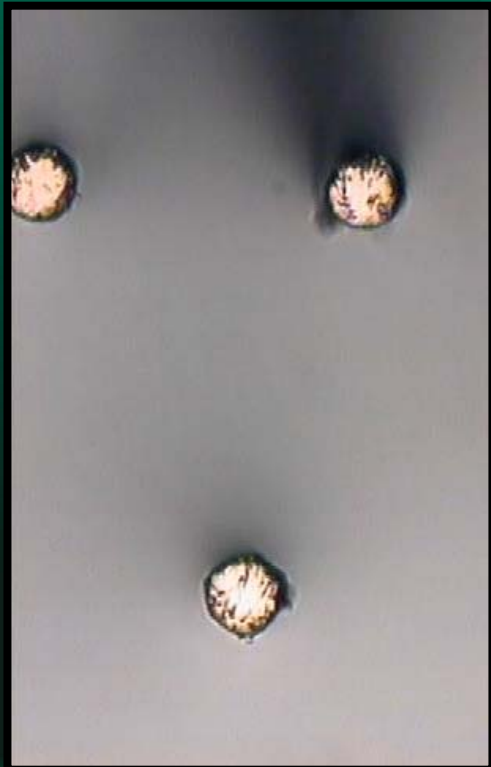
Pre-Probe

- *Online/Offline Visual Inspection of Probecard:*
 - *Complete visual of Probecard including image capture of same pin location pre and post windowing study*
 - *No visible debris or contamination build-up found on probes or tips*
- *No abnormal wear observed including no oxide buildup*

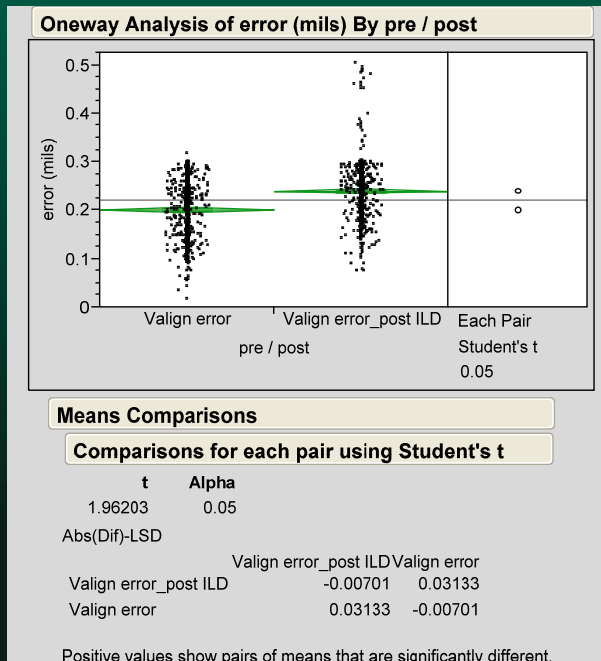
- The Technoprobe No Scrub™ card was measured on the PRVX analyzer before and after the ILD wafer was probed
- A minor increase in Alignment Error was observed
- Significant improvement in Planarity
- Minor increase in Tip Diameter

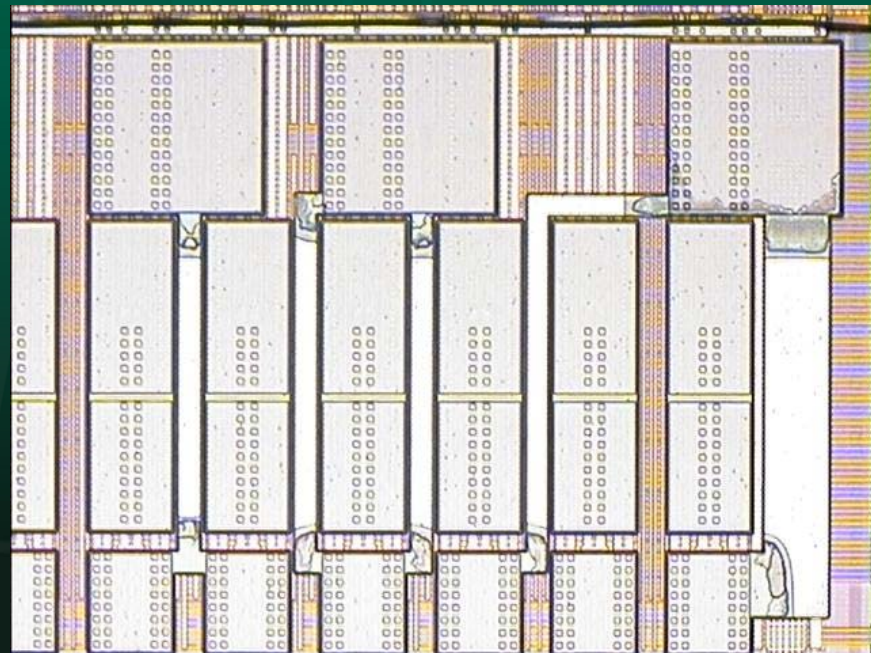
Pad Damage Inspection Example

- Sample shown is from the heaviest-stress cell (OD70 / TD08).
- Aluminum removed from pads to enable barrier layer damage assessment.
- Extremely minor barrier layer deformation is observed in the heavy-stress cells, but no evidence of barrier layer breach or ILD damage is observed in any cell.

100% pads inspected per die (575 probed pads per die)
 No barrier layer breach or under-etch observed in any cell

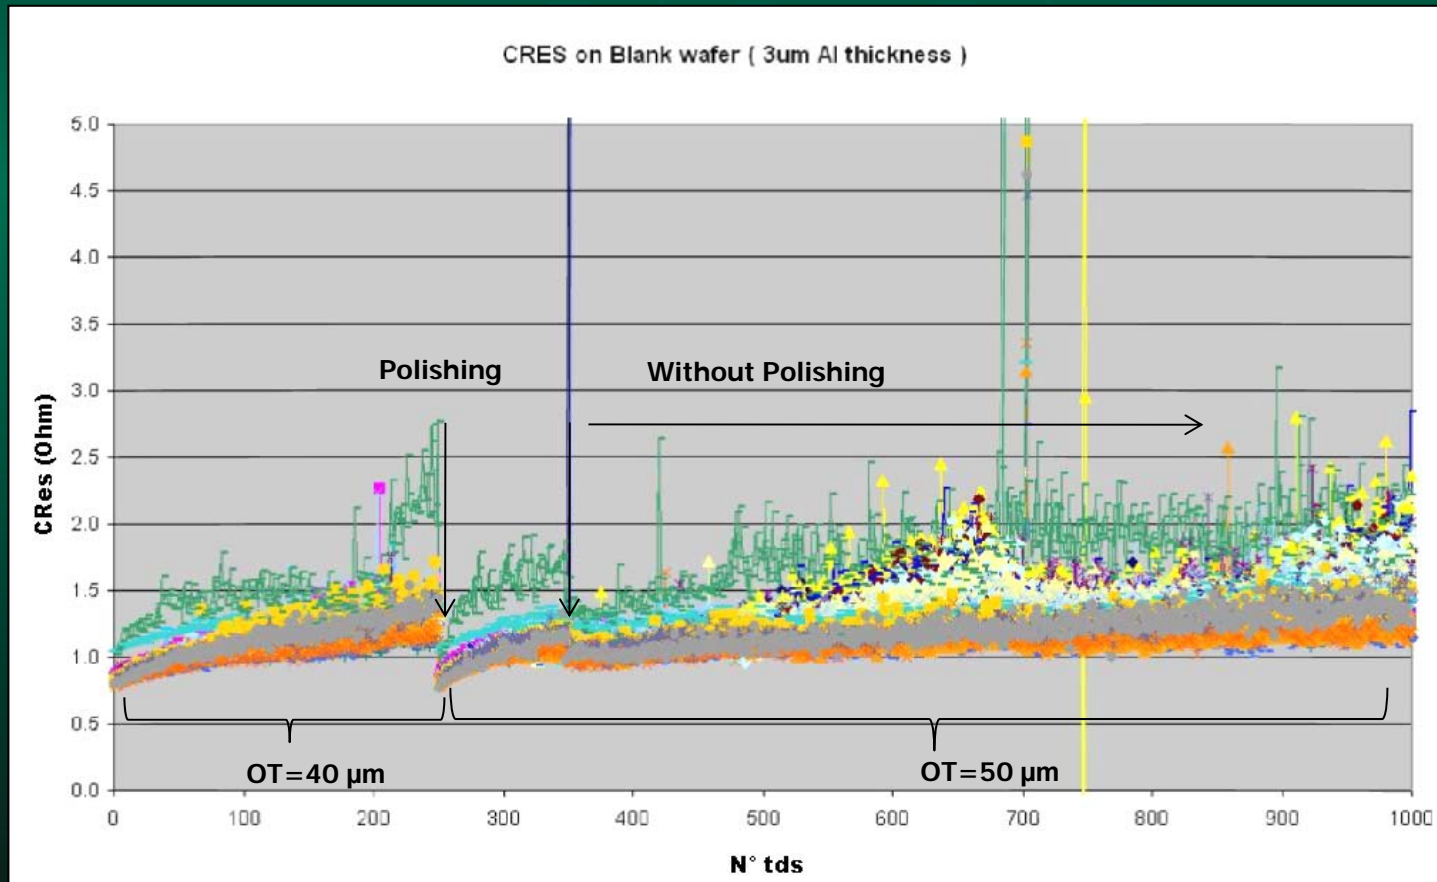
No Scrub™ Cres analysis at room temperature

- CRES measurement on Blank Al wafer with UF3000 Prober
- Technoprobe suggest a polishing cycle every 75 TD
