**SW Test Workshop**  
Semiconductor Wafer Test Workshop

# PROBING CU PILLAR APPLICATIONS W/ VERTICAL TECHNOLOGIES

**Brandon Mair**  
Texas Instruments

June 5-8, 2016

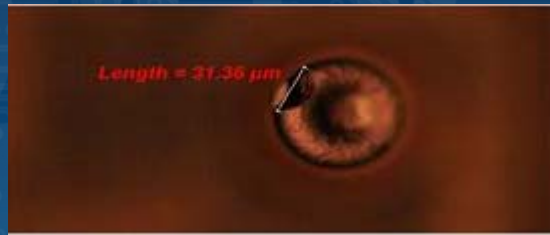
Examples of misalignment of pillars using cantilever technology causing failures hitting on edge of pillars.

- Cantilever technology has traditionally been the baseline for probing on Cu pillars within TI.
- Smaller feature sizes and adds more stringent requirements such as high temp, challenges cantilever on probing Cu pillars.

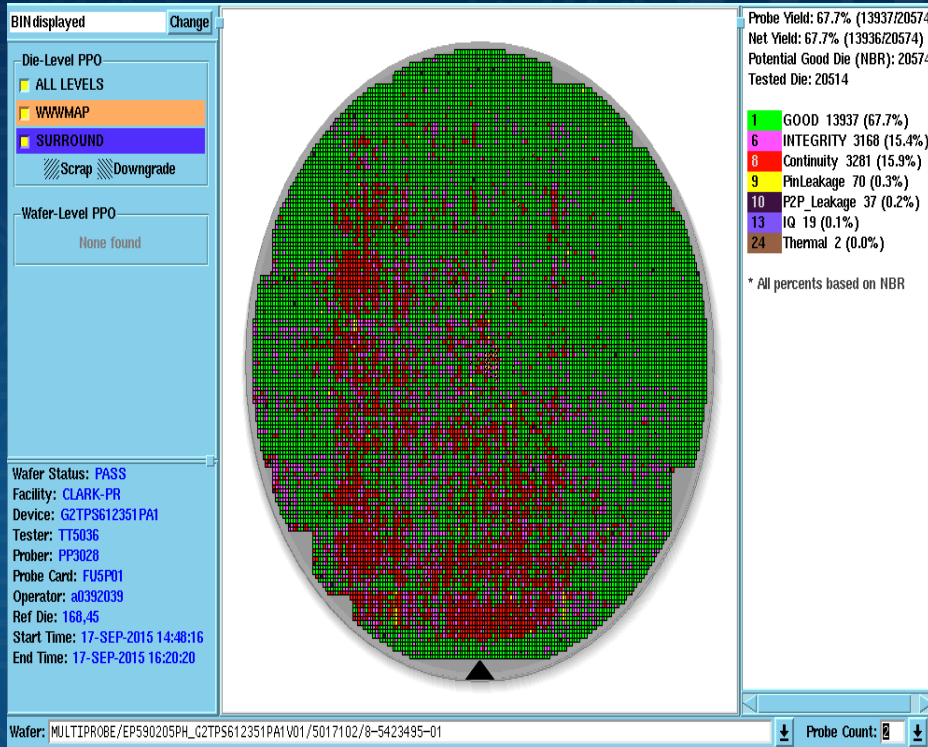
**TP M2XLT**  
 AutoZ Planarity = 5um  
 Cleaning = 200x5  
 Yield = 67.7%

Fail Contributor – CONT and INTEGRITY tests

- Initially in Clark, TI tried to utilize the M2XLT as it was already qualified on pad.
- The data showed much better results on initial correlation for M3XLT when compared with M2XLT.

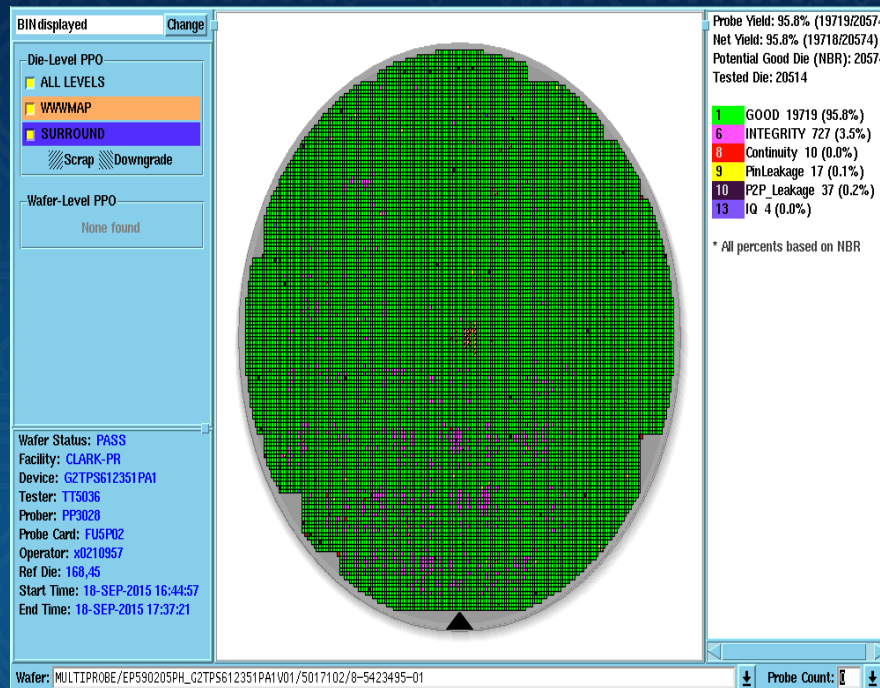
TP M2XLT  
 Cleaning = 50x5  
 Yield = 95.8%

- Next, the M3XLT was compared with the baseline cantilever technology.
- The cleaning interval was reduced from 200Td to 50Td.
  - INTEGRITY test failure was greatly reduced from 6.5% to 3.5%
  - CONT test failure was reduced from 0.3% to 0.05%
- Yield increased from 92.6% to 95.8% but is still not satisfactory compared with Cantilever (99%)

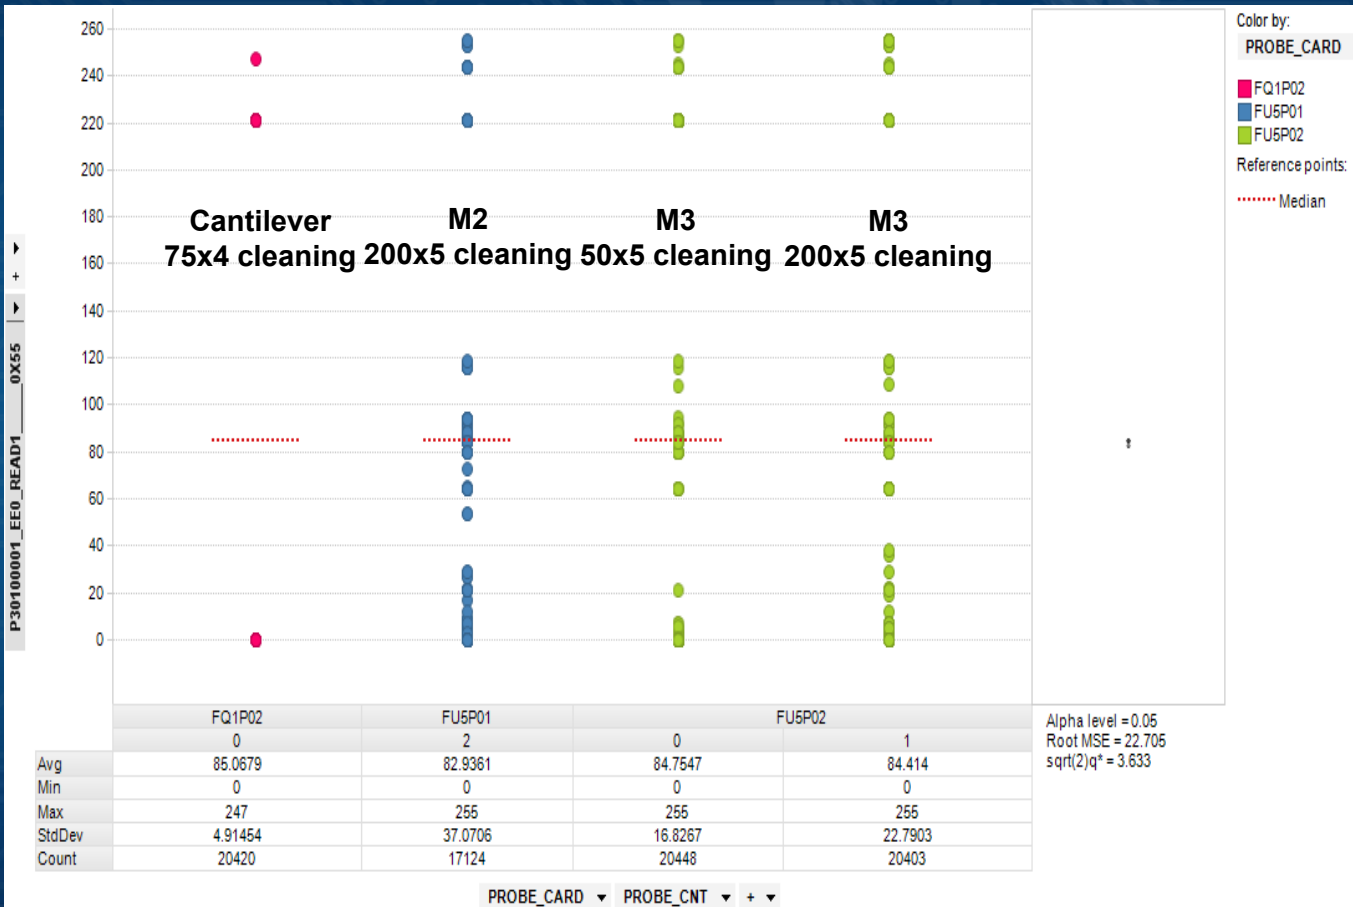
# EE0\_READ1 Distribution

LSL: 0dB  
USL: 85dB

EEPROM Test distribution is much better on Cantilever.

M3 though had a better reading over M2 even when cleaning was still at 200 die interval.

Reduction of cleaning interval further improved M3's performance but it is still not comparable to baseline.

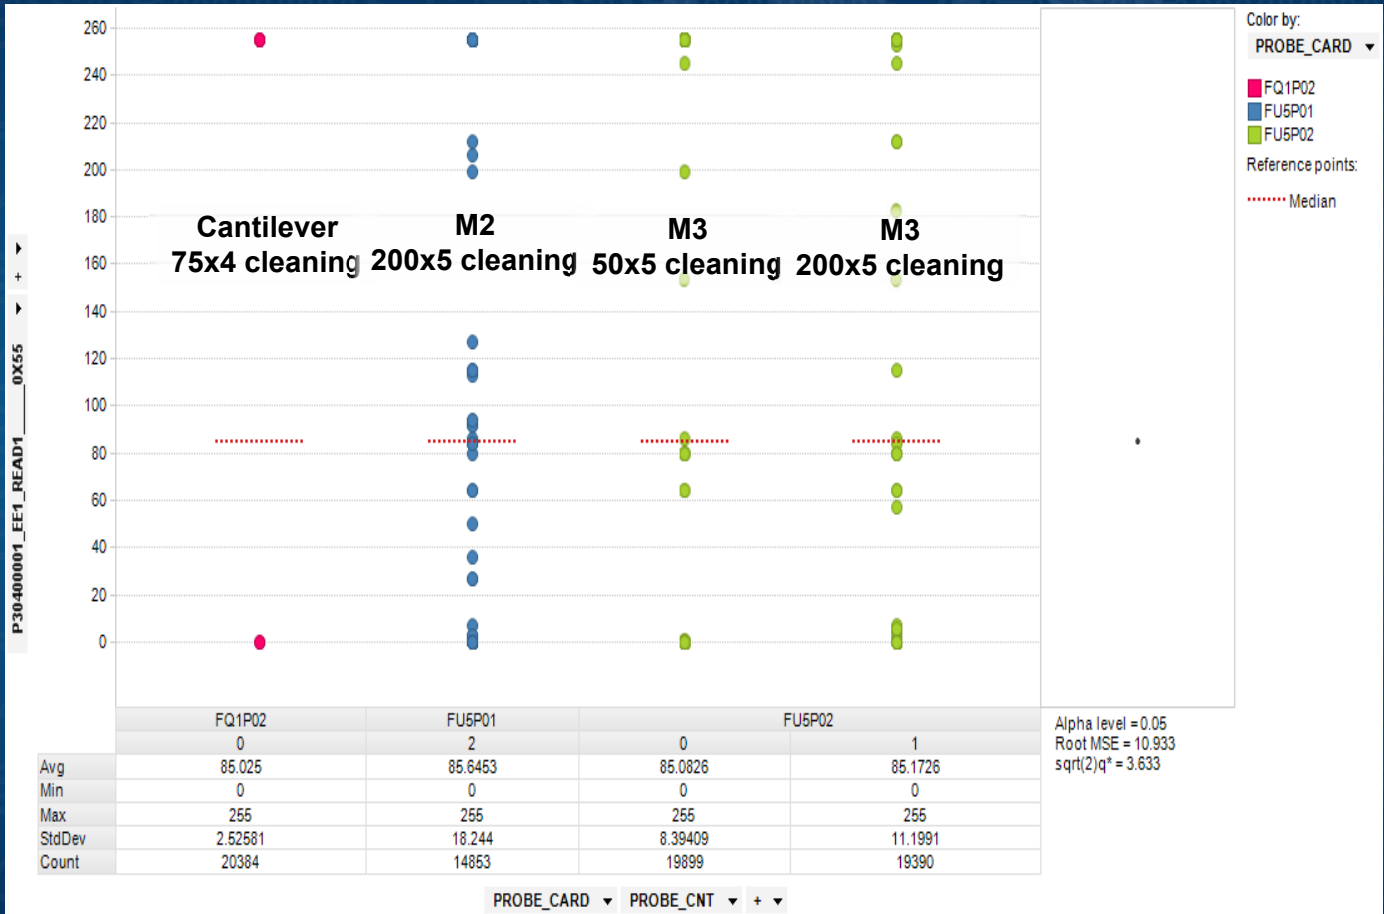
# EE1\_READ1 Distribution

LSL: 0dB  
USL: 85dB

EEPROM Test distribution is much better on Cantilever.

M3 though had a better reading over M2 even when cleaning was still at 200 die interval.

Reduction of cleaning interval further improved M3's performance but it is still not comparable to baseline.

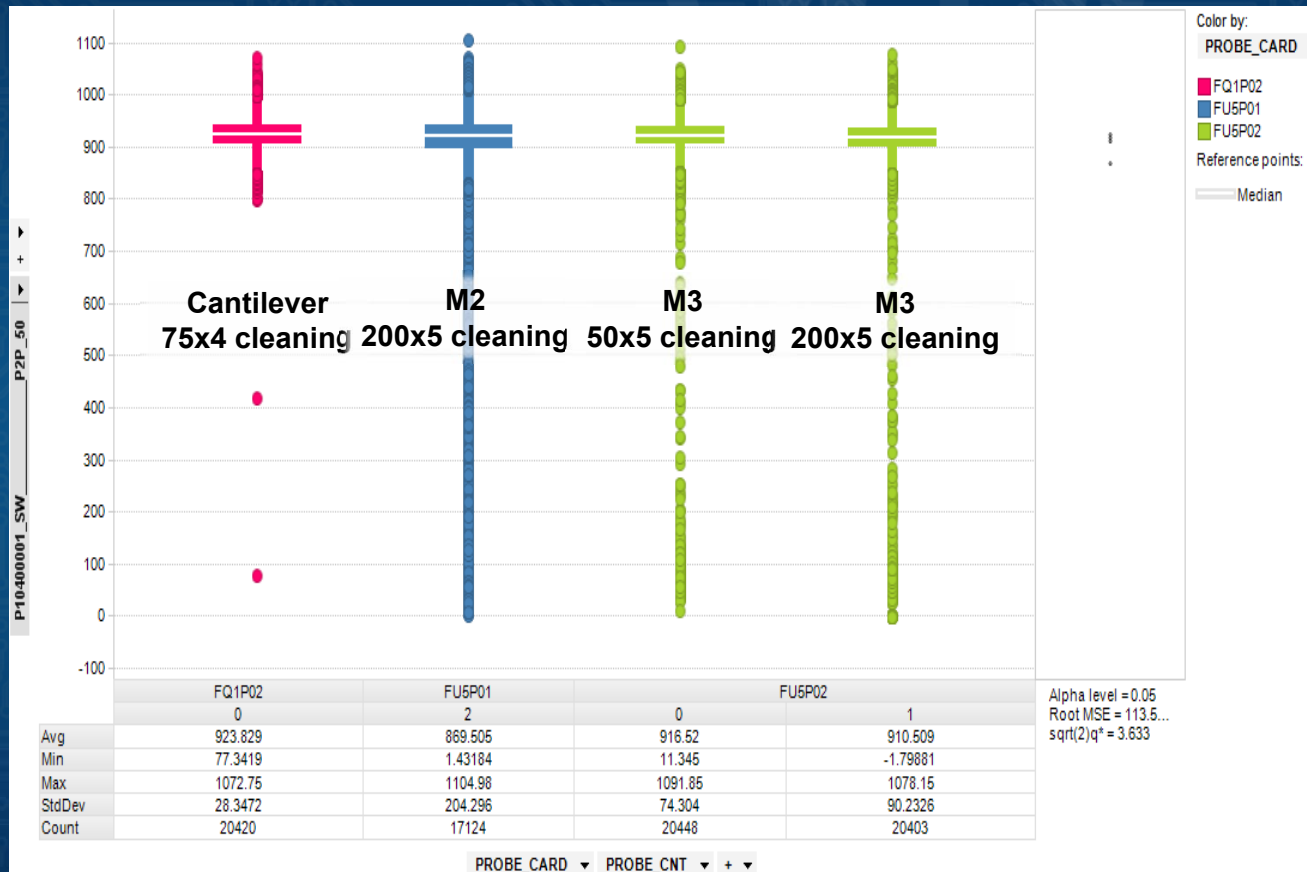
# SW (P2P) Distribution

LSL: 300nA  
USL: 2000nA

P2P Test distribution is much better on Cantilever.

M3 though had a better reading over M2 even when cleaning was still at 200 die interval.

Reduction of cleaning interval further improved M3's performance but it is still not comparable to baseline.

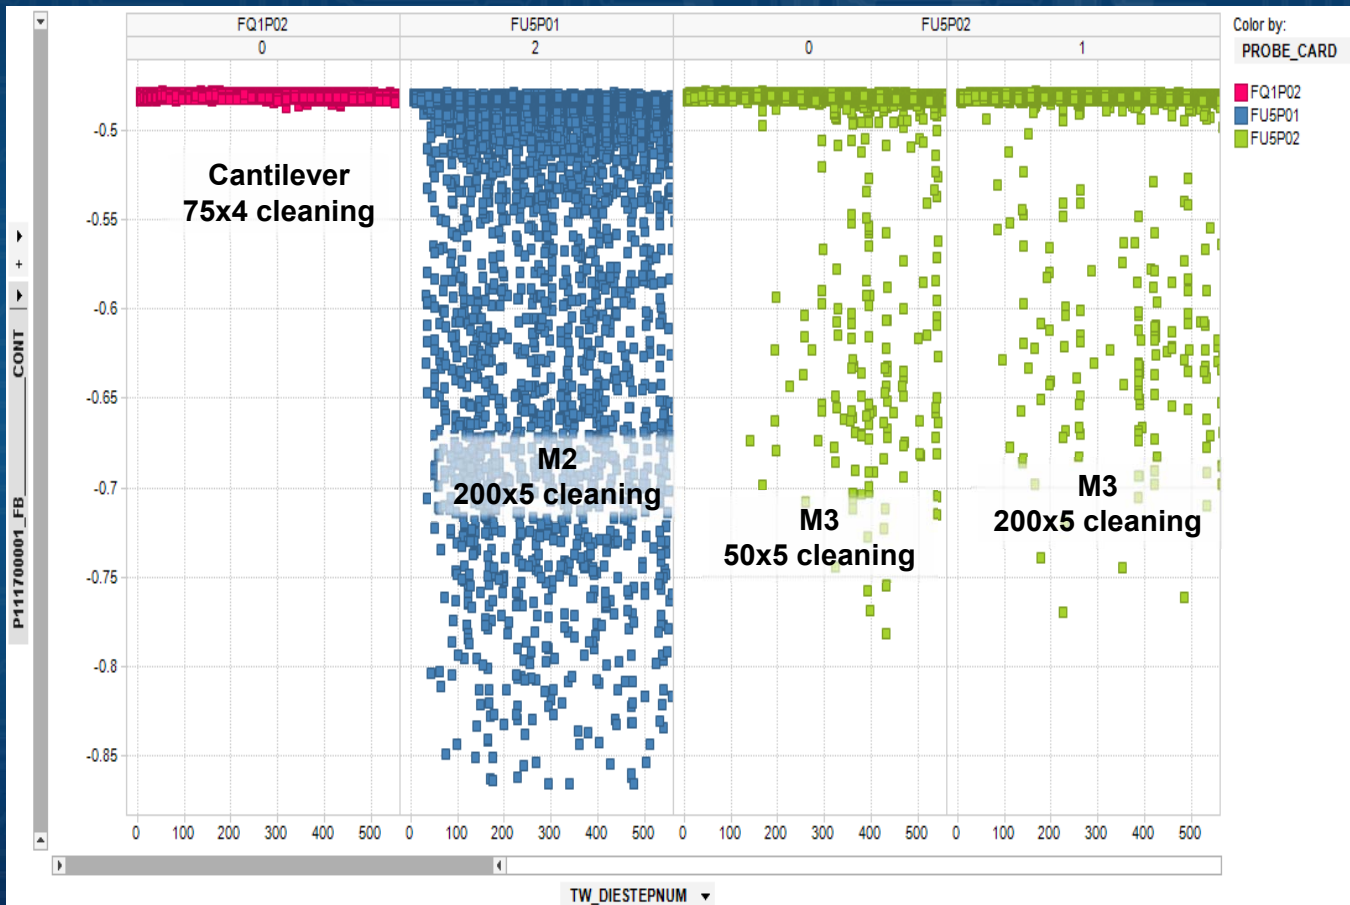
# Readings vs TD (FB\_CONT)

LSL: -0.9V  
USL: -0.2V

Cantilever is consistent all through out its TD.

M2 had not reached the 200 die mark before readings started to get worst.

M3 had some outliers and it is getting worst as TD accumulates but not as bad as M2. Cleaning interval reduction also minimized the number of outliers.

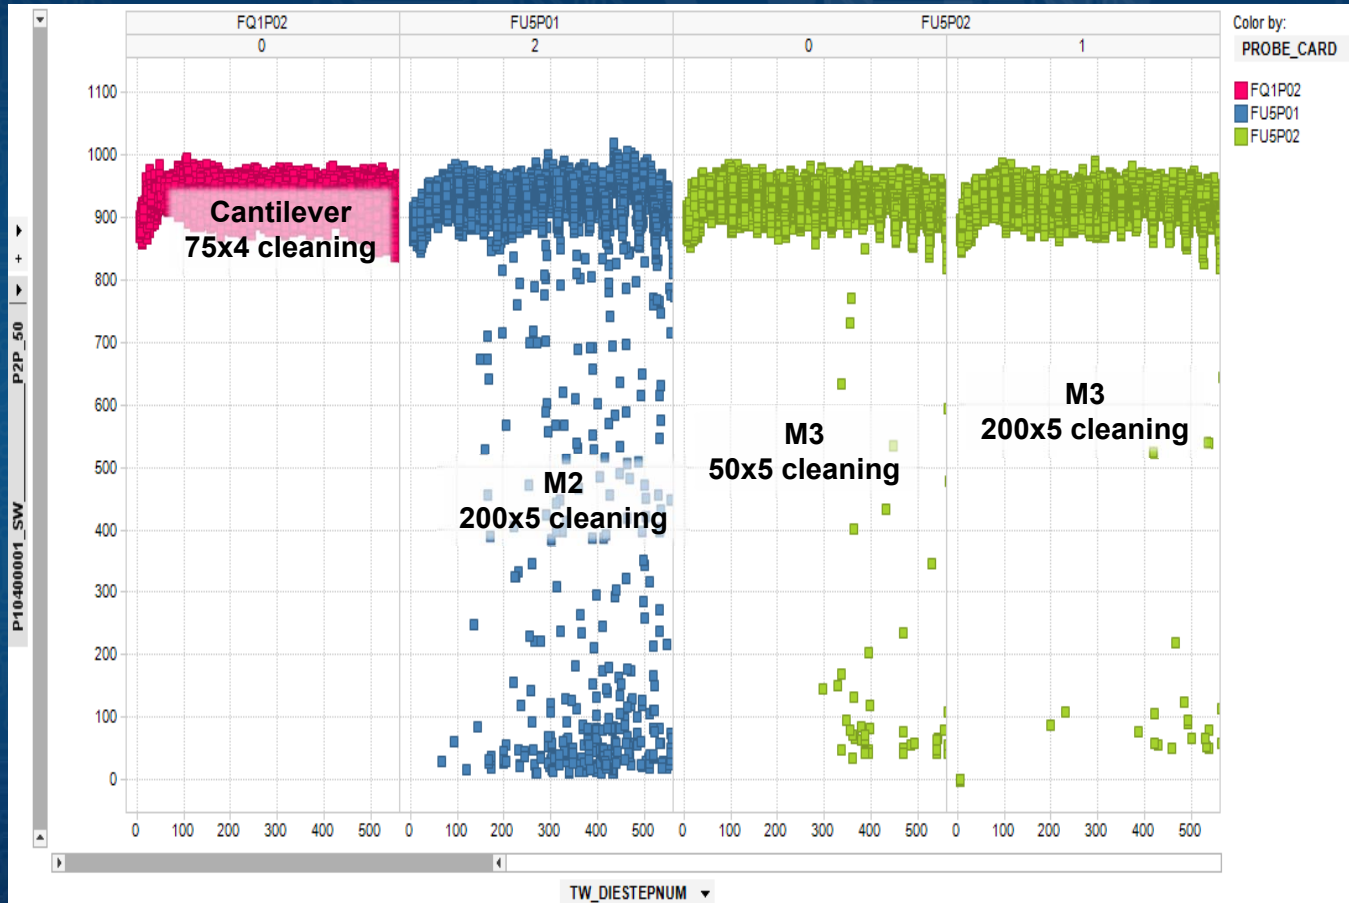
# Readings vs TD (SW\_P2P)

LSL: 300nA  
USL: 2000nA

Cantilever is consistent all through out its TD.

M2 had not reached the 200 die mark for cleaning before it started to get worst.

M3 had some outliers and it is getting worst as TD accumulates. Cleaning interval reduction also minimized the number of outliers.

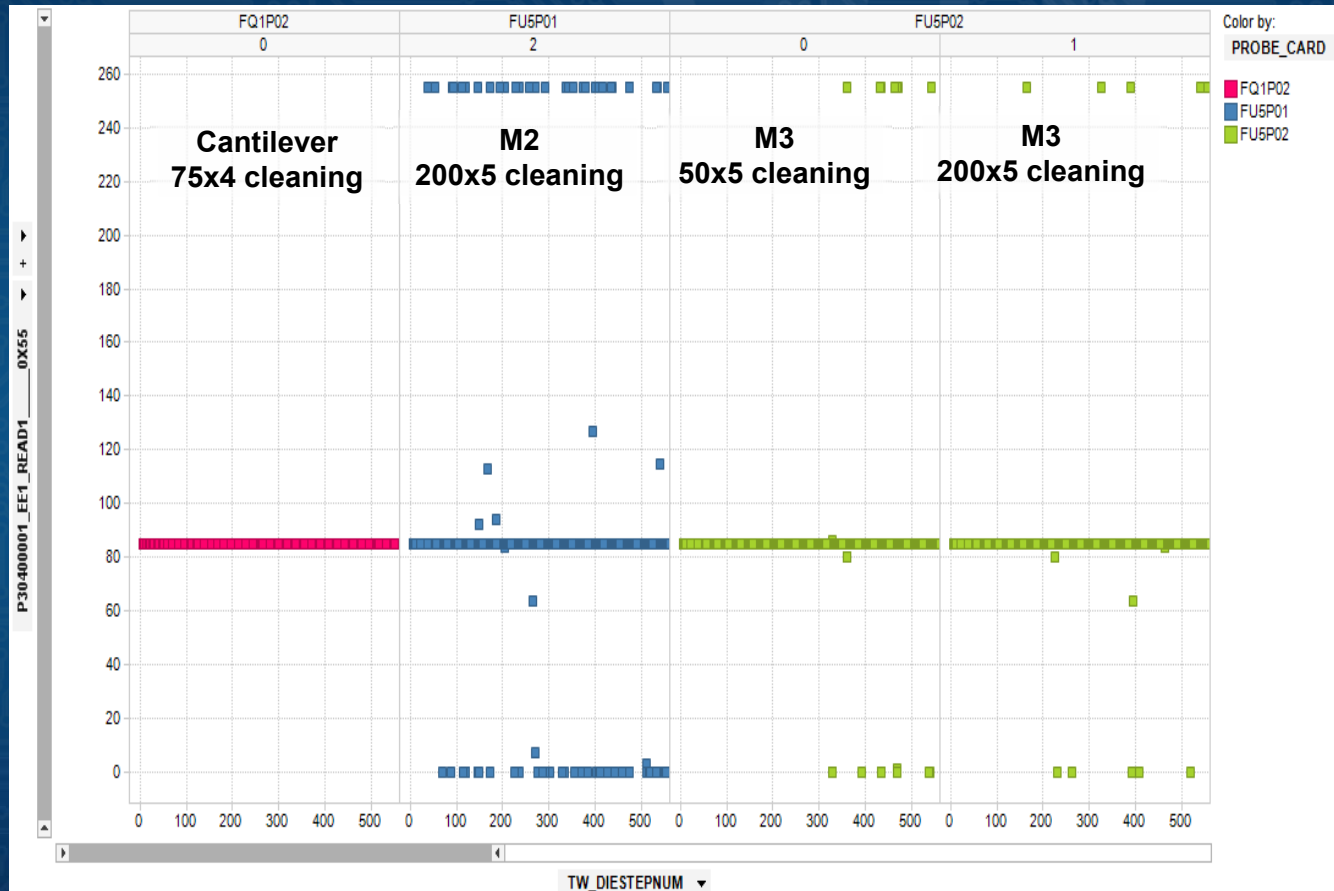
# Readings vs TD (EE1\_READ1)

LSL: 0dB  
USL: 85dB

Cantilever is consistent all through out its TD.

M2 had not reached the 200 die mark for cleaning before it started to get worst.

M3 had some outliers and it is getting worst as TD accumulates. Cleaning interval reduction also minimized the number of outliers.

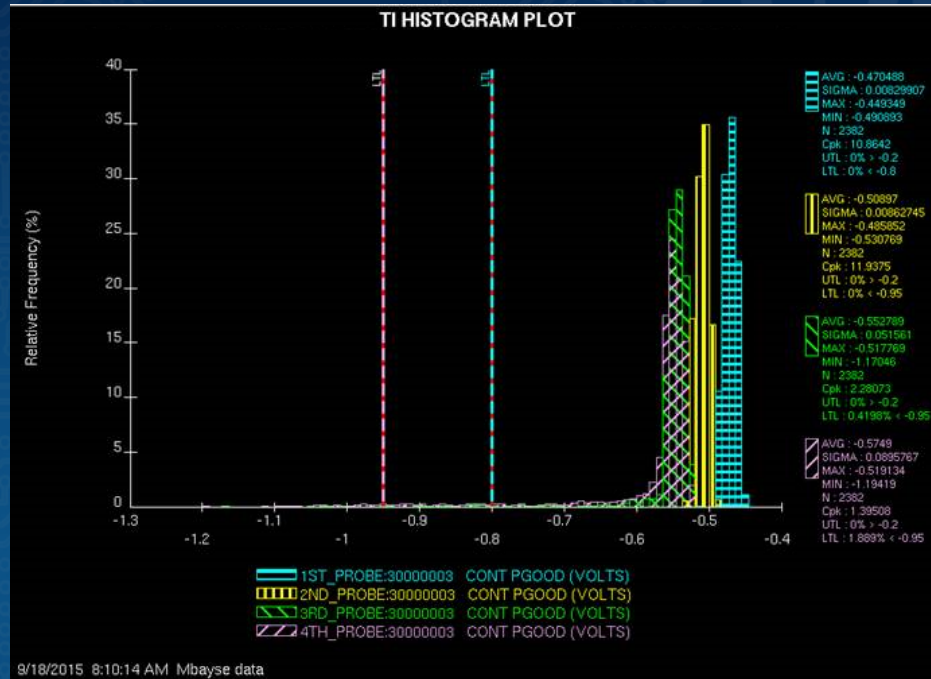
- Cantilever was the baseline probe card technology for this device.
- Table above shows the difference in continuity failures between prebake and post bake.
  - Large increase in open failures after bake. The current should go down from prebake. Result show current went up 1uA post bake.
  - Wafer was probed 4 more times post bake and opens were seen ~6-8% on each run.
- TI decided to evaluate Technoprobe's M3XL technology here to see if could help improve on these contact related failures.

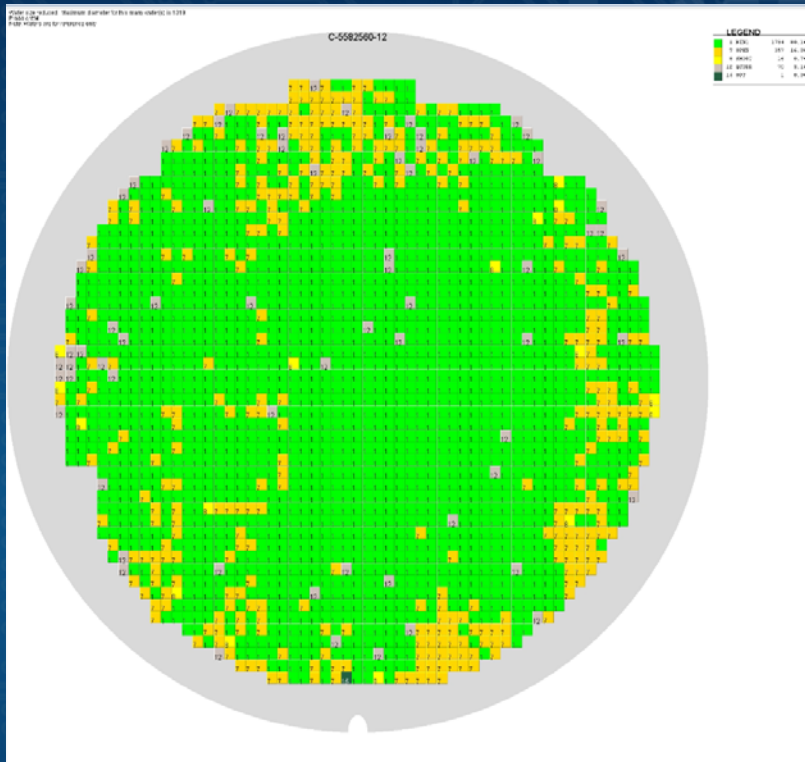
- Initial results using the M3XLT showed a large number of open failures (16.1%) on prebake wafer using radiused 9um tip.
- The photo of the probe indicate pin is sliding on pillar.

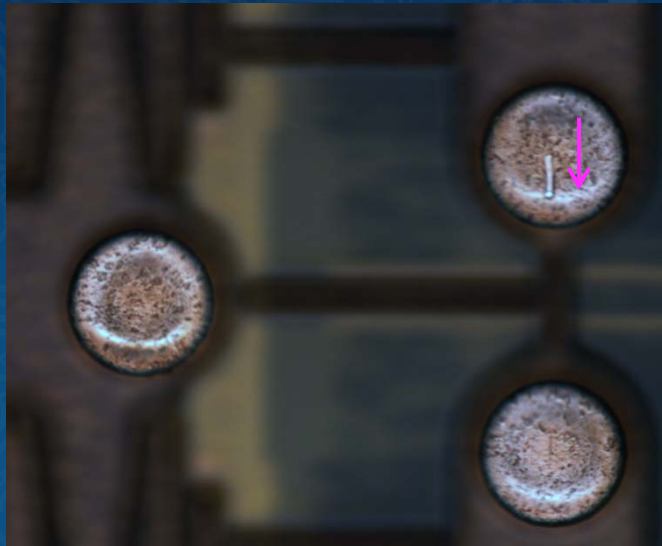
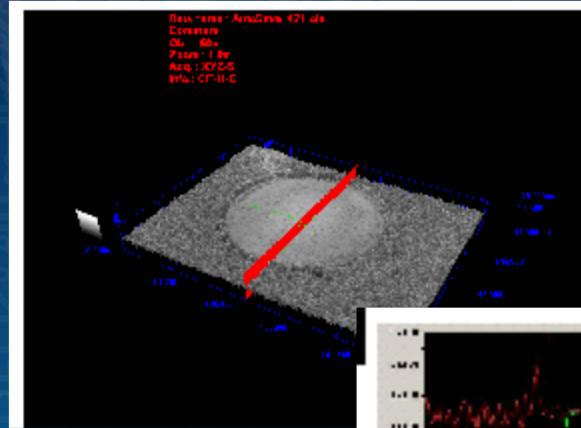
- Cu pillars are raised  $\sim 3\mu\text{m}$  in center.
- Pins sliding on curvature of the pillars.
- Technoprobe's pin uses a radiused tip causing pin to slide on curvature of the pillar.
- Moving to a flat tip to prevent this.

- **The increased opens found when probing with the 9um radiused tip caused sliding on the Cu pillar.**
  - Based upon the initial results, Cantilever was seeing ~1-2% opens pre bake and ~7% post bake.
  - The TP M3XLT card was seeing ~16% opens prebake.
  - The Cu pillars being probed had a slight curvature towards the center of the pillar. The pin was sliding as it hit this curvature.
- **The tip was increased to 18um and flattened to reduce the opens down to ~9.4% prebake.**
  - Probed wafers indicated correlation between over travel and open failures.
  - The higher the OT the more the pin slide creating failures.
