Semiconductor Wafer Test Workshop

A Real Life Pad Crack Study

Gunther Boehm (FM)

Jory Twitchell (NXP)

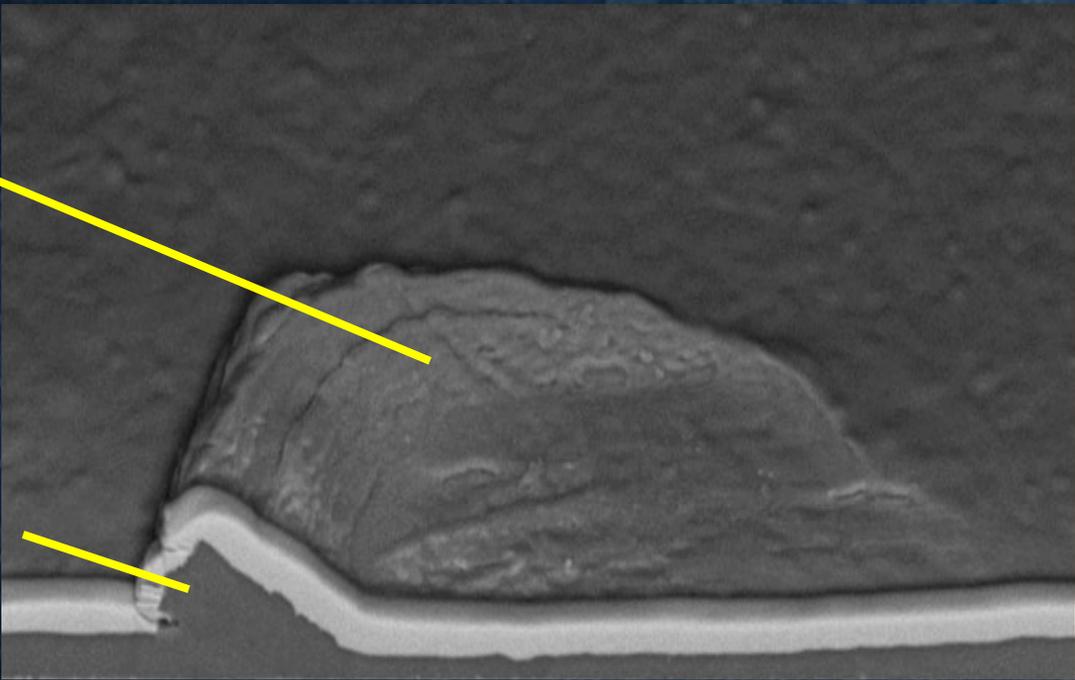
probed pad with substructure
SEM picture

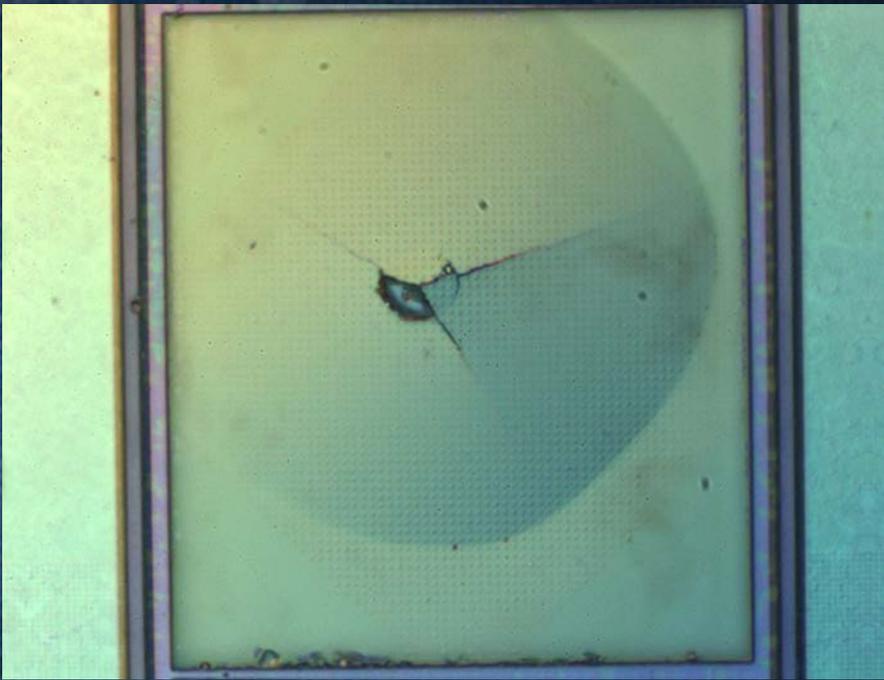
cracked pad
Al surface layer removed

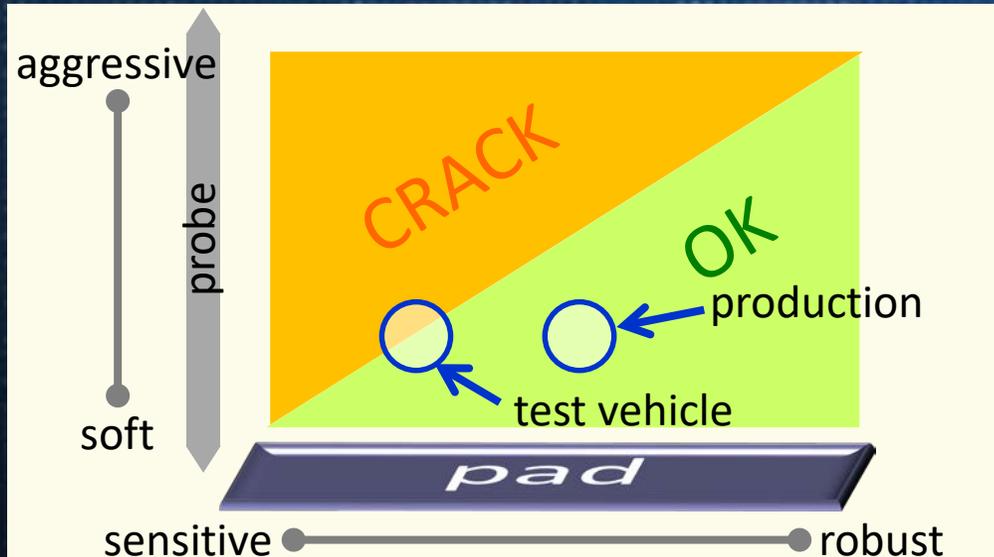
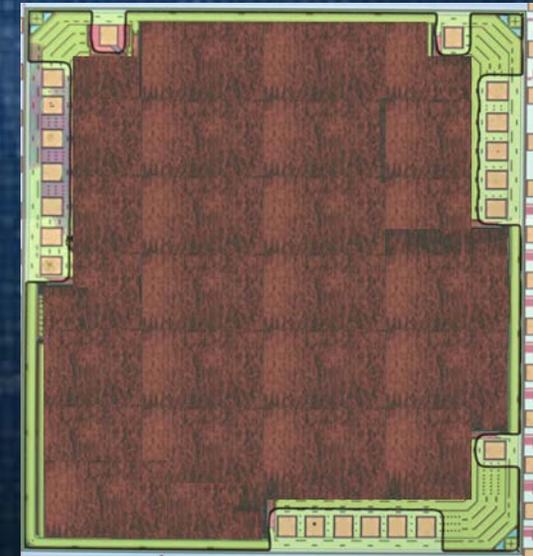
a test vehicle with adequate sensitivity is needed to investigate pad cracks

- our test vehicle:
- 21 pads
 - 2.05 x 2.3 mm

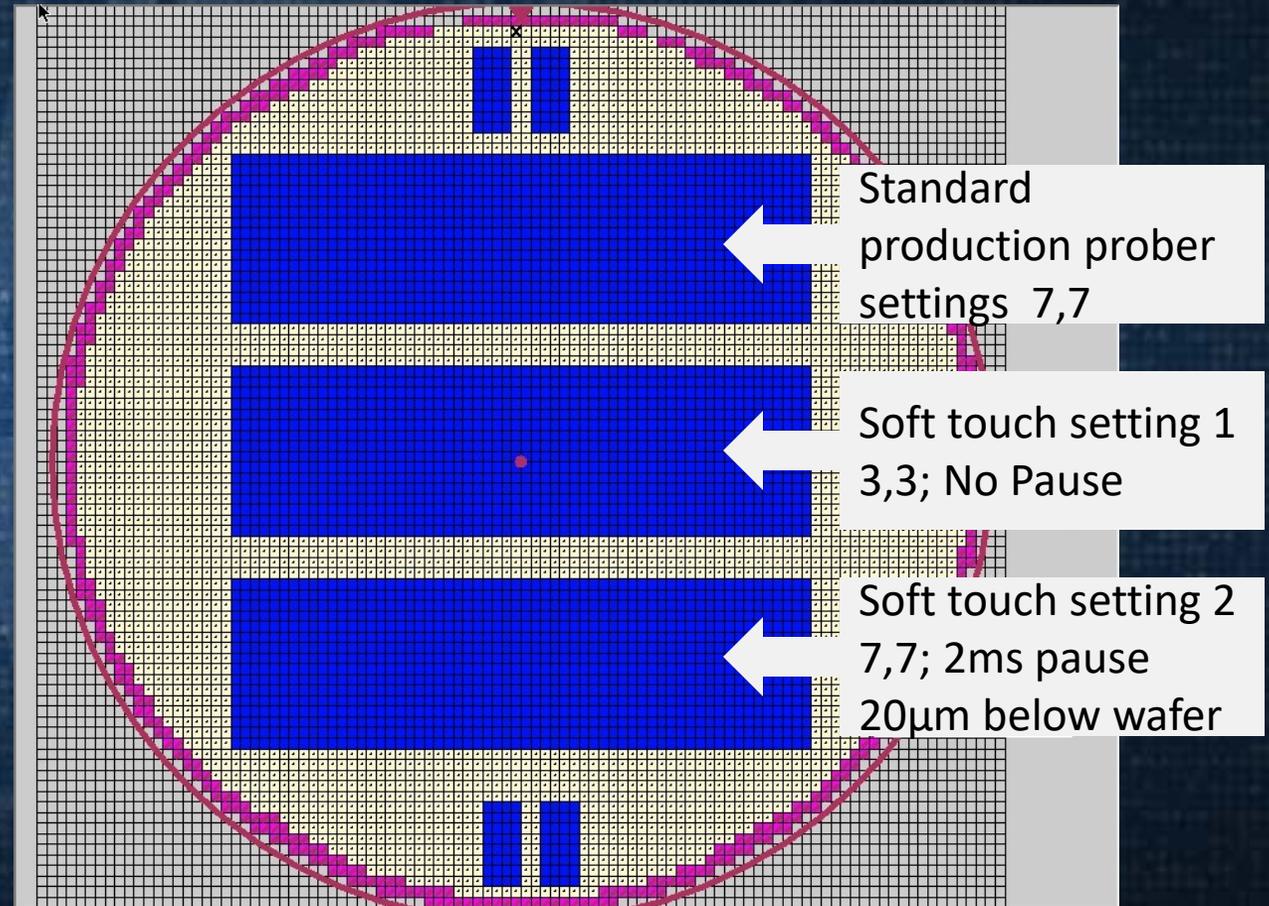
test vehicle stepmap on 200mm wafer

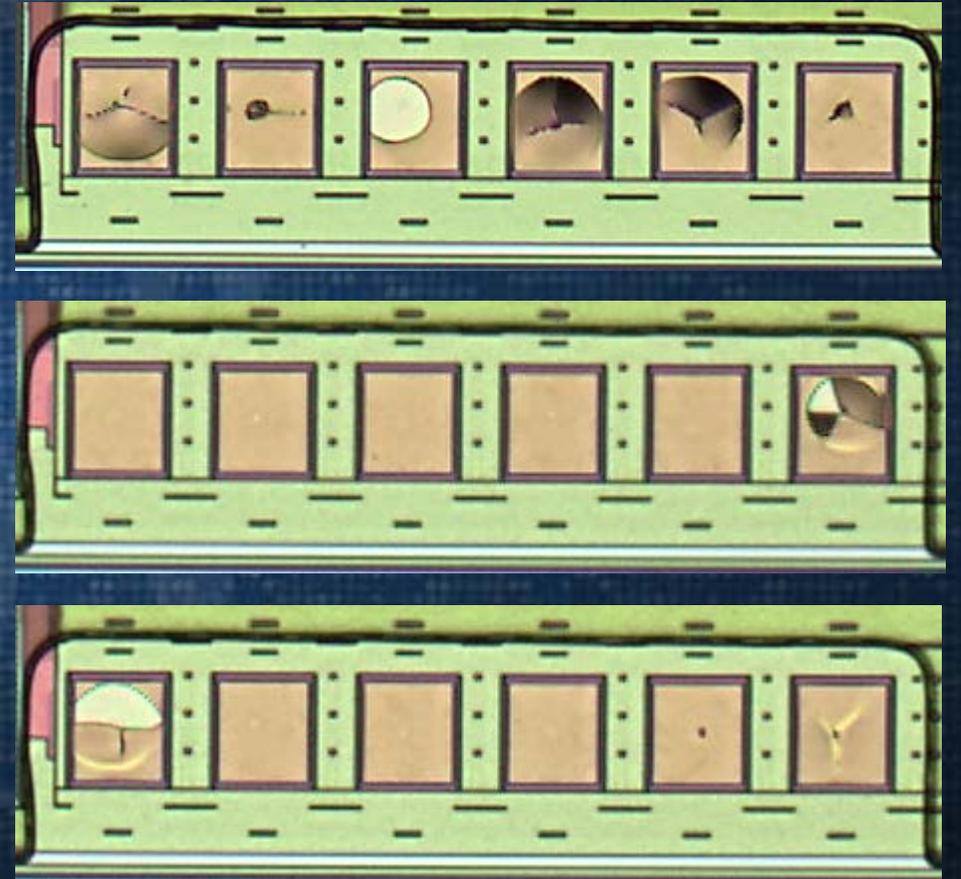
- Standard production settings:
20 out of 20 die contained pad cracking
- Soft touch setting 1:
10 out of 20 die contained pad cracking
- Soft touch setting 2:
18 out of 20 die contained pad cracking

cracked pads from the test vehicle after etching

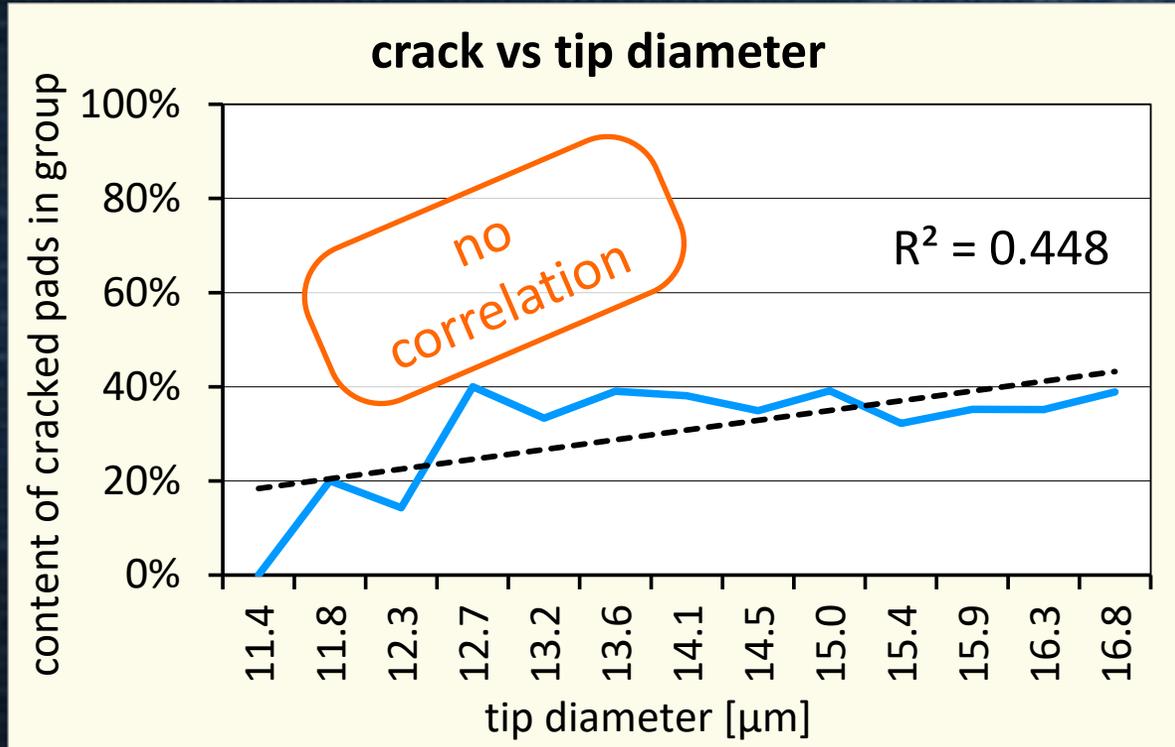
Probe card analyzer data have been correlated to the crack data

No correlation for tip diameters from 11 to 17 μm

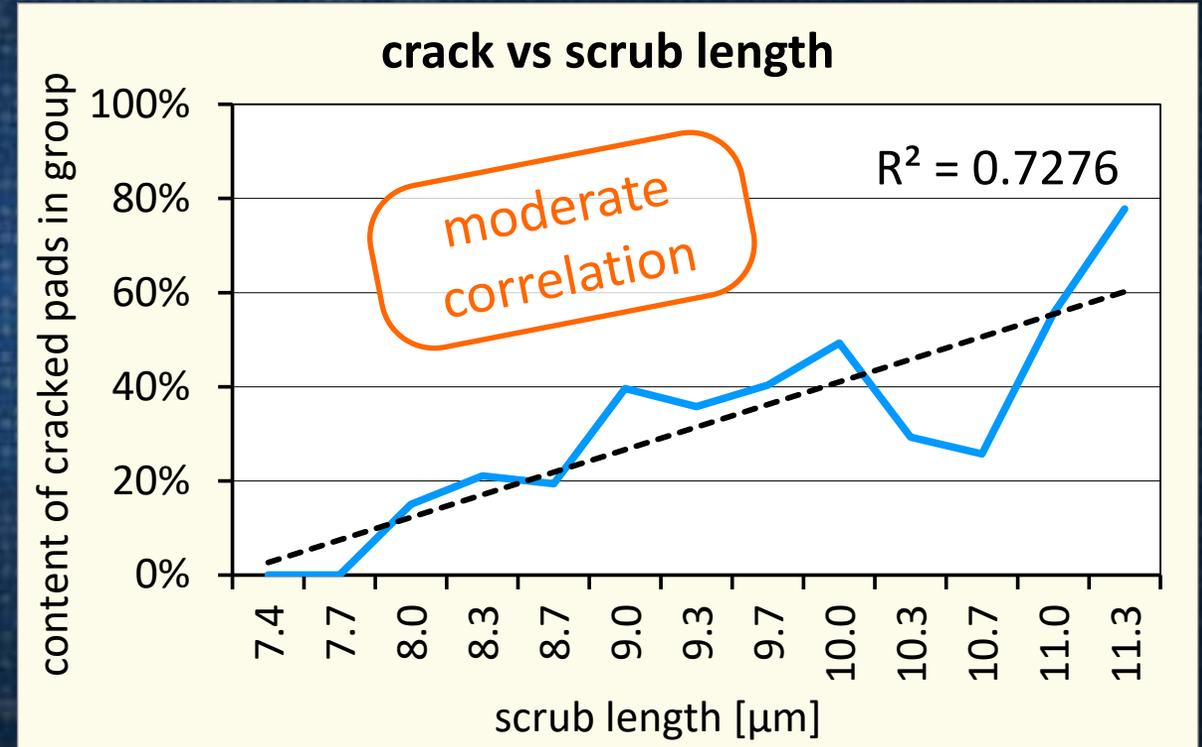
Moderate correlation for scrub length from 7 to 11 μm

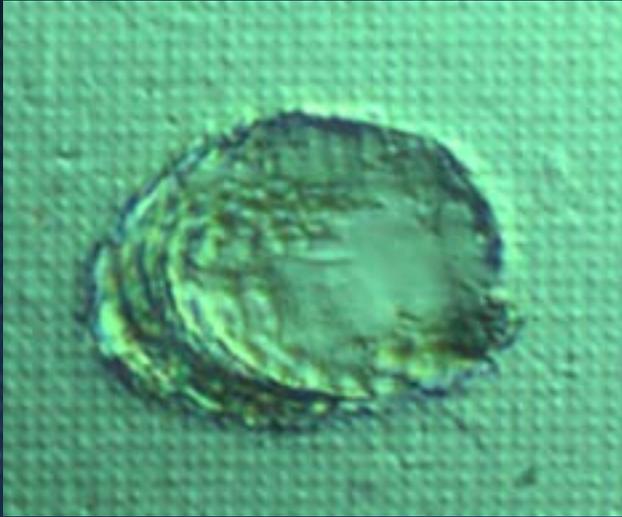
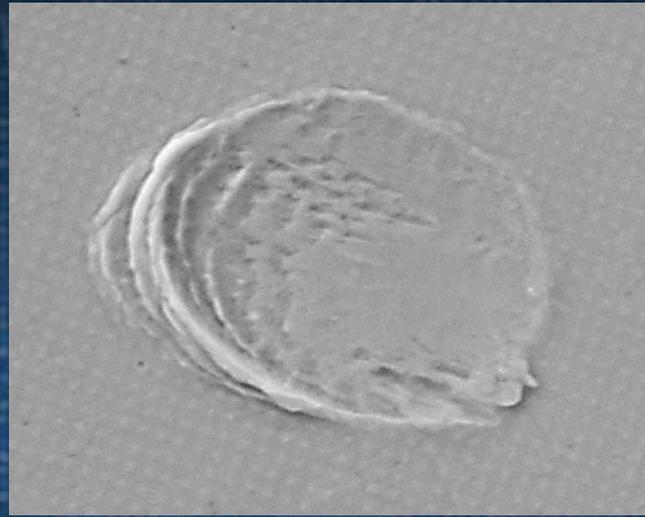
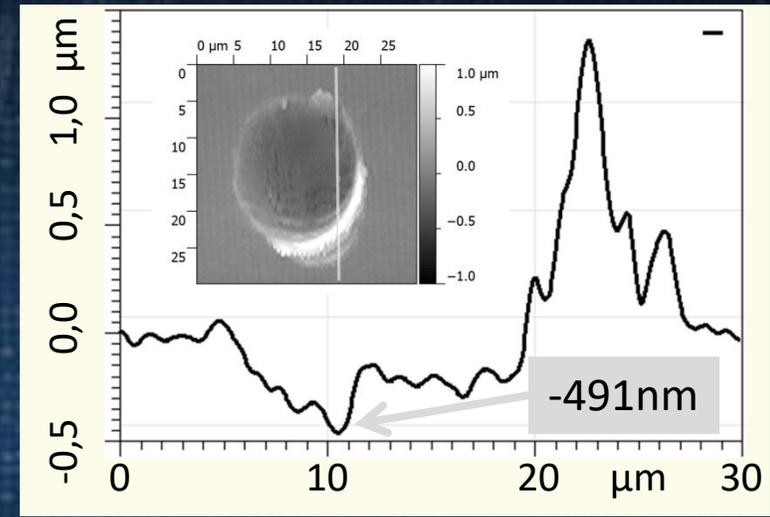
shallow
scrub mark

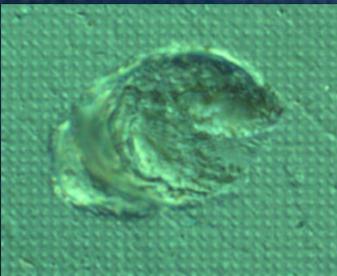
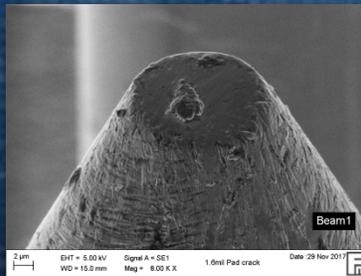
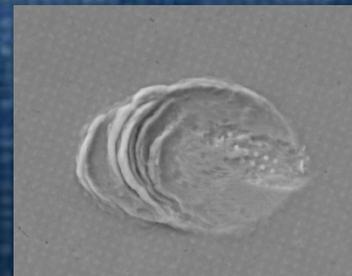
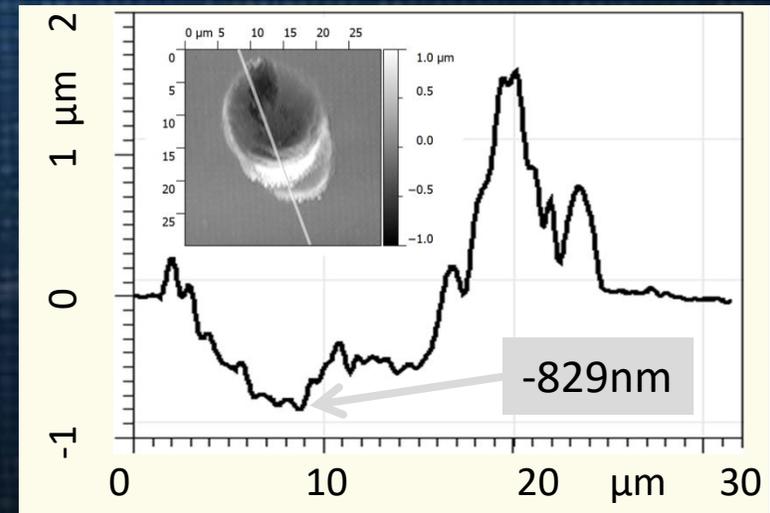
deep
scrub mark

tip contamination can be part of the problem

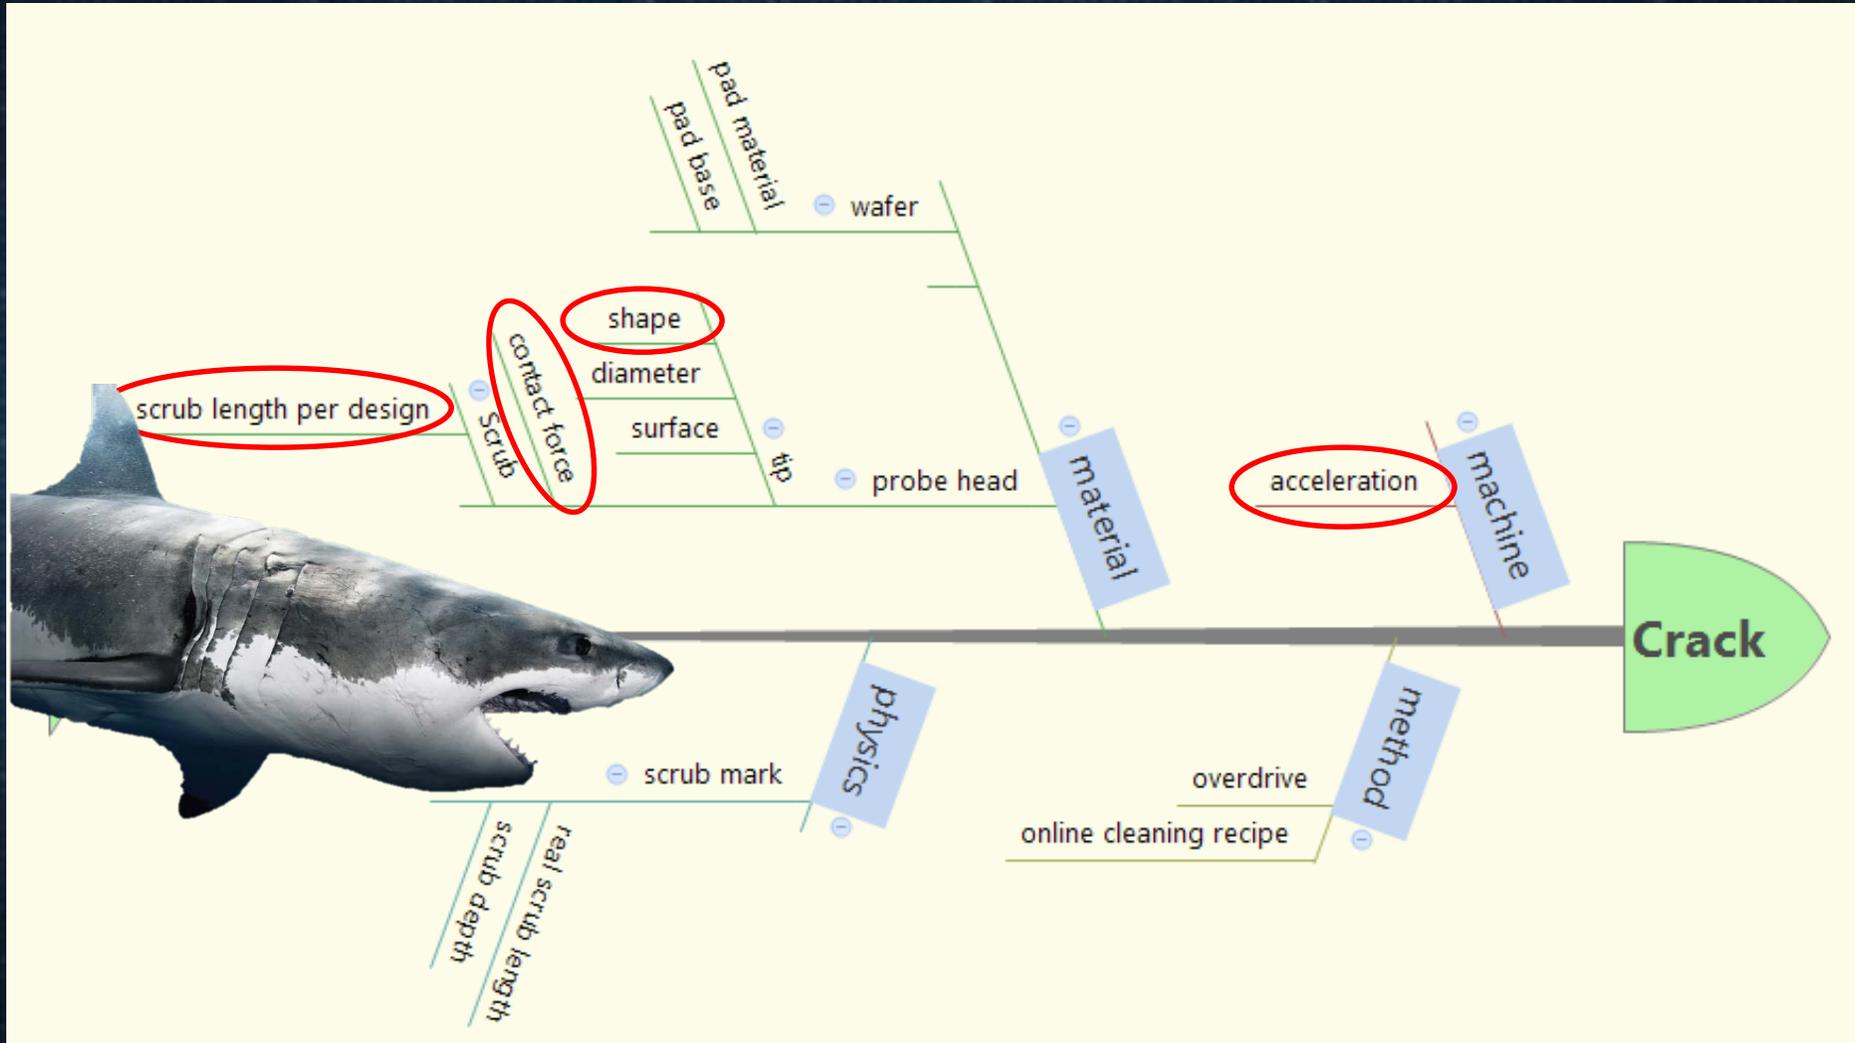
What are the Main Factors to Cause Pad Cracks?

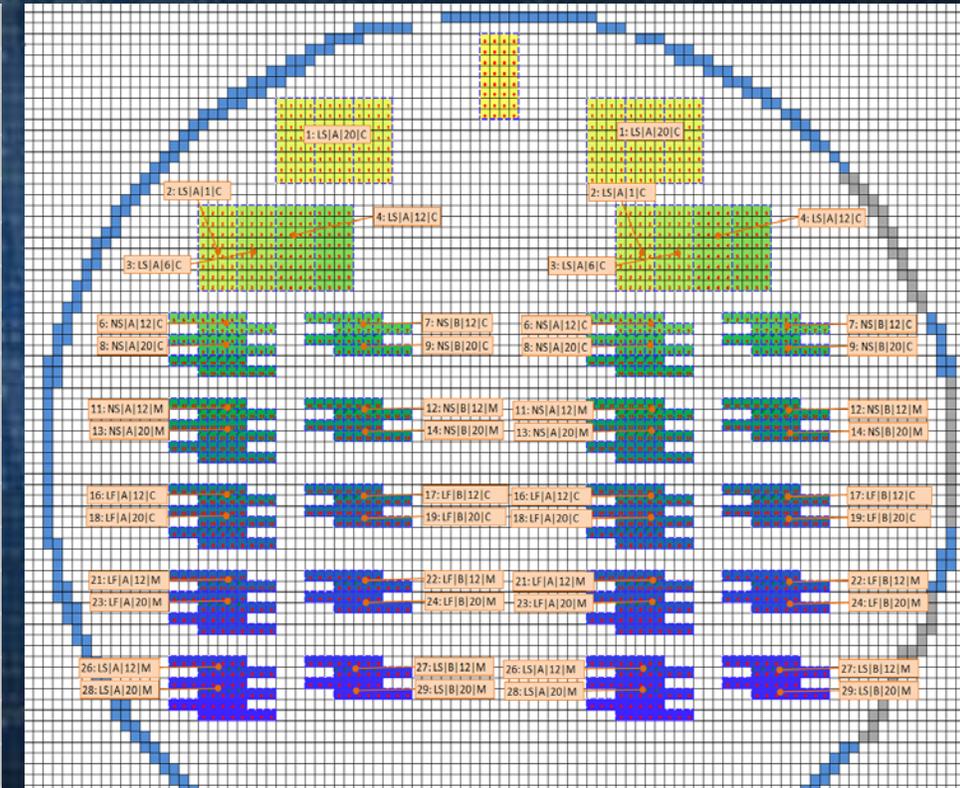
stepmap

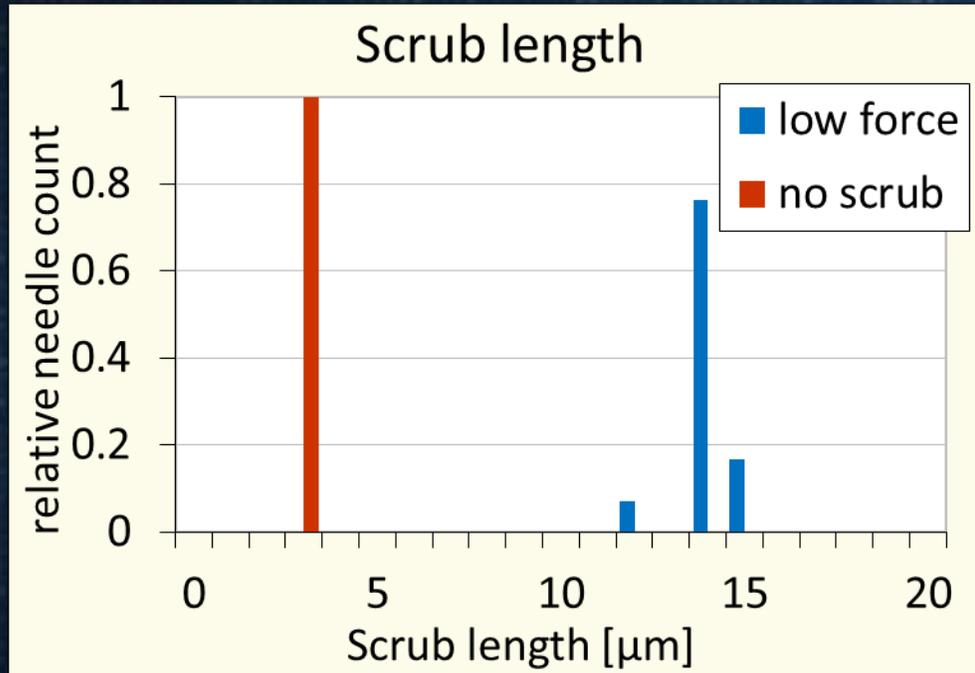
the „no scrub“ design leads also to a very narrow scrub distribution

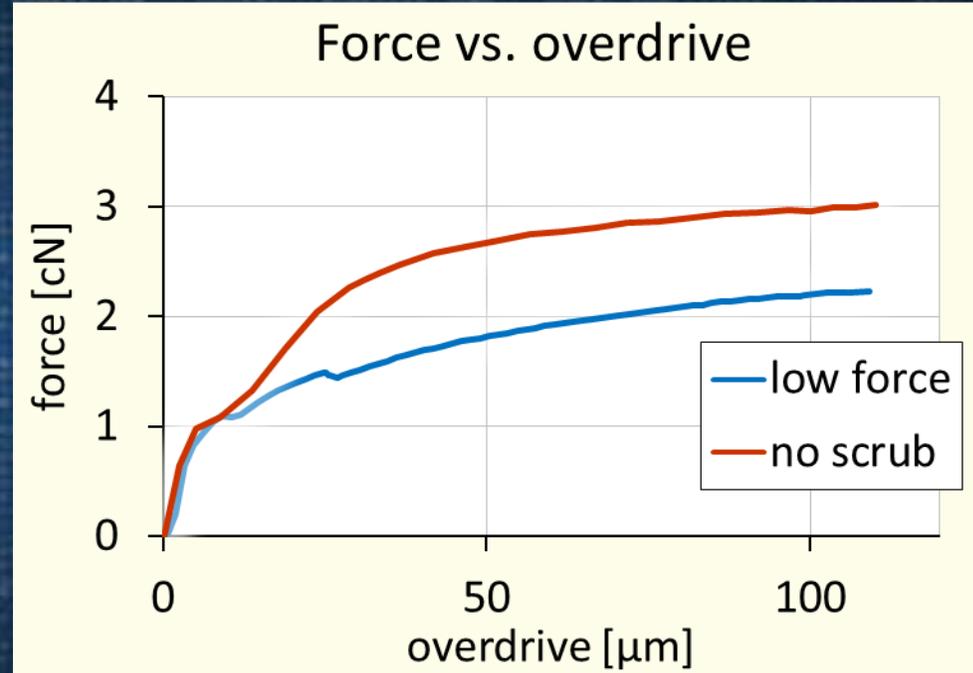
same needle but different head design leads to different force characteristics

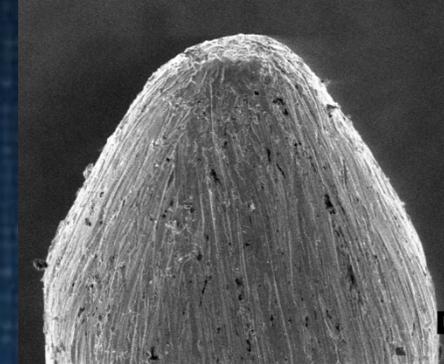
rounded tip

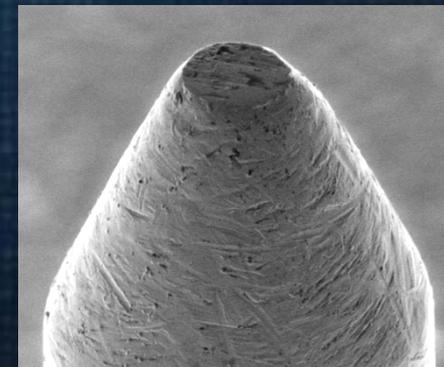
truncated cone tip

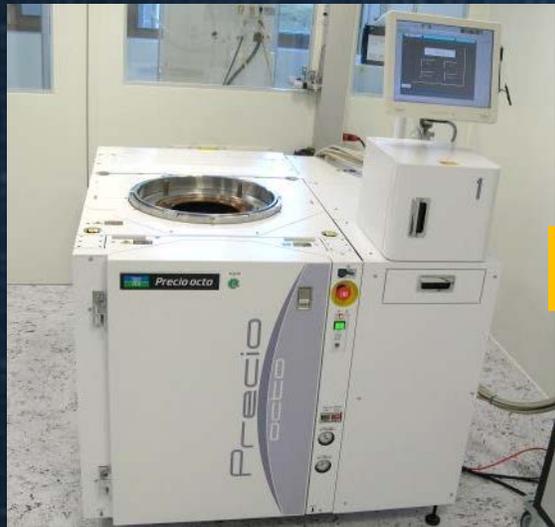
prober
TEL precio octo 200mm

ambient temperature; 85µm overdrive; no online cleaning; prober max. speed: 175k; prober init speed: 2k

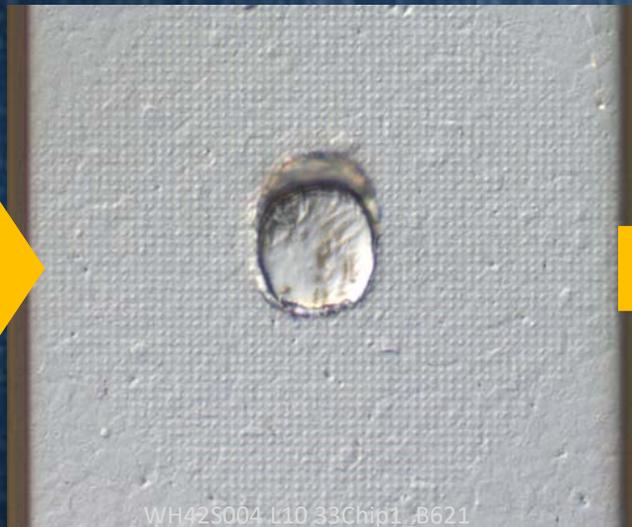
probed pad

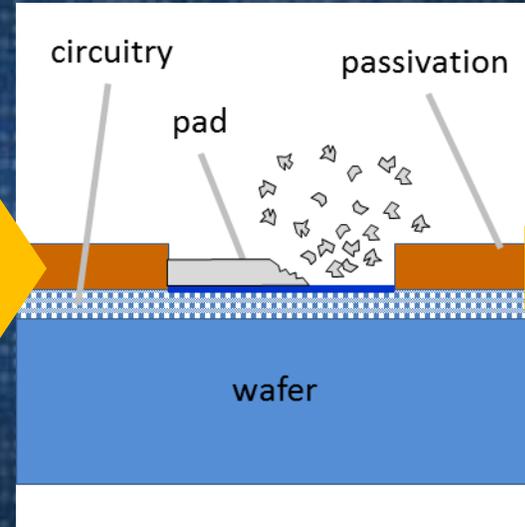
only the aluminum
is etched away

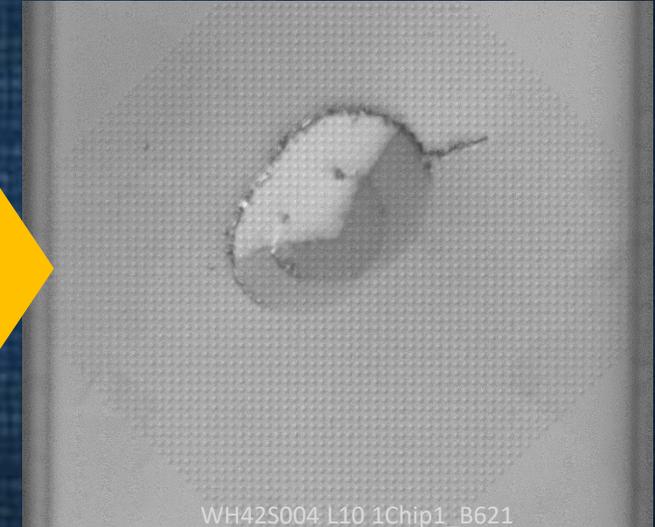
cracked pad

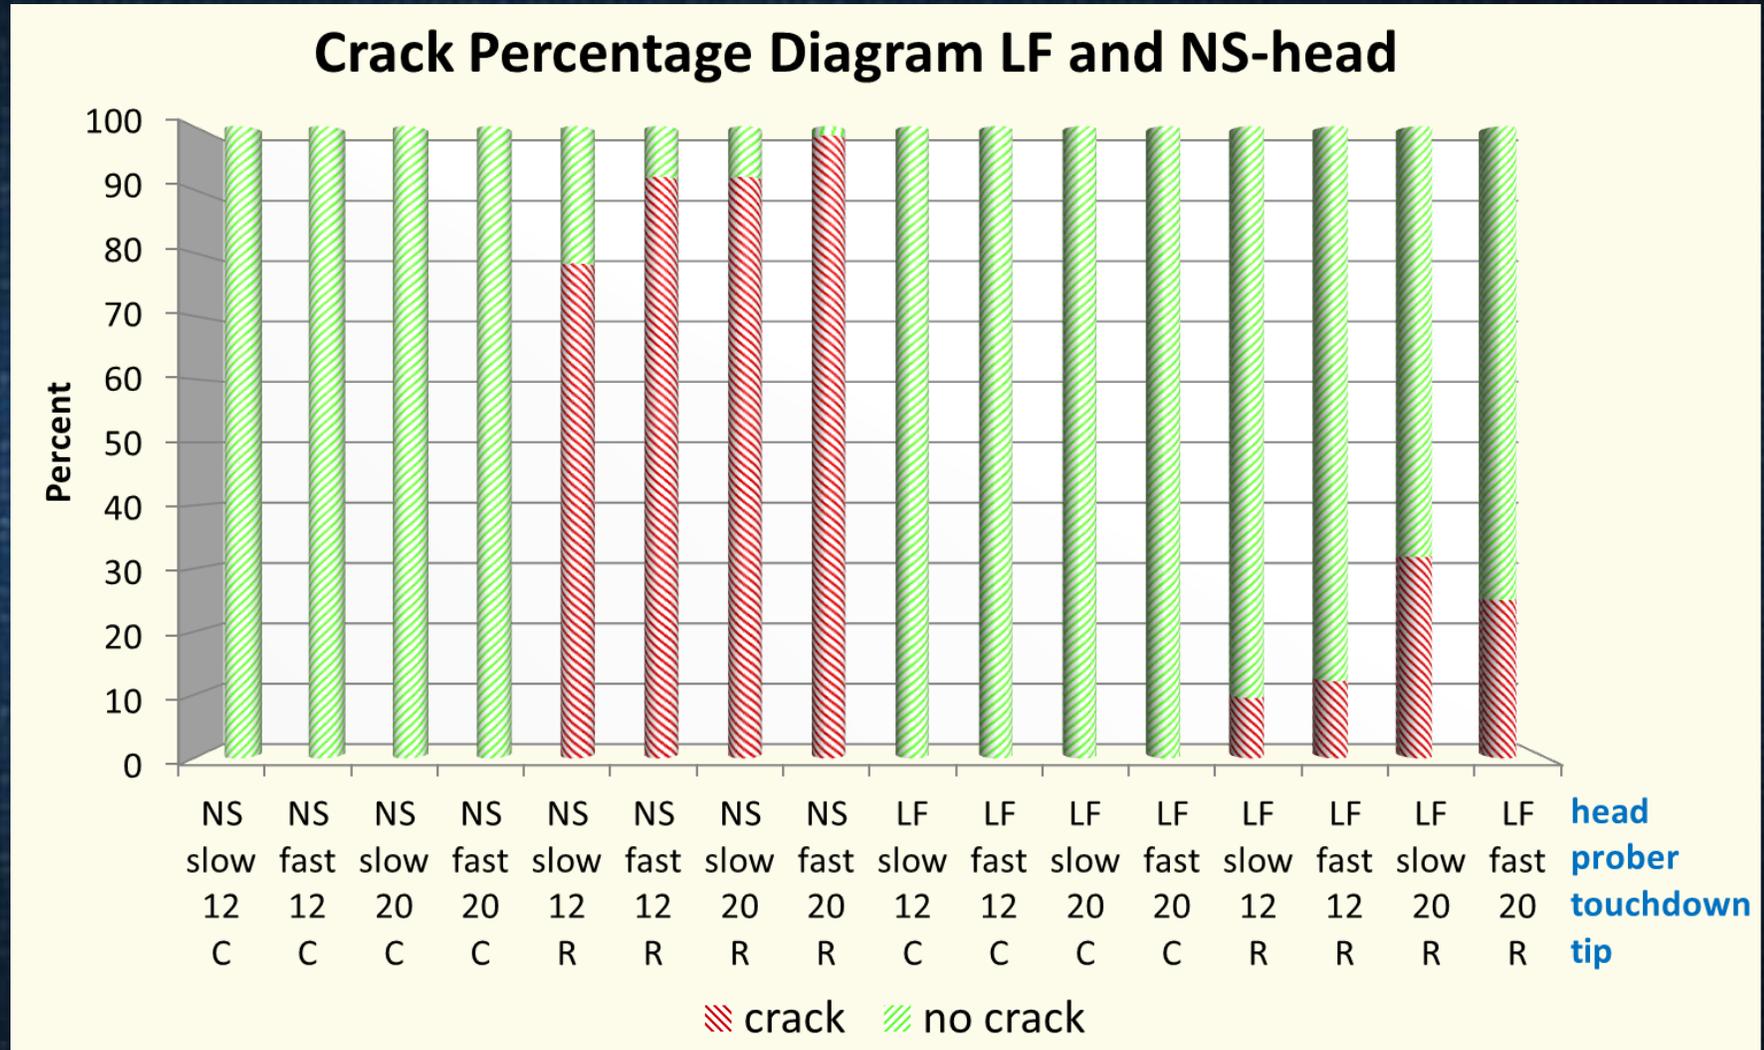
The major effect comes from the tip shape: The truncated cone is much better than the rounded tip.

The Low Force head is significantly better than the No Scrub head.

Very little effect comes from the touchdown count, as expected: 20 is worse than 12.

No effect comes from the prober speed.

- Major effect is the tip shape: rounded cracks more than the cone
- Low force is more important than low scrub to reduce cracks
- Scrub mark size may be not as important as assumed
- Touchdown count (12|20) has a little influence
- No effect from the prober speed

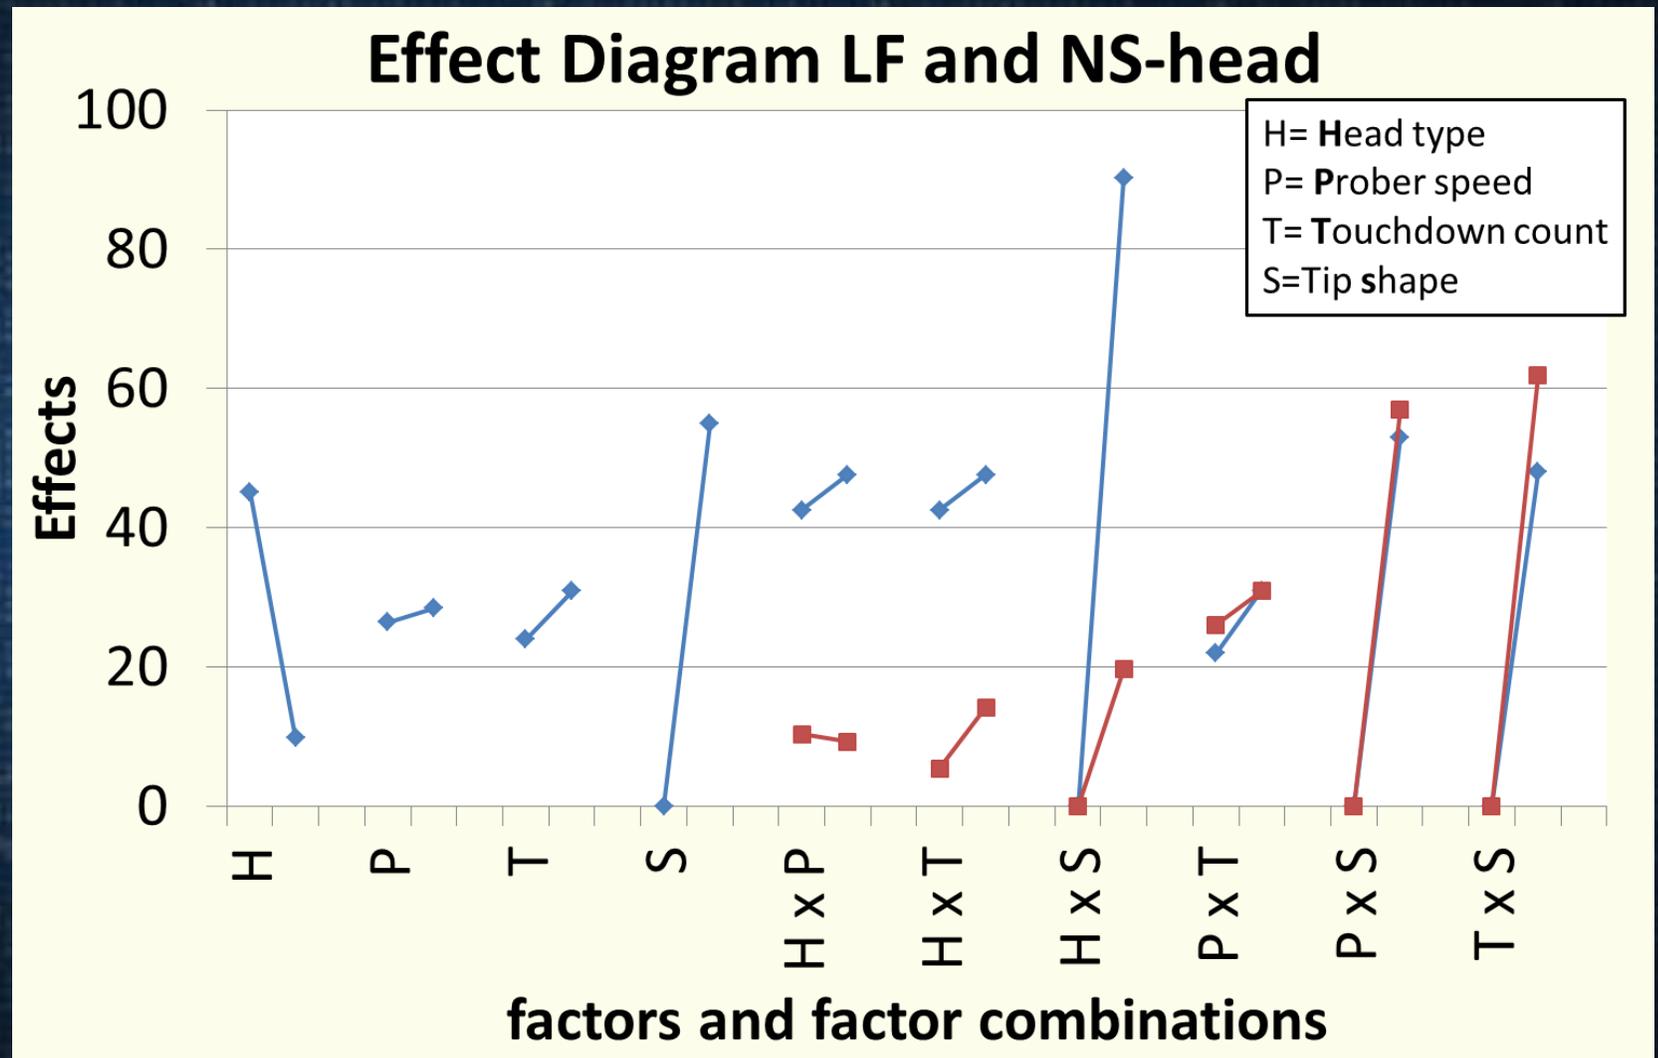
The major effect comes from the tip shape: The truncated cone is much better than the Rounded tip.

The Low Force head is significantly better than the No Scrub head.

Very little effect comes from the touchdown count, as expected: 20 is worse than 12.

No effect comes from the prober speed.

The No Scrub head seems to react more to the tip shape change than the Low Force head.

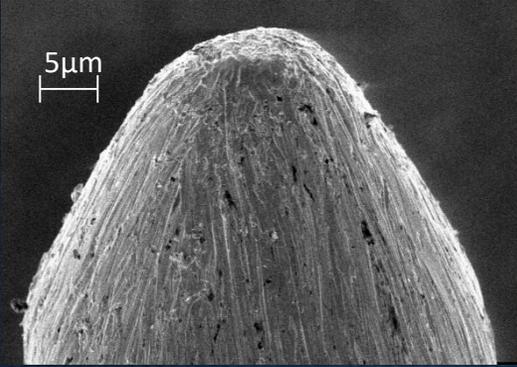
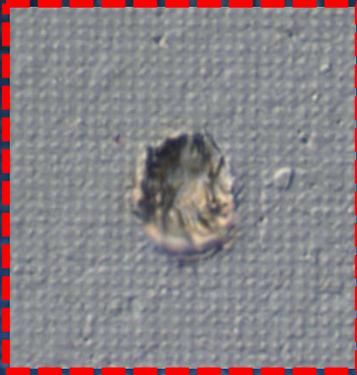
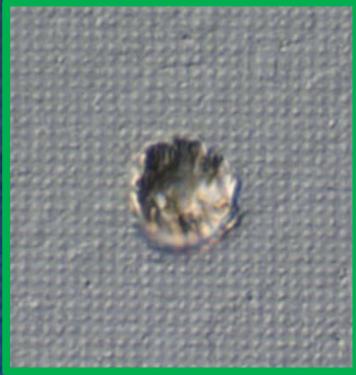
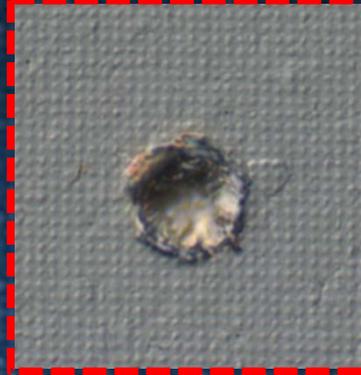
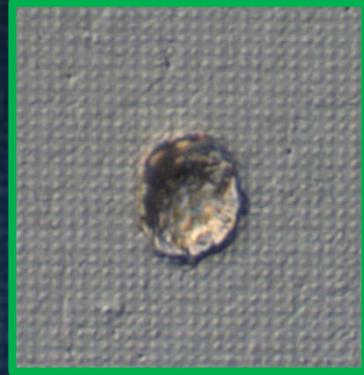
Typical Scrub Marks (Prober = 3/3 Touchdowns = 12)

rounded tip

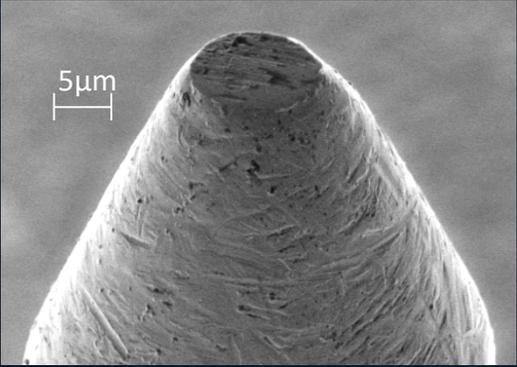
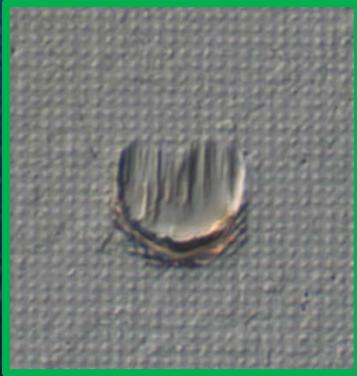
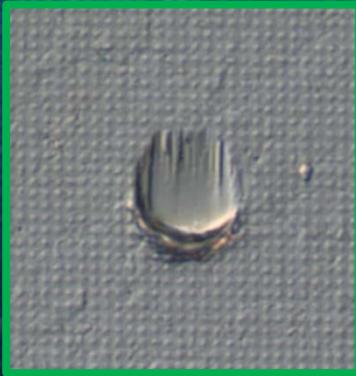
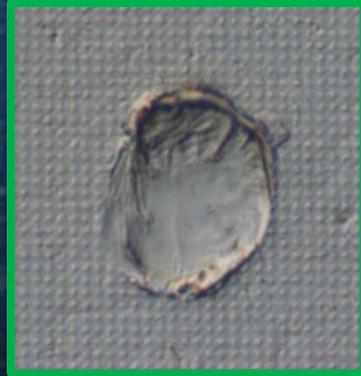
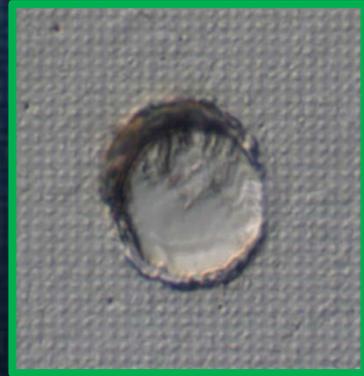
truncated cone tip

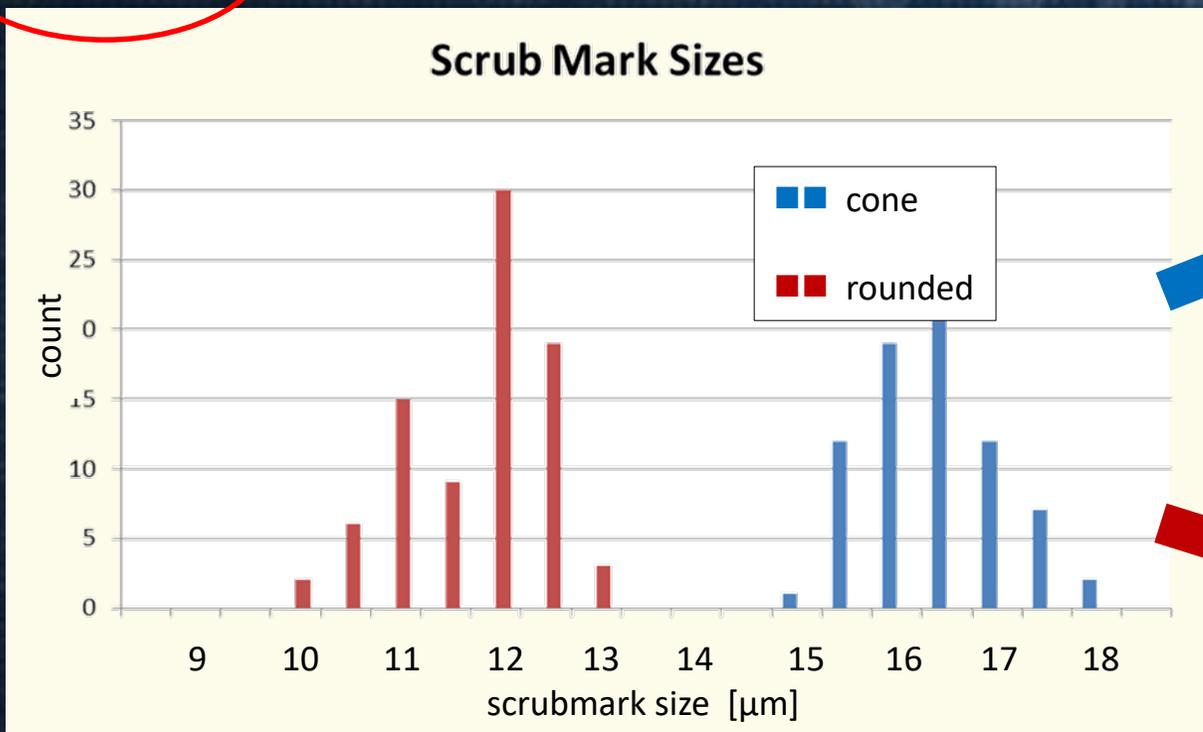
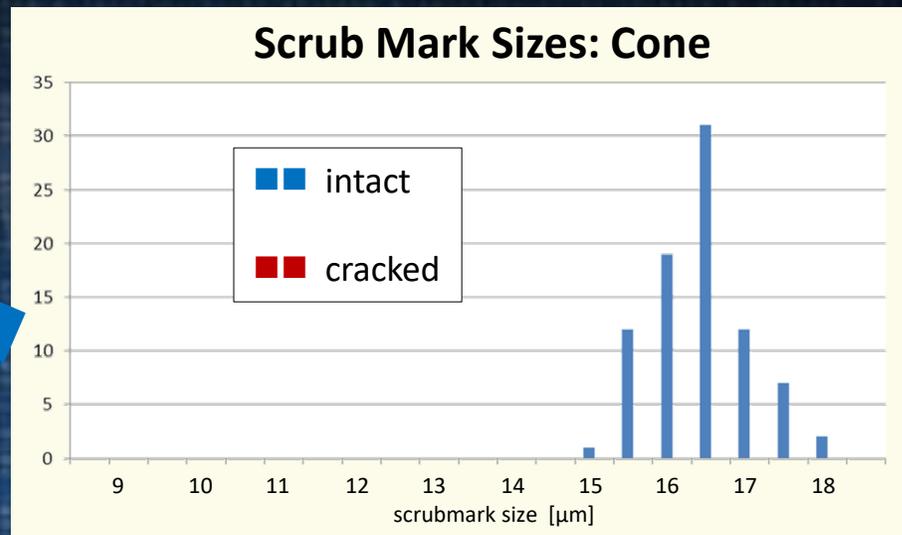
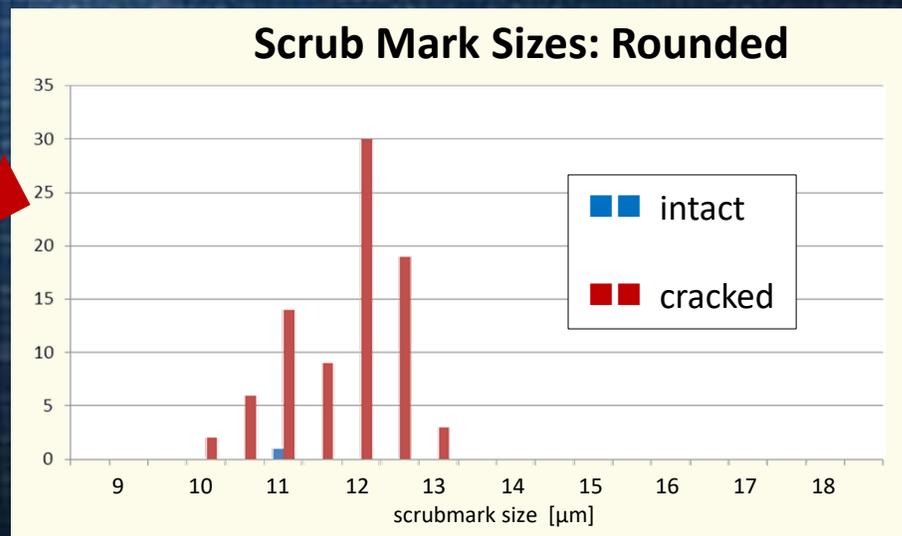
No Scrub Head: Crack vs. scrub mark size

- ➔ no cracks with the cone tip, 98% cracks with the rounded tip
- ➔ possible dependency from scrub mark size

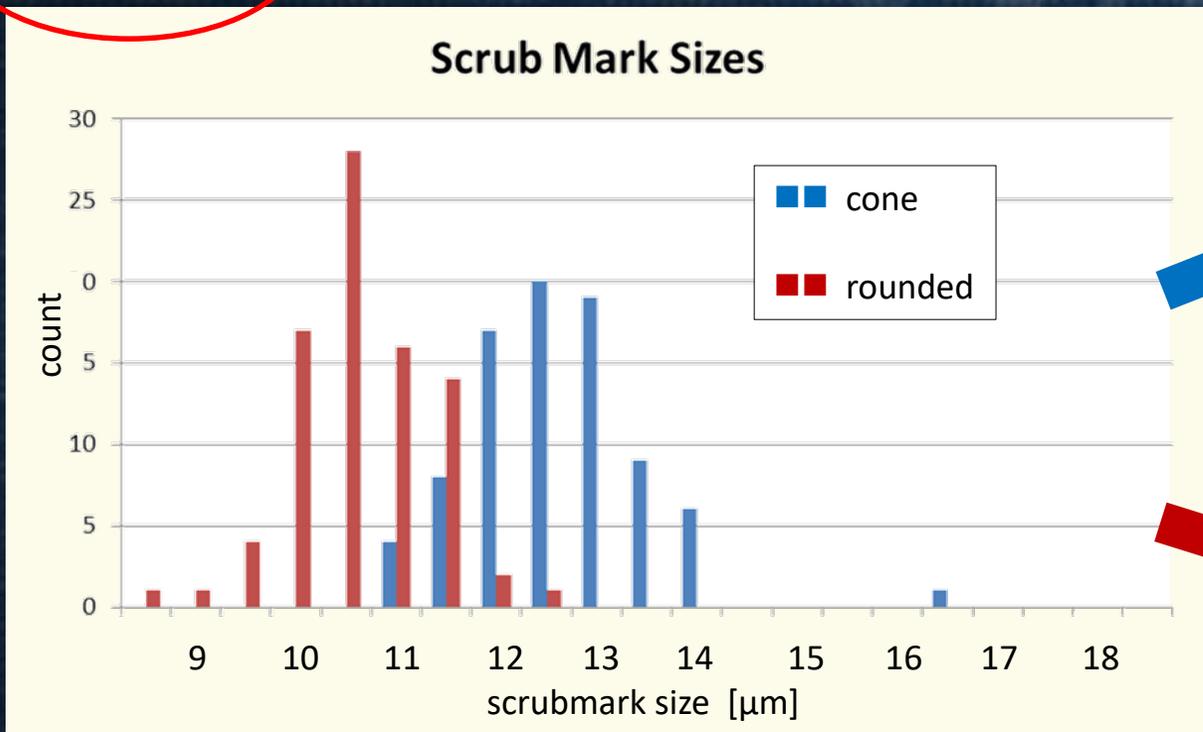
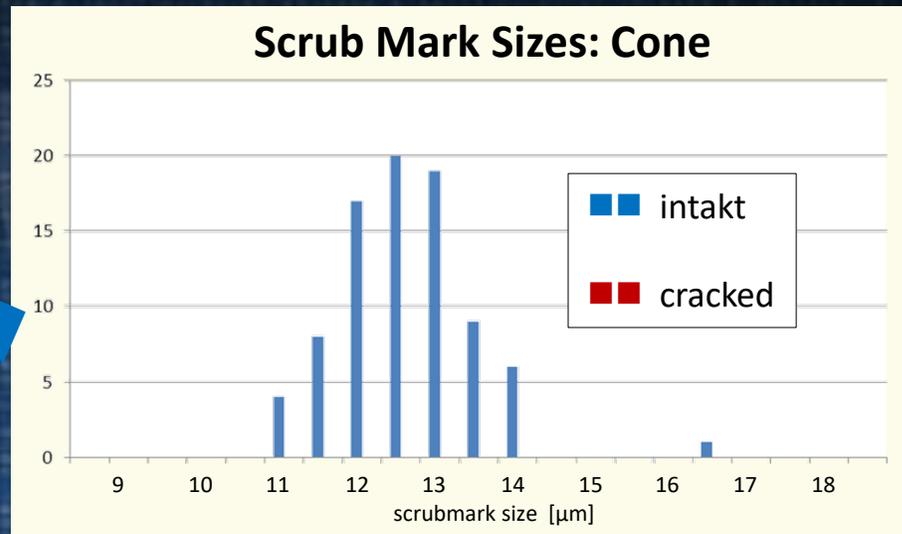
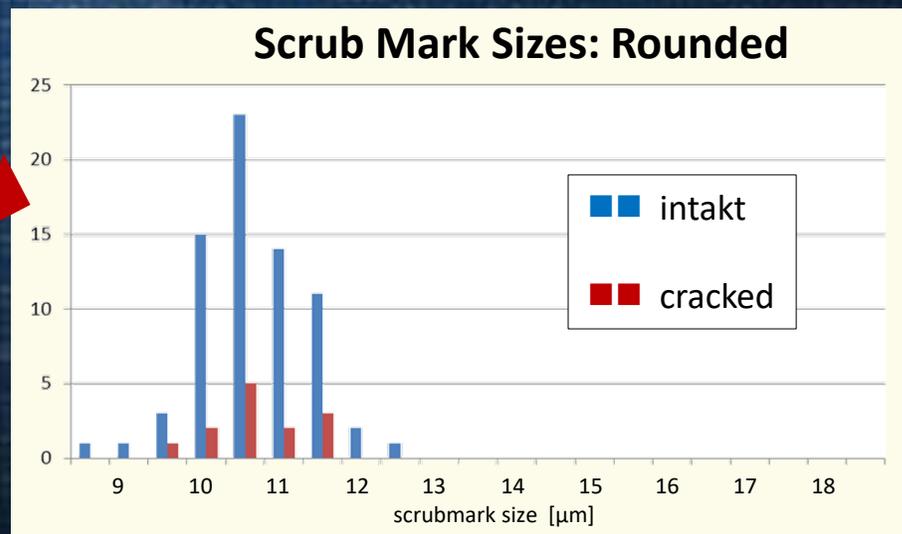
Low Force Head: Crack vs. scrub mark size

➔ no cracks with the cone tip

➔ cracks with the rounded tip but no scrub mark size dependency
