Semiconductor Wafer Test Workshop

A Real Life Pad Crack Study

Gunther Boehm (FM)

Jory Twitchell (NXP)

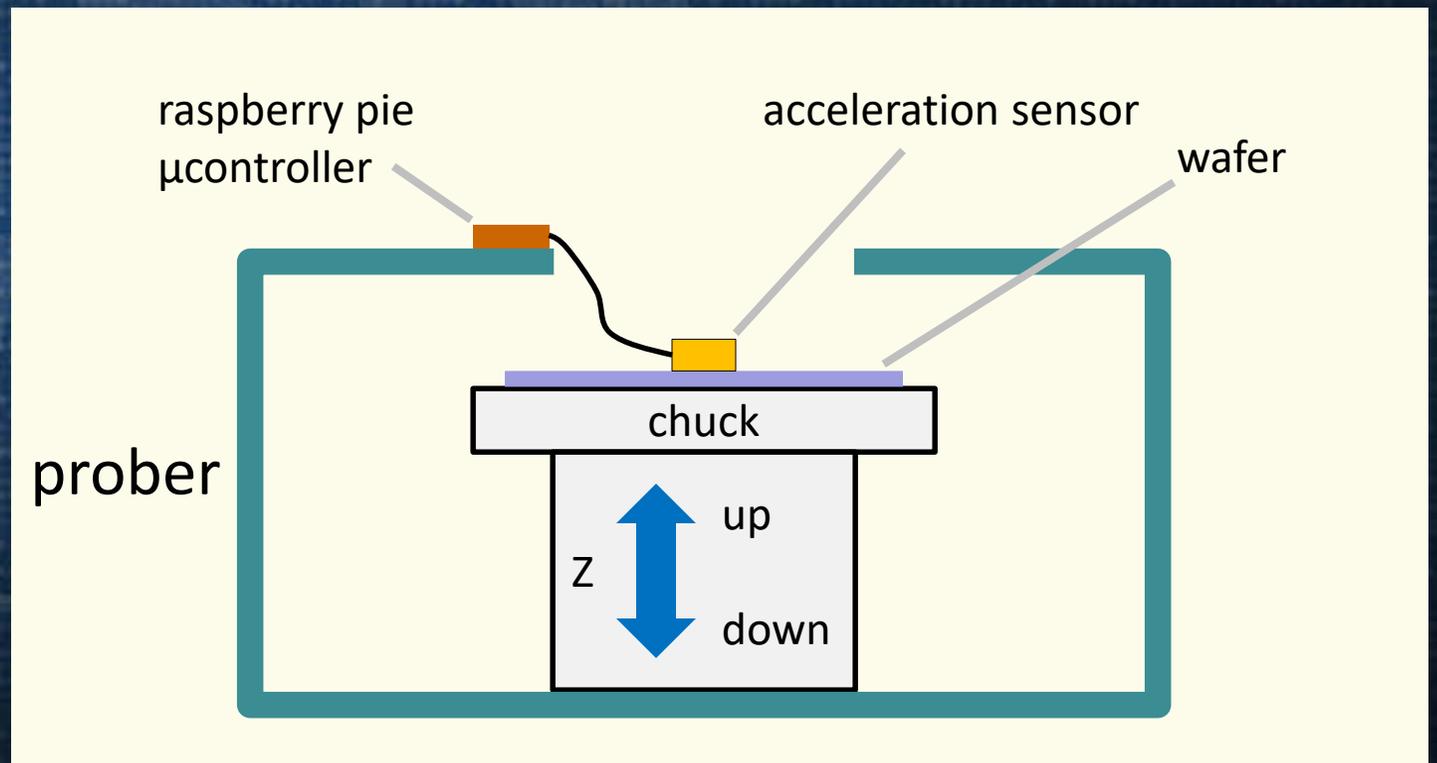
Measurement of the prober*
Z-movement using an
acceleration sensor

device:	BMA280
measurement frequency:	2000 Hz
resolution:	0,002 m/s ²
metering range:	±40 m/s ²

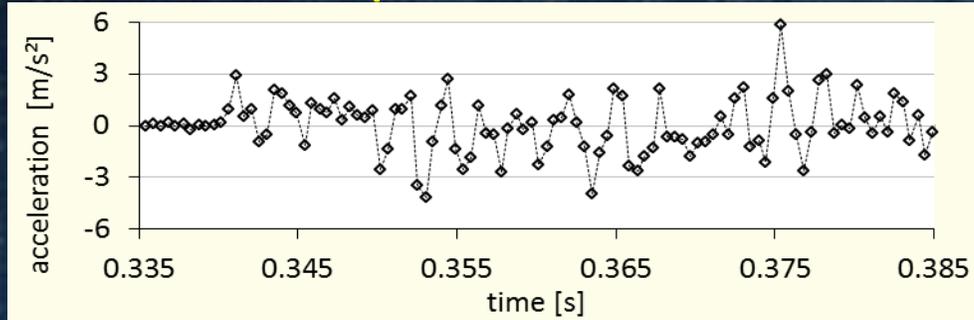
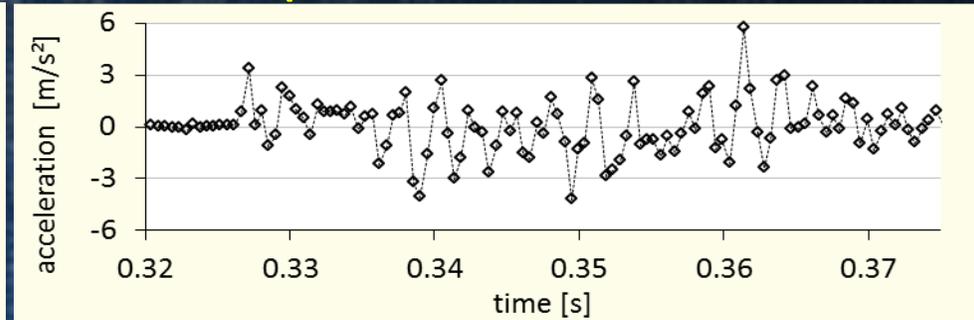
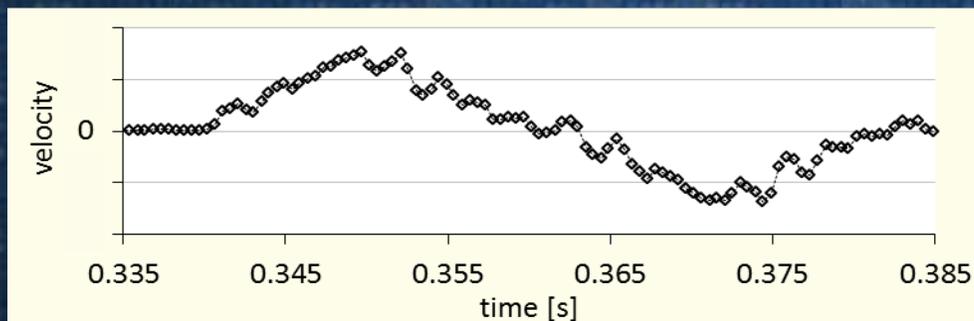
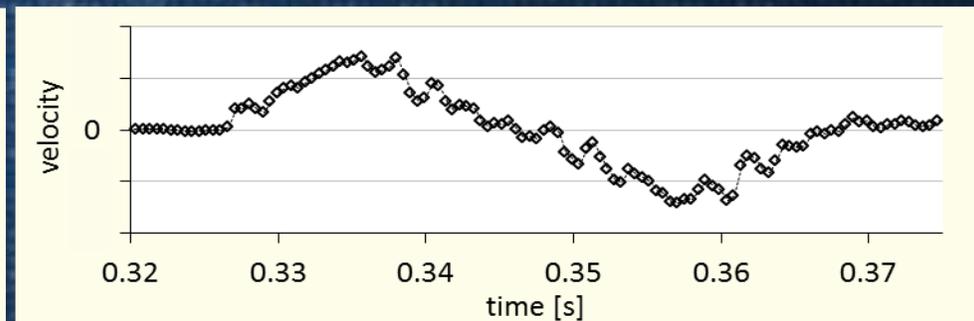
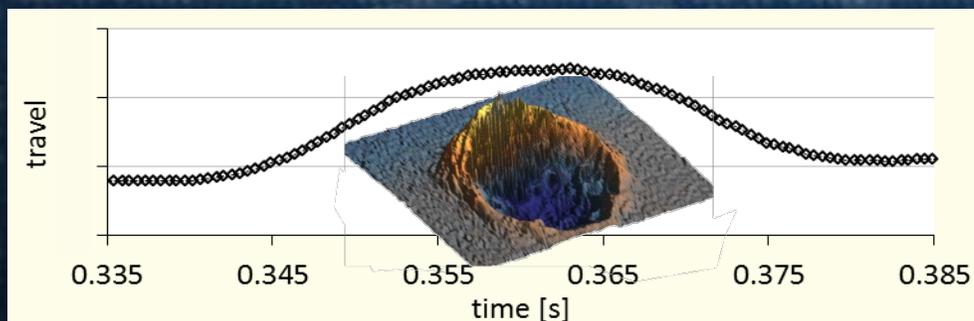
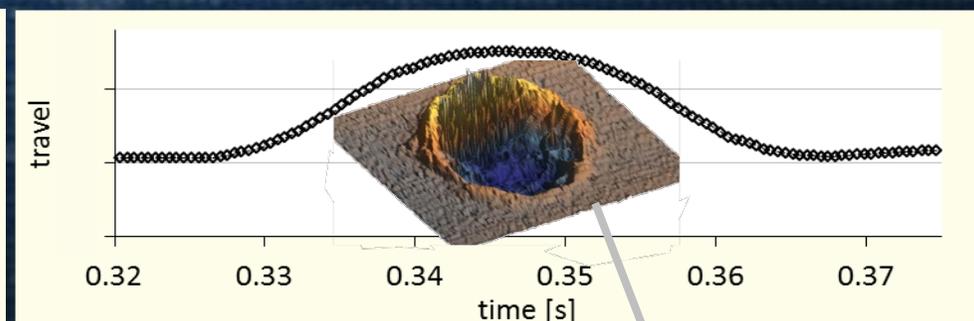
Both prober settings behave almost identically

→ we still have to learn how to change prober Z-kinetics effectively

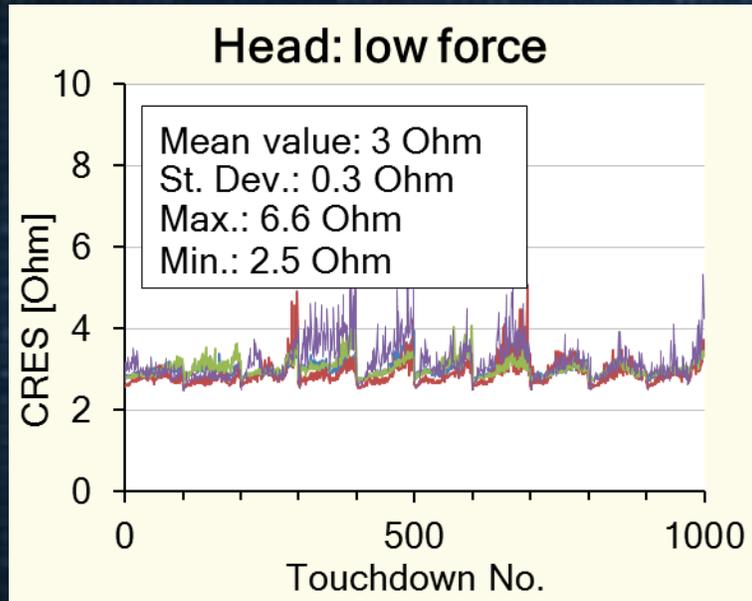
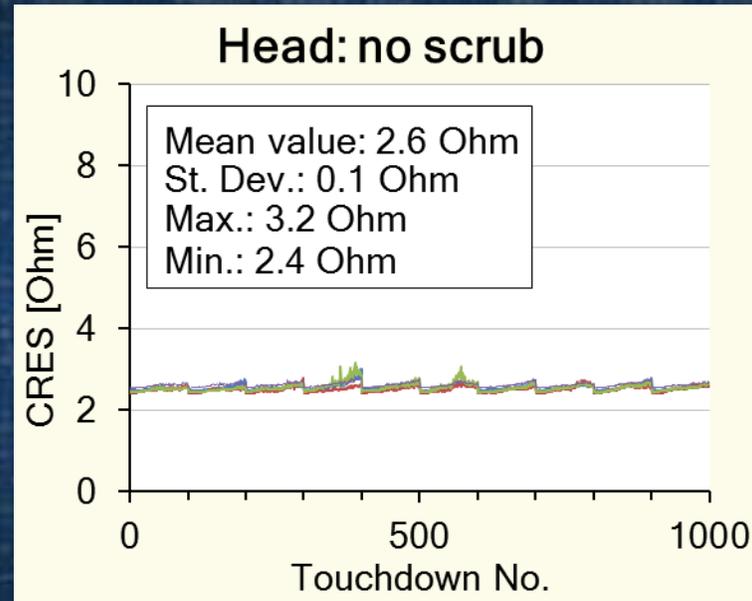
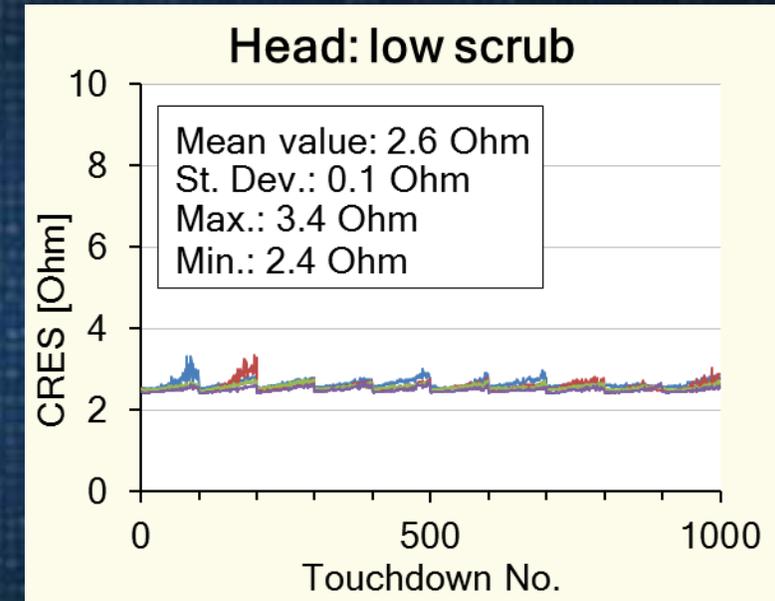
Force is more important than scrub for a stable contact

- 85 μ m overdrive
- 2V / 20mA
- cone tips
- bare Al-wafer
- TEL prober (full speed)
- online cleaning intervall: 100TD

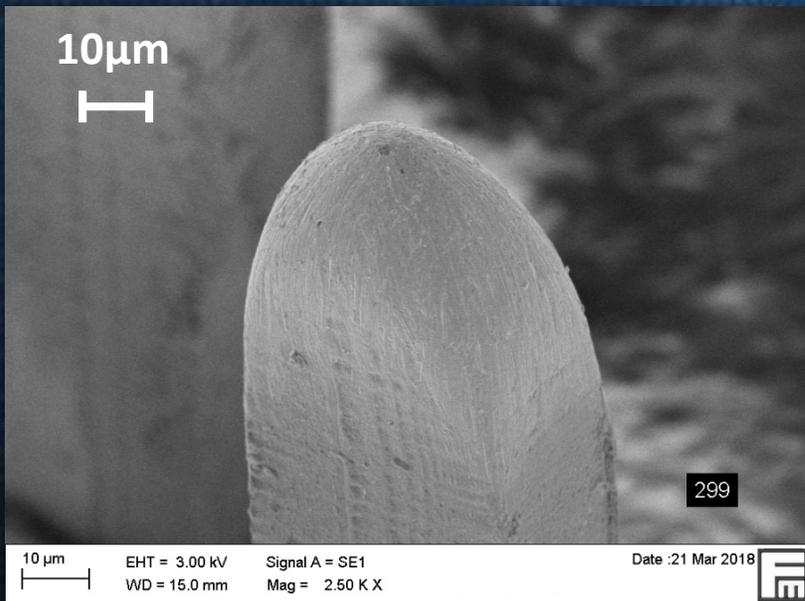
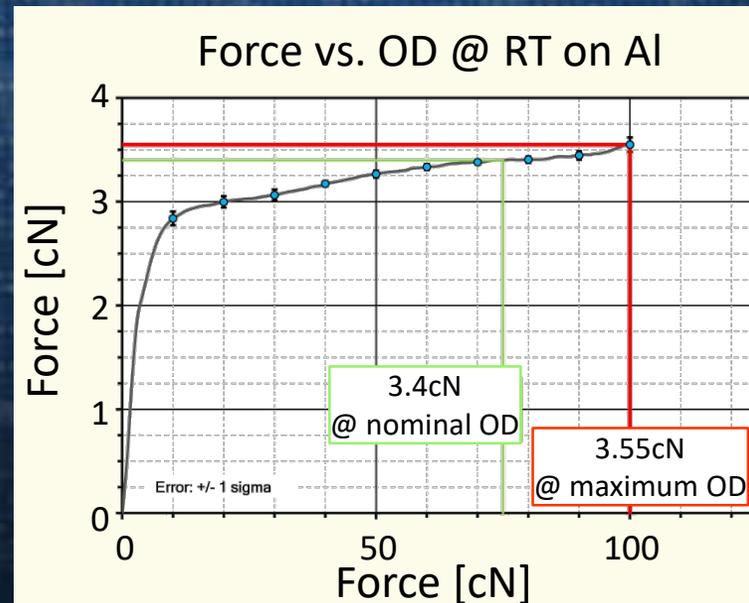
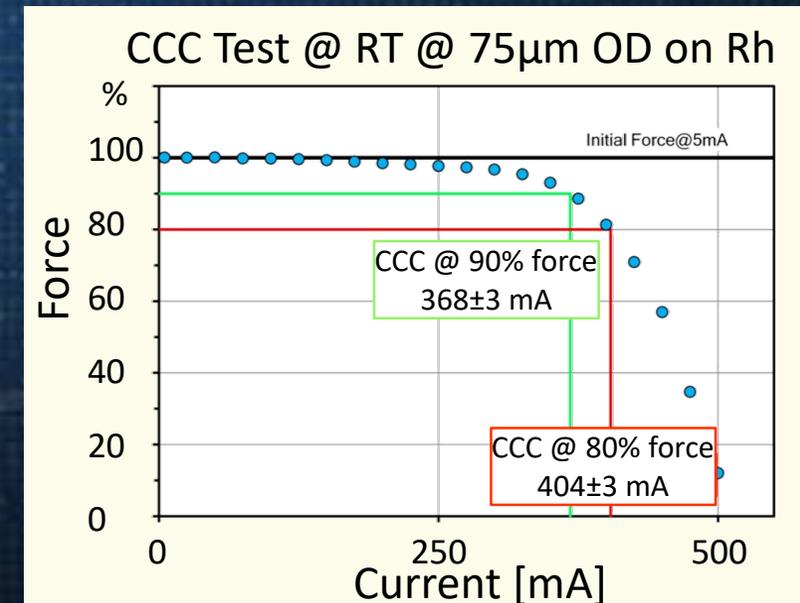
- Using “M μ Probe[®]” (60 μ m pitch) probing technology
 - Vertical MEMS probe
 - Rounded tip
 - Very high current material

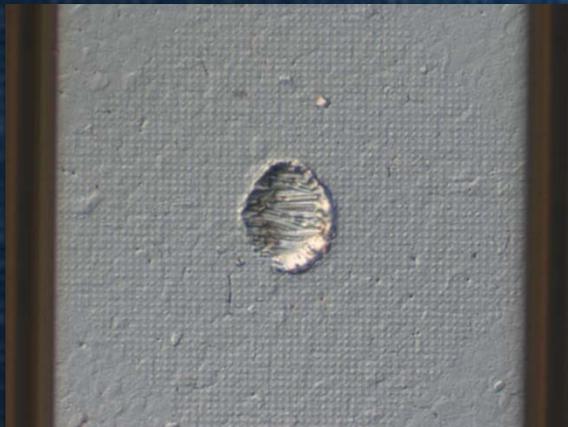
- No pad cracks (few TD only, 20x TD)
- Very stable contact resistance

probed

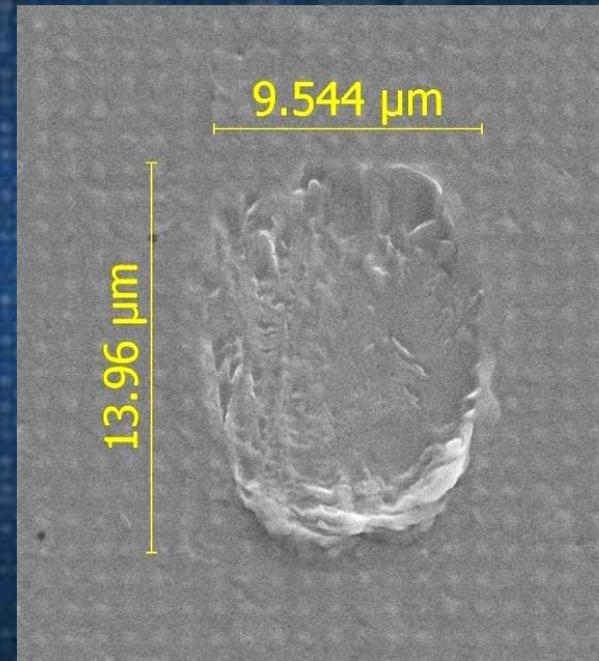
8 TD; 70 μm OD

- No cracking observed during any of the overdrive conditions or touchdown counts.

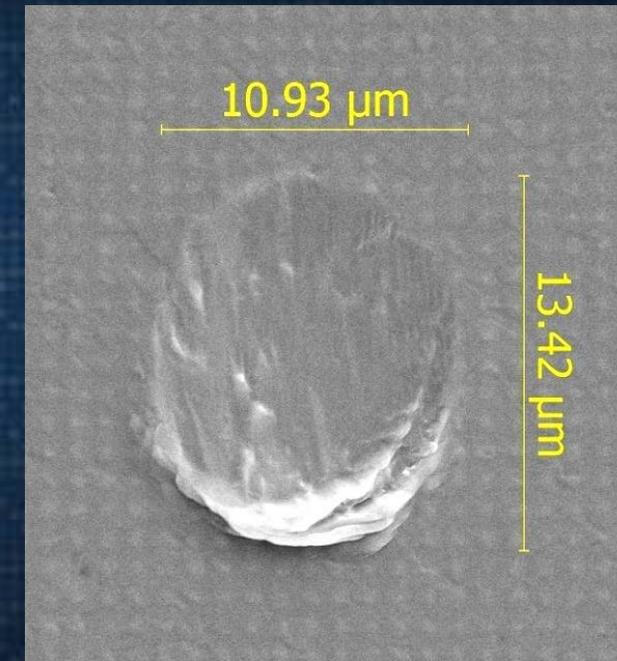
20 TD; 100 μm OD

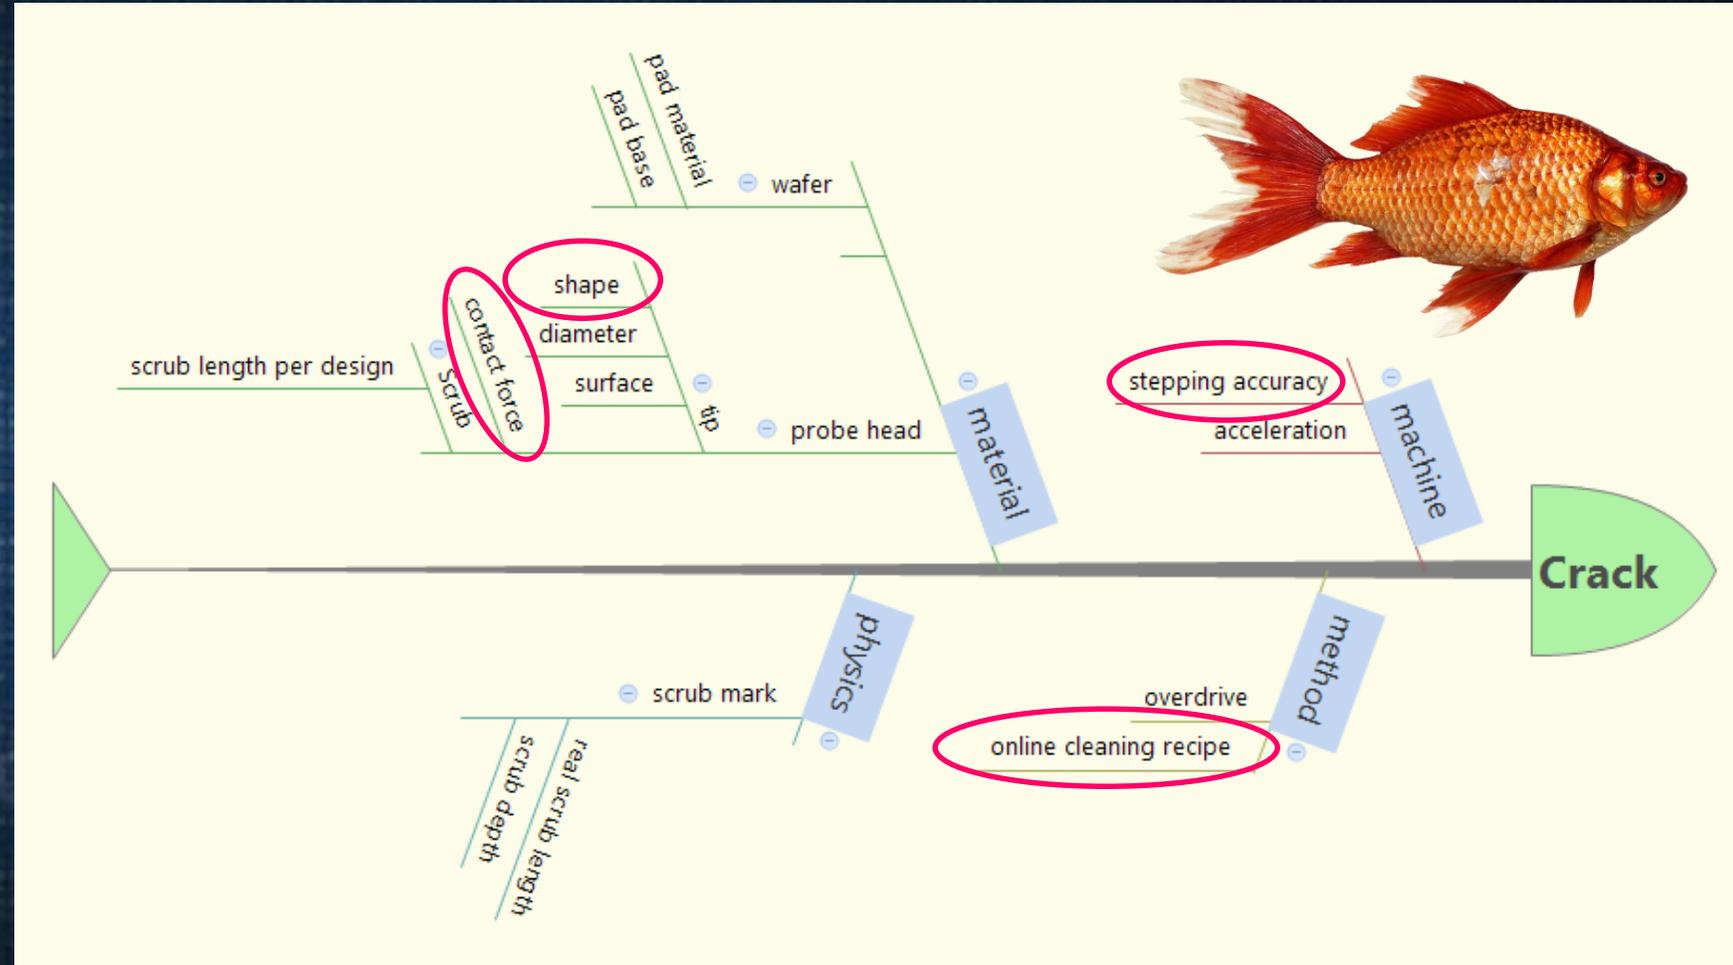
- **Most important factors**

- tip condition: shape, contamination
- contact force
- step accuracy

- **Finally, all factors on this diagram are still in the game.**
