SW Test Workshop
Semiconductor Wafer Test Workshop

New Approach in Pogo Socket Design to Improve Total Cost of Ownership

Richard Incognito
Texas Instruments

June 3-6, 2018

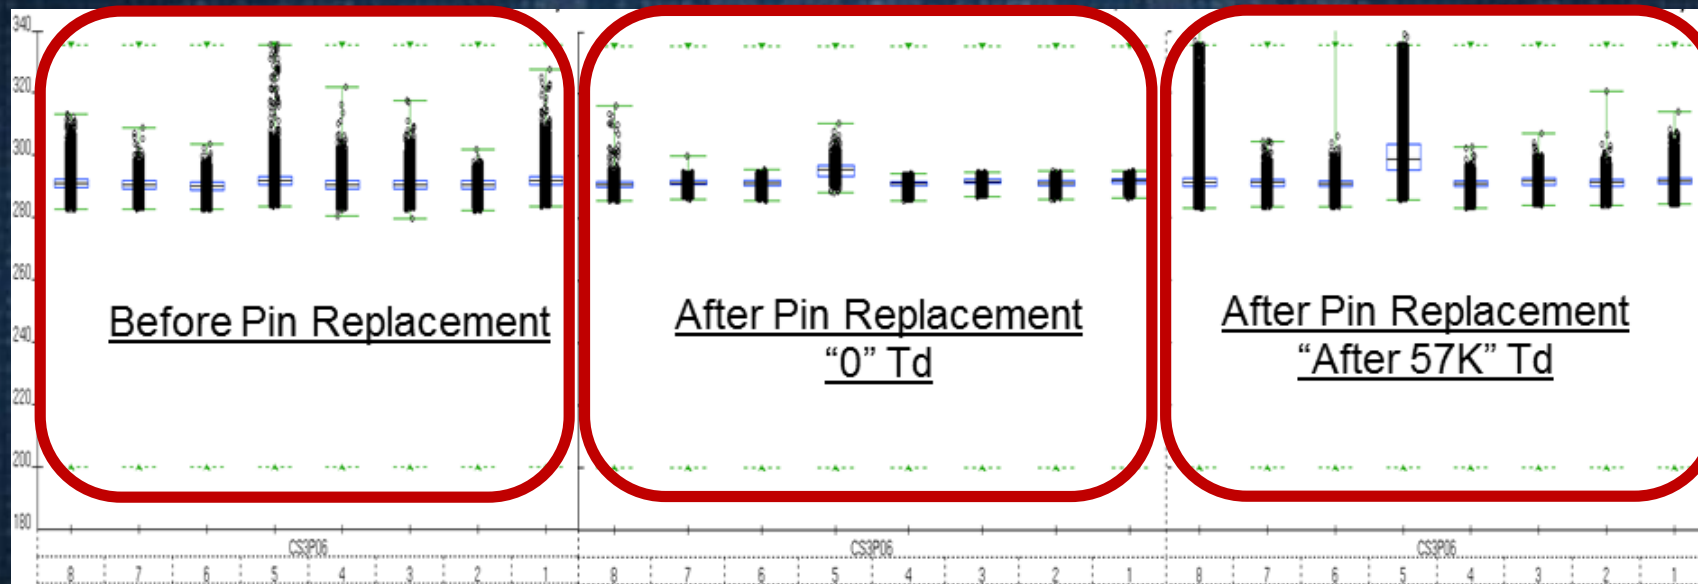
- Site to site distribution of device with test failures.
- 100% pin replacement to resolved Site-to-site failure.
- Failures were observed again at 57k touchdowns. Problem not solved.

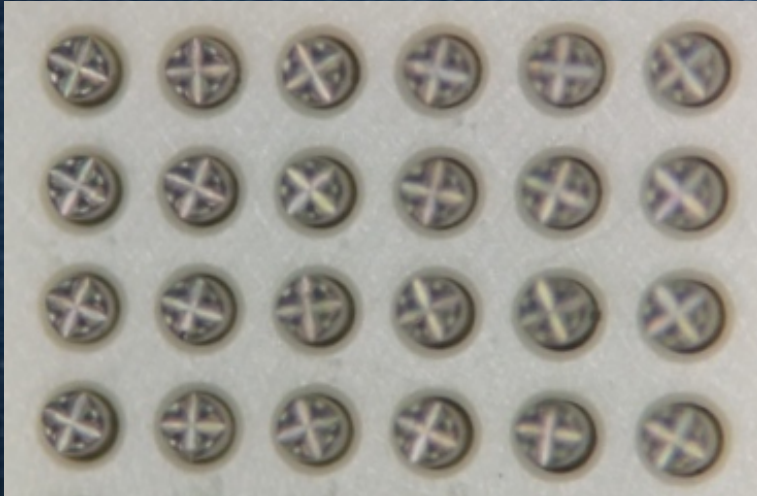
2M touchdown

- **The MDS100 vs Ceramic socket material**
 - Ceramic material can cause more debris over time

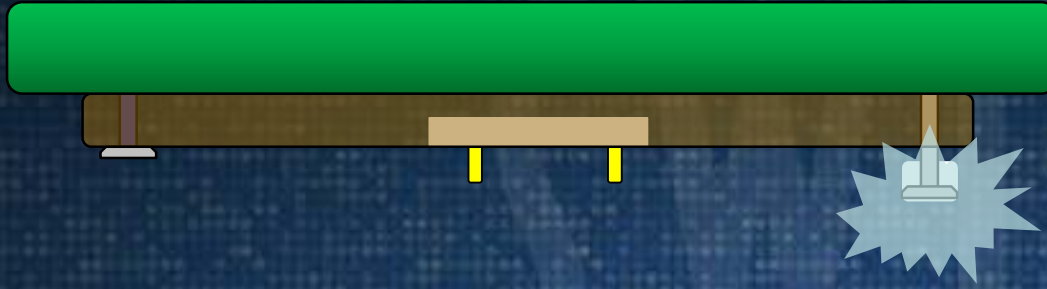
➤ **Damaged bump will be induced on the units that already passed electrical testing.**

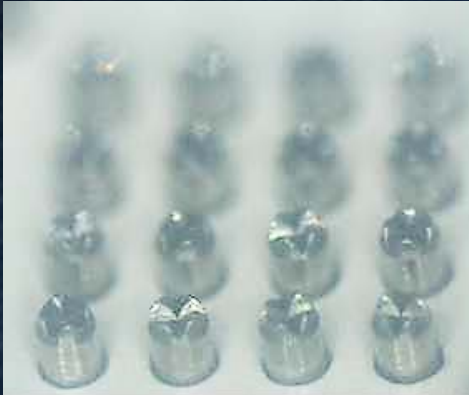
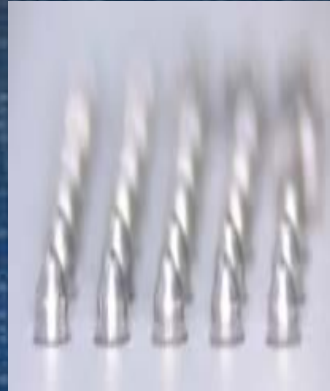
- Crown to Pointed Tip pogo
- Cleaning frequency started with 2000 touchdowns ~ unstable
- Works fine at 200 touchdown cleaning frequency.
- Need further study and optimization on cleaning
