# *Building the Framework of an Integral Process to Ensure Fine Pitch Probe with Fine Pitch Wirebond*

Semiconductor Products Sector

Motorola Inc.

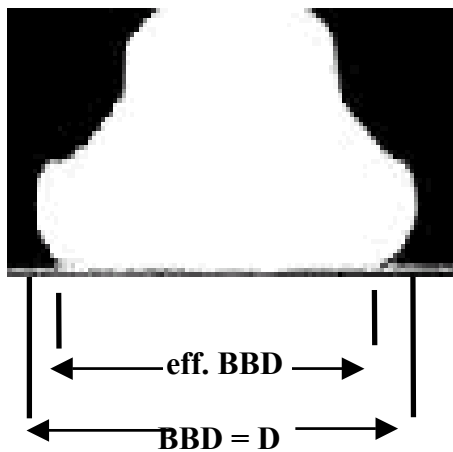
The effective bond diameter (actual pad contact area) is even smaller than the ball bond diameter (BBD)

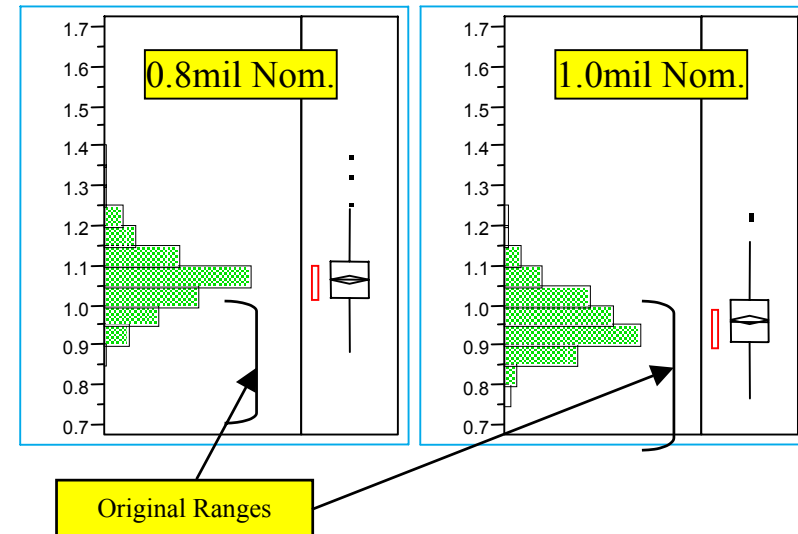
## Subsequent Tip Measurements

0.8 mil	1.0 mil
Maximum	1.3890	1.2370
Median	1.0658	0.9594
Minimum	0.8867	0.7701
Mean	1.0675	0.9657
Std Dev	0.0747	0.0749

- Pareto of original tip sizes unavailable
- Significant tolerance on probe tips allows for large and overlapping ranges
- Tip measurements are not consistent between analyzers, accurate values difficult to define
- 0.8 mil probe card tips worn by subsequent production use (1.0 mil card not used subsequently)

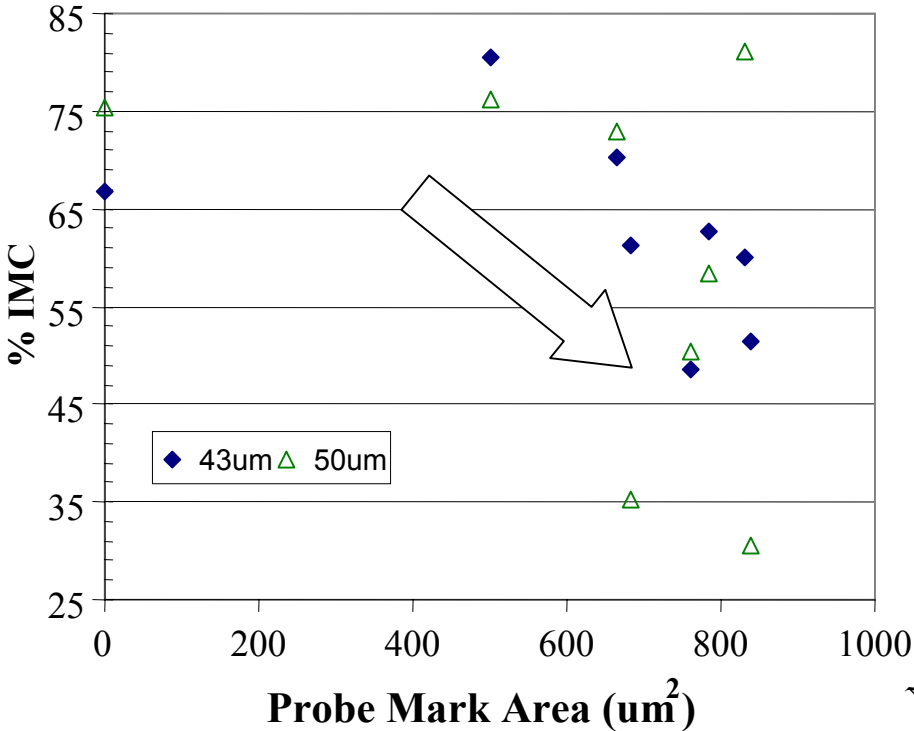
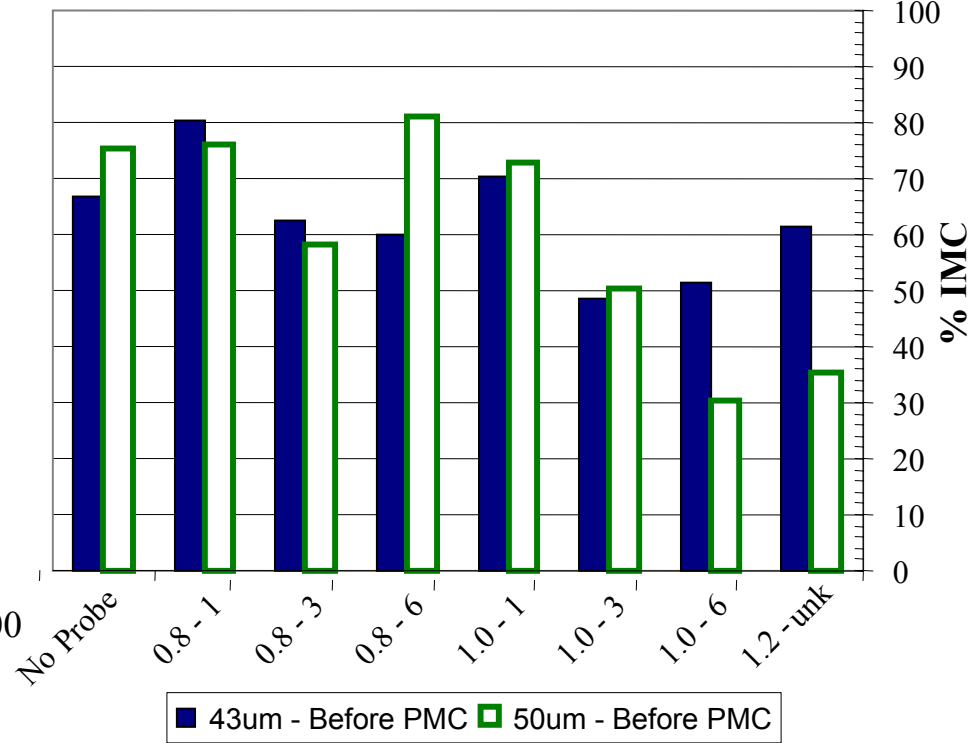
# Intermetallics Reduced by Touchdowns

Areas  
without  
IMC

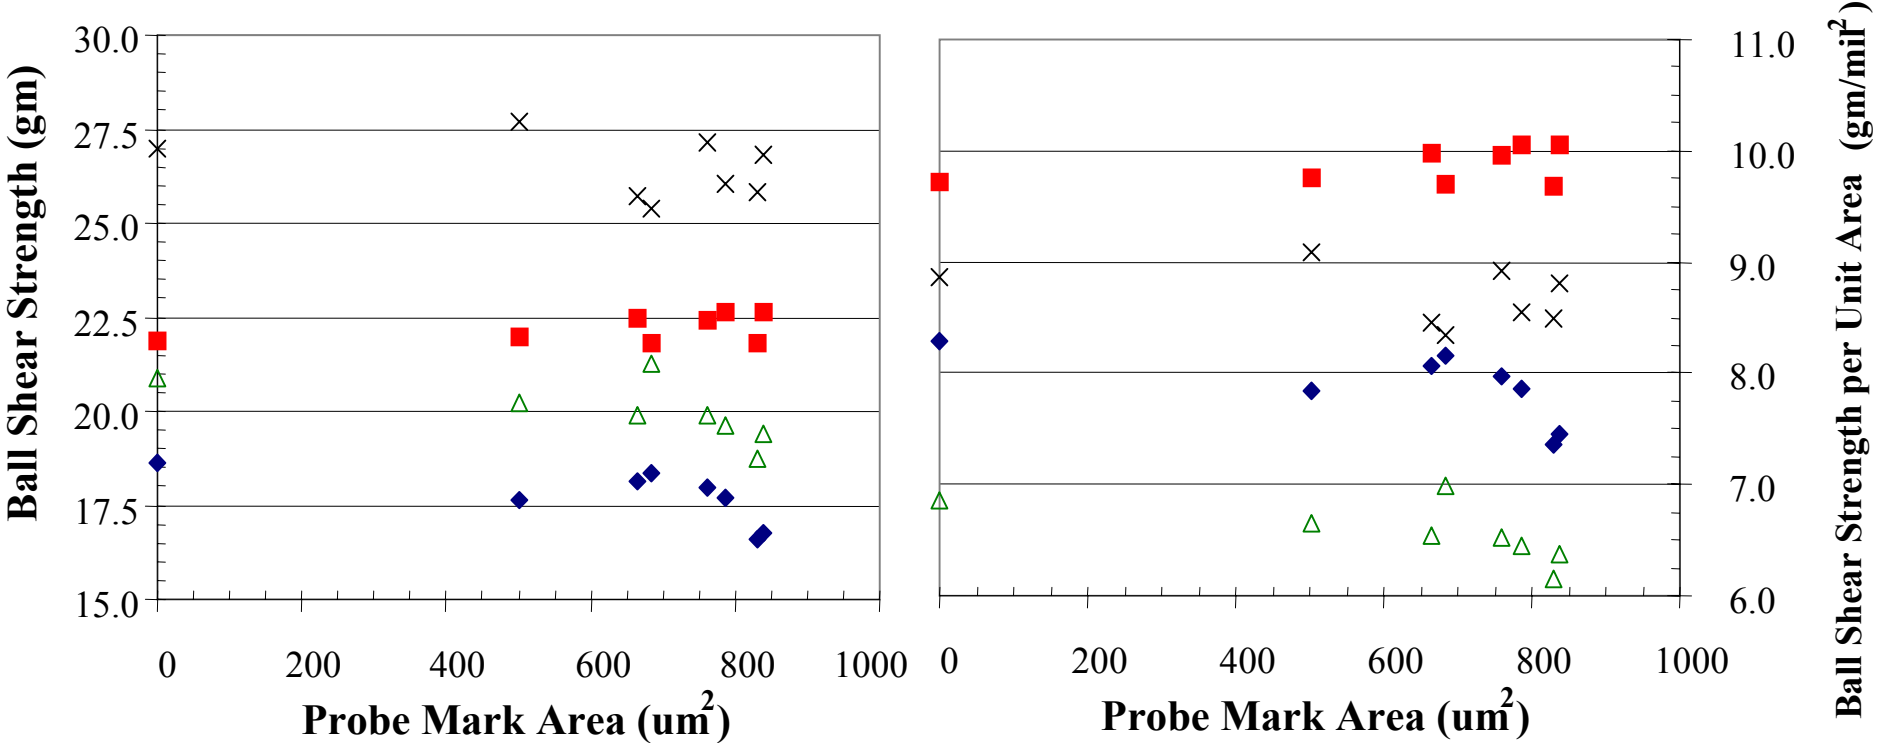
# Probe Mark Area Relation to Shear Strength

- Strength degraded by probe mark area (fine focus microscope measurements), particularly before PMC
- Strength increases after PMC, diminishing effect of probe mark
- 43um and 50um bond strength per unit area do not overlap, larger diameter ball has lower shear strength per unit area

◆ 43um Ball - Before PMC    ■ 43um Ball - After PMC  
 △ 50um Ball - Before PMC    × 50um Ball - After PMC

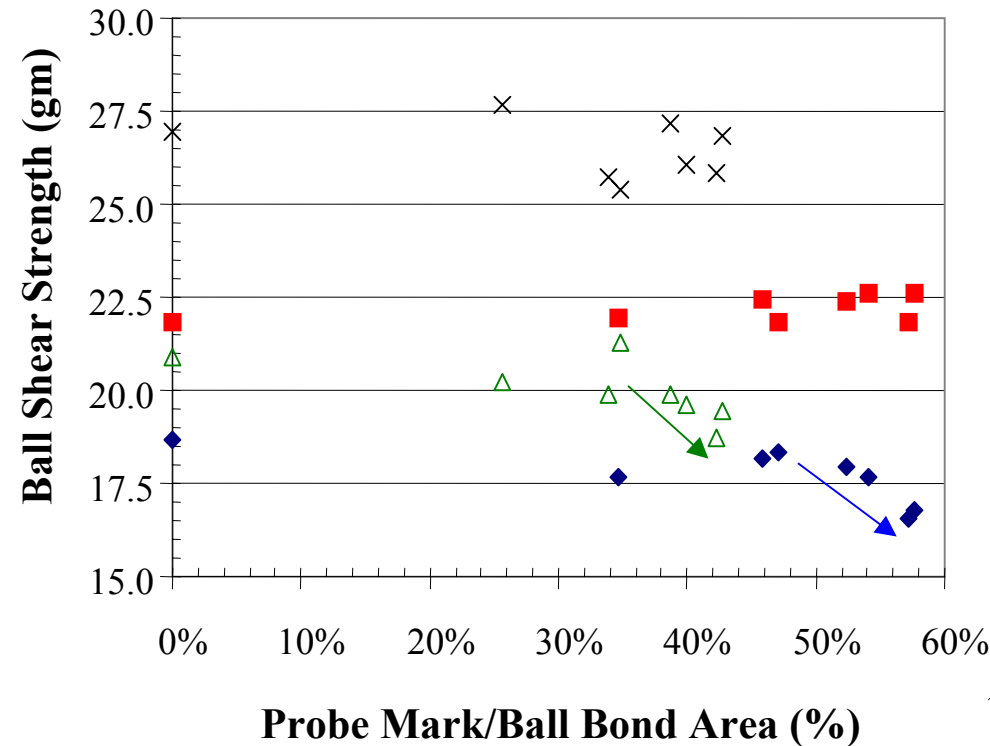
# Further Shear Relation to Probe Mark

- Before PMC, the 50um bond strength degrades at a smaller ratio of probe mark to ball bond area than the 43um bond (43um > 50%, 50um > 38%)
- 0.8 mil probed bonds have lower strength than 1.0 mil probed bonds for each number of touchdowns before PMC (except the 50um ball at 1 touchdown)

◆ 43um Ball - Before PMC    ■ 43um Ball - After PMC  
 △ 50um Ball - Before PMC    × 50um Ball - After PMC

■ 43um - Before PMC    □ 50um - Before PMC

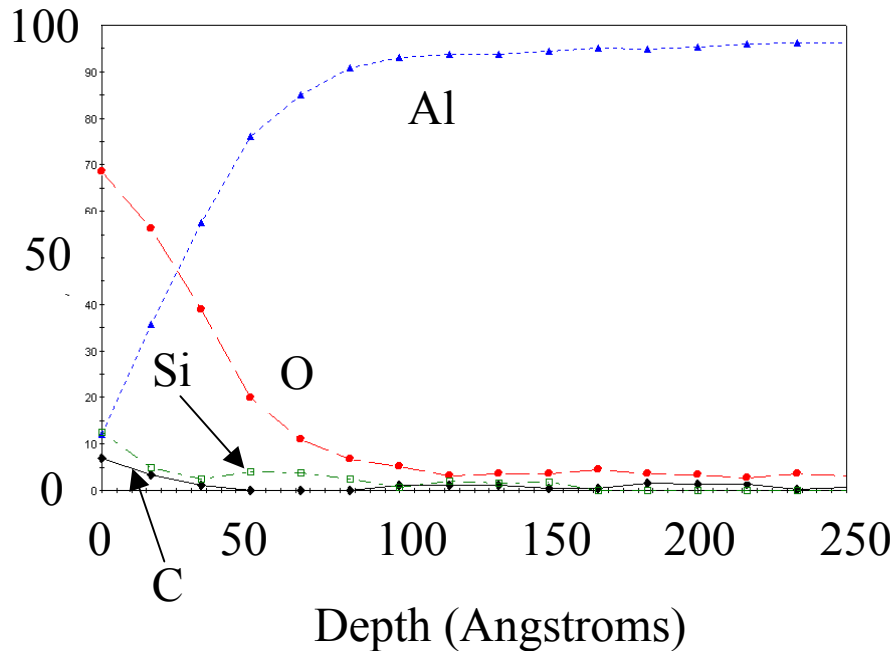
0.8 mil probed wafer

- Auger analysis did not reveal foreign material or contamination
- A normal thickness of Aluminum Oxide found
- Older 1.2mil probed wafer had less surface oxygen and more carbon than the newer 0.8 and 1.0mil probed wafer
