IEEE SW Test Workshop

Yuan Huang, Thompson Hsu, Gary Liu
United Microelectronics Corporation (UMC)

Wensen Hung, Cahris Lin, Dean Yang
MPI Corporation (MPI)

An Experimental work and Analysis of Vertical Cobra Probing on Low-k Wafers

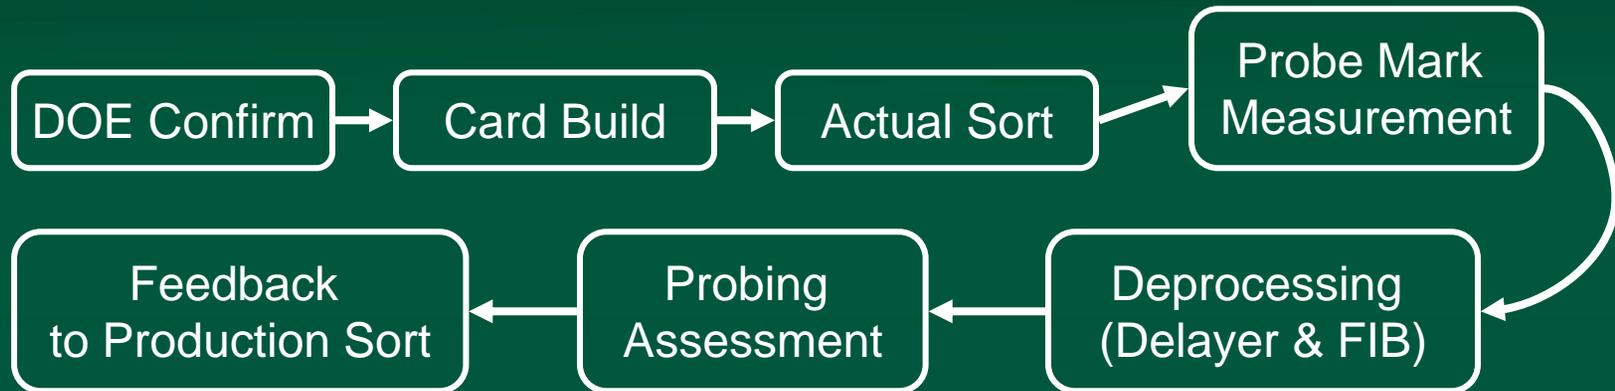
- Flow

- Production sort setup procedures
- Use O/S program to detect 1st electrical contact
- Multiple contact by auto mode setting at prober

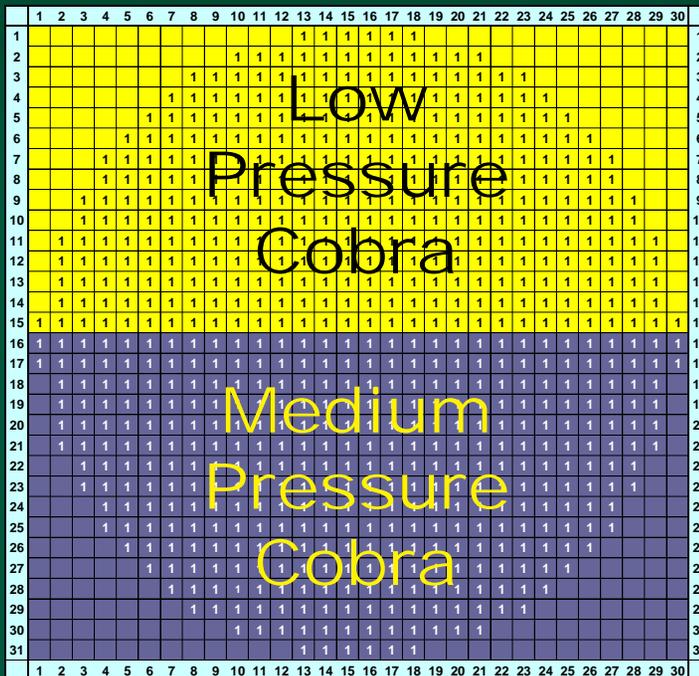
1st Device Wafer

- DOE Plan (Probing Map)

- Overdrive with nominal, high and worst condition
- Max. touchdown up to 3x, 6x and 9x

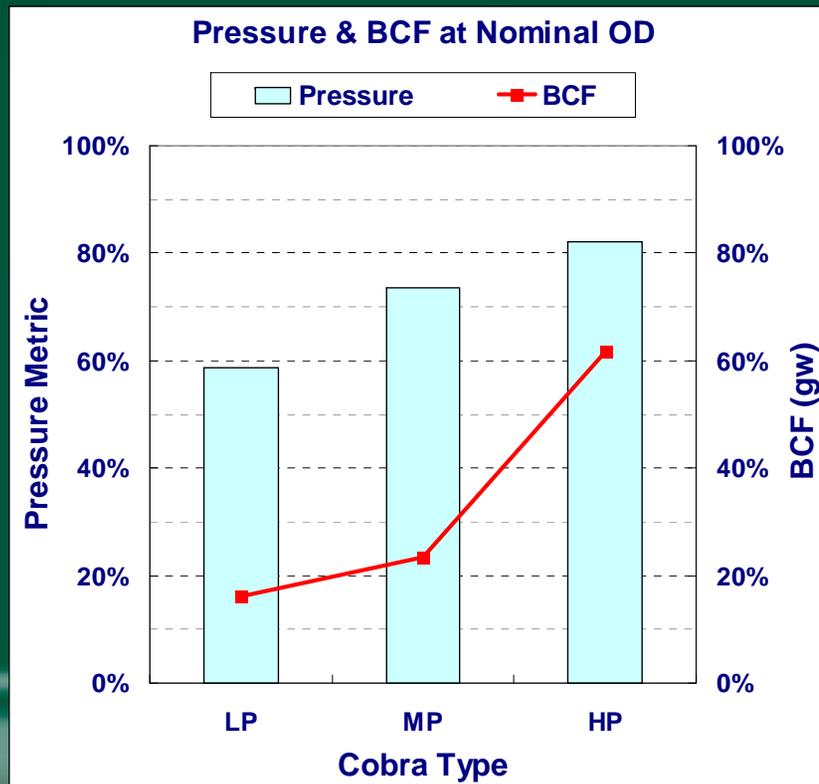
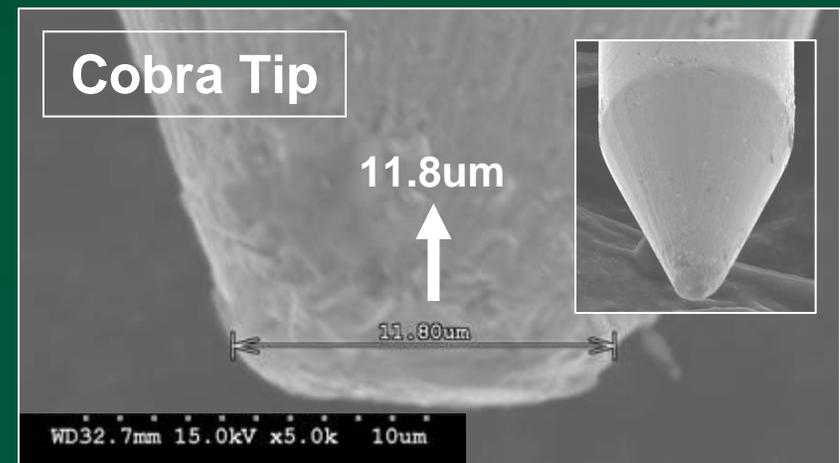
Accurate tip diameter measurement by SEM Equipment (3xprobes/PH)

Customized Cobra Design			
Pressure Rank	Low (LP)	Medium (MP)	High (HP)
Tip dia. spec	15±5um

Cobra design based on probe geometry, tip diameter, and contact force (BCF).

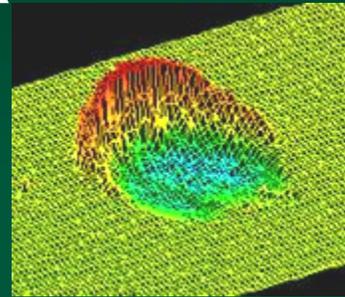
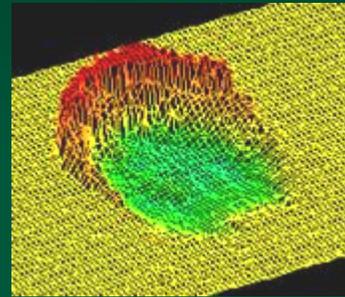
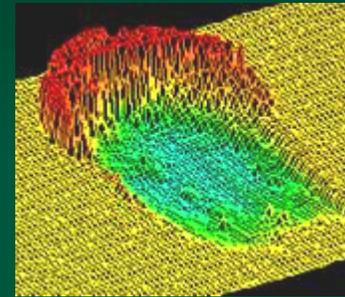
Cobra
Pointed
Probing

Nominal OD

High OD

Worst OD

All 3 Cobra designs (LP,MP, HP) showed the trends such as → Increased OD, adds more scrub to the pad, while increased TD did not add further scrubbing action.

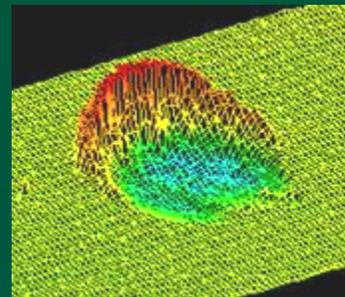
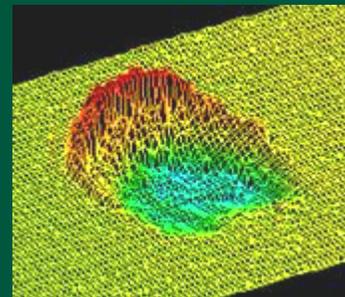
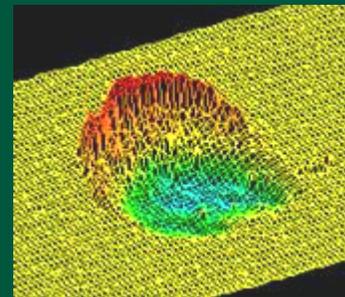
Cobra
Probing
~ Nominal OD ~

TD 3x

TD 6x

TD 9x

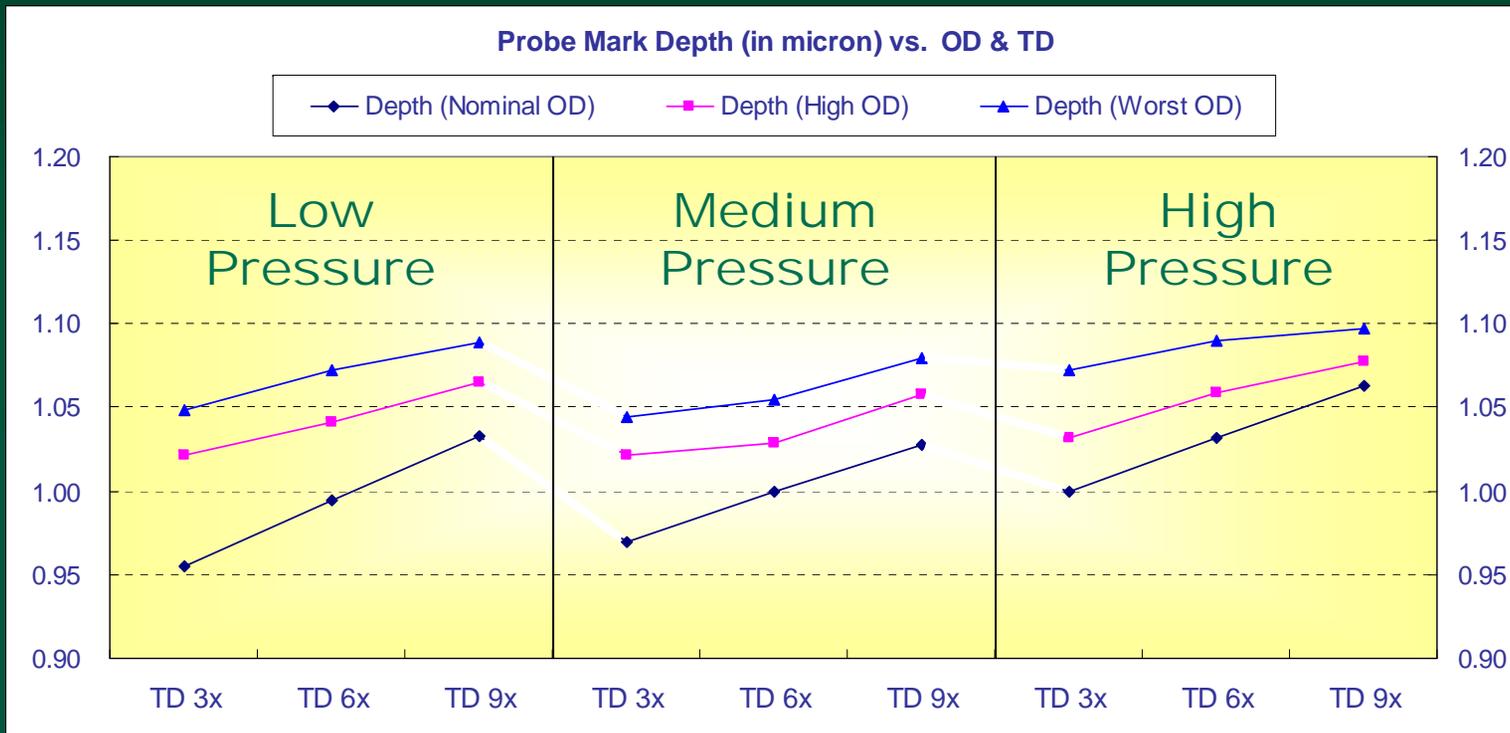
Confocal Laser Scan

Min. sampling = 8pads

Depth

- ◆ Trends showed larger OD & more repeated TD caused deeper probe mark
- ◆ Pressure magnitude is in linear correlation with the resulted probe mark depth.

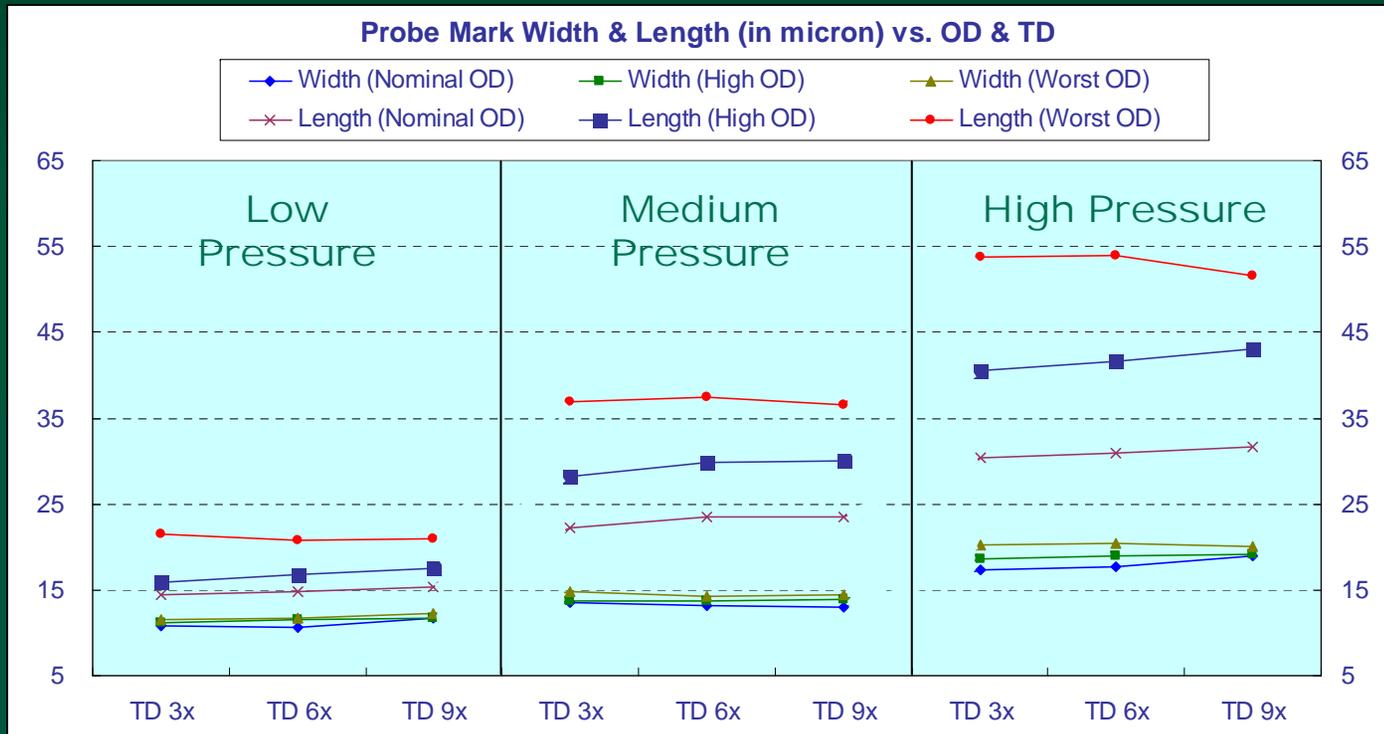
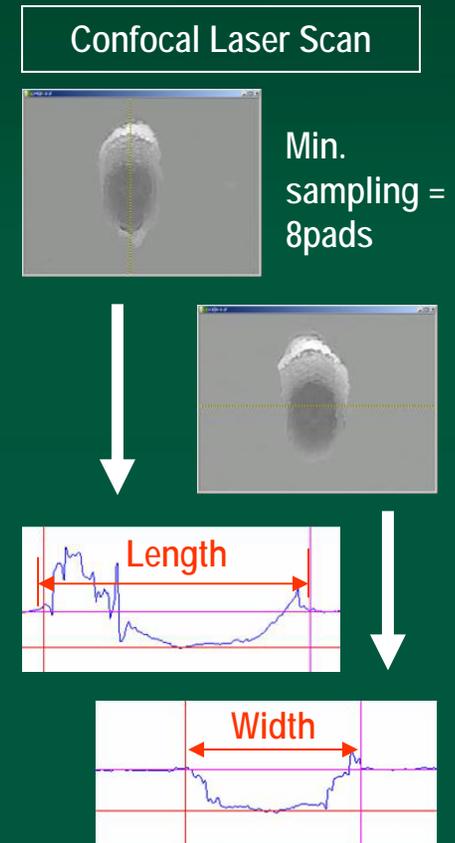
- ◆ Probe mark width trend was stabilized while OD & TD increased
- ◆ Longer probe mark length whenever increasing OD, however repeated TD did not cause additional probe mark length

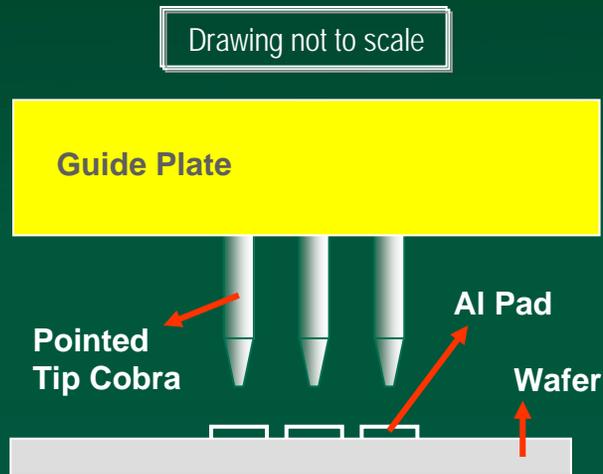
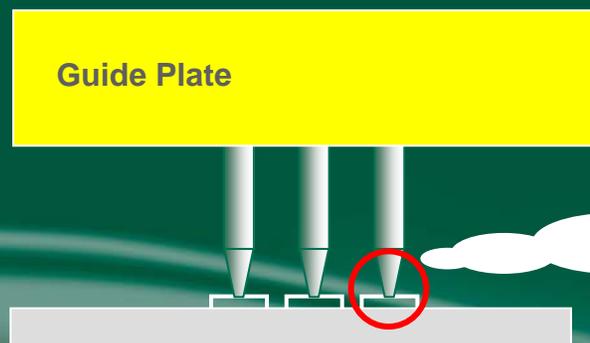
Methods:

1. Collect the 2D & 3D laser scan data
2. Identify the similar patterns
3. Propose the contact mechanism
4. Real-time visualization

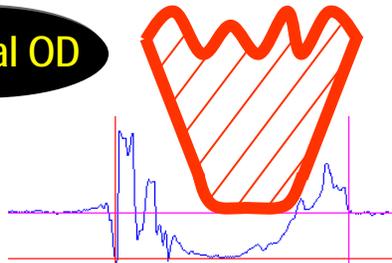
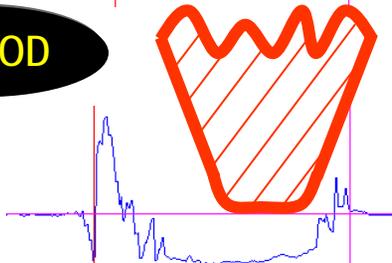
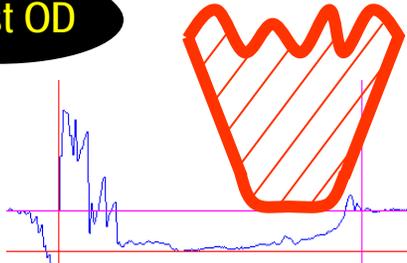
Animation Model

Nominal OD

High OD

Worst OD

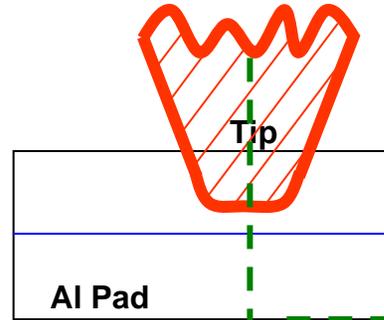
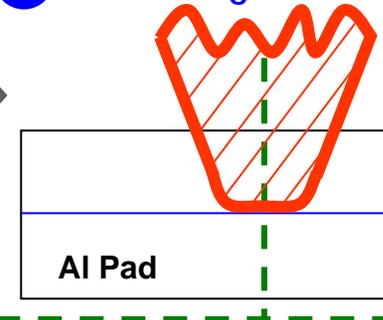
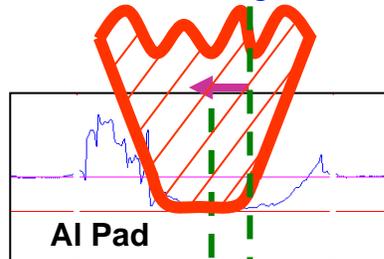
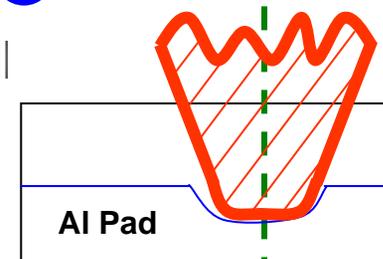
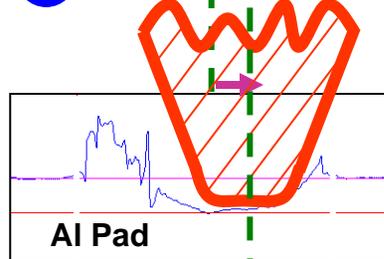
1 Before Contact

2 Contacting

4 Lateral scrubbing

3 Penetration contact

5 Back scrubbing

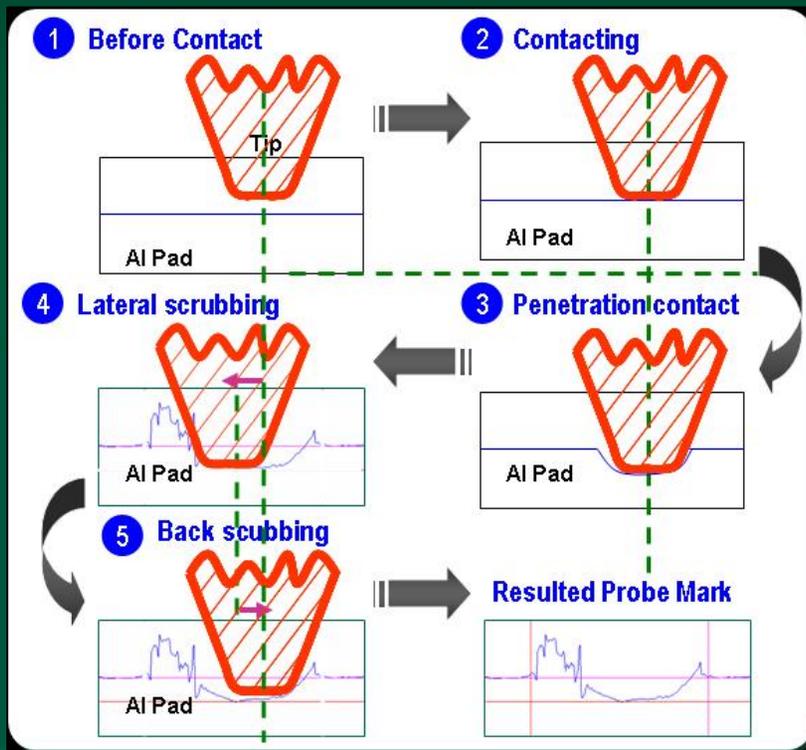
Predicted Model

Real-time visualization

The predicted model was agreed with real-time video. The **Cobra tip** has tendency to **SCRUB** at **Initial** and **End** of contacting moments.

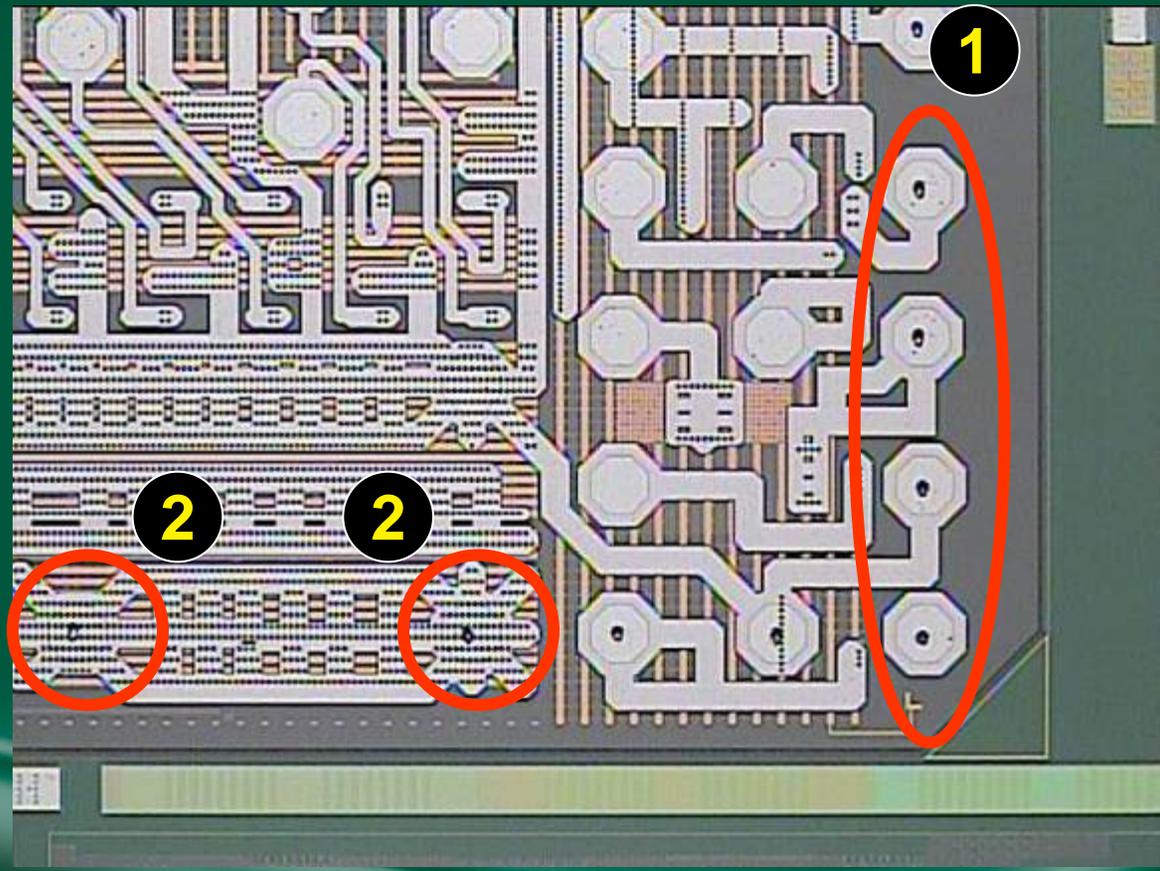
Pad Type

1 Solid Pad

2 Slotted Pad

Actual Pads on Probed Wafer

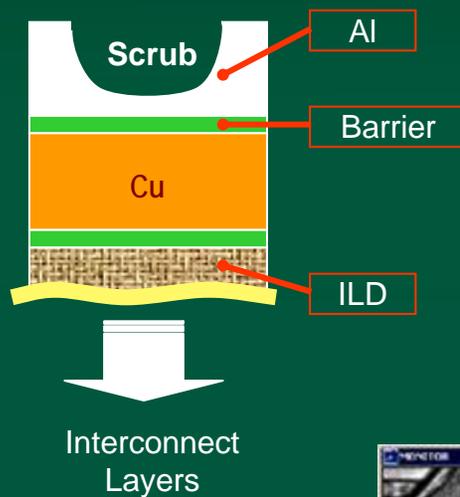
Before Delayer

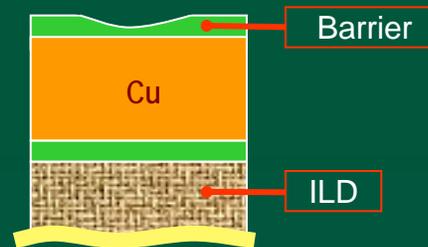
After Delayer, Check Barrier Layer

Mode 1 ~ Craters

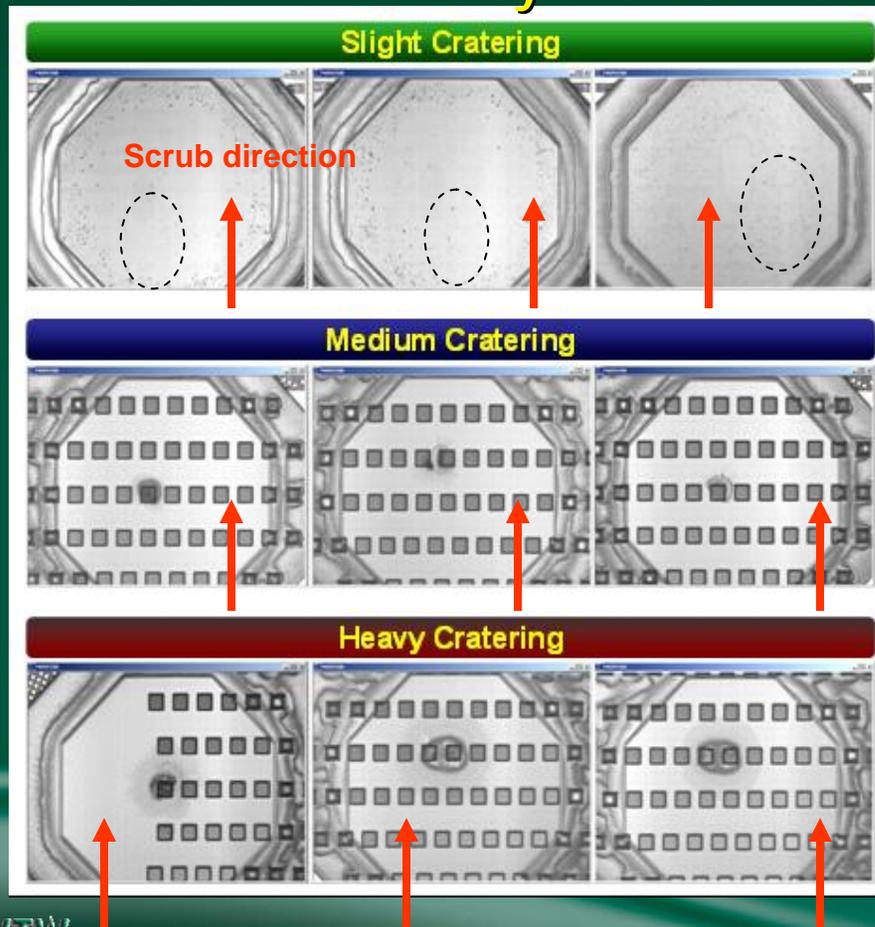
- **Deprocessing (Pad type, Delayer & Failure mode)**
"Mode-1 Barrier Layer Crater" showed 3 damage levels :

1. Shallow & small depression
2. Slight mark coloring

1. Medium depression area & depth
2. Darker mark coloring

1. Largest depression area & depth
2. Darkest mark coloring
3. Deformation of slotted pad wall

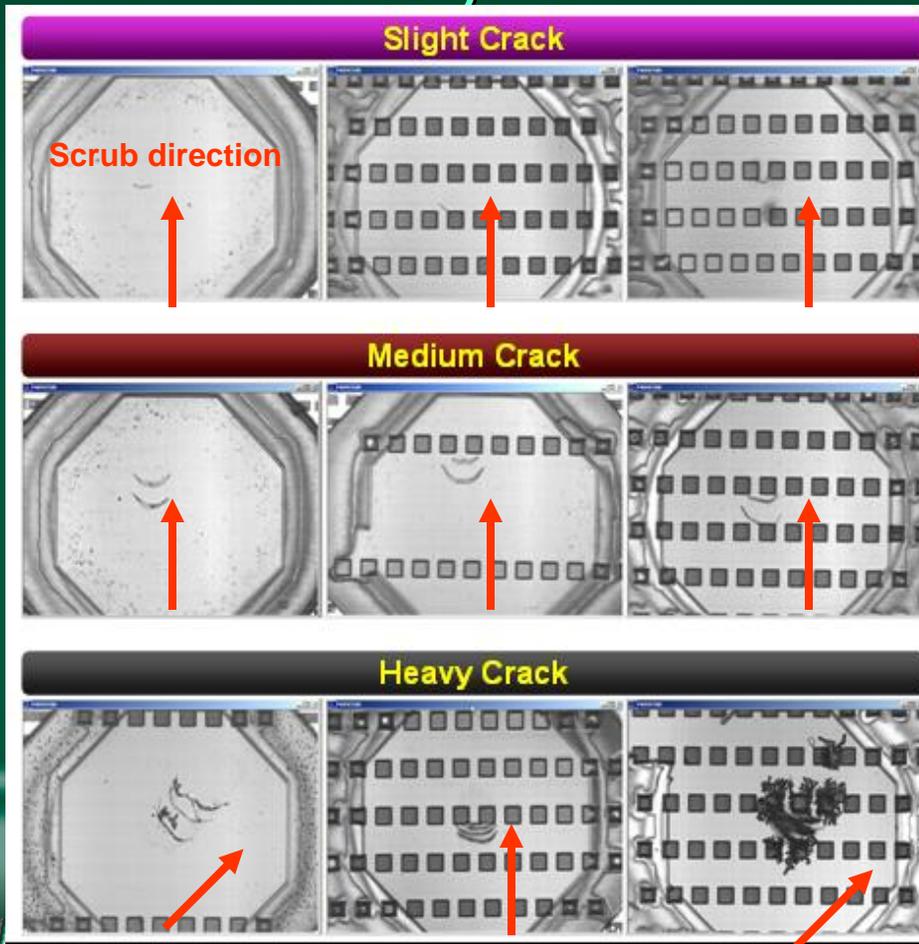
“Mode-2 Barrier Layer Crack” showed 3 damage levels :

1. Short crack length
2. Thin crack opening

1. Longer & multiple cracks
2. Medium crack opening

1. Worst multiple cracks
2. Largest crack opening
3. Tearing off barrier layer

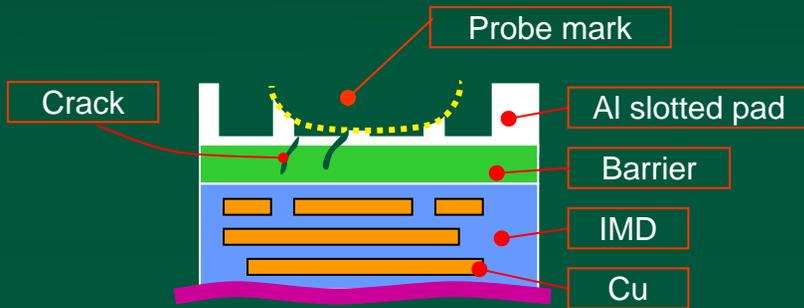
Mode 1 ~ Slot Edge Crack

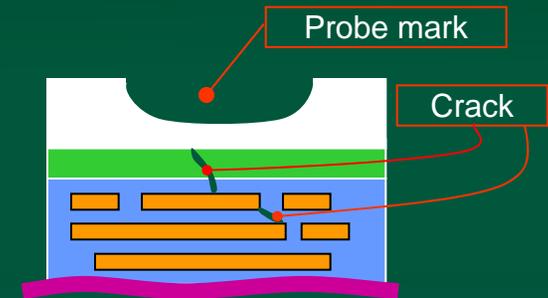
Mode 2 ~ Multi Level Crack

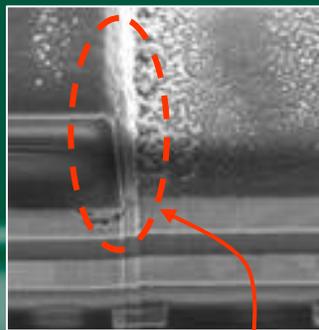
Crack propagation at underlying layers

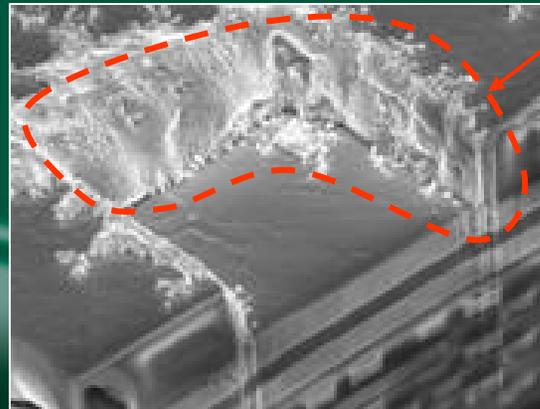
Slot edge cracks

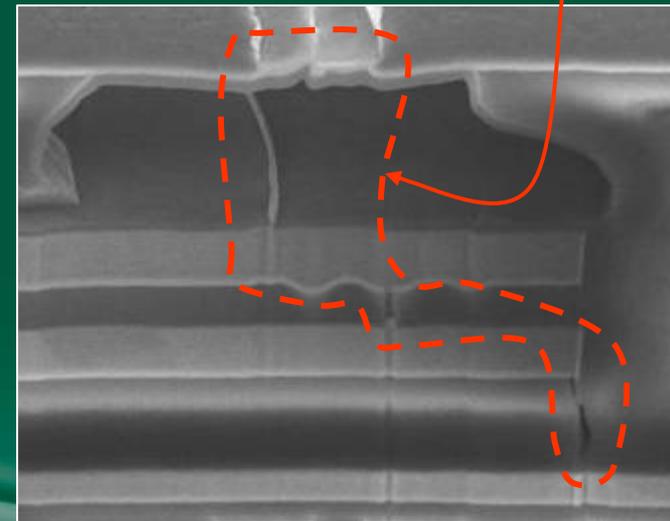
Reactive products due to slot edge cracks

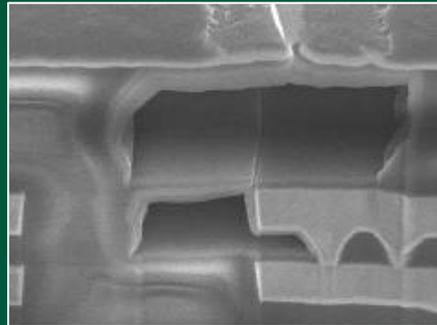
Heavy Crack

HP Cobra (Worst OD & TD6x)

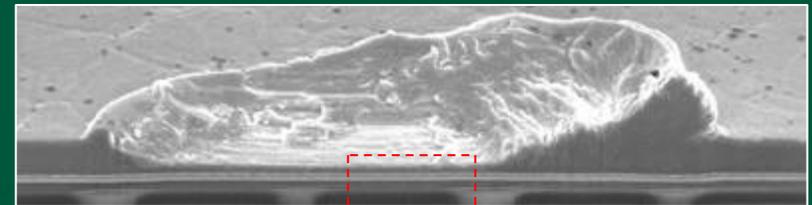
No Crack

LP Cobra (Worst OD & TD9x)

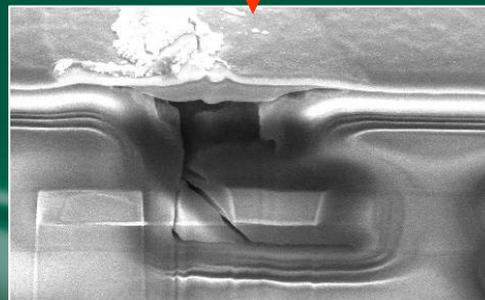
Multi-level barrier layer
cracking beneath the pad

HP Cobra (Worst OD & TD9x)

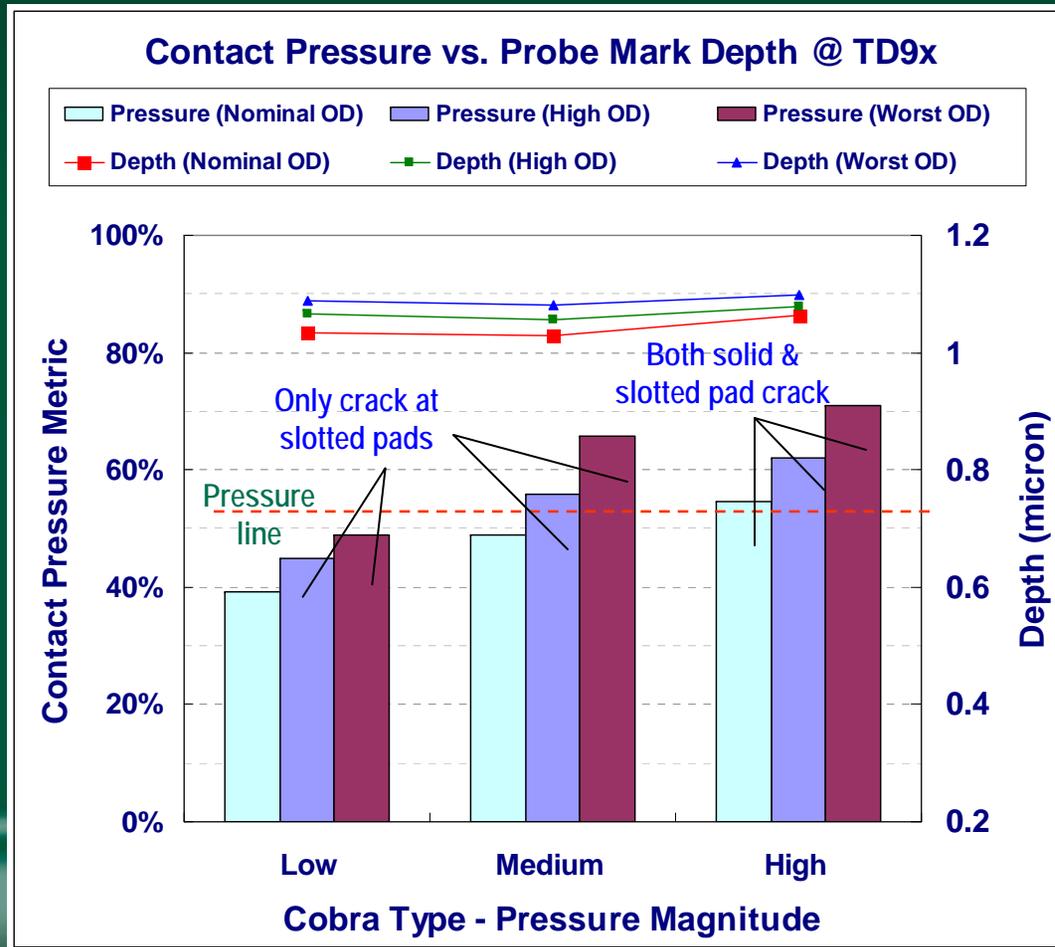
- Pressure analysis (Tip Measurement, Analysis)

“Slotted pad” is more risky to crack than “solid pad”

Same pressure condition could lead to different results.

“Impulse-Momentum” effect between the pad & probe

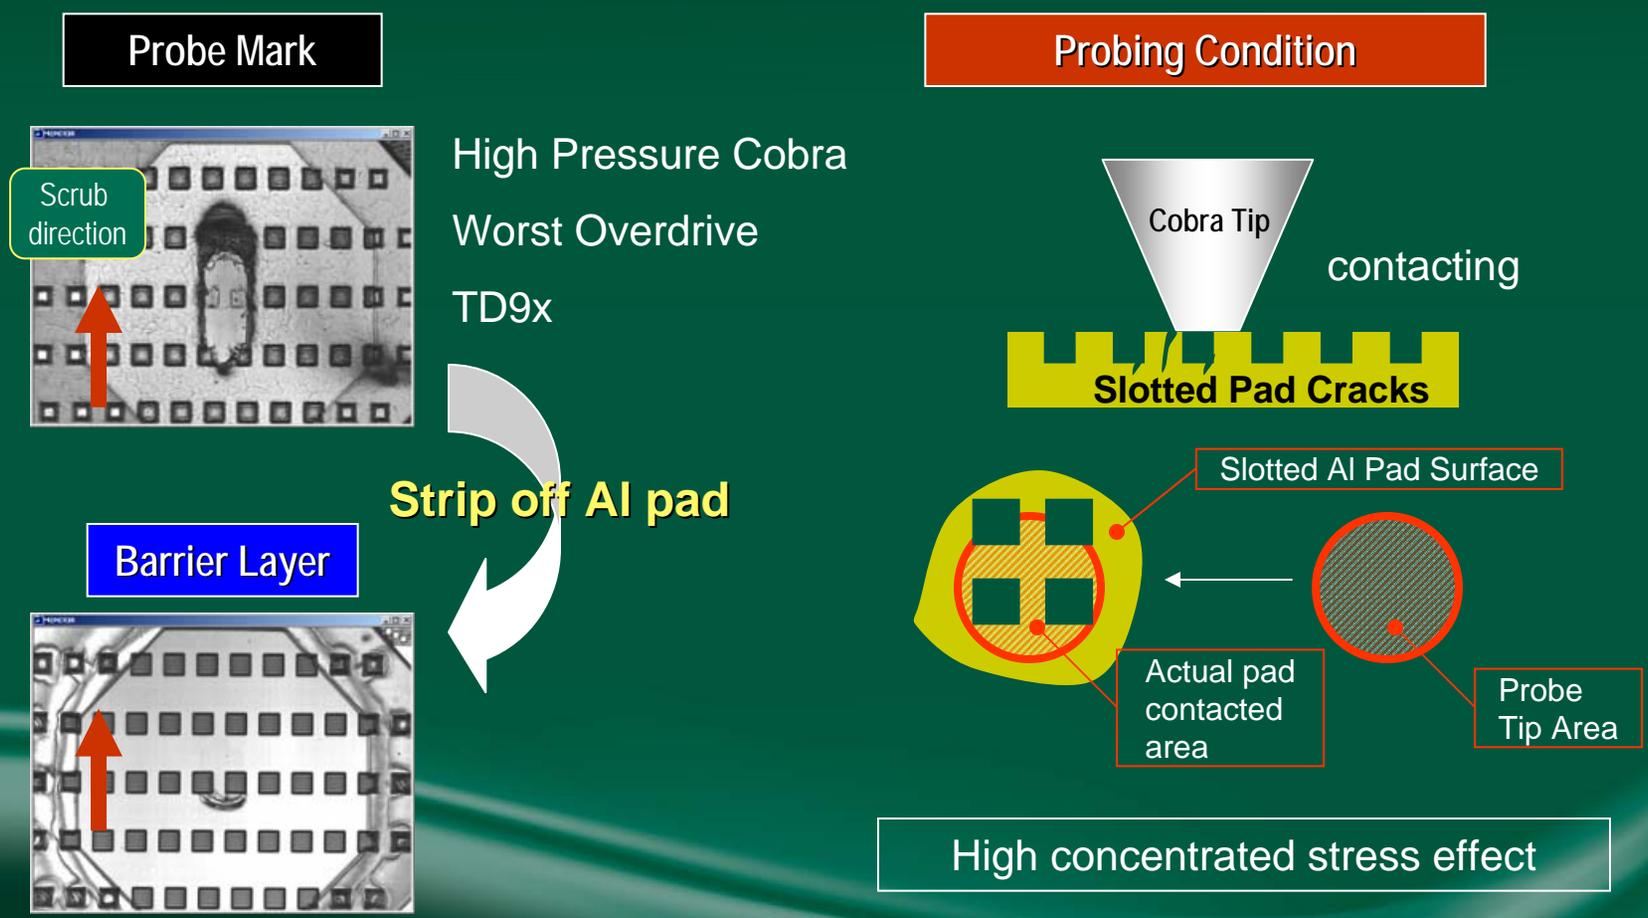
2. **Slotted pads** are more susceptible to **barrier/underlying cracks** due to “**High Stress Concentration**” resulted on relatively smaller contact area on pad.
