IEEE SW Test Workshop

Use of Harsh Wafer Probing to Evaluate various Bond Pad Structures

ON Semiconductor, Pocatello, ID

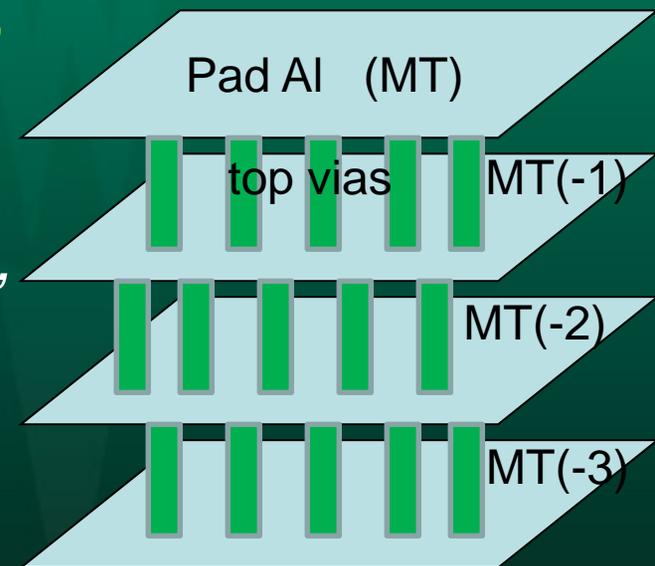
A 4-level metal pad structure within the “pad window” is illustrated in concept:

*Al metallization: TiN / Al(0.5%Cu) / TiN,
W vias, SiO₂ dielectric*

- sheets of metallization at all levels
- via arrays connecting the plates
- SiO₂ dielectric surrounding

(Periphery of pad structure, passivation, Si devices, etc. are not shown)

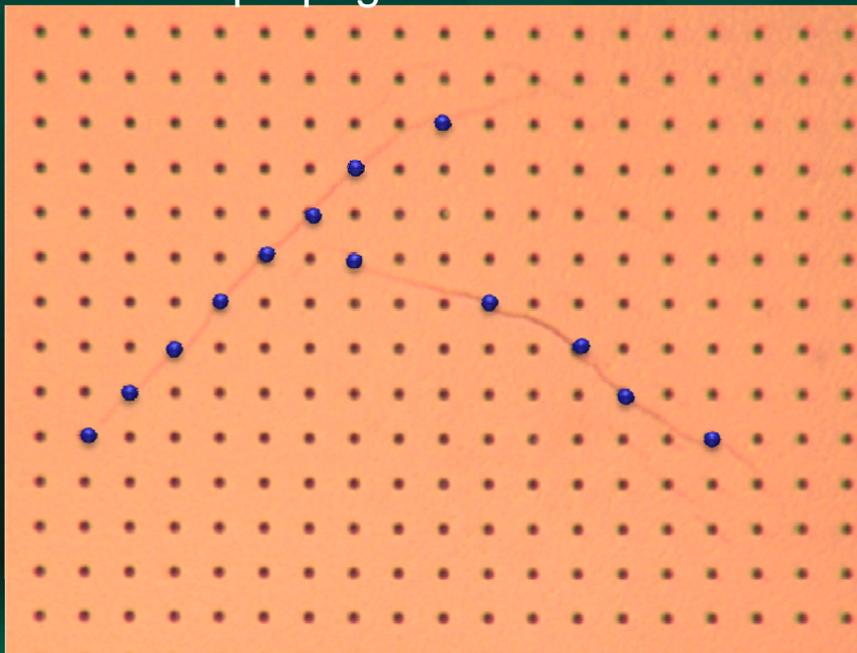
- top vias participate in SiO_2 cracking, giving traditional pads with top vias the worst record for cracking
- lifting TiN, SiO_2 divots, and craters are much more likely with top vias

cracks propagate from via to via

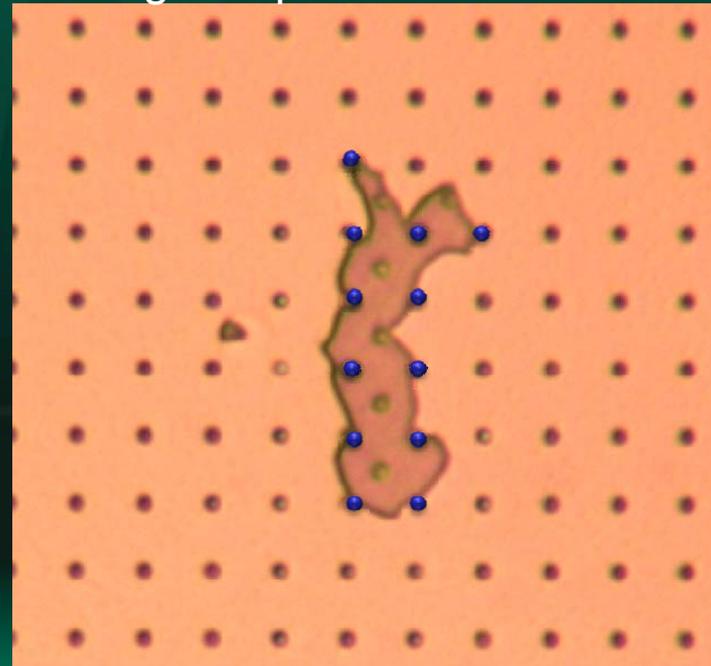
an example of “lifting barrier”, relating to top vias

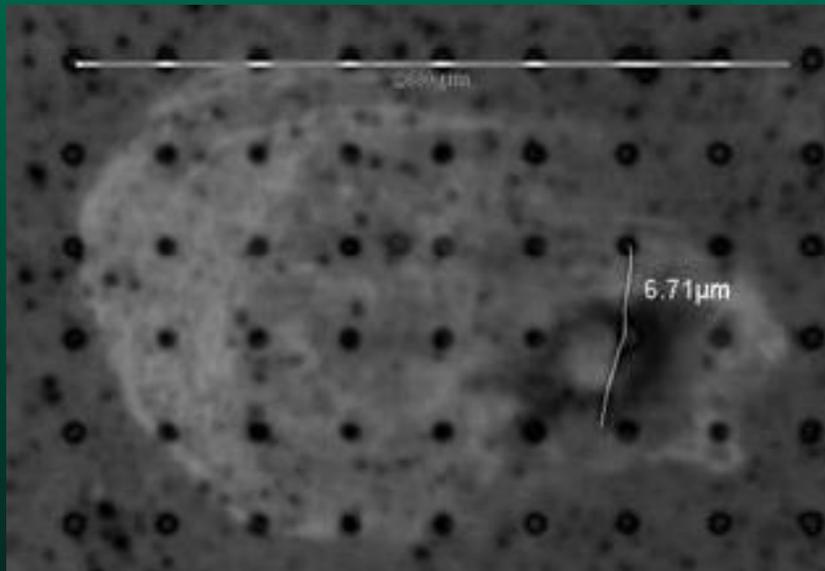
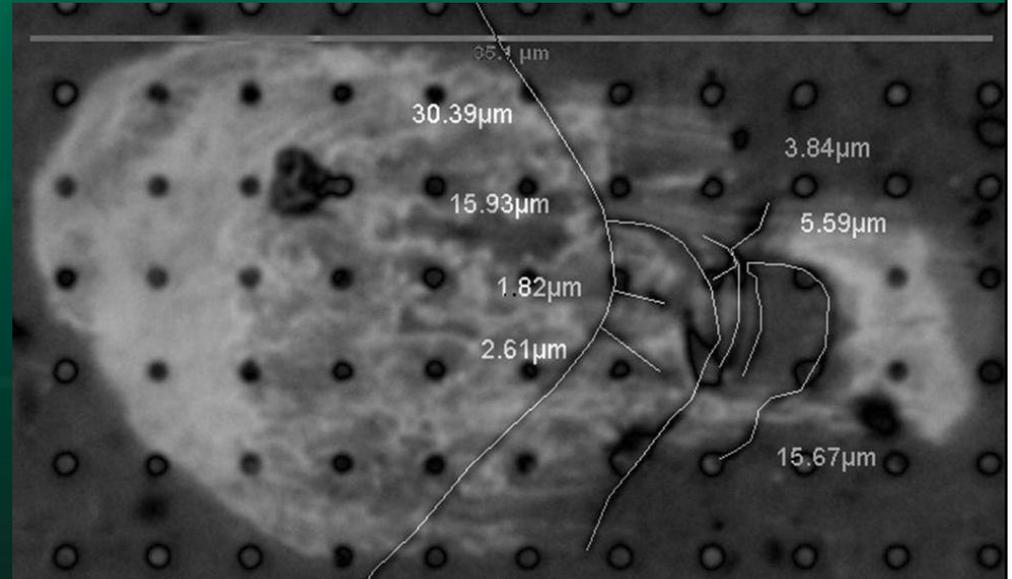
Examples of pad crack photos overlaid with the probe marks

1. **Chuck overdrive** is the strongest factor for cracking
 2. **Probe touchdowns** is a strong factor when high overdrive
 3. **Short probe tips** are worse for cracking
- (**Thick top metal** >1um reduces cracking)

traditional pad design	% pads cracked: 6 TD, 4mil OD	Ripple effect	other damage
0.55um MT, dense VT	95 - 100 %	strong	some barrier lifting
0.8um MT, dense VT	90 - 100 %	strong	some barrier lifting
0.55um MT, no VT	60 - 90 %	strong	
0.8um MT, no VT	40 - 90 %	strong	
1.0um MT, no VT	20 - 50 %	strong	
1.5um MT, no VT	15 - 25%	reduced	
3.0um MT, no VT	0	barely visible

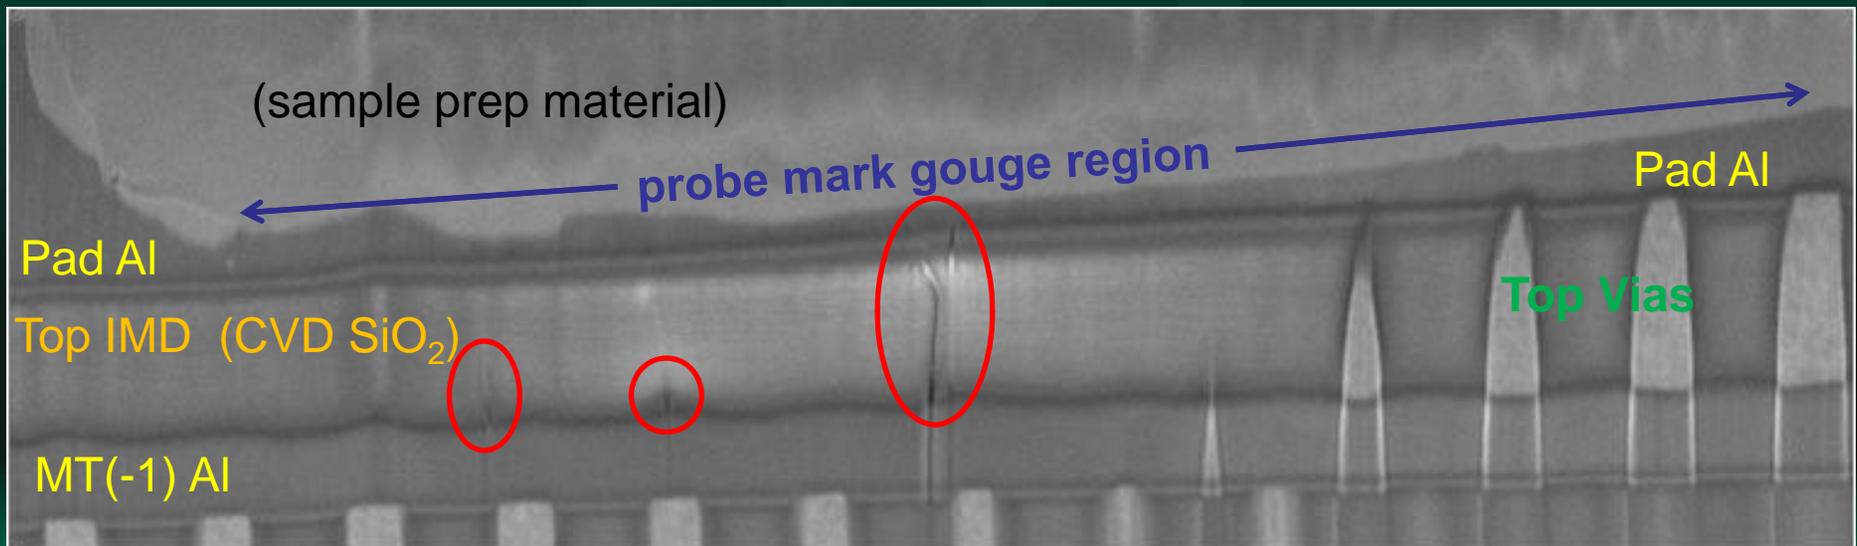
- This FIB cross section of a probe mark on a traditional pad structure shows 4 cracks in the top dielectric
 - 3 cracks initiate in the bottom of the dielectric
 - cracks are located near the deepest part of the probe mark
 - only one is easily visible in a cratering test: cracked TiN
 - cracks will become worse (propagate, widen) during wirebond

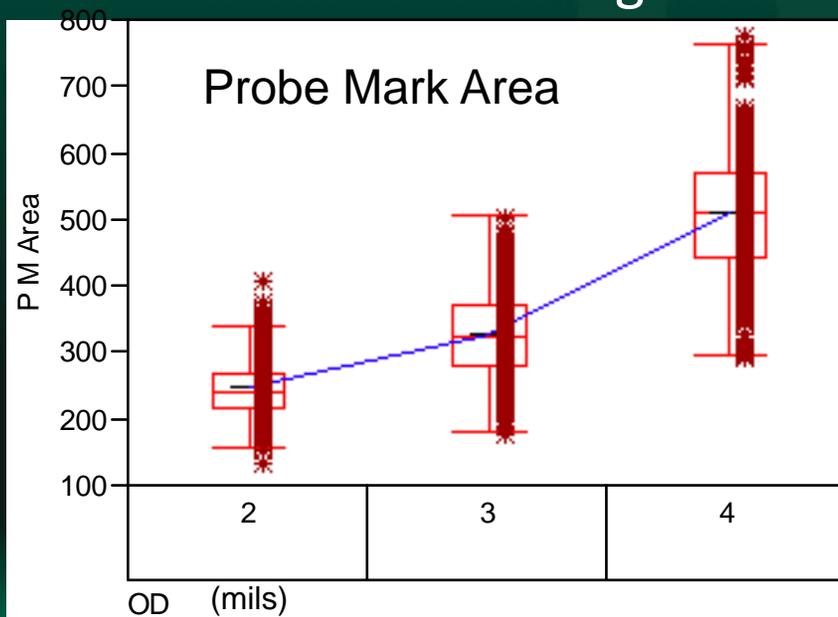
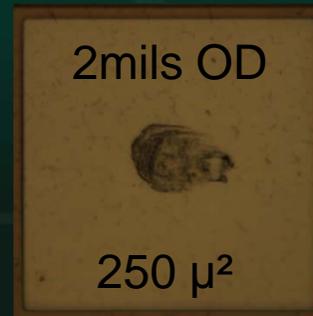
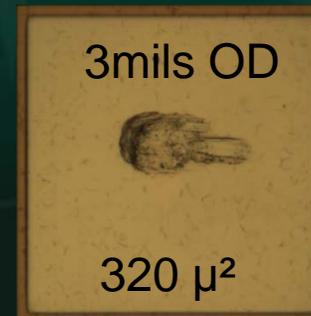
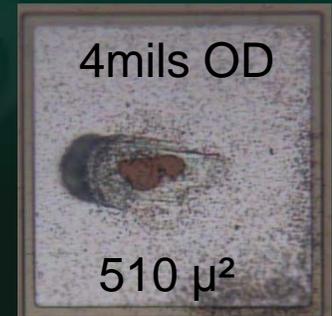
- **Chuck overdrive increase is the largest factor in causing cracks for traditional bond pads**
 - probe mark size increases
 - probe mark depth increases
 - % of pads cracked increases
 - number and length of cracks increases

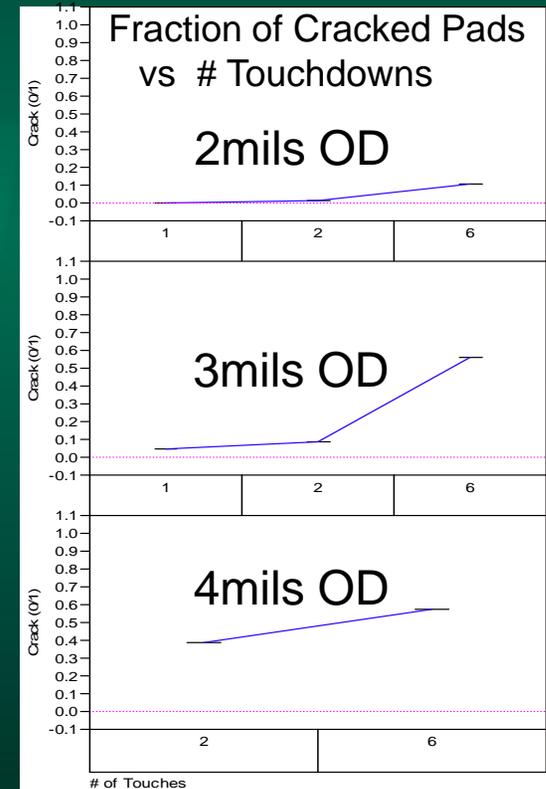
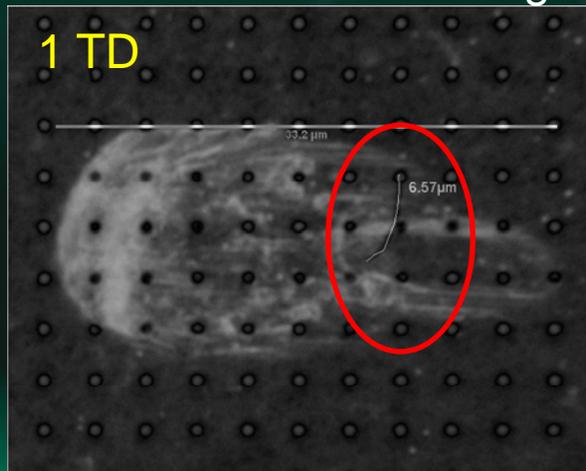
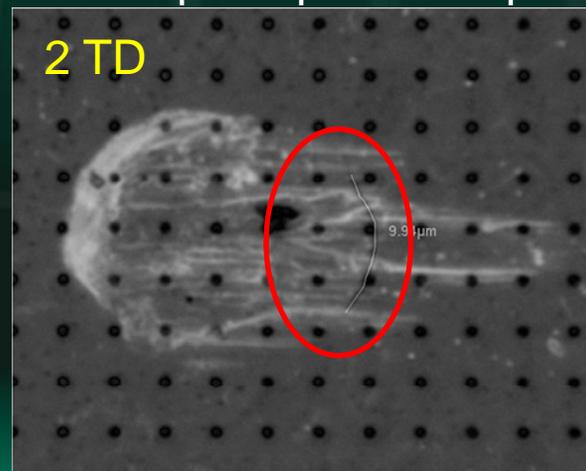
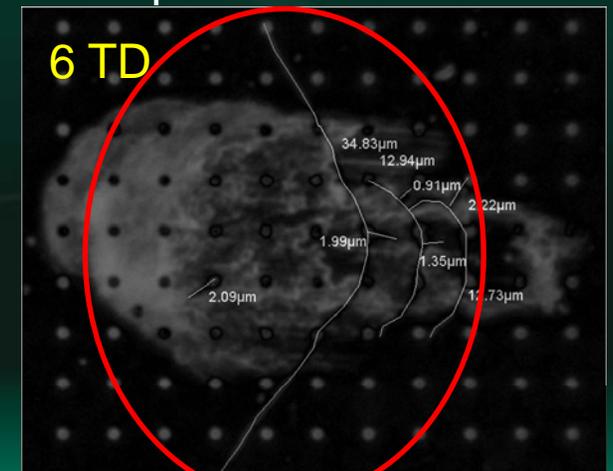
- Probe touchdowns is not a large factor in cracking until the overdrive is high on traditional pads
- crack length and number of cracks increase with more touchdowns

below: cracks in cratering test are superimposed on probe mark photos

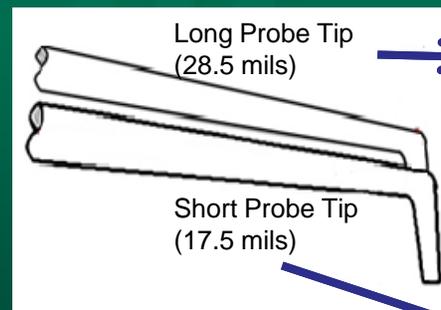
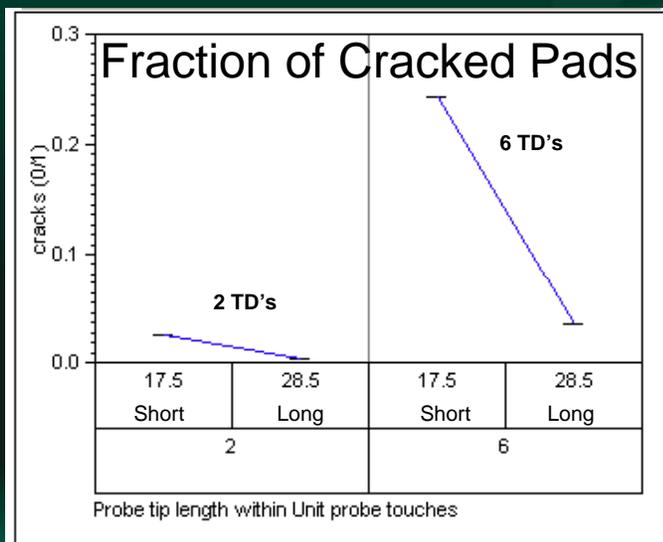
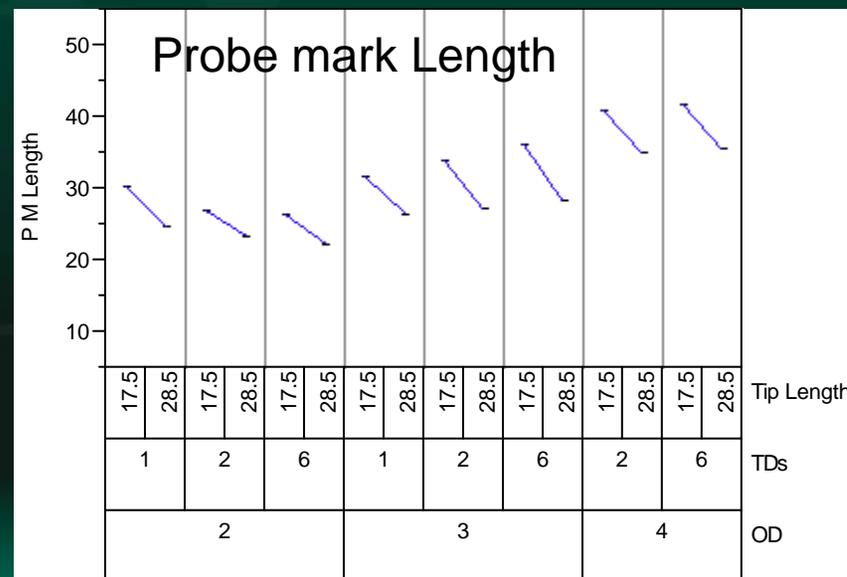
- shorter tip length causes more cracks, most apparent with high touchdowns on traditional pads
- shorter tip length causes longer probe mark

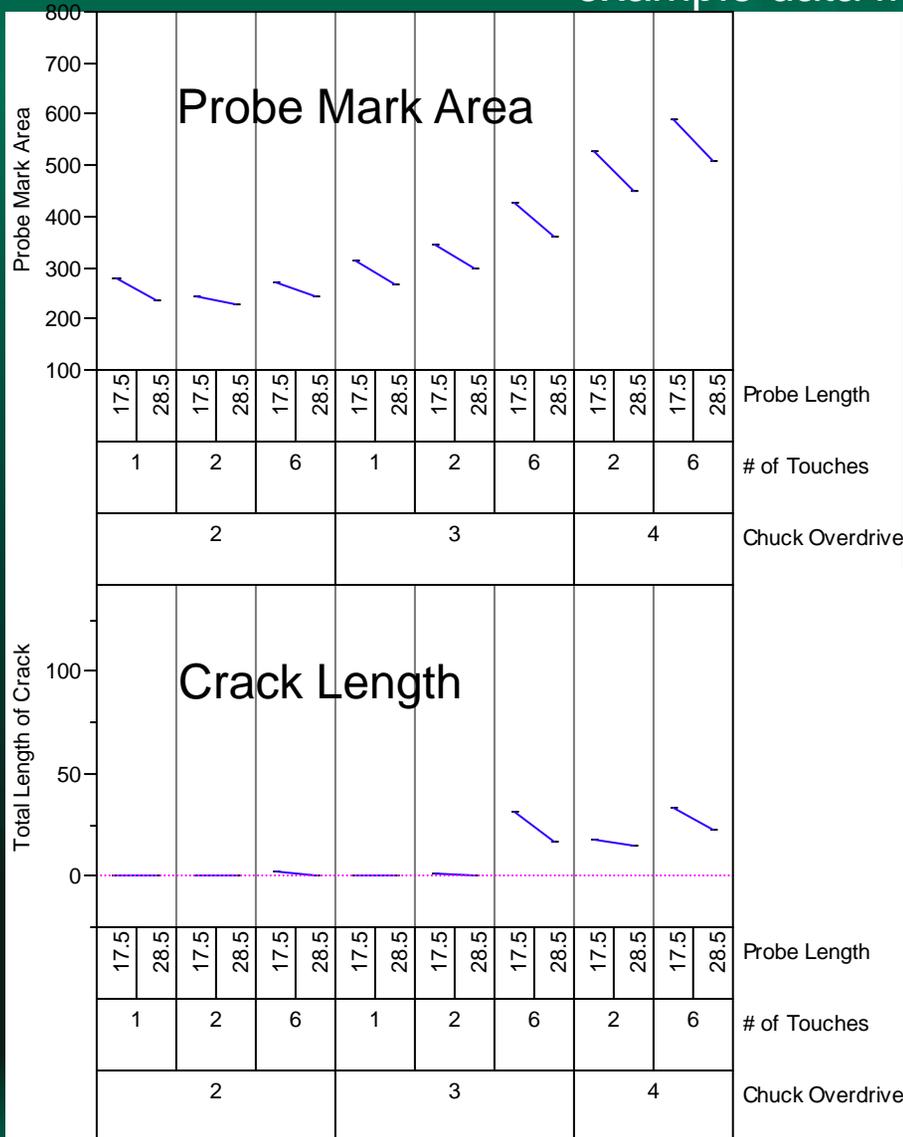
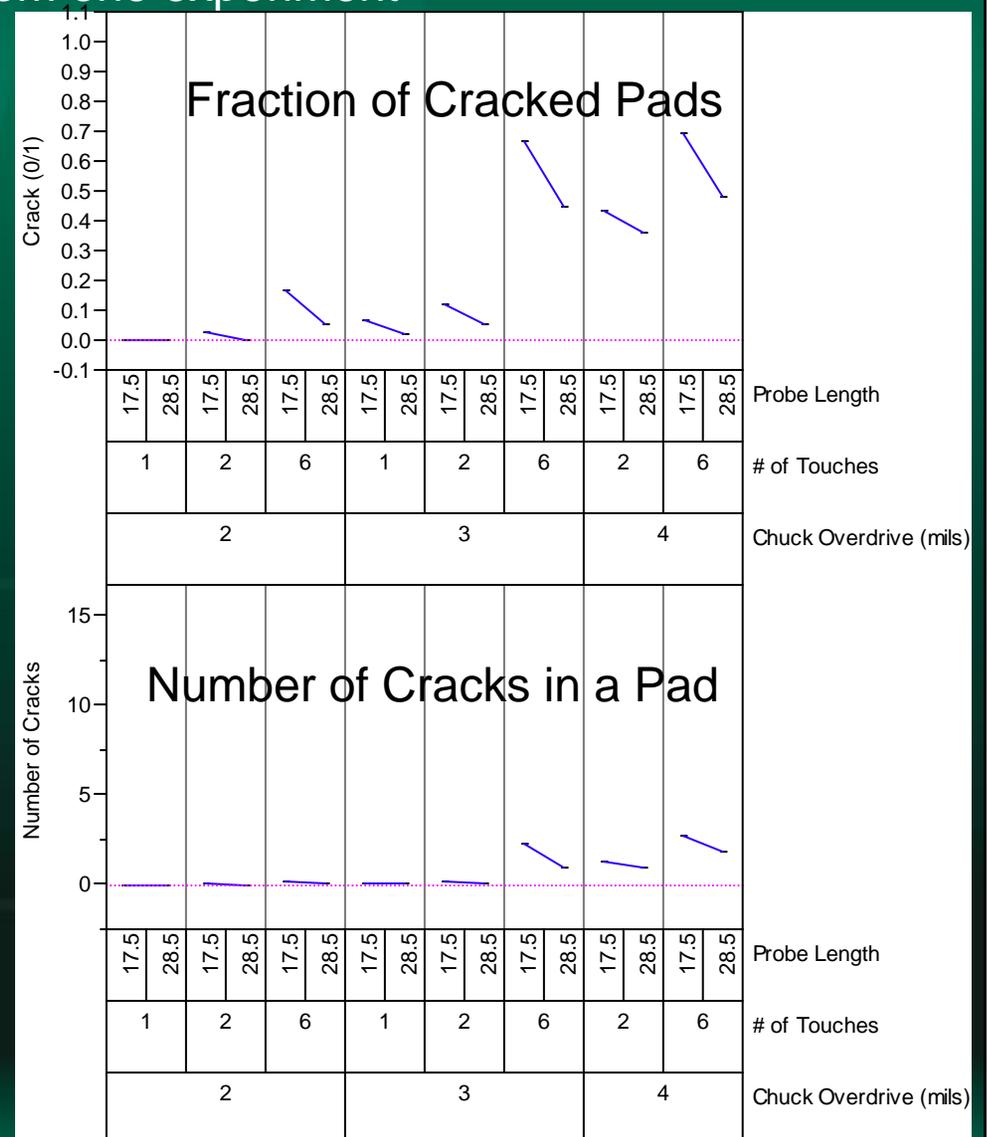
main factors interactions for traditional pads

example data from one experiment

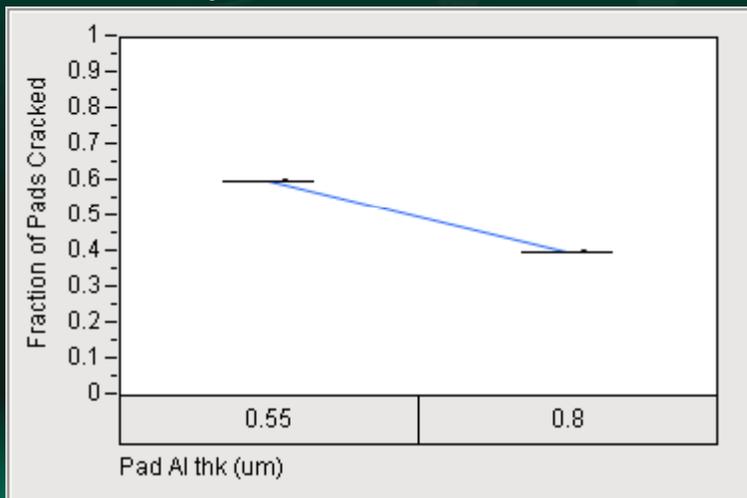
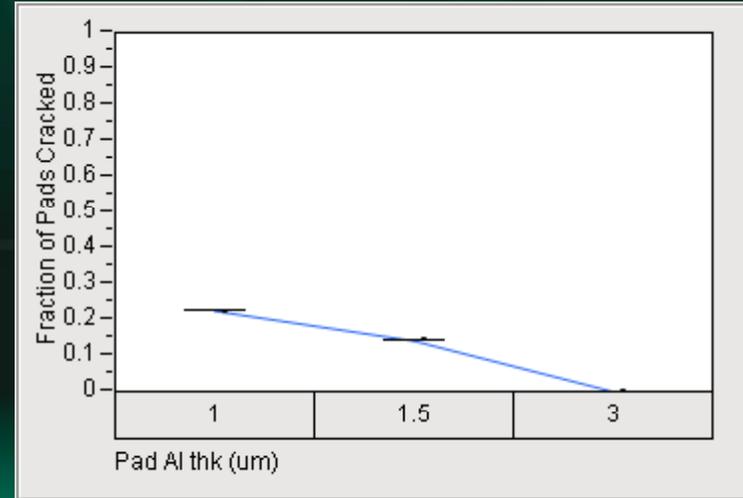
- **Cracking reduces with increasing pad Al thickness**
 - harsh probing conditions reveal this dramatic trend
 - pad Al thickness of 3um prevents cracks from harsh probe

*Example experiment data below is from two different technologies;
No top vias, 6 Touchdowns at 4mils Overdrive*

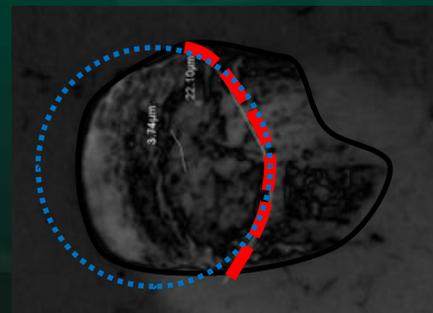
- Cracks (red) tend to form with a radius the same as the probe tip (blue)

Probe Mark from
Long Probe Tip,
no top vias

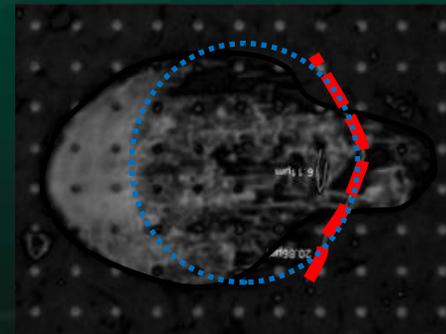
Probe Mark from
Short Probe Tip,
with top vias

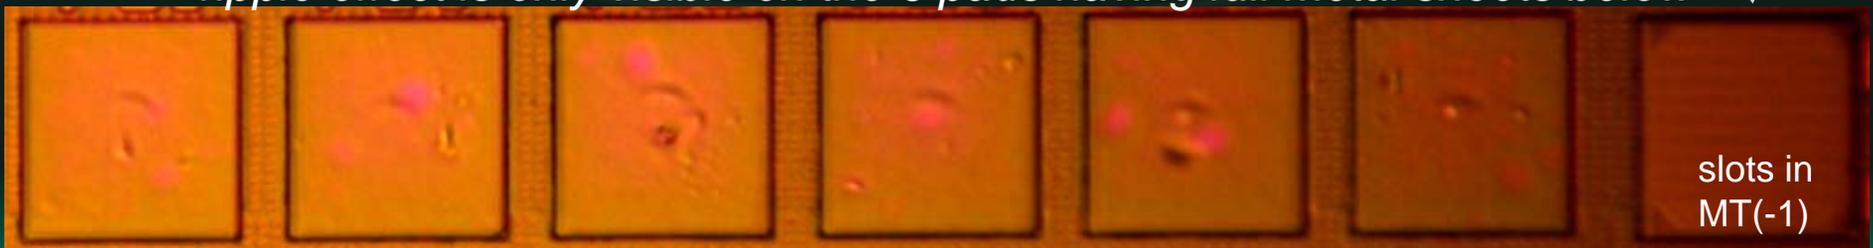
- ripple effect seen in cratering test, due to underlying Al deformation and bending of SiO_2
- (often has the appearance of ripples on a pond)
- the pad on the right has slots in MT(-1): no ripple, and greatly reduced cracking tendency
- ripple effect correlates well with cracking
- ripple is best observed with differential interference contrast (DIC) microscope

ripple effect is only visible on the 6 pads having full metal sheets below

- **Ripple effect from probing is seen “worst” anytime there is a full sheet of metal beneath the pad window**
- **Cracking occurs “worst” anytime there is a full sheet of metal**
 - MT(-1) sheet: largest ripple, and highest % pads cracked
 - MT(-2) sheet, missing or pattern in MT(-1): reduced ripple, and order of magnitude fewer pads cracked
 - MT(-3) sheet, missing or pattern in MT(-1, -2): further reduced ripple, and another order of magnitude fewer pads cracked

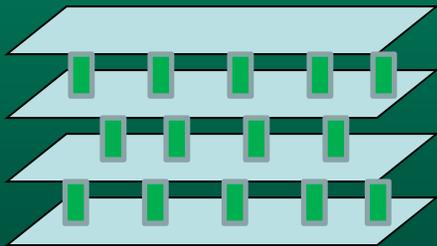
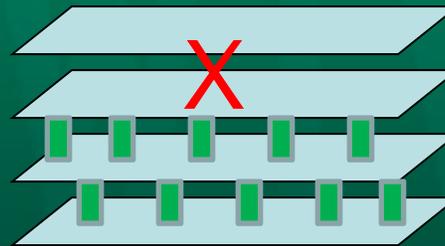
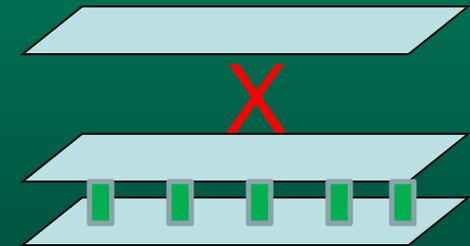
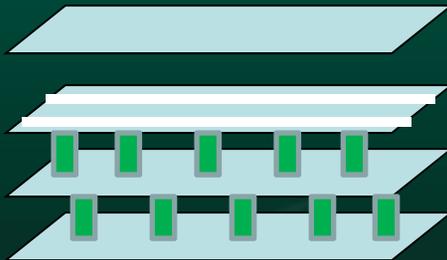
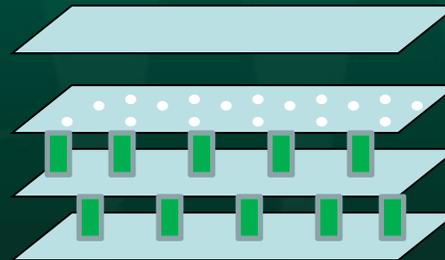
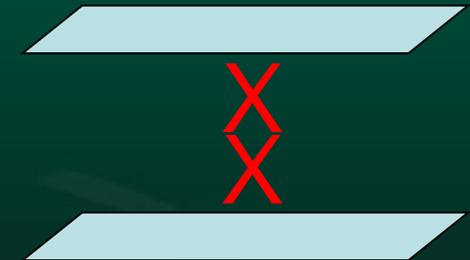
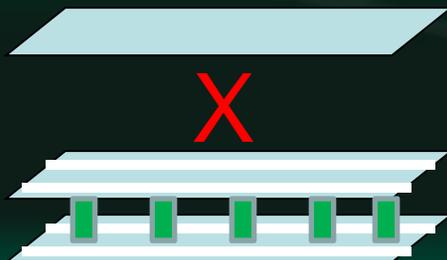
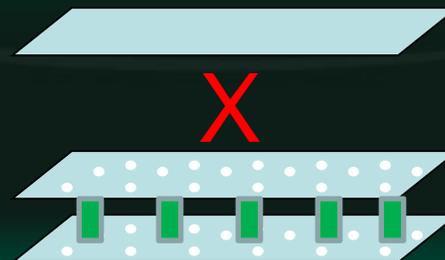
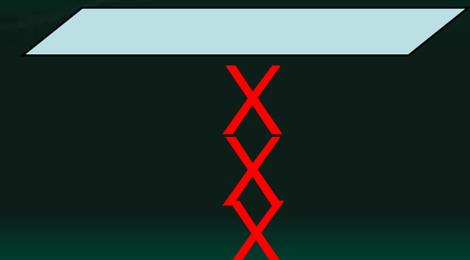
Summary Bond Pad Structure Cracking Results: 6 touchdowns at 4mils overdrive

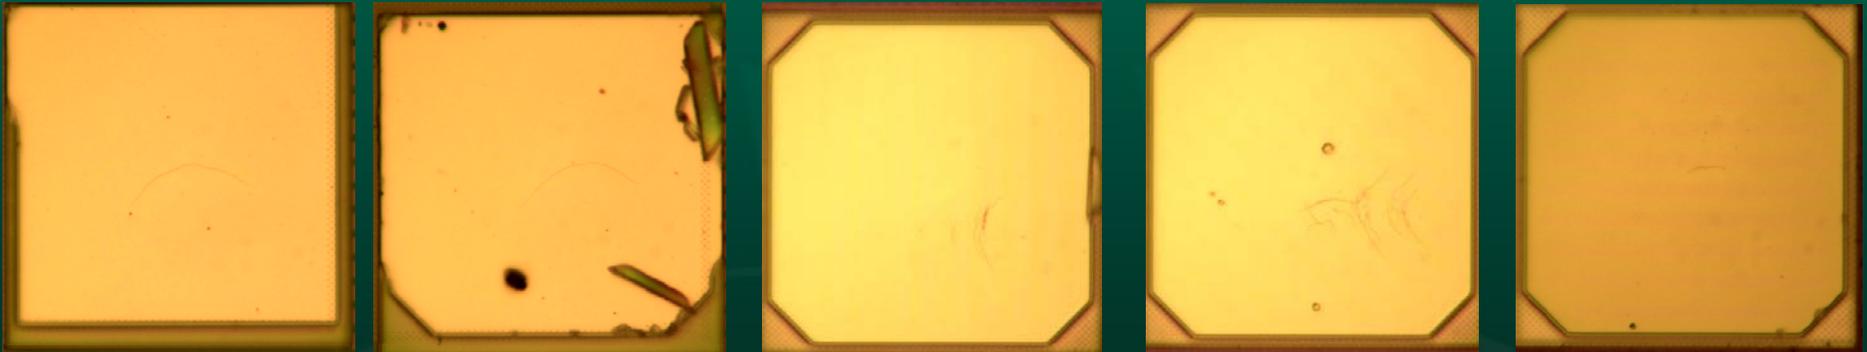
- After cratering test, cracks are visible in the TiN barrier
- MT(-1) patterns can be seen, after removal of pad Al and TiN barrier film

Cracks visible after cratering test on various design examples

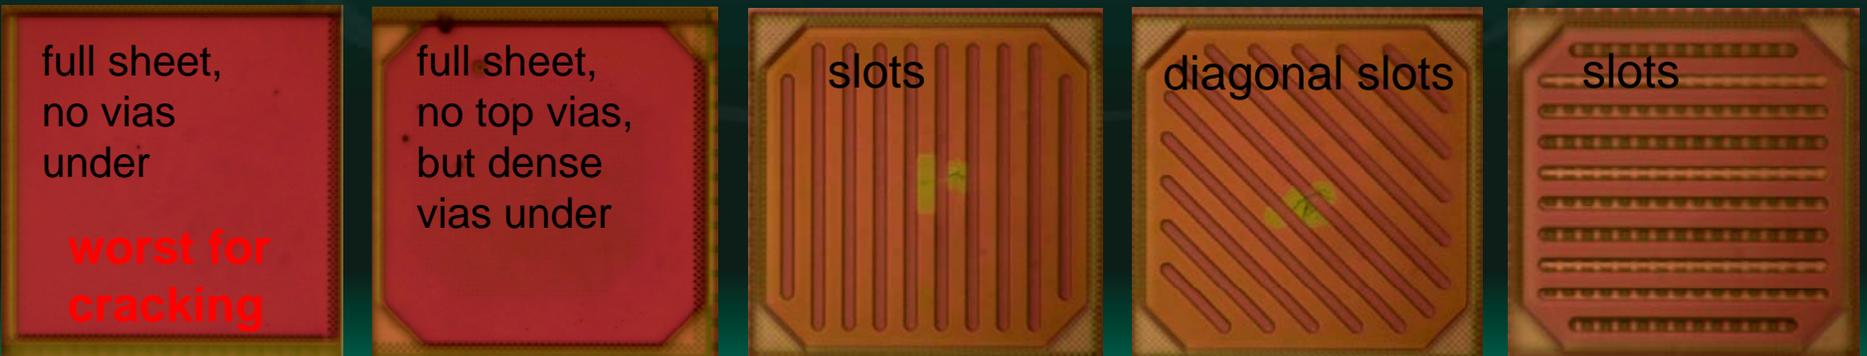
Extra cratering etch reveals MT(-1) patterns (not the same pads as above)

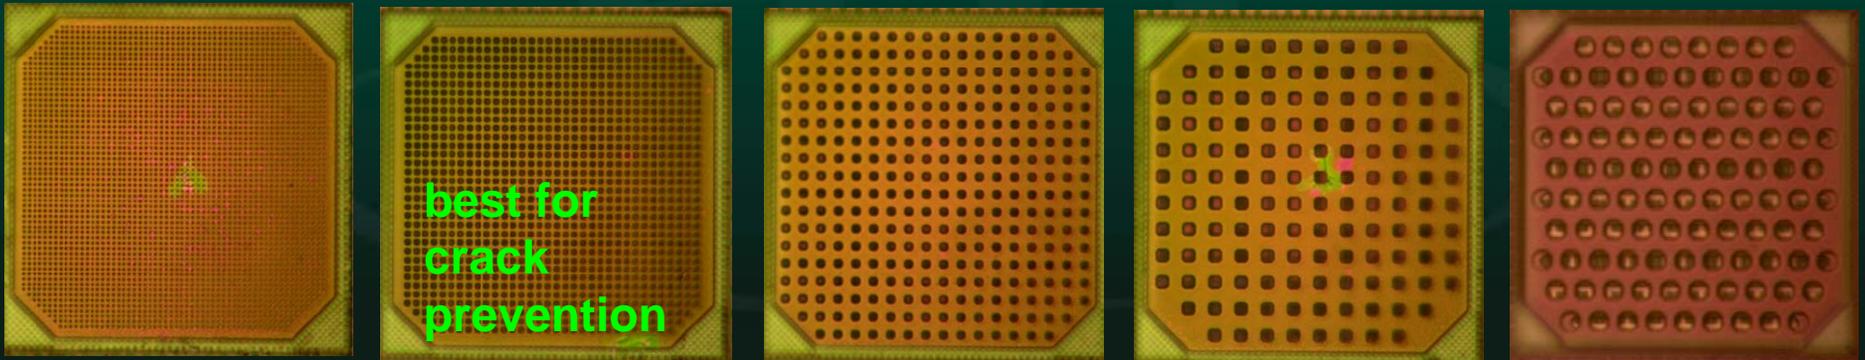
- More MT(-1) patterns can be seen, after removal of pad Al and TiN barrier film

Various MT(-1) patterns: arrays of holes

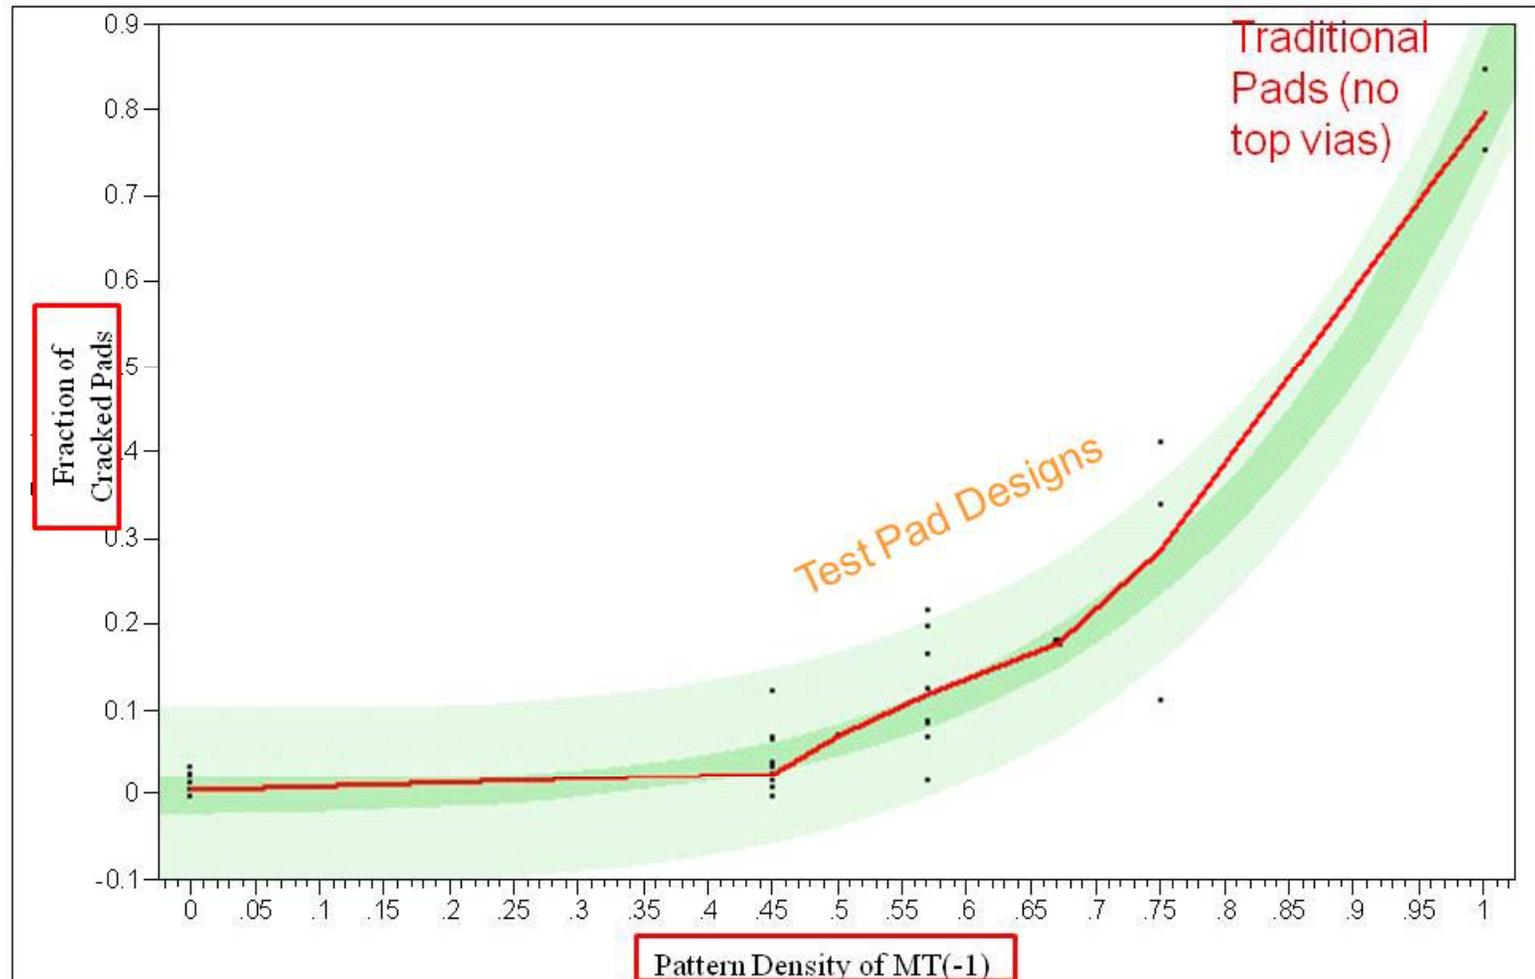
Fraction of Cracked Pads vs. Metal Pattern Density of MT(-1)

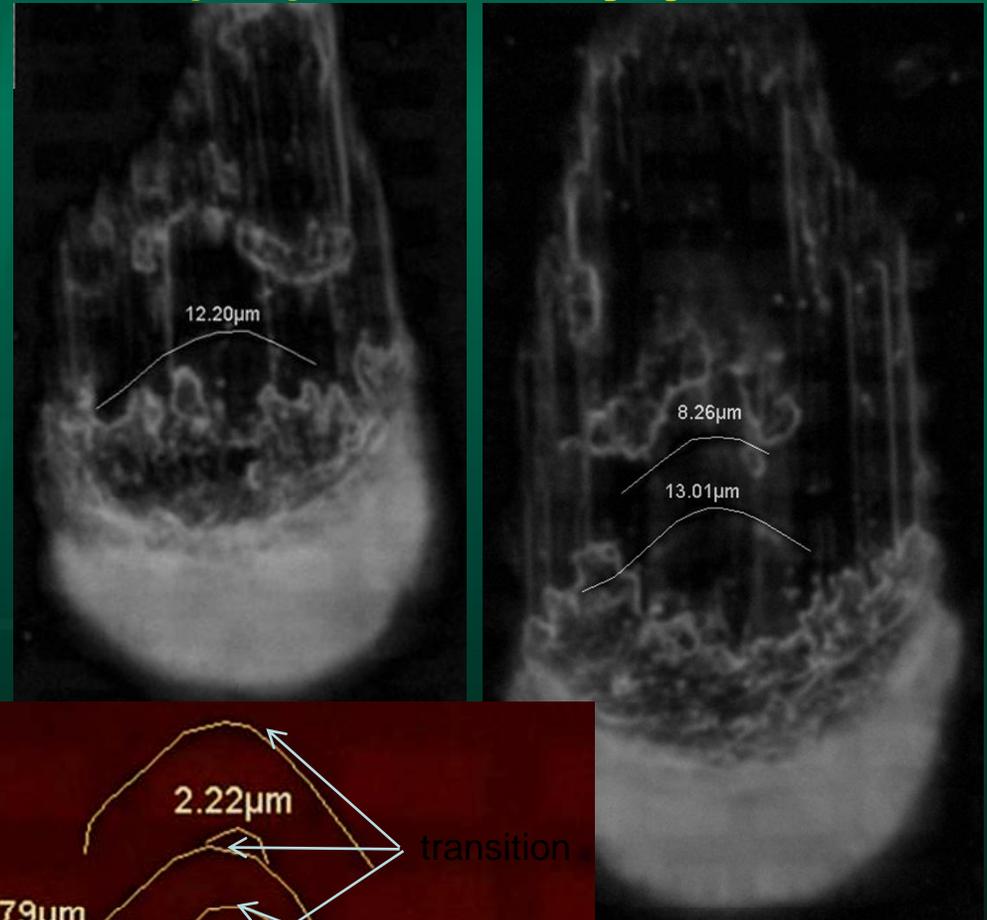
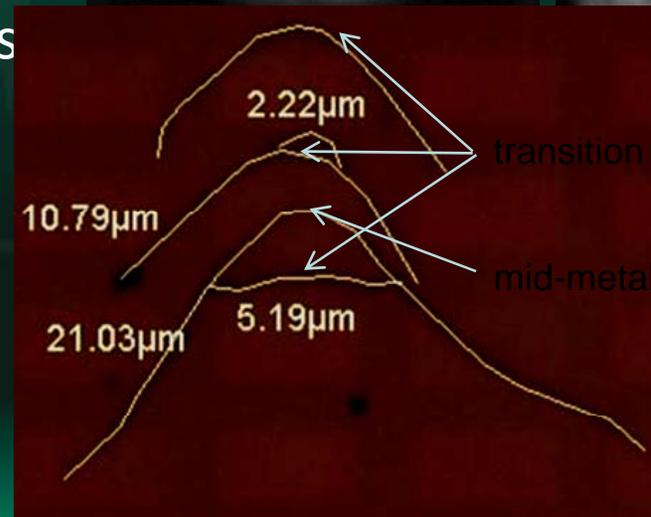
- cracks from harsh probing with dummy fill pattern in MT(-1)
- cracks initiate at the transition of space to metal
 - (the pattern is very difficult to see in photos but this interaction is observed routinely)

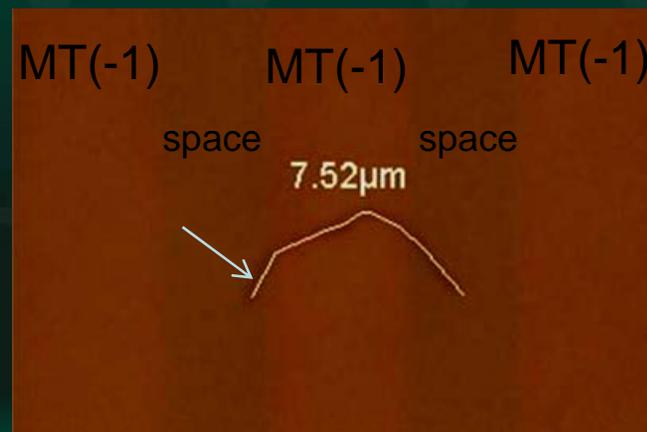
- crack initiates above the metal (light orange)
- crack propagates normally until the edge of the metal
- propagation in the “space” changes direction
 - tends to be more parallel to the metal edge

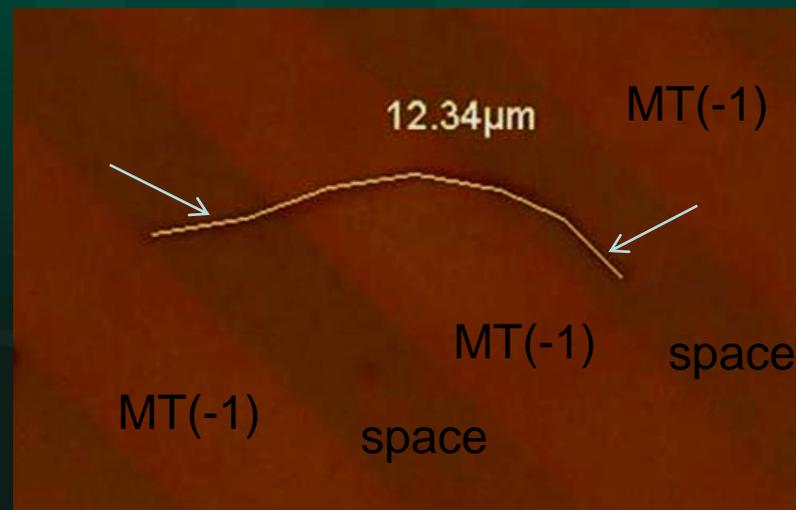
- crack initiates above the diagonal metal (light orange)
- crack propagates normally until the edge of the metal
- propagation in the “space” changes direction
 - tends to be either perpendicular or parallel to the metal edge

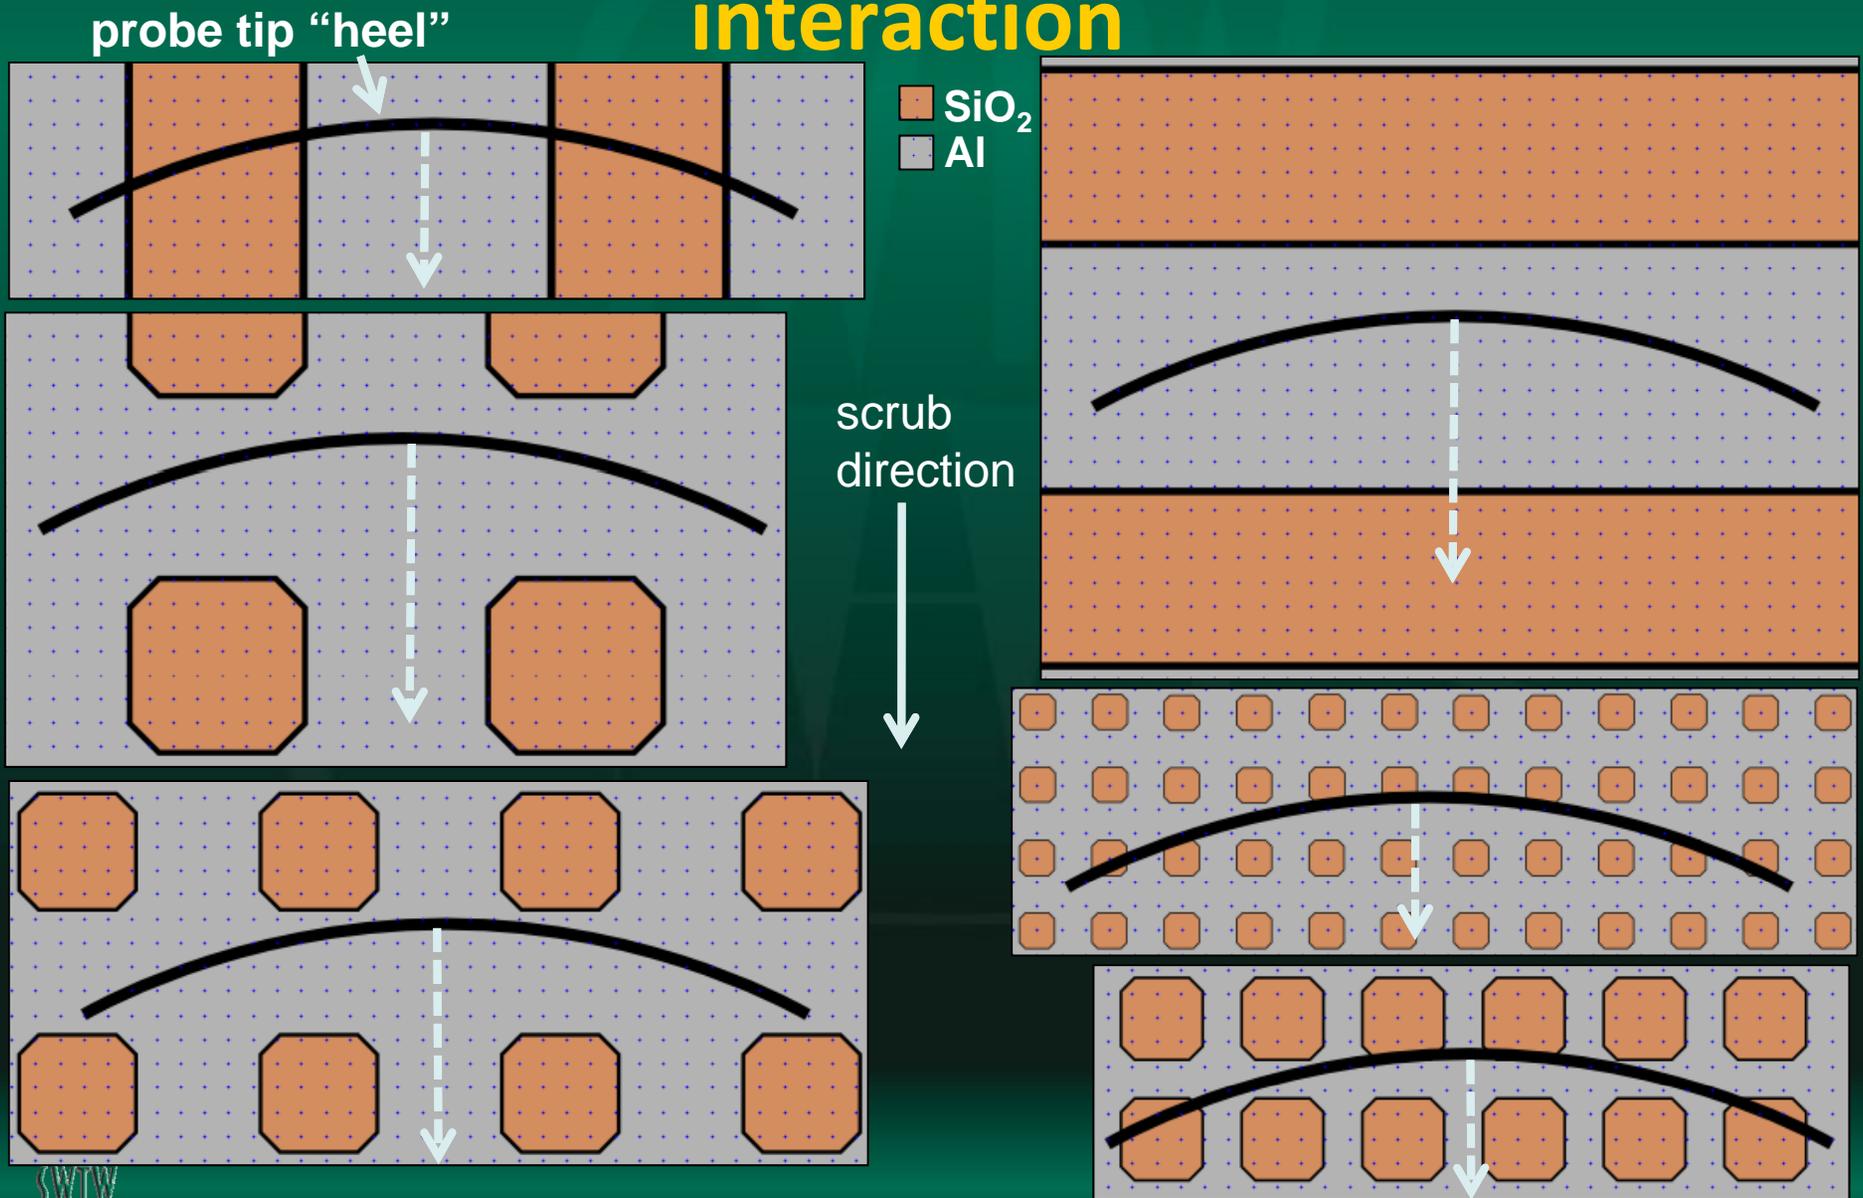
illustrations to explain probe-pattern interaction

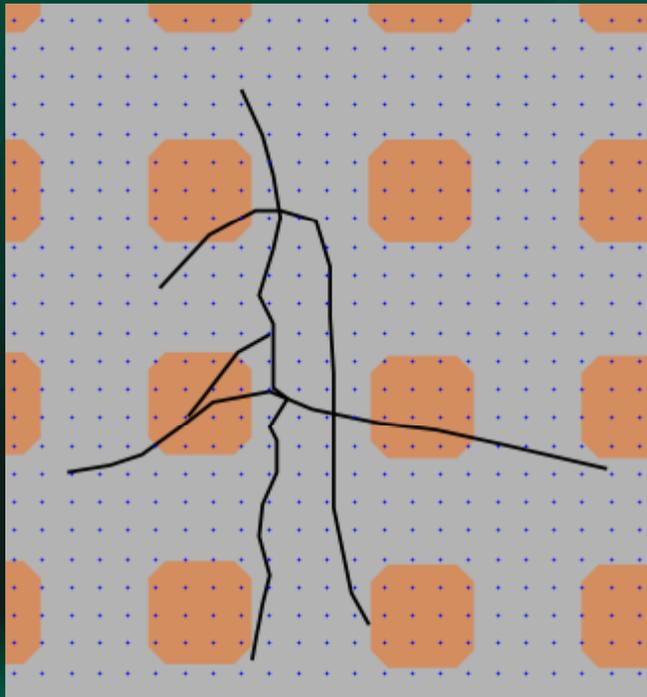
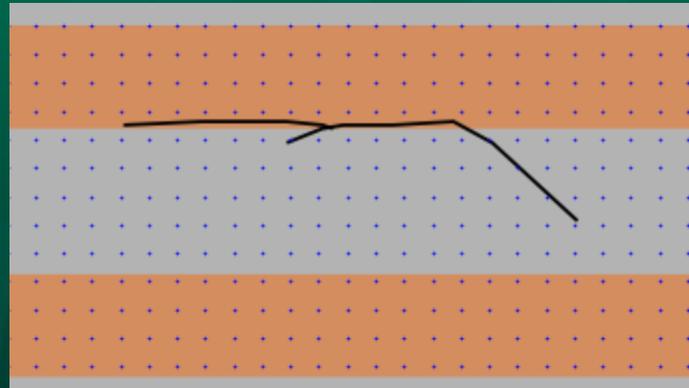
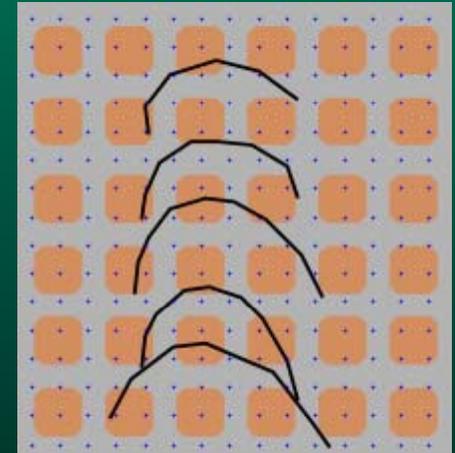
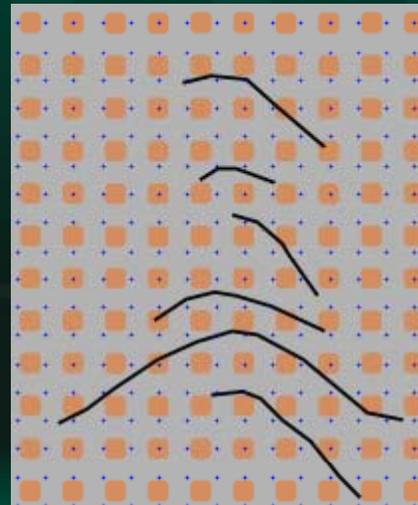
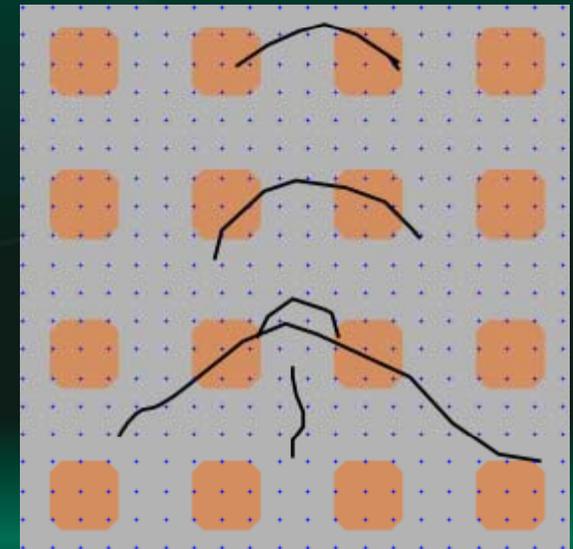
Illustrations to show actual crack interaction with MT(-1) patterns

■ SiO₂
■ Al

scrub
direction
