IEEE SW Test Workshop

Use of Harsh Wafer Probing to Evaluate various Bond Pad Structures

ON Semiconductor, Pocatello, ID

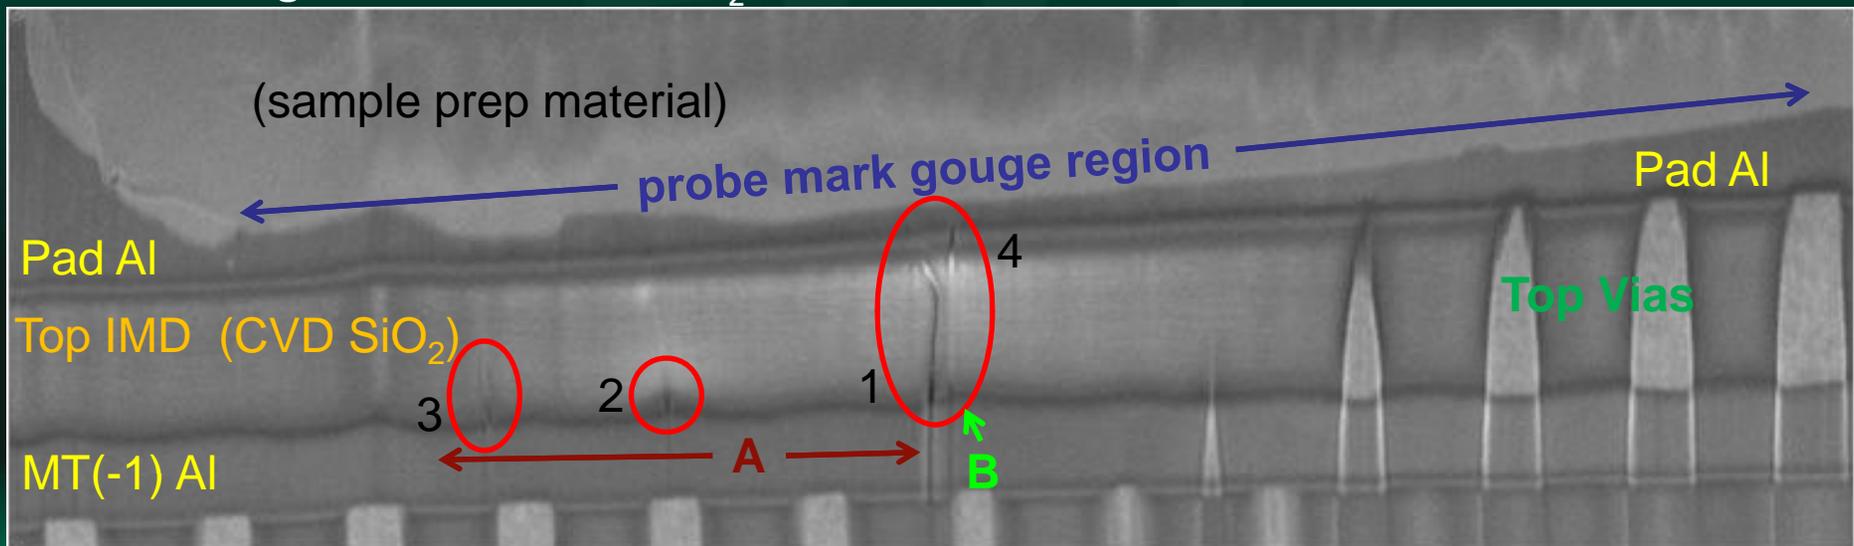
Proposed crack mechanism

1. region A films in compression during probe scrub

- cracks 1, 2, 3 initiate at bottom of SiO₂ film from high tension as SiO₂ bends in a “u” shape following the temporary Al “valley” in MT(-1)

2. location B becomes a local maximum in MT(-1) Al thickness due to continued probe scrub action

- crack 4 initiates at top of SiO₂, cracking the pad barrier with it, due to high tension as the SiO₂ bends over the Al “hill”

- 1.) A predominantly downward force from the probe causes the pad Al to undergo plastic deformation (the probe mark) when its yield strength is exceeded (Al is weak in compression).

- 2.) Some of the probe stress reaches the top dielectric and any top vias in the vicinity.
- 3.) The SiO₂ will compress elastically like the Al, having a similar elastic modulus, but the W vias will not due to the much higher elastic modulus, resulting in extra local stress within the SiO₂ at the top via positions. SiO₂ is strong in compression and would not be expected to yield (crack) from the downforce unless it is allowed to bend.

- 4.) Probe stress that reaches the MT(-1) will compress the Al elastically (and plastically if high stress) into a local “valley” (with local “hills” forming nearby due to the displaced Al material). The deforming Al of MT(-1) is expected to absorb the majority of the stress such that any films below it will not be deformed.

- 5.) SiO₂ top dielectric bends into the “valley” of compressed MT(-1) Al, and a crack will easily initiate at the bottom due to the high tensile stress at that surface.

- 6.) The crack or cracks may then propagate upwards in the SiO₂ during probing or in later processing or thermal cycling, breaking the upper SiO₂ surface and the TiN barrier to become visible in a “cratering test”.
