June 12 to 15, 2011  
San Diego, CA

# The Development of a Flexible and Efficient Chip Thermal Imaging Capability

Marc Knox,  
Chenzhou Lian,  
Alan Weger,  
Xiaojin Wei,  
IBM

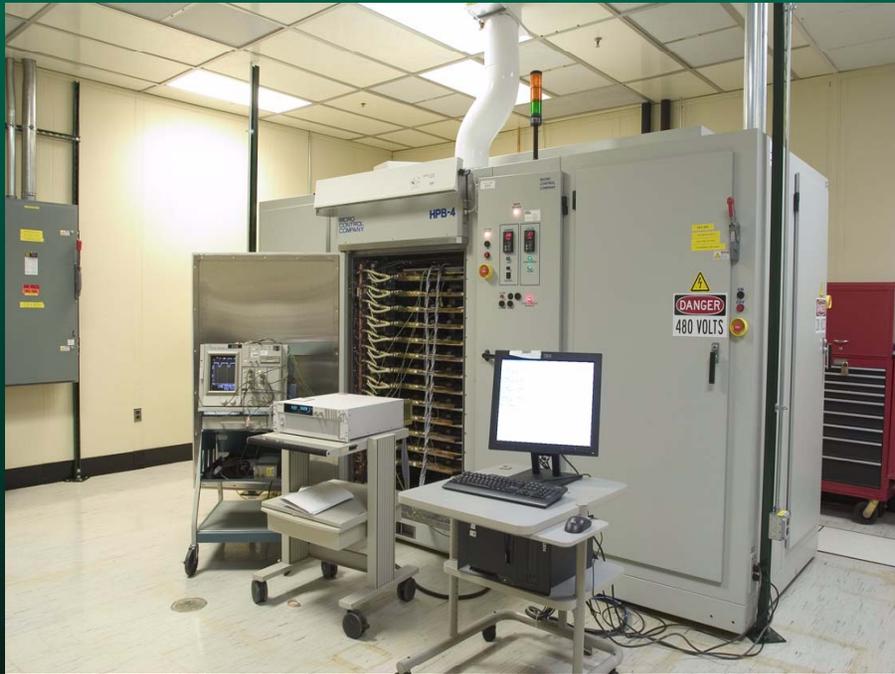
Figure 3-3. Simplified Side View of System

## Production Burn-In Tool

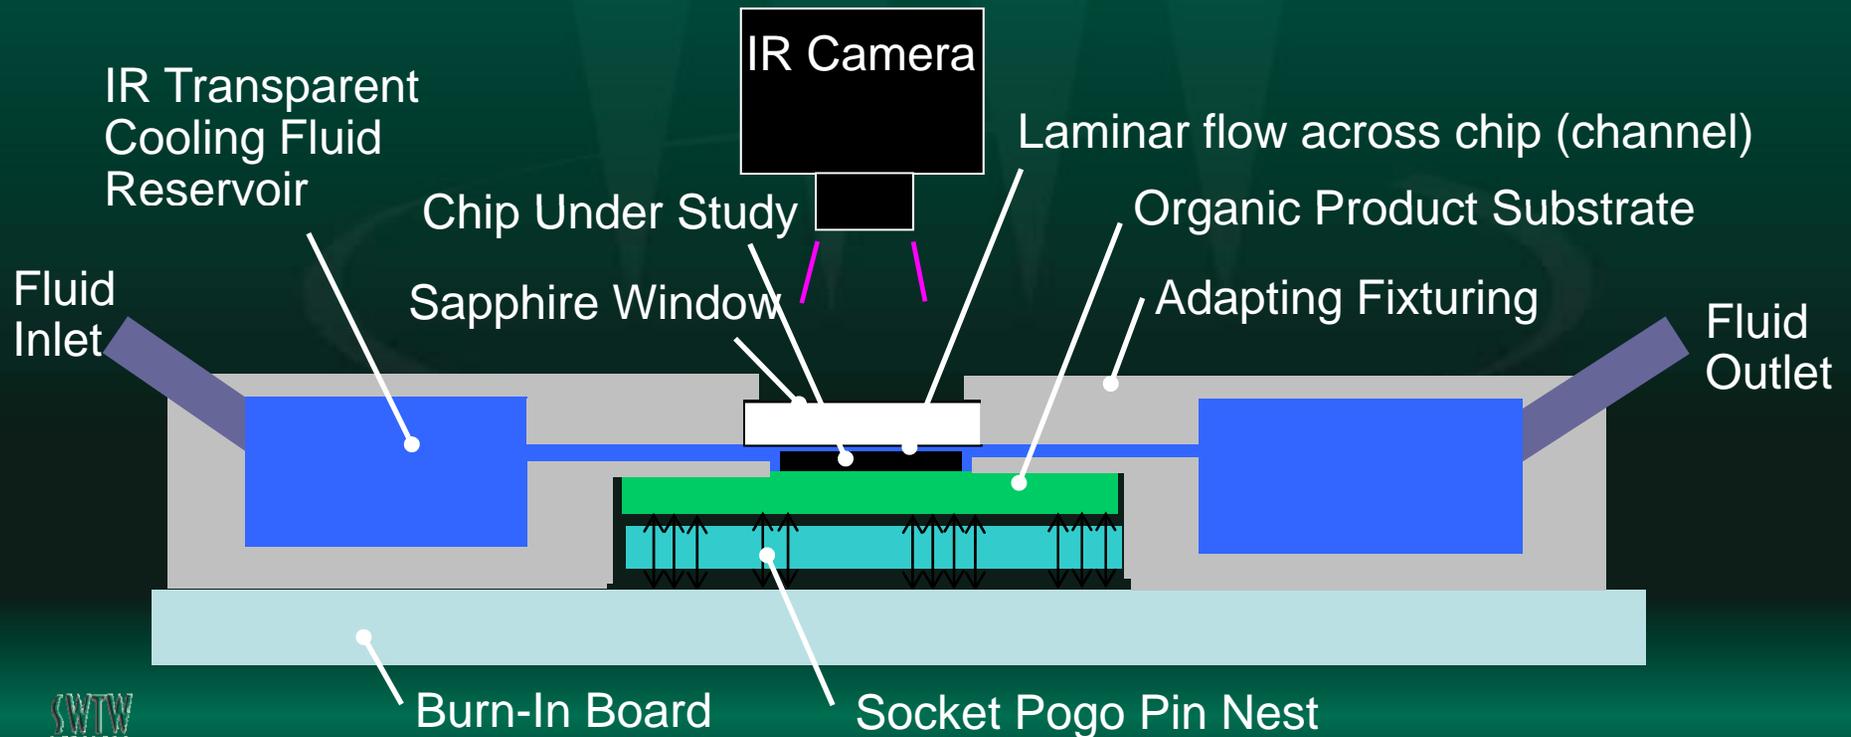
# Thermal Imaging Hardware Concept

- Modified screener
  - Parts face up, sink array modified for IR cooling and camera access
  - Socket modified to accommodate IR cooling
  - Sapphire (IR transparent) window on top of chip with cooling fluid flowing between the chip and the window
  - Objective is uniform laminar flow, Cooling fluid = FC77
  - Camera mounted above and looking down at chip

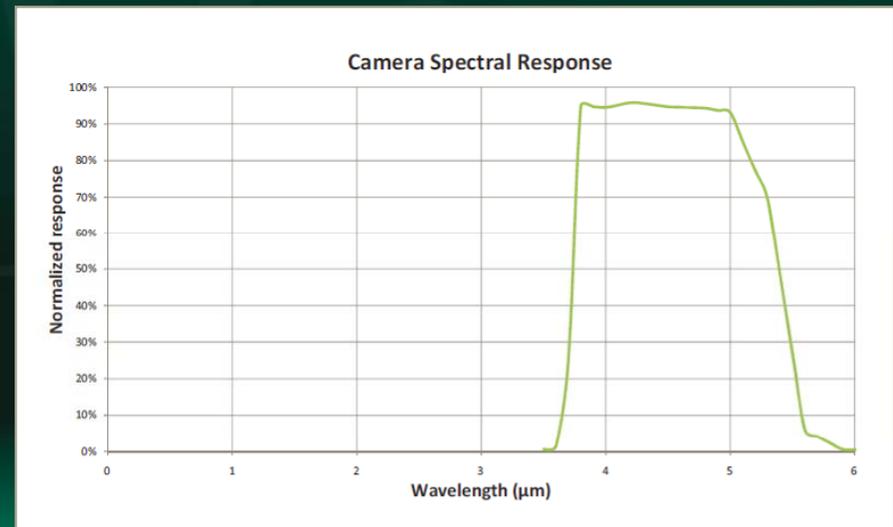
# Camera Description

- Camera Type: FLIR SC7600BB
- Lens: 25 mm, G1, and G3

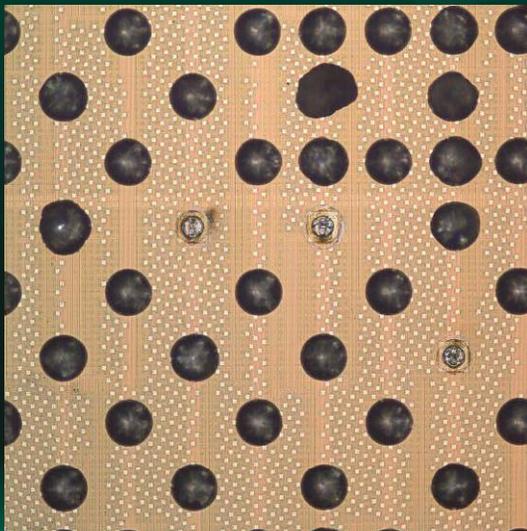
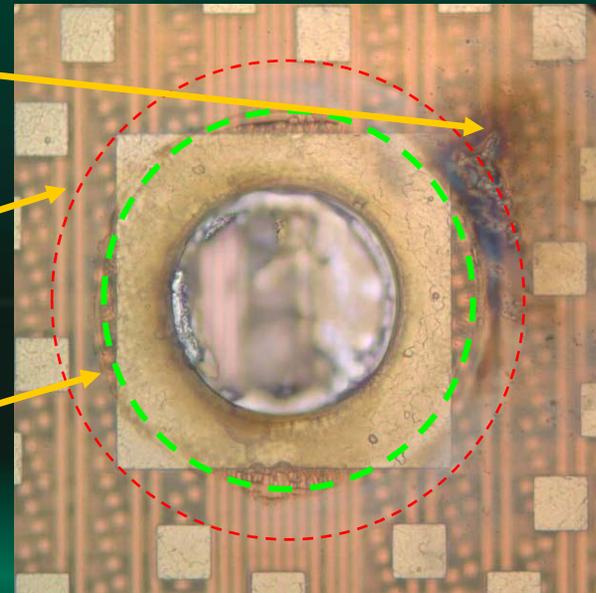
Optical images of pull-out sites:

Polyimide  
burned/charred

Original  
footprint  
of Ni

Original  
footprint  
of TiW

- C4 “pullouts” being seen primarily at the wafer test sector
- A C4 Pullout is loosely defined as a C4 that detaches from the underlying metallurgy after probing
  - Very low percentage of chips overall but large number of wafers impacted
  - Chips and Probes being Damaged, Impacts to yield and productivity

Highly Localized, Self Limiting Thermal  
Runaway - Pwr/Gnd Bumps and underlying  
metallurgy destroyed

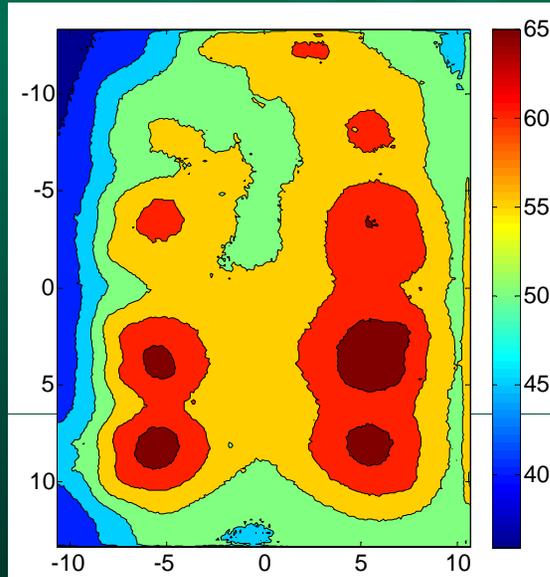
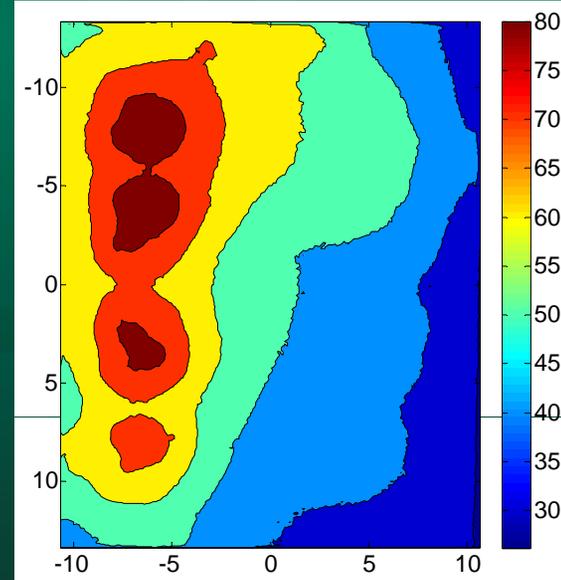
Control Chip @  
Nominal Voltage  
+300mV, ~70W

Coolant Flow

- **Control/normal part indicates variation due to coolant flow (known issue) but all of the cores have relatively even heating indicating well distributed power density**
- **Entire outer edge of the suspect die (labeled hot die) shows high power density corresponding to the outer edge of the wafer**
- **Hotspot is regional in nature, it is not from a single spot**
  - the entire end of the chip lights up, two end cores and the MC
- **Same base power (70W) but large cross chip variation on the suspect part**
  - >90C core to core delta on the suspect part vs. 20C on control
- **Results clearly confirm prior root cause hypothesis and matches with prior supporting evidence and conclusions**
  - Results NOT indicative of a small area defect nor a point defect

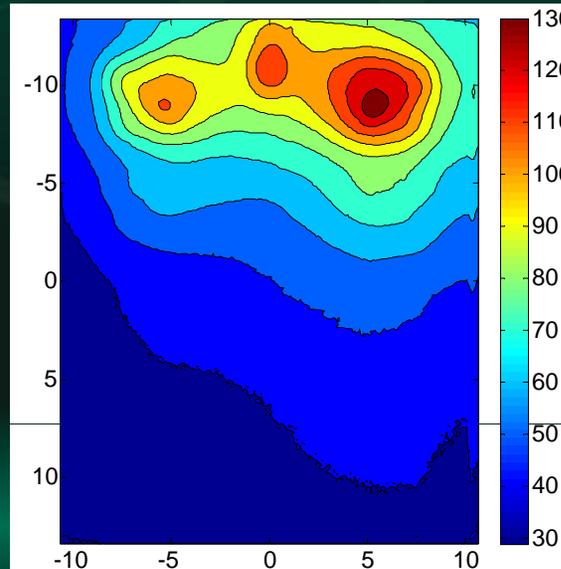
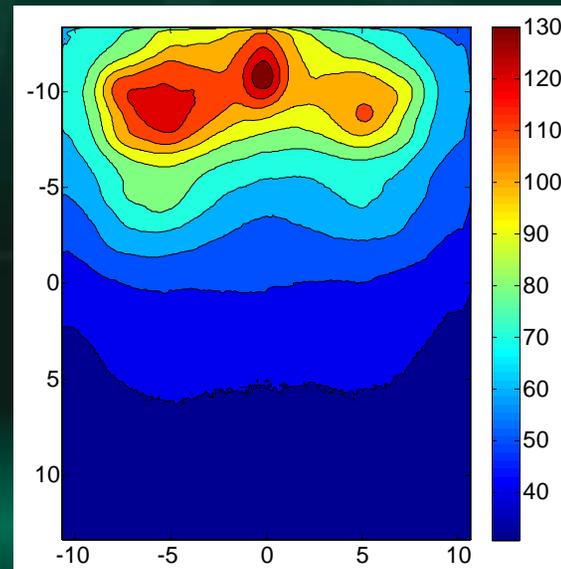
Suspect Chip  
@ Nominal  
Voltage ~70W

Coolant Flow
