Semiconductor Wafer Test Workshop

June 8 - 11, 2014 | San Diego, California

3D TSV Cu Pillar Probing Challenges & Experience

Ray Grimm/Mohamed Hegazy

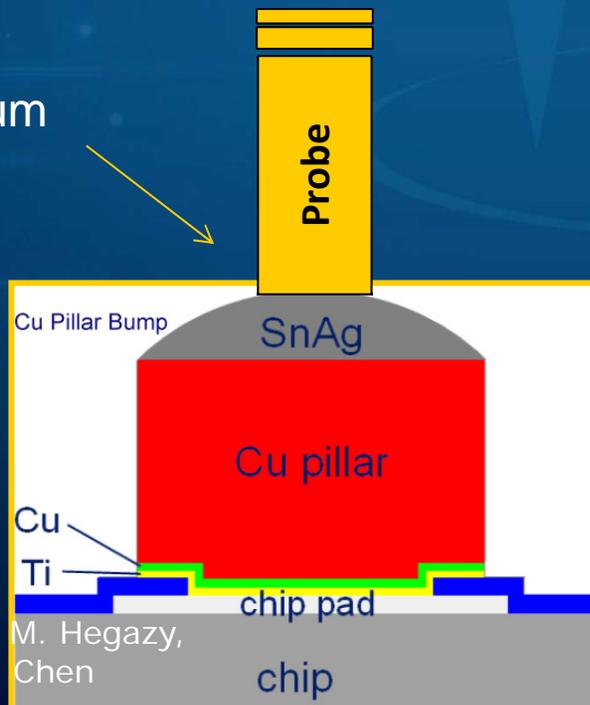
Optimum

Bump shear tests were performed as per the JEDEC standards (JEDEC22-B117).

For Bump Shear Test, the wedge force at 20%~30% of Total Height of Pillar
Eg. TH= 80 μ m, shear test start at 25 μ m & the other to solder cap at 70 μ m.

After the shear test was complete, the next step is for TCT Thermal Cycle for 1000 cycles, and results were observed to be passing. If the geometry is not optimized then fractures will show up on the stress points. Same concept was performed if probing on 2 different conditions...

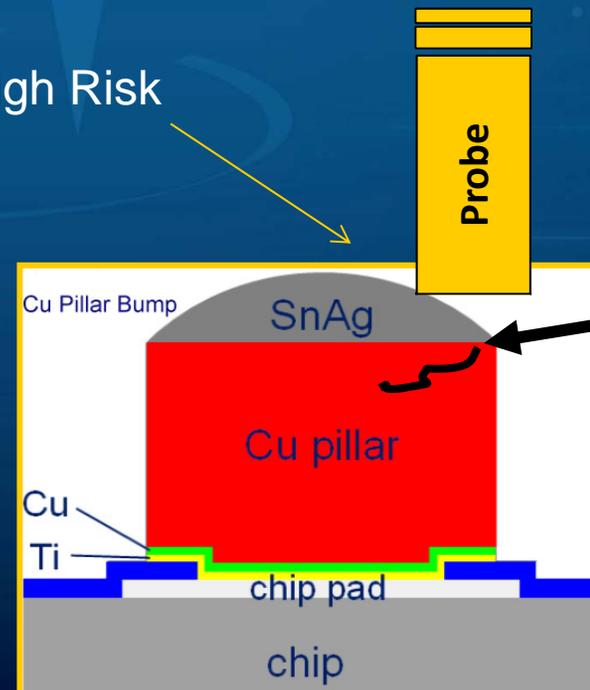
High Risk

shear force apply on stress point.

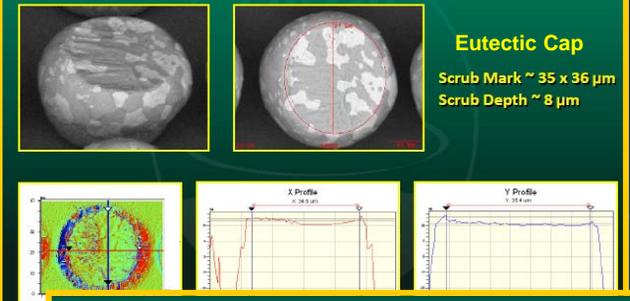
Scrub Marks with 36 μ m Tips at 50 μ m OT

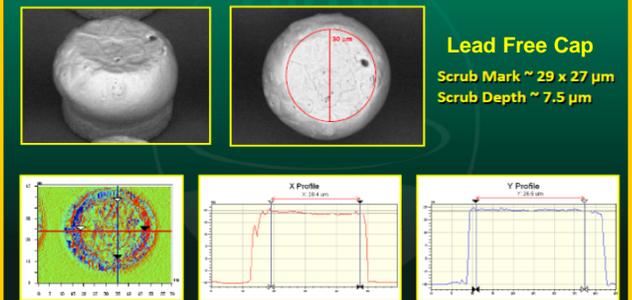
Scrub Marks with 36 μ m Tips at 50 μ m OT

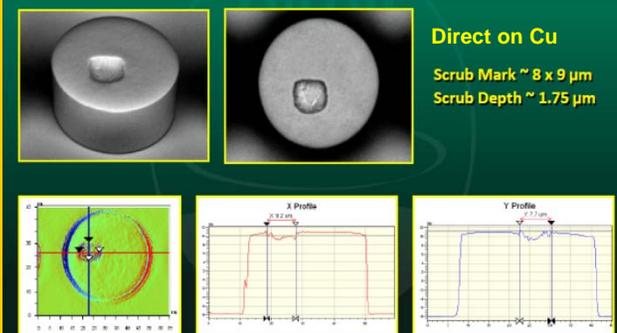
Scrub Marks with 9 μ m Tips at 50 μ m OT

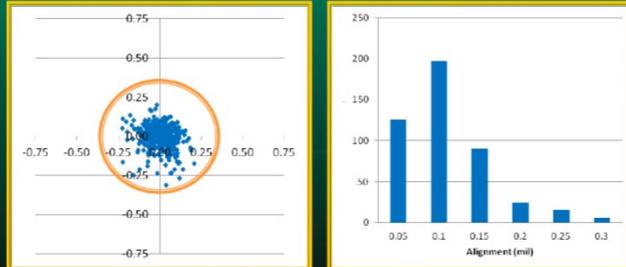
Tip Alignment

- Probe Tip Alignment – 0.3 mil Radial

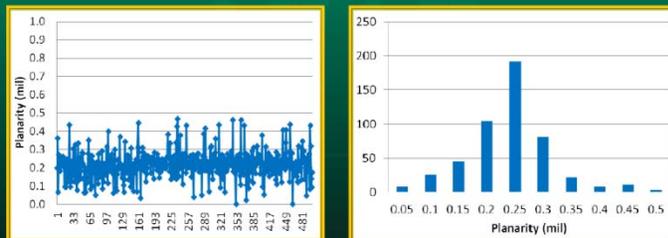
Planarity

- Probe Planarity < 0.5 mil (12 μ m)

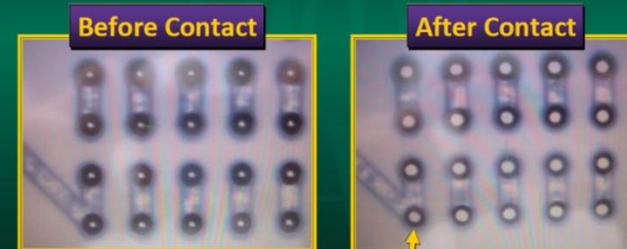
Probe Mark

*Over-Drive: 40 μ m
probing: 2 TDs

Probe Mark Area Under 30%

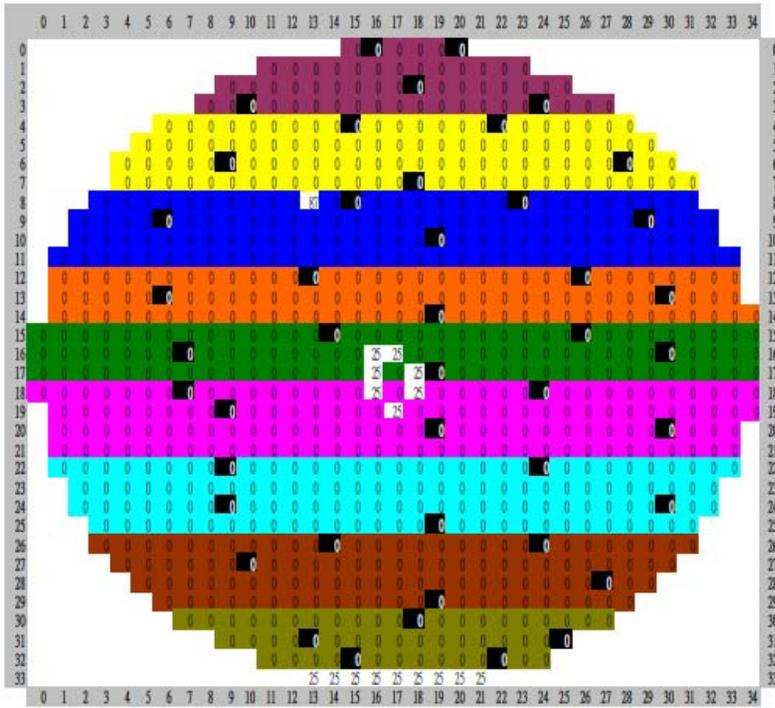
5 die per each area

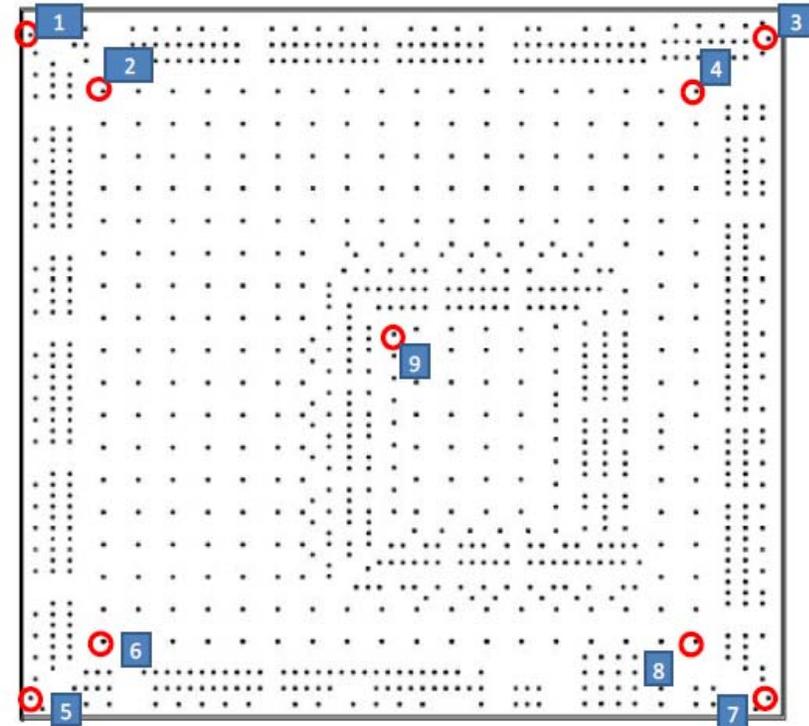
9 bump per each die

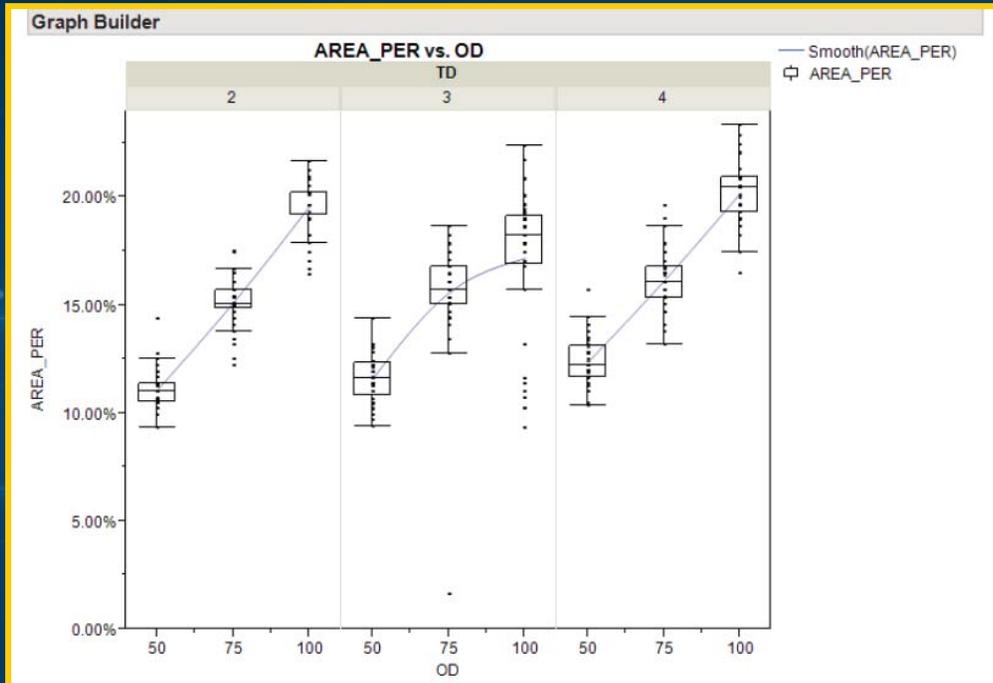
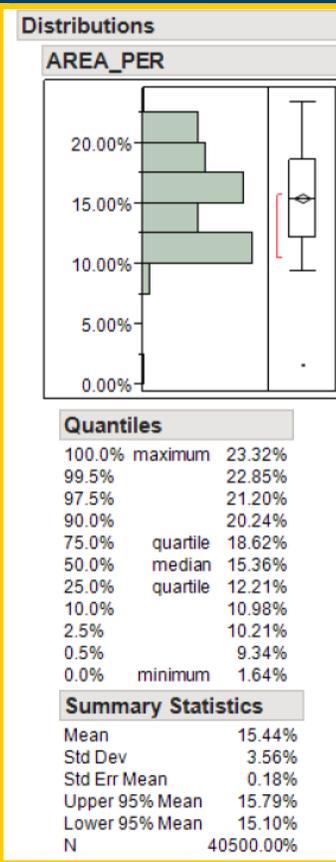
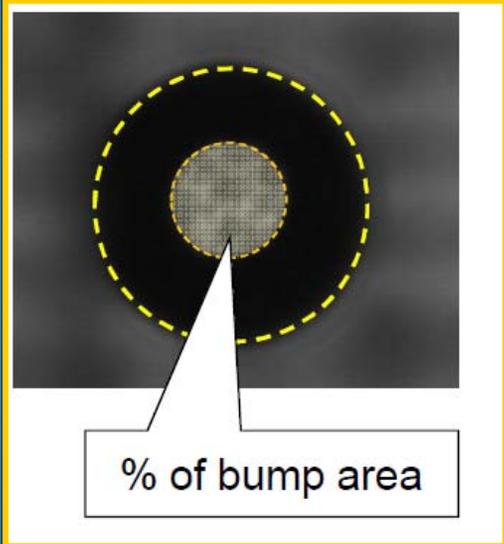
Probe Mark Size Analysis

Probe mark related to OD strongly than TD

Probe mark range is 1.64%~23.32%

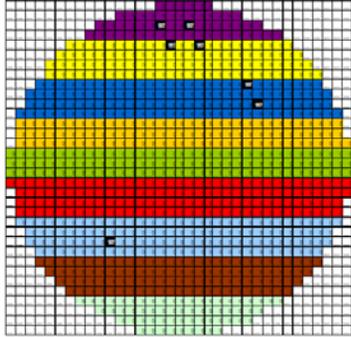
Before DOE

Robotic vision bump inspection system

•No missing bump was found before DOE and after DOE

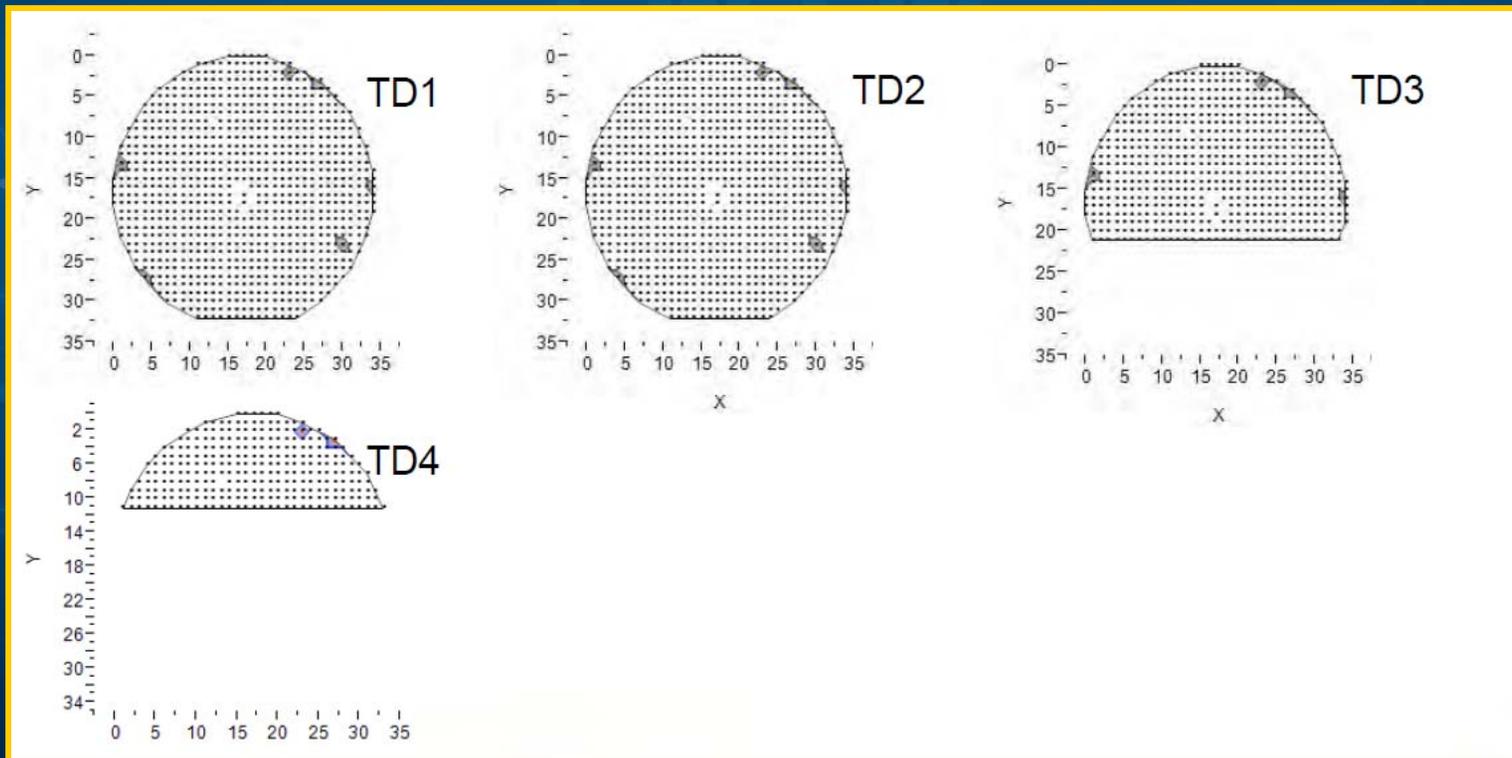
Die Test Results

- No Bin shifting observed
- Stability shown even with increasing TD and OD

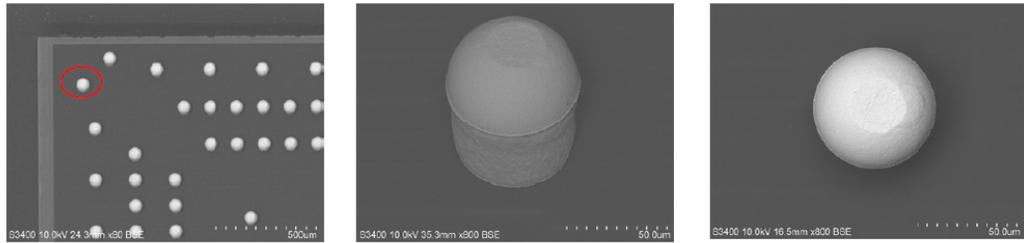
Leg	Unit location X	Unit location Y	Bump location	Probe mark area
C	6	9	1	20.86%

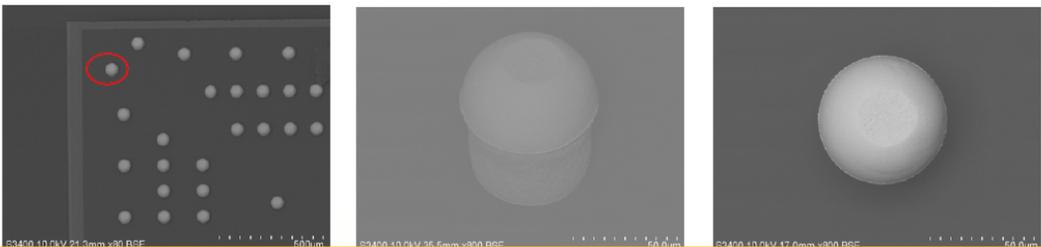
Leg	Unit location X	Unit location Y	Bump location	Probe mark area
F	7	18	1	13.19%

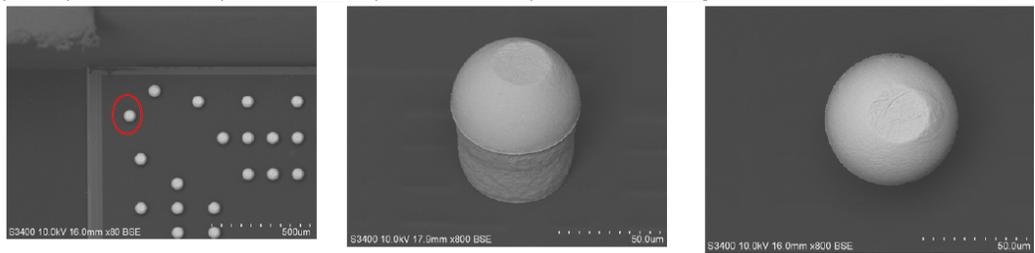
Leg	Unit location X	Unit location Y	Bump location	Probe mark area
I	13	31	1	20.11%

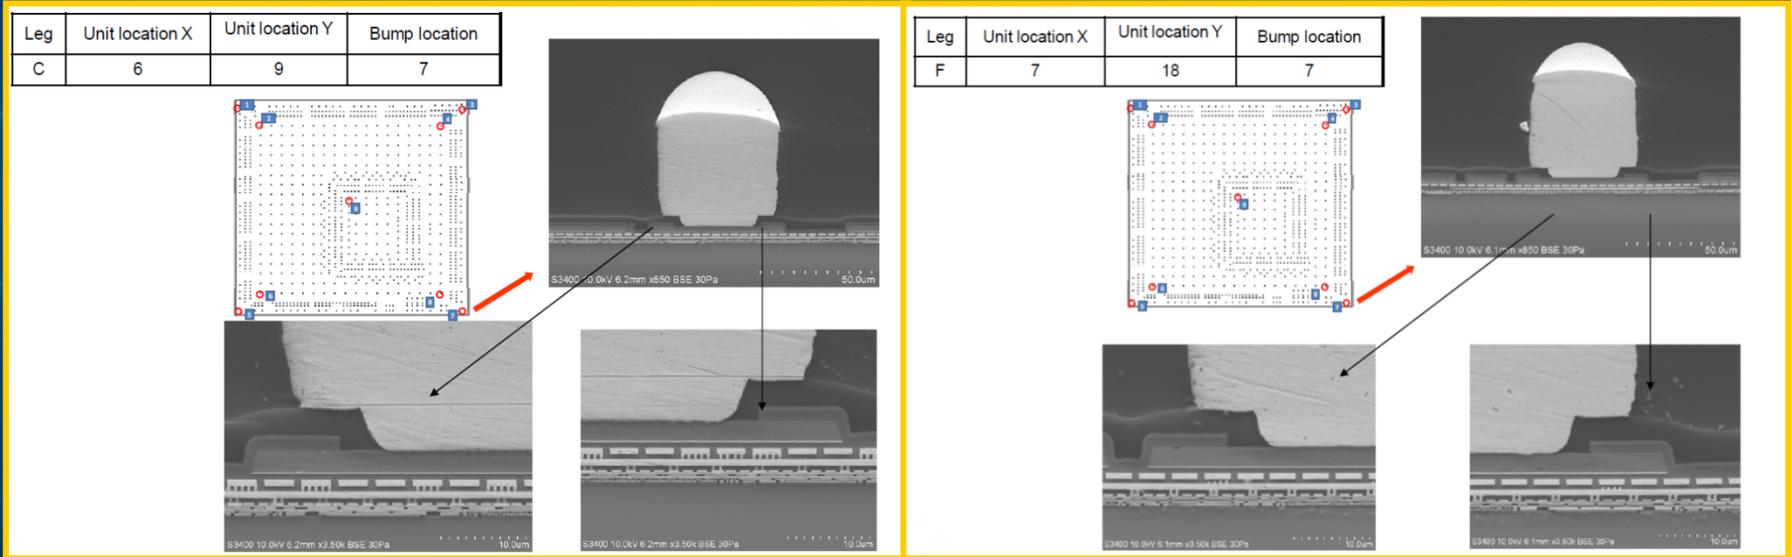
Ion Miller Verification of Low K Layer

- No Low K cracking observed

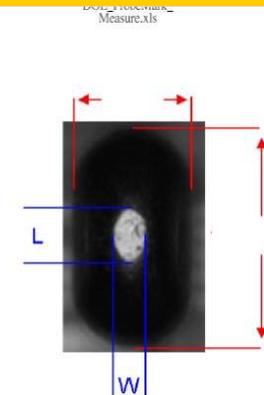
Set probe mark area = probe mark W x L

The ratio of average probe mark area/bump area is pretty low.
