IEEE SW Test Workshop

Cost Effective 1,000V High Voltage Parametric Test Technique

Texas Instruments, Japan

FormFactor, Japan

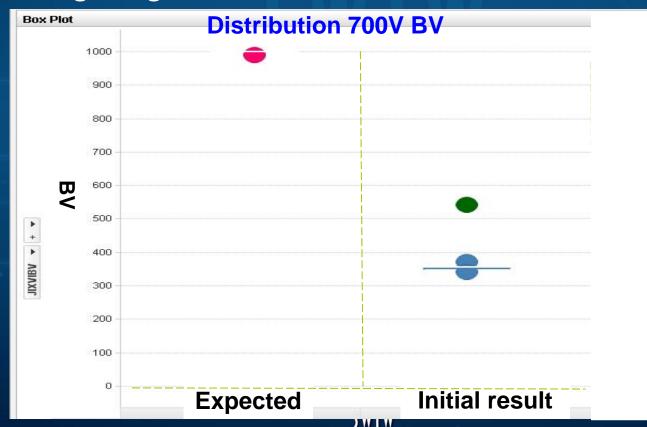
- Conventional Test System
 - Unstable Voltage Measurement Result
 - Voltage Degradation

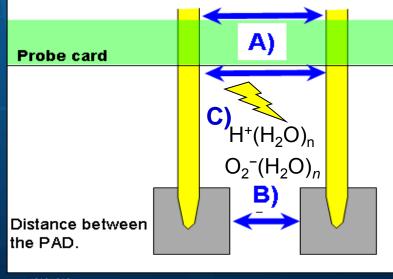
- A) Leak by discharge on surface of the Probe Card.
- B) Leak by discharge on surface of the device.
- C) Atmospheric Humidity

Current Leak through cluster ion formation

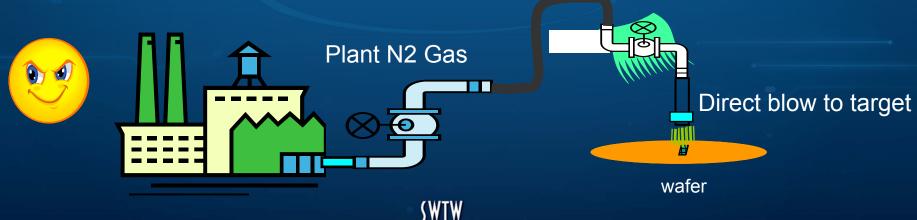
Conventional (Chamber Based) System

Needs a chamber filled with gas

Texas Instruments Miho Idea (Pinpoint)

Chamber Type Prober Conventional System	Dry Gas Purge Probe Card New System
Hardware	Low Temp Chamber Type ProberN2 Gas System	 Nozzle for N2 Gas Probe Card Development for Production Use
Cost	500 (relative to new system)	1
Operation	Wait 20minutes for filling gas	No wait time

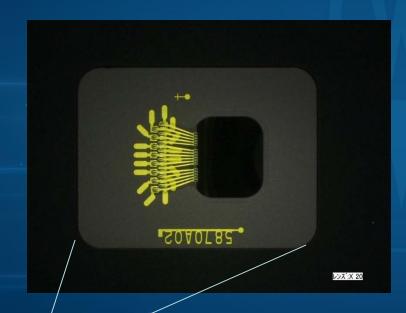
N2 Gas Hole on Ceramic • N2 Gas Mechanical Option

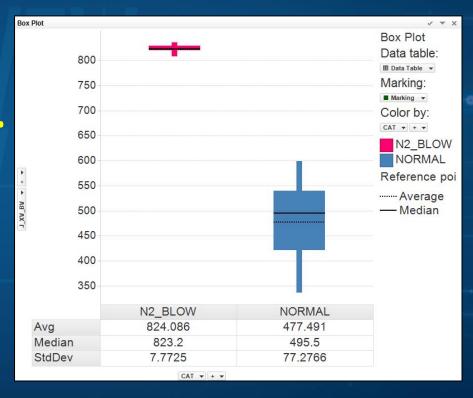
Achieved a stable
 High Voltage
 measurement by
 pinpoint blow system.

No Operation wait time required. High voltage test
N2 Blow vs. Normal(No N2 Blow)

No CDA/N2 Blow	CDA/N2 Blow
High Voltage Test	<600V Standard Deviation 77.27	>800V Standard Deviation 7.77 9.9X Improvement
Leak Test	Standard Deviation 0.067	Standard Deviation 0.005 13.4X Improvement
Cleaning Wafer	Number of Particle 112/wafer	Number of Particle 10/wafer 11.2X Improvement
Cleaning Probe Tip	Al debris stick on probe tip	Remove loose Al Debris on Tip
Contact Resistance	Standard Deviation 3.94	Standard Deviation 0.60 6.5X Improvement

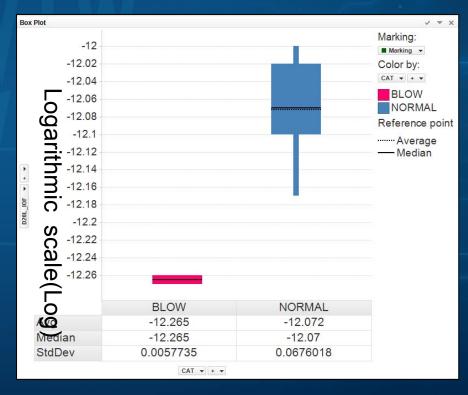
Stable Leak Test Result with N2 blow

Leak test
*CMOS Low voltage element
N2 Blow vs. Normal(No N2 Blow)

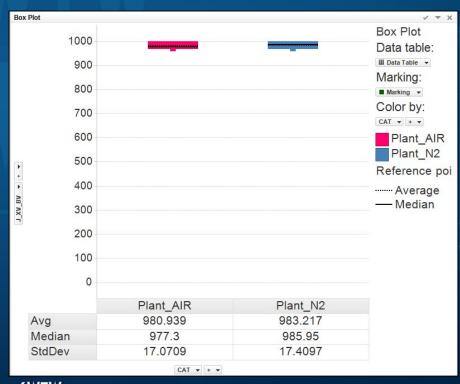
Same distribution for both CDA and N2 Blow.

High voltage test CDA Blow vs. N2 Blow

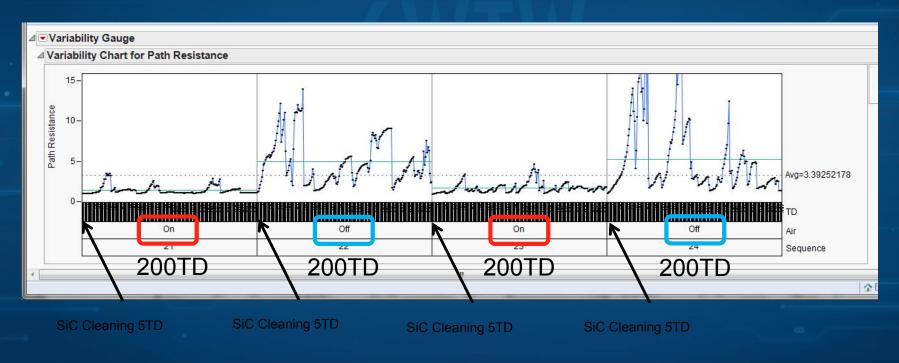
FFI T3 Spring Al Wafer 2Pin Path Resistance Evaluation by CDA On/Off

Verified CDA was effective on FormFactor MicroSpring Cres

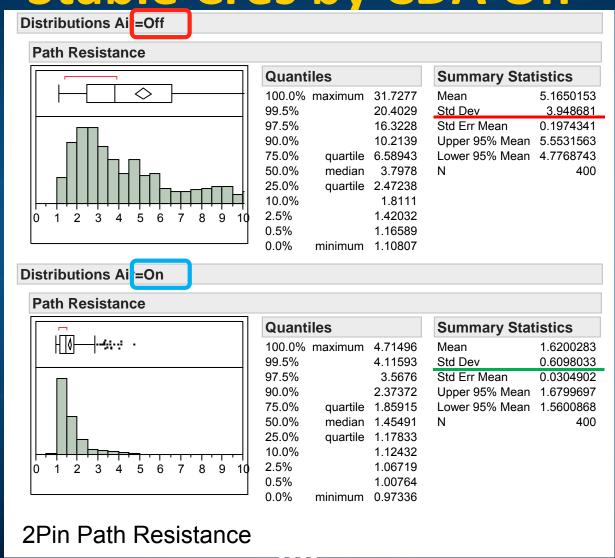
Additional Benefit: Stable Cres by CDA On

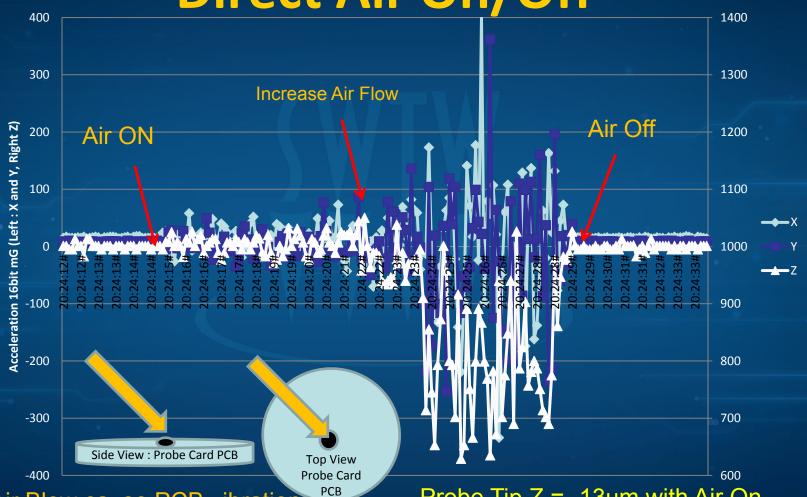
Probe Card PCB Vibration with PCB Direct Air On/Off

Direct Air Blow cause PCB vibration

Probe Tip Z = -13um with Air On
Require Electrical Auto Z Arcing Countermeasure

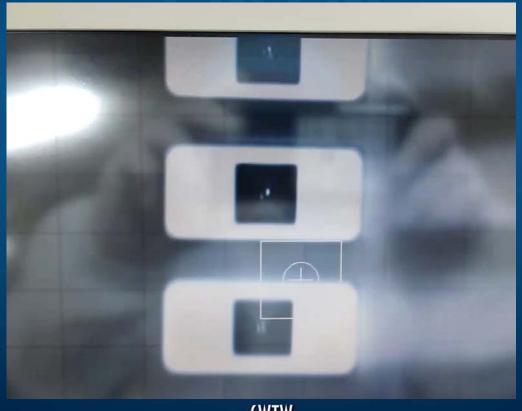
Probe Tip Vibration Video by N2 Flow Rate

N2 Mechanical Option Probe Card Evaluation

• 70L/min

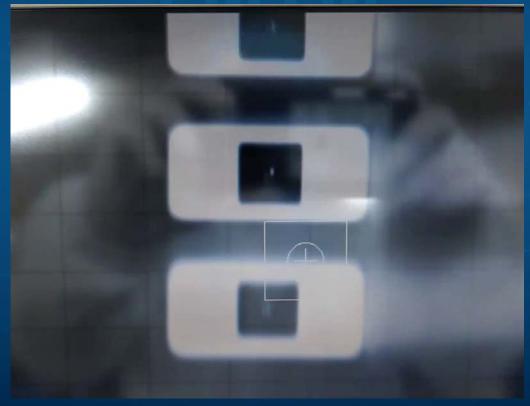
Probe Tip Vibration Video by N2 Flow Rate

N2 Mechanical Option Probe Card Evaluation

• 130L/min

- Vibration Affected Prober Tip Alignment
- No Major Change for Scrub Mark Position
- Need to optimize Flow rate and direction
