SW Test Workshop
Semiconductor Wafer Test Workshop

Effects of Probe Marks on Wirebonding

A tutorial, summarizing work of ON Semiconductor and BYU-Idaho since 2010

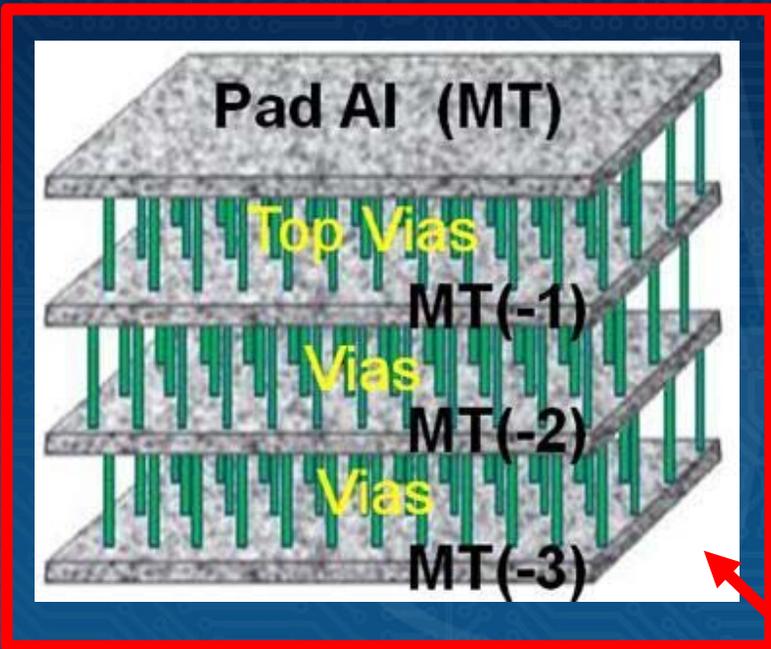
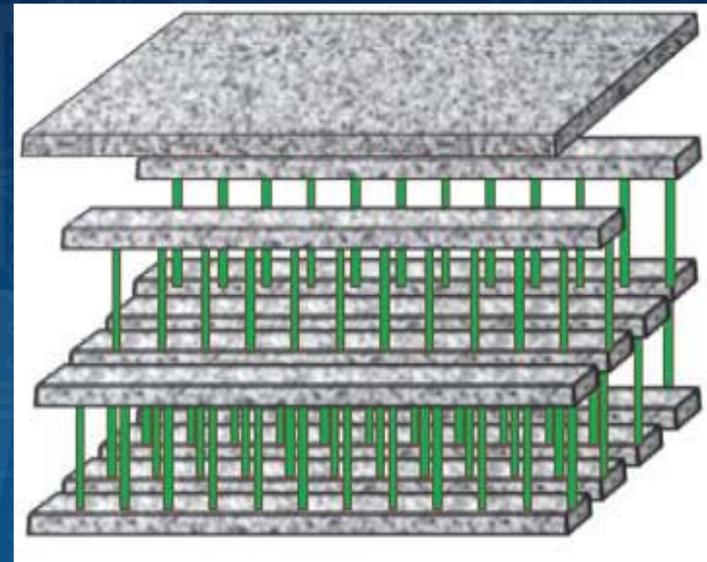
Bond Pad Structure Examples

Traditional Bond Pad is structurally weak

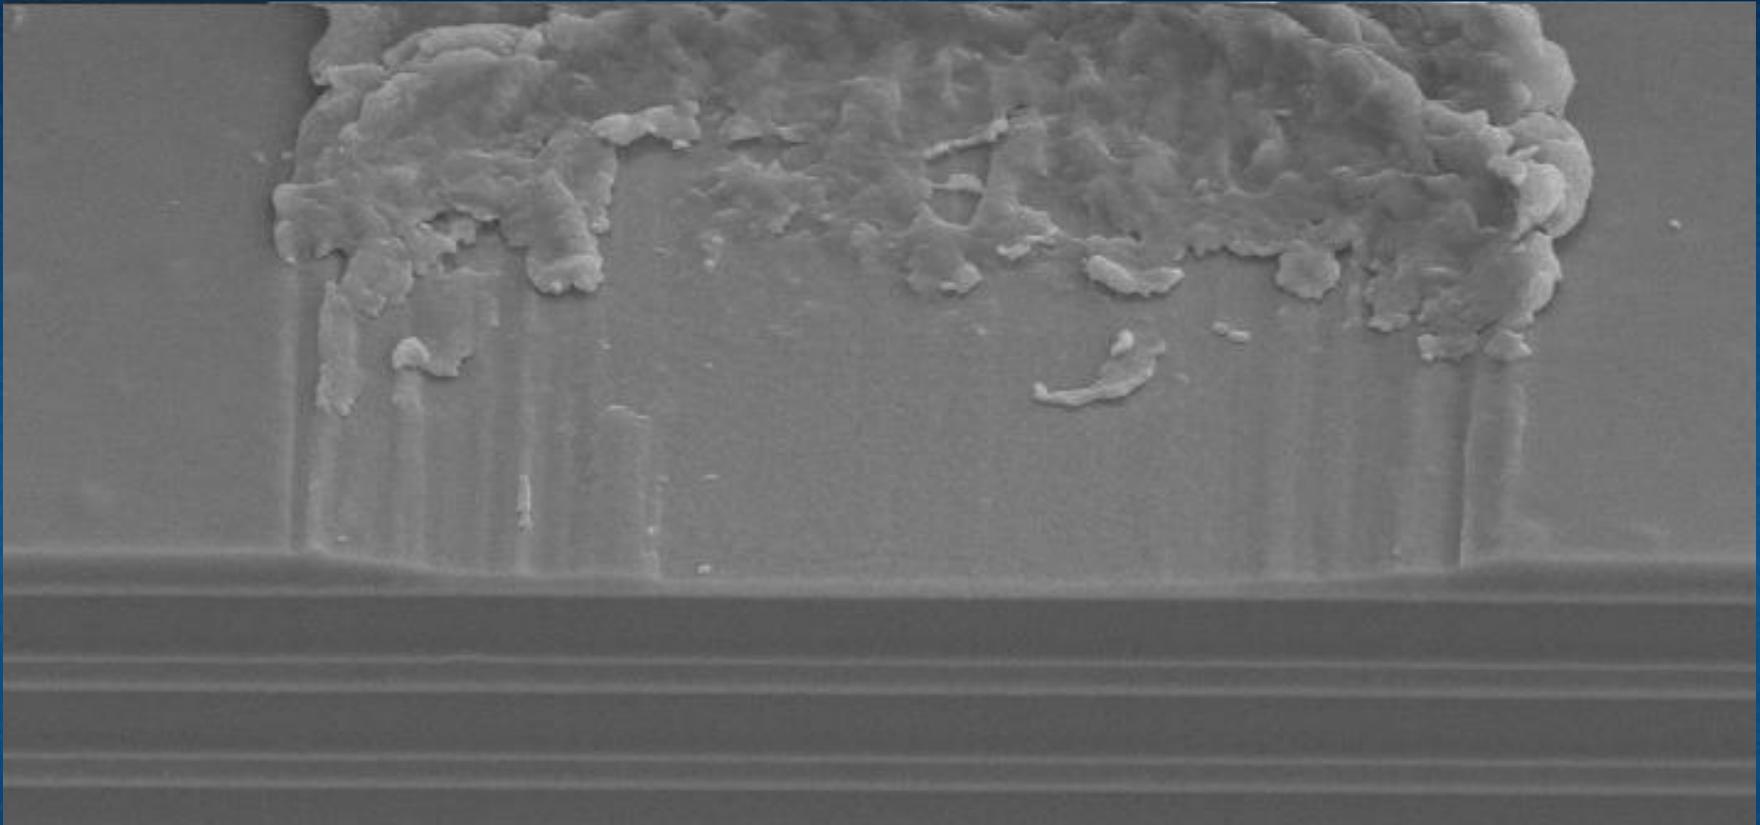
FIB of Cantilever-Probed Traditional Pad

A focused ion beam (FIB) cross section through a harsh probe mark

- Almost no pad Al thickness remaining in the deep scrub region
- Displaced Al in the “prow” is not continuous and is somewhat oxidized
- High risk of sublayers deformation and cracks

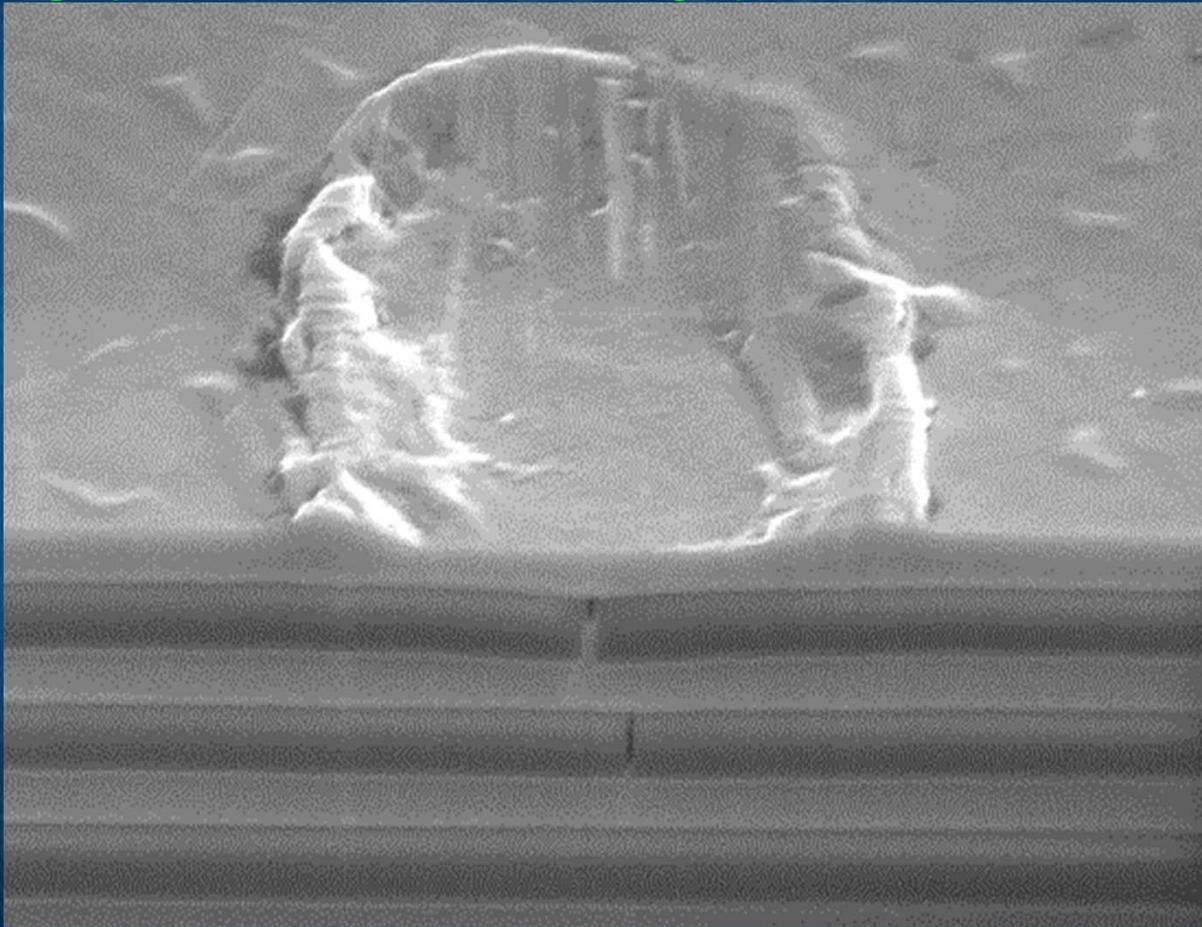
FIB of Vertical-Probed Traditional Pad

FIB through a harsh probe mark made by a vertical probe

- Deep depression in pad Al, high “splash”
- Sub-layer films show local ripple and cracks
- Cracking in lower SiO_2 film is unusual, caused by the high pressure at small tip area
- Al extruding up in to the cracks due to high pressure

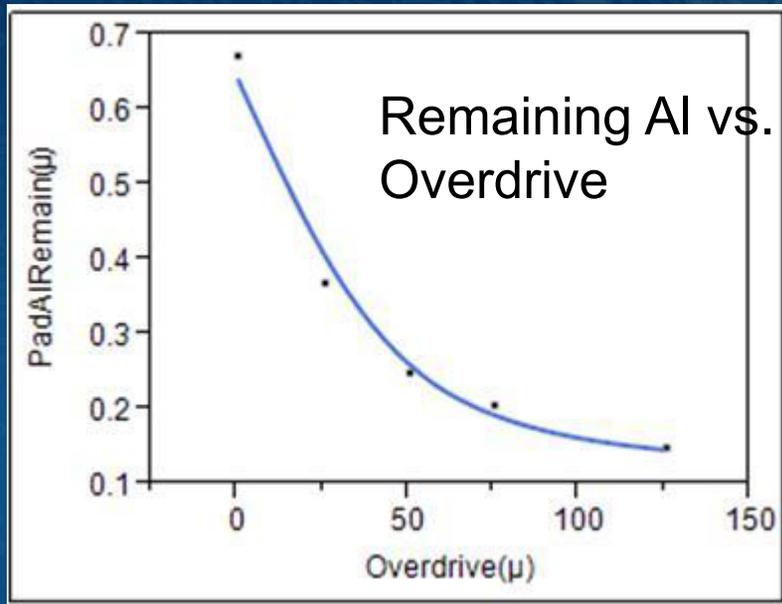
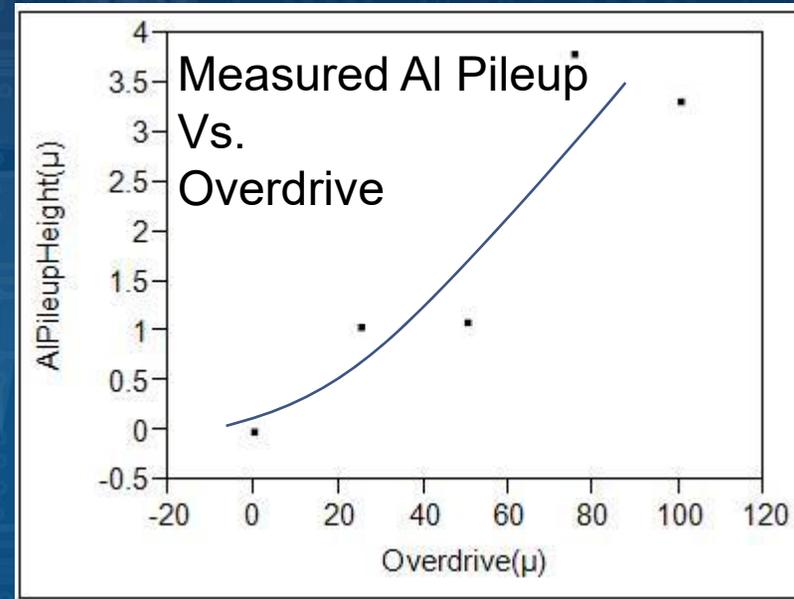
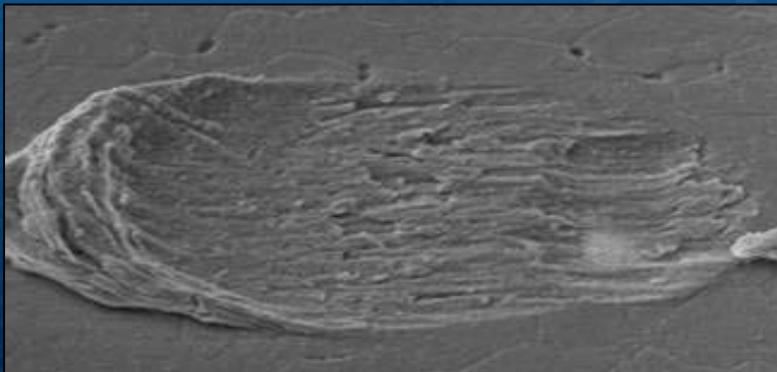
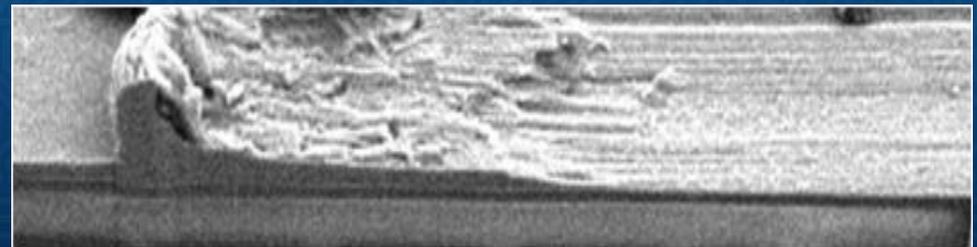
Pad Al Remaining, Prow Height

Overdrive on prober is the most significant factor for probe marks area and Al deformation

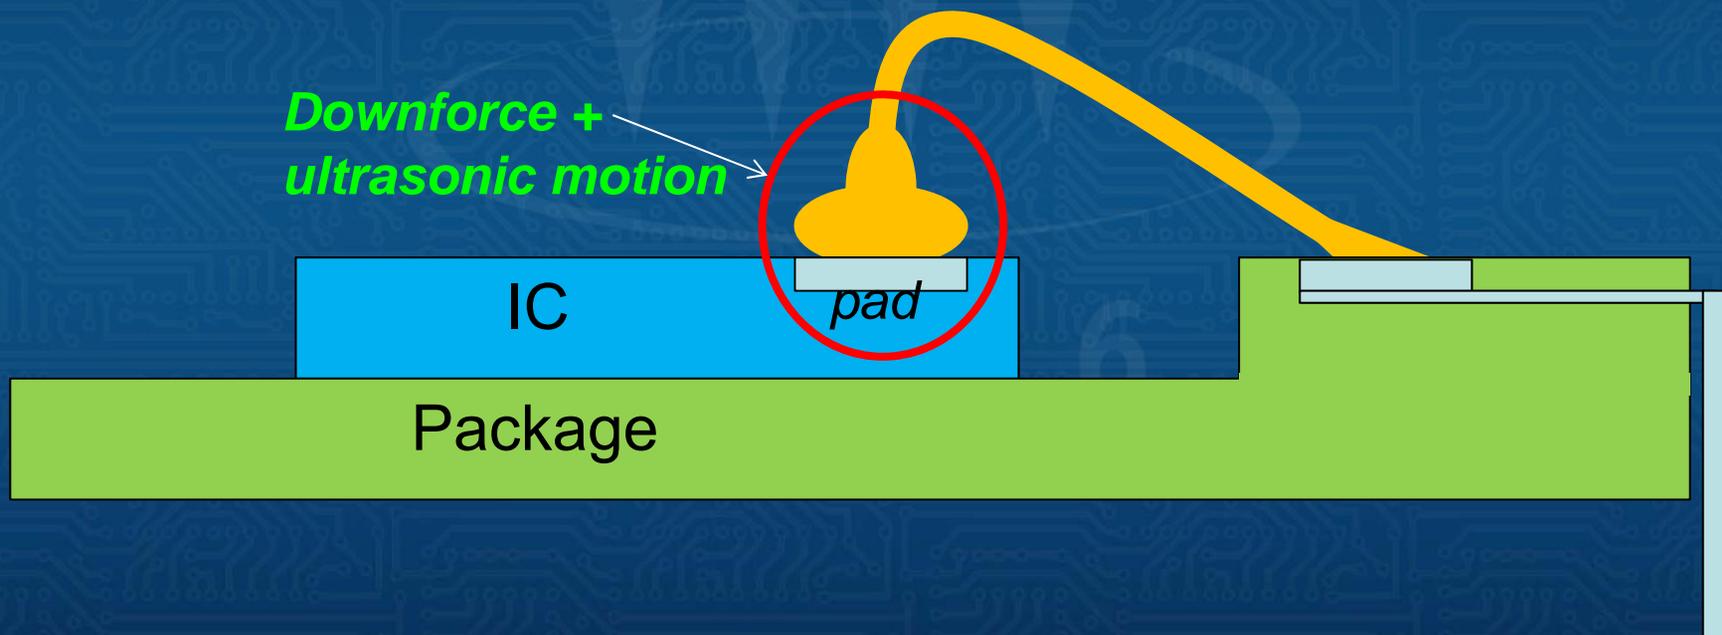
Au Wire Ball Bonding

- A ball is formed at the end of a Au wire, then the ball is squashed onto the Al pad surface and welded by ultrasonic energy
- The second bond of the same wire piece is a “wedge” bond

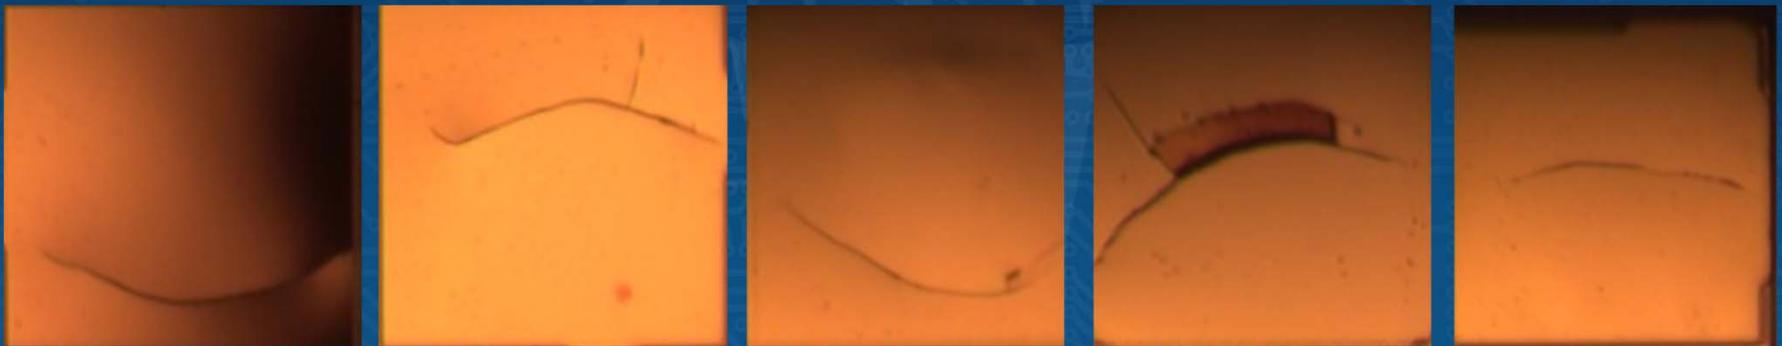
Bonding Cracks, after Crater Etch

Can't see any ripple in these pads...

...these pads were actually cracked *due to severe ripple*

>> *crater etch solution seeped into the cracks and etched away some sublayers!*

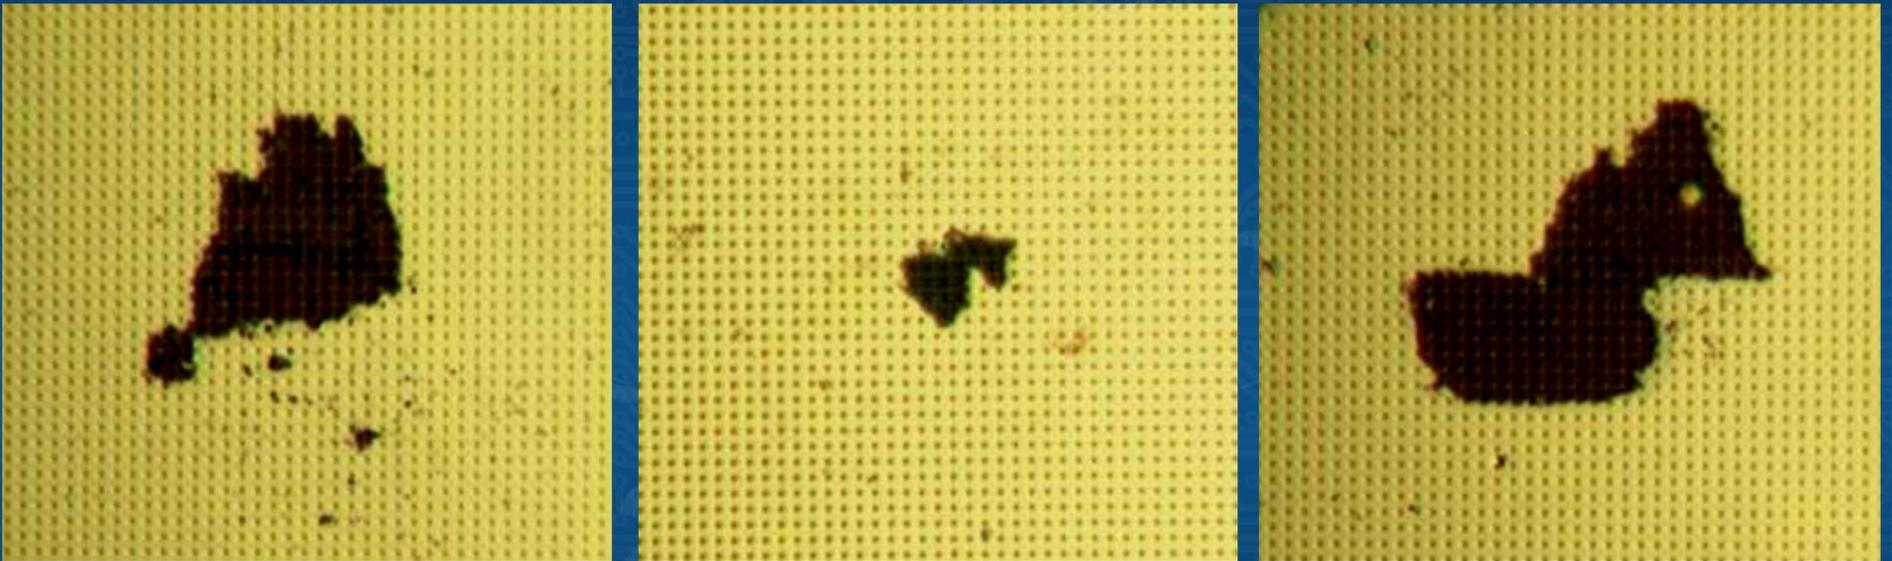
Additional Pad Damage Due to Wirebond

Probe damage, ...after wirebond

Cracking and sublayers lifting in the cratering test

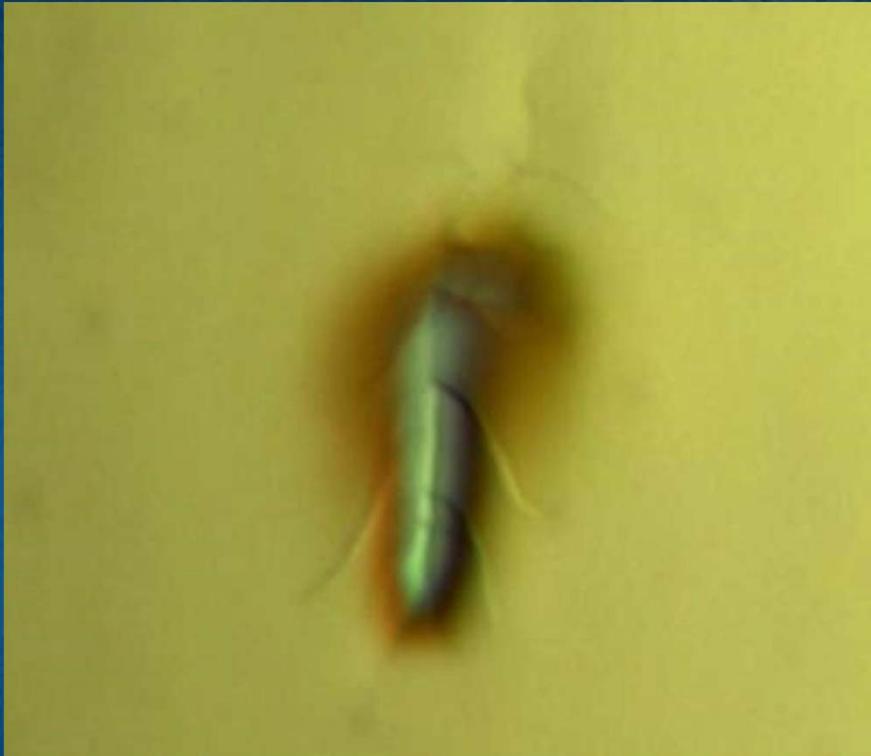
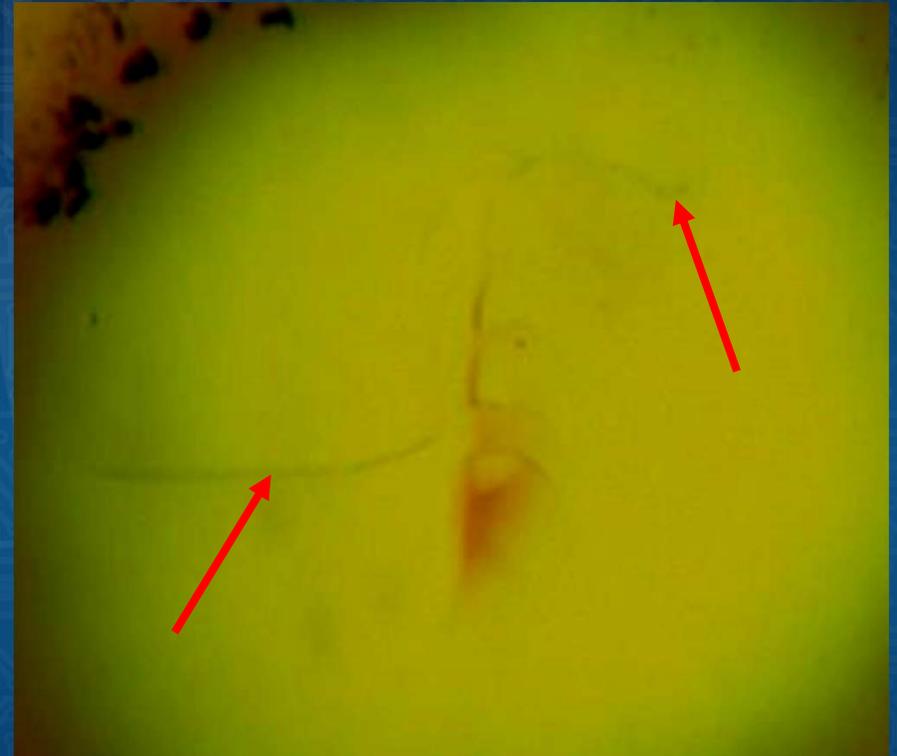
Probe Cracks, then more Cracks after Wirebond

Crater Test *after probe*

Crater Test *after bond*

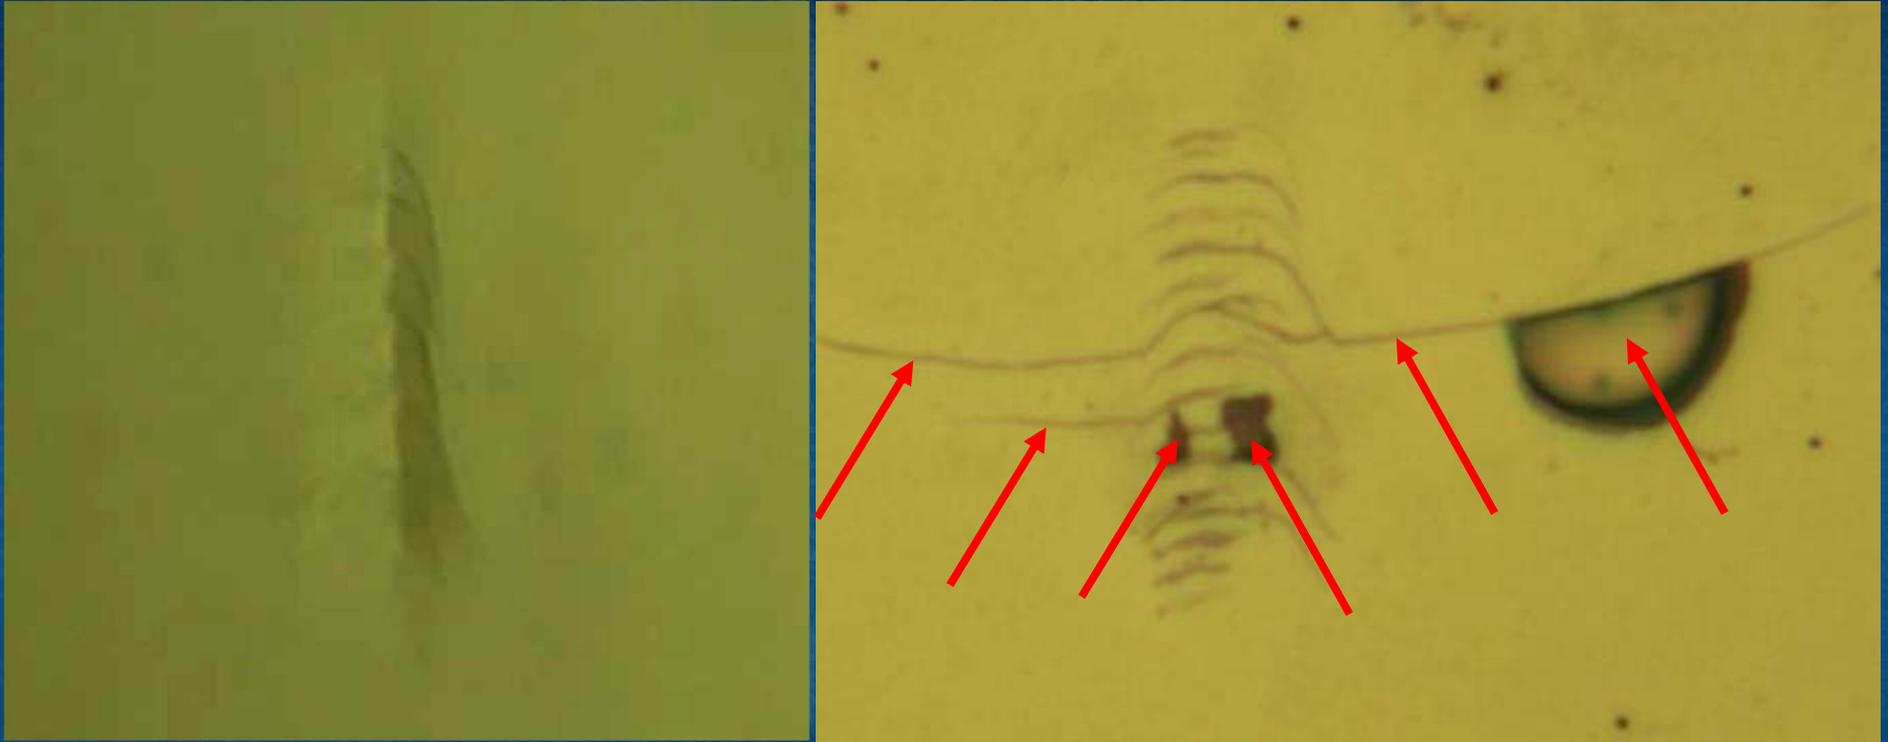
Probe Cracks, then more Cracks after Wirebond

Crater Test *after probe*

Crater Test *after bond*

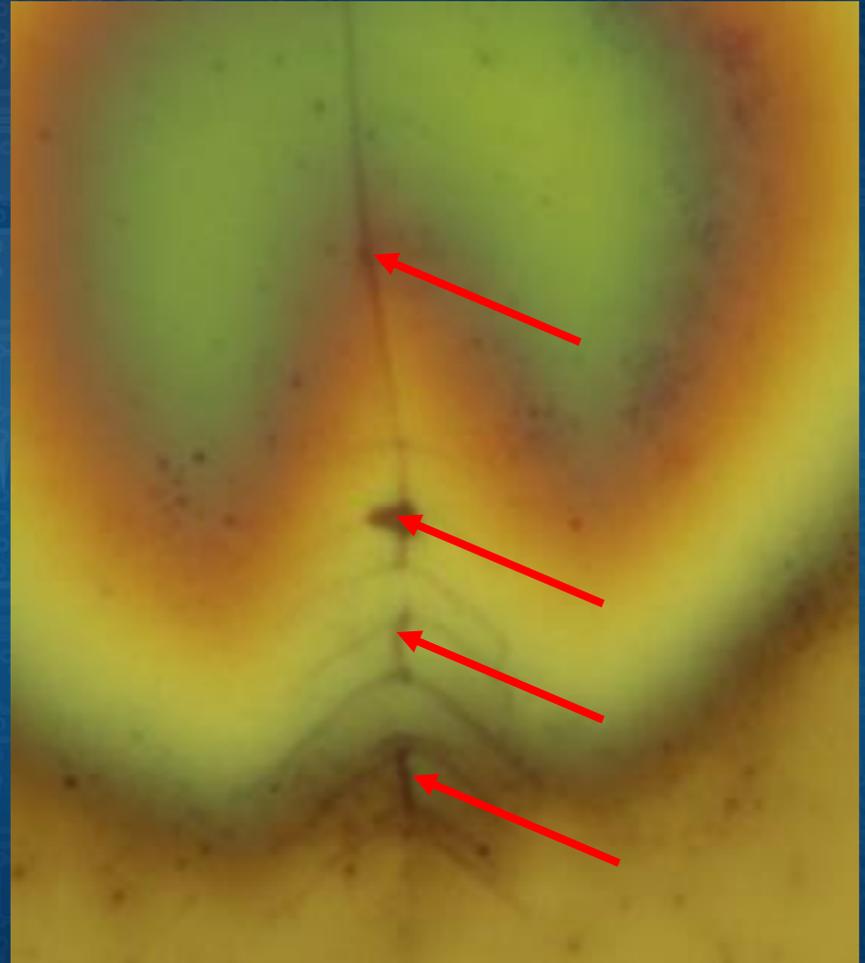
Probe Cracks, then more Cracks after Wirebond

Crater Test *after probe*

Crater Test *after bond*

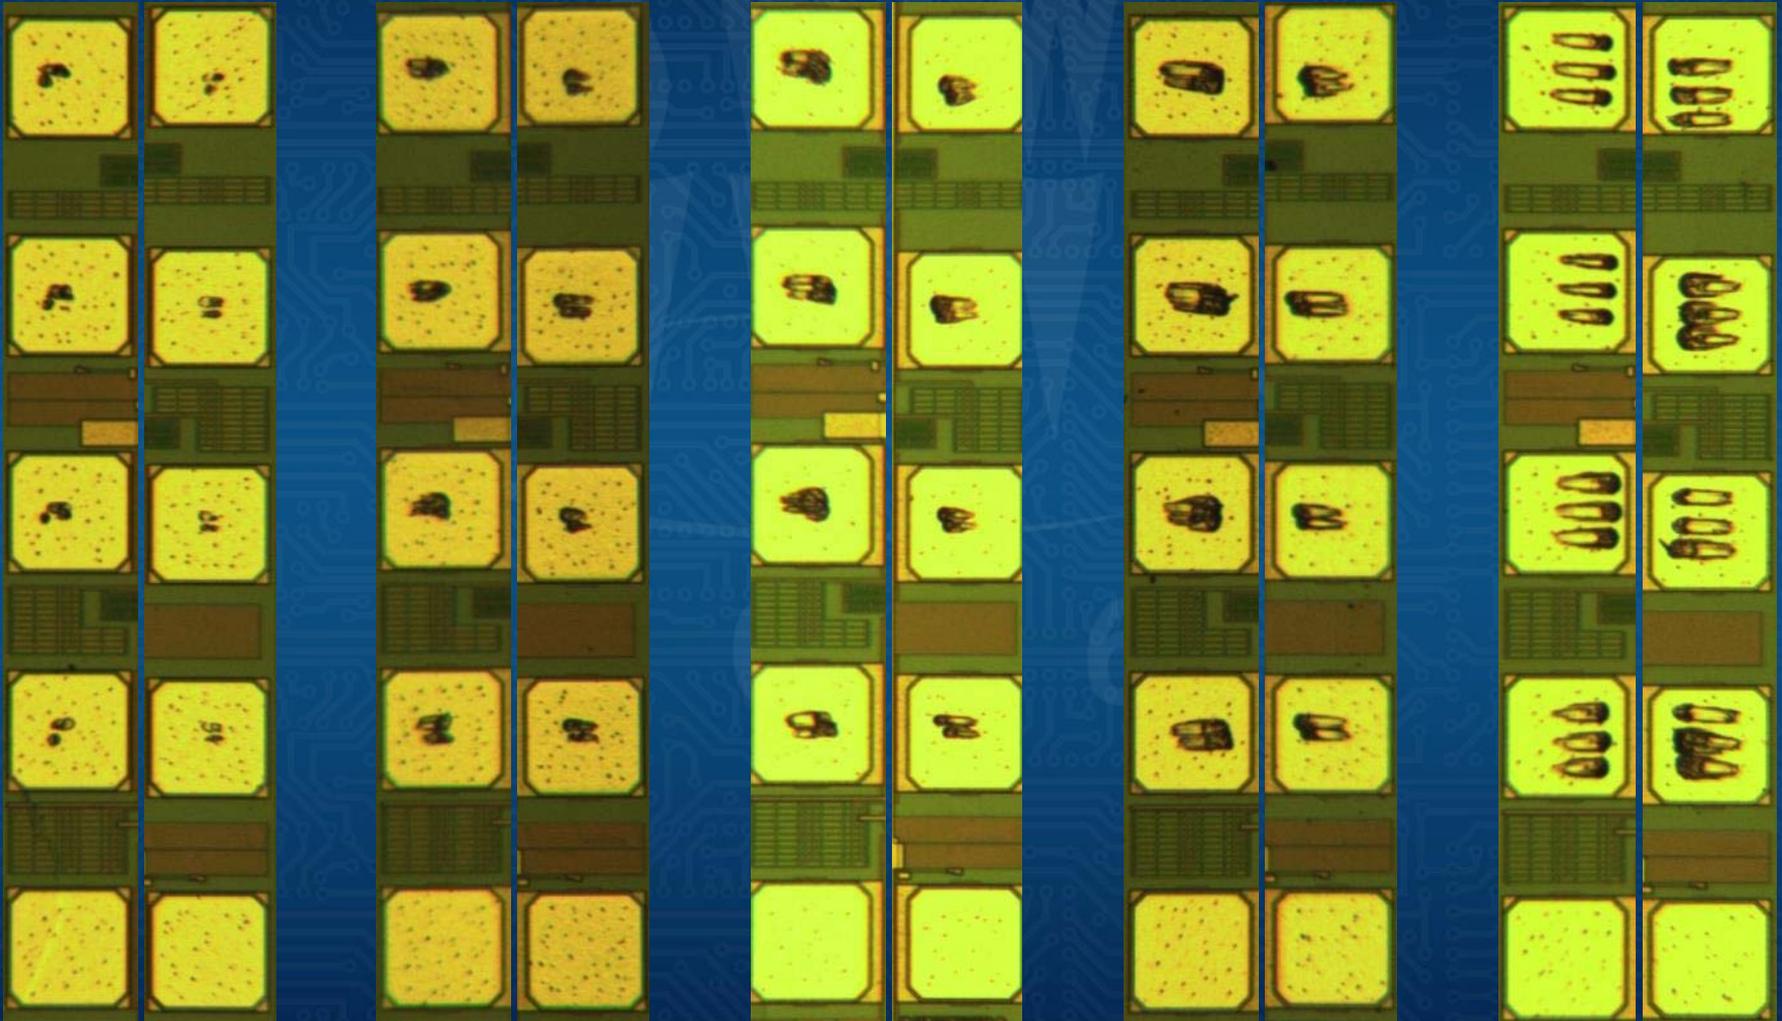
A Variety of Probe Marks

- Au wirebonds in 2 different ball diameters will be bonded over these marks

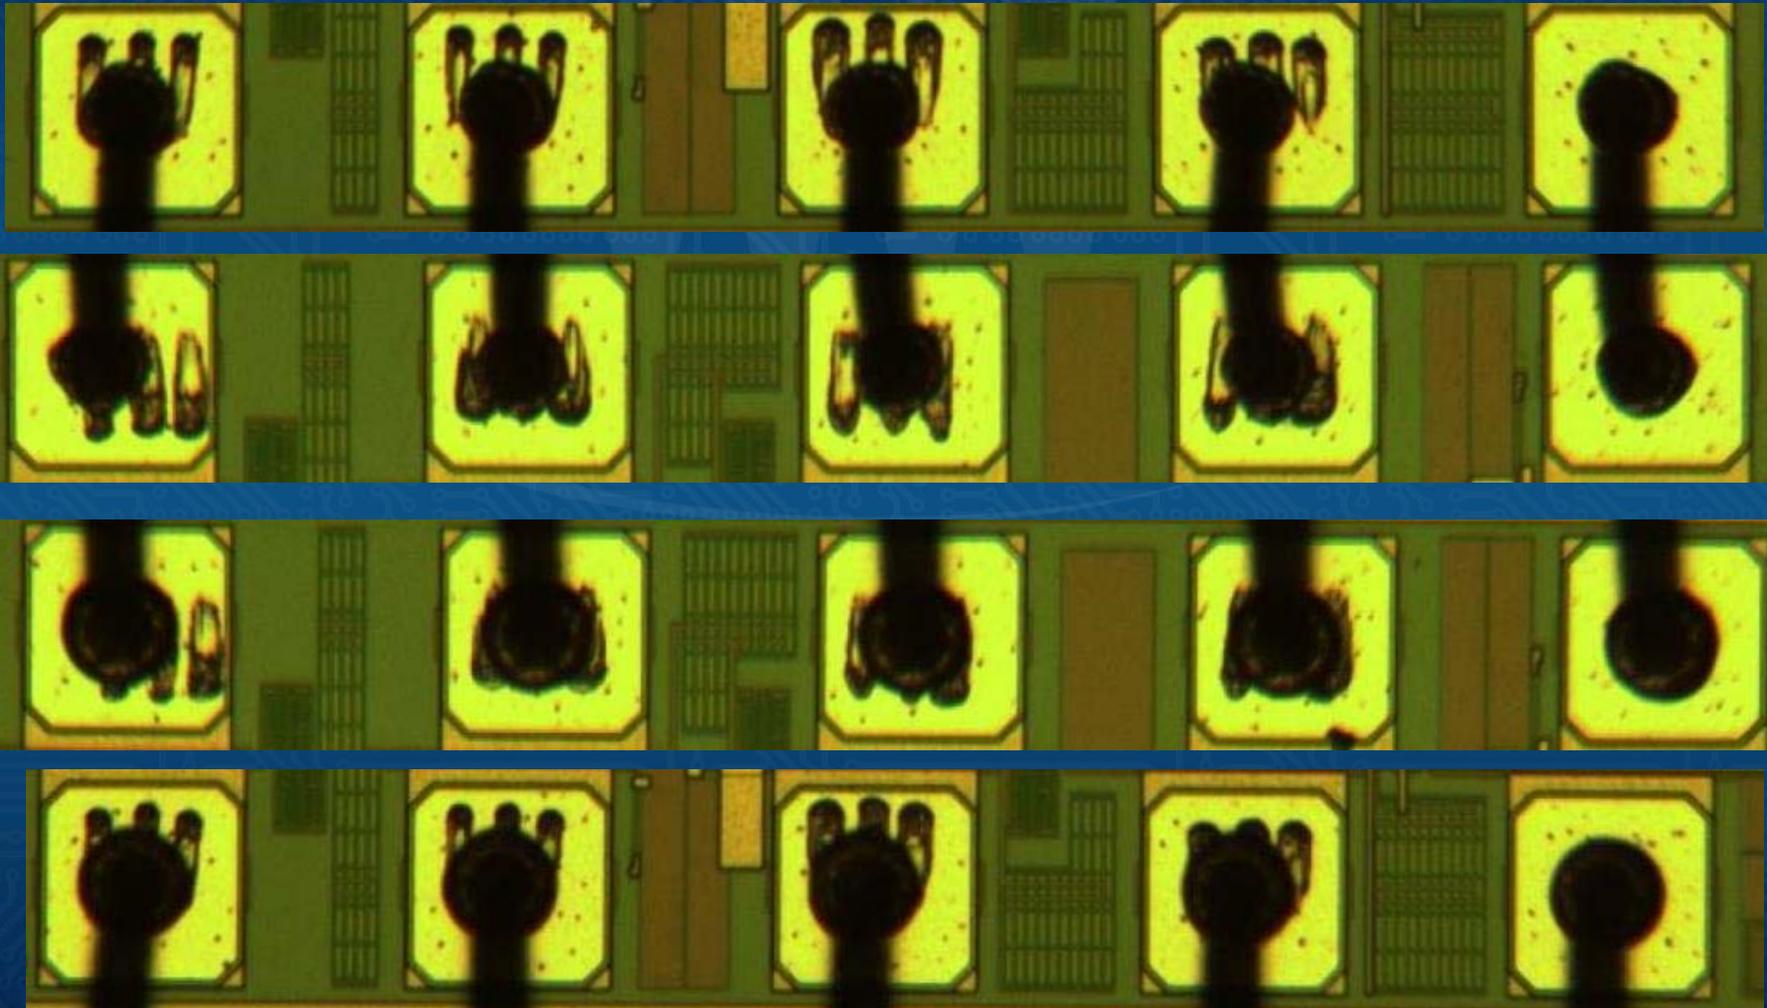
Au Ball Bonds over Probe Marks

- Reduced ultrasonic energy on some bonding to “detune”
- Bonds slightly more susceptible to “ball lift” in pull test

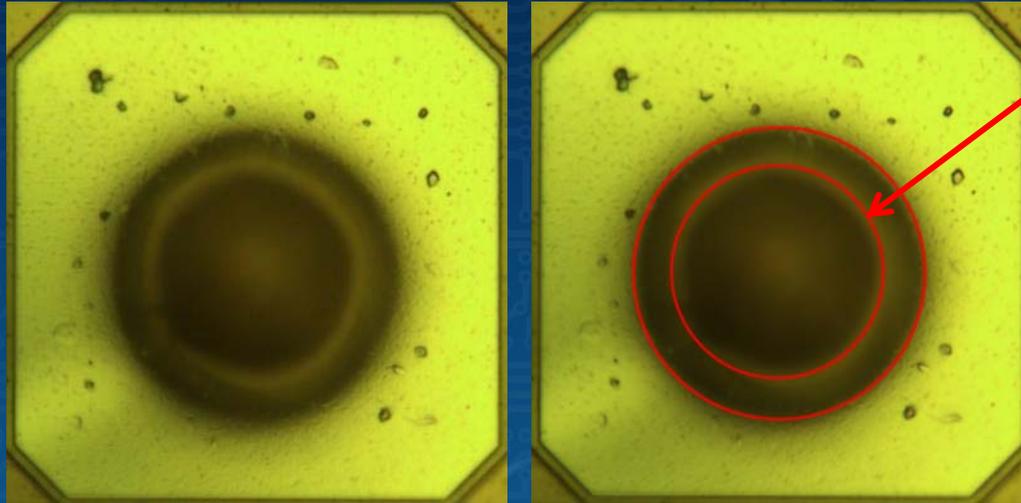
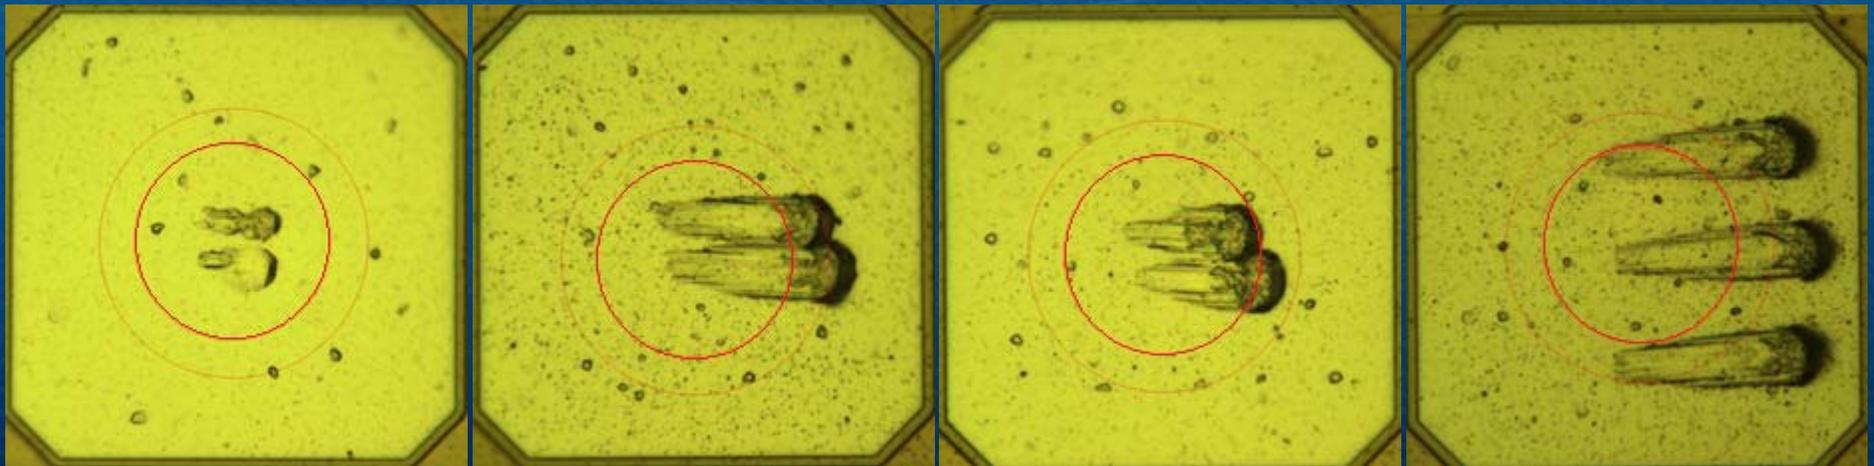
% Bond Contact Area Measurement

- Inner circle is an estimate of the contact area, drawn on the optical microscope photo
- For each pad, estimate the area of bond contact on the probe marks

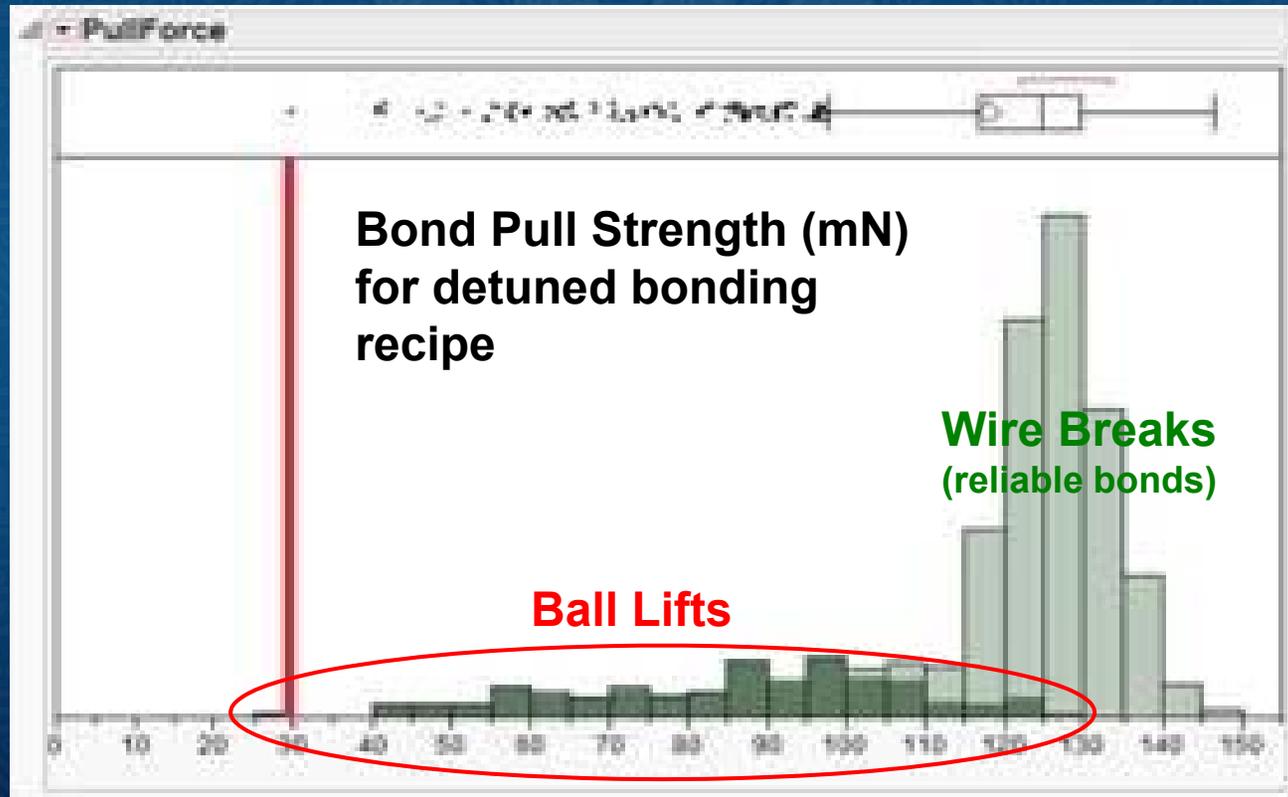
Au WireBond Pull Strength (mN)

- No ball lifts for standard Au wirebond
- Some ball lifts on detuned bonding recipe, over probe marks

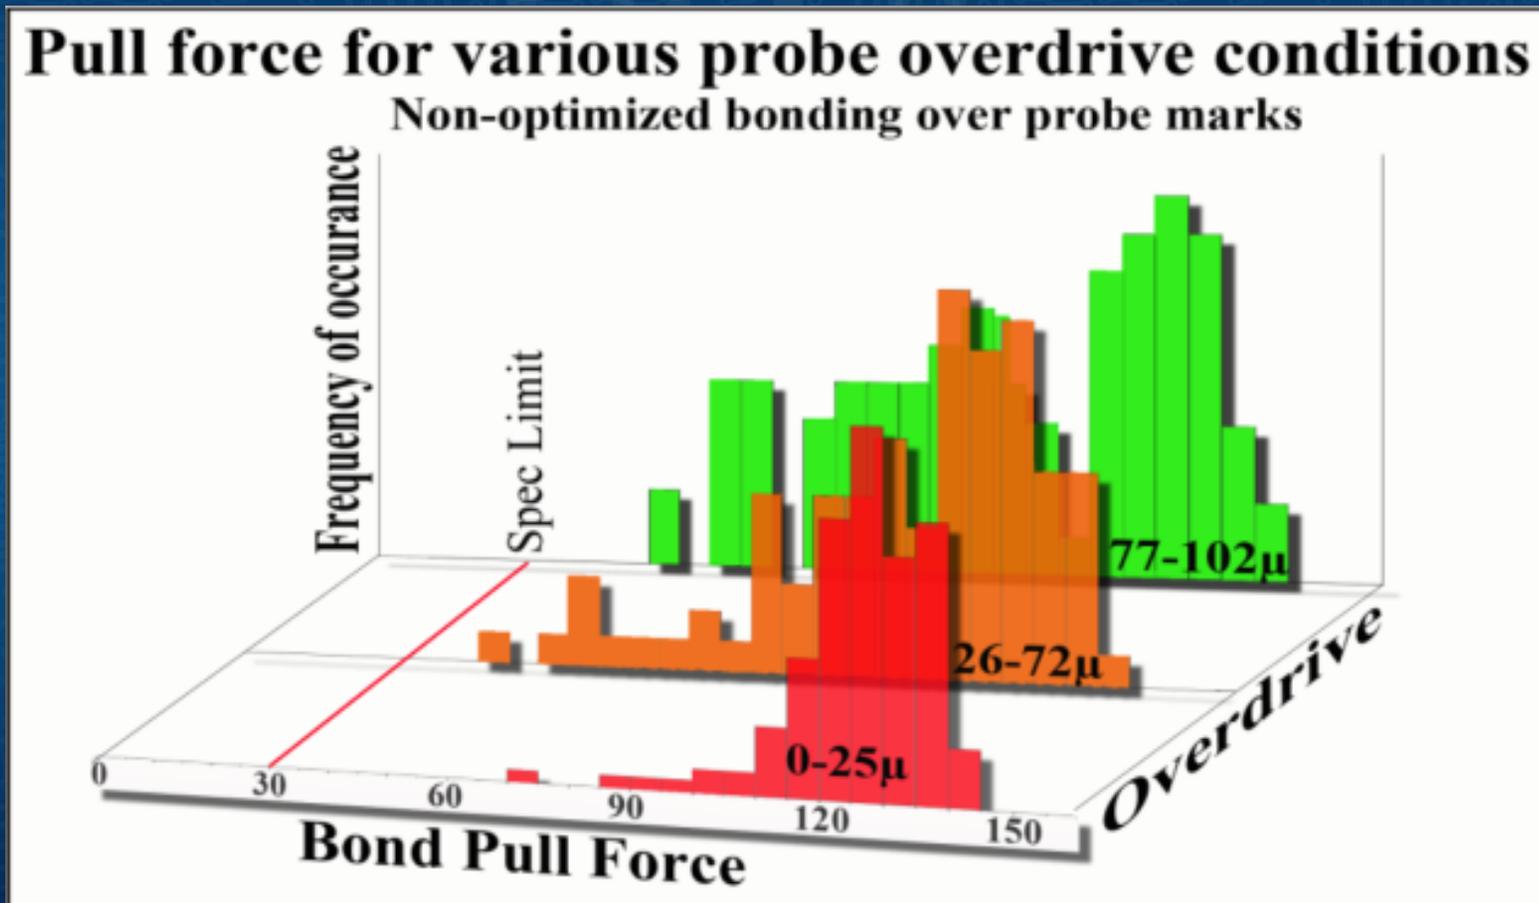
Au Wirebond Pull Strength (mN)

- Increasing Ball Lifts with higher probe overdrive, due to larger, deeper marks

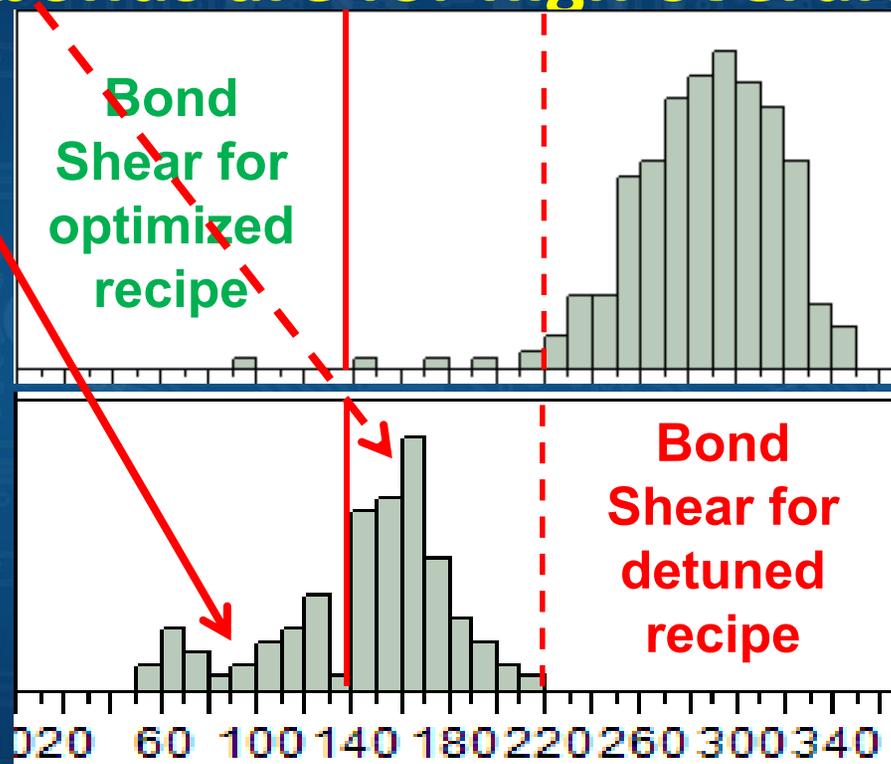
Au Wirebond Shear Strength (mN)

- Weaker bonds on un-optimized recipe over probe marks
- Weakest bonds are for high overdrive values

- For a detuned Au wirebond process, bonds are unreliable
- ***Au bonds over invasive probe marks are weakest***

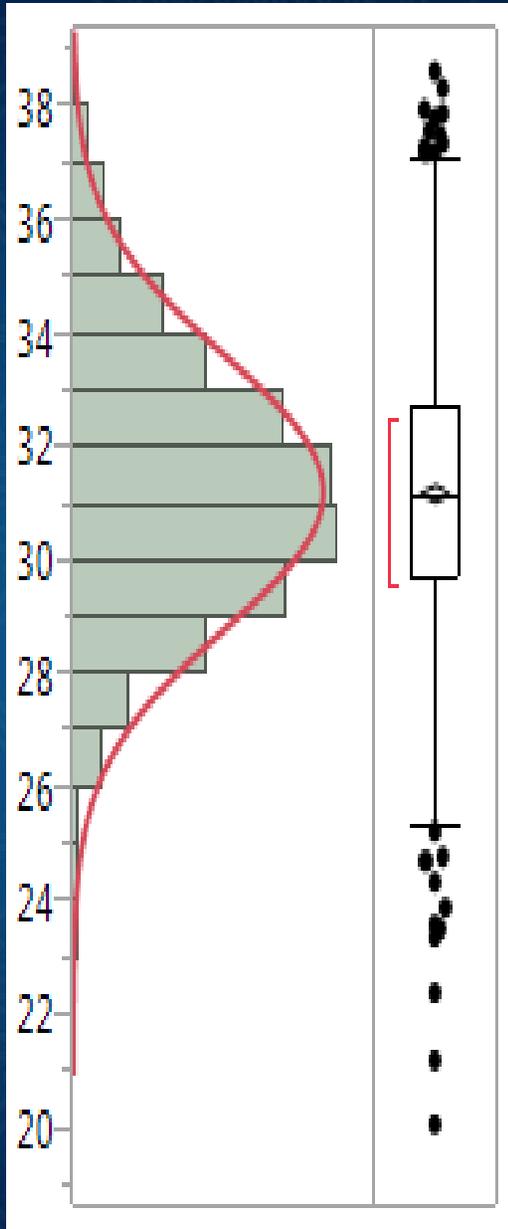
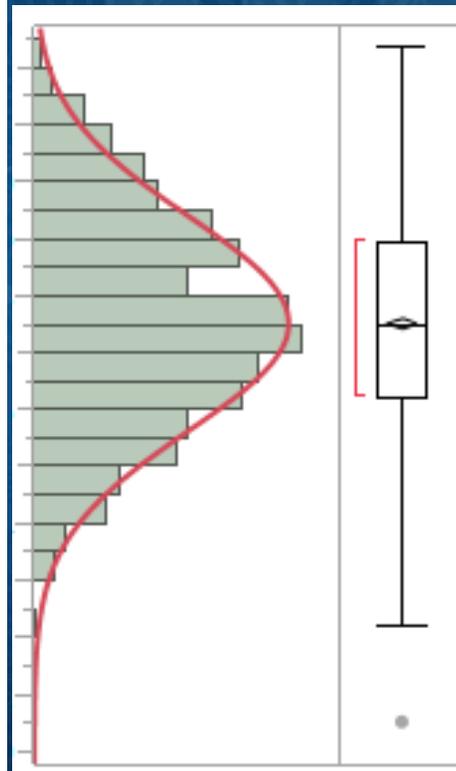
Shear Test Distributions on Thick and Thin Pad Al

- 3.5 gF lower shear values on thin pad Al for same bonding recipe
 - About 11% less strength
- Assume high energy ultrasonic required for thick pad Al is too high for the thin Al
