Advances in Vertical Probe Material for 200°C Wafer Test Applications

Author & presenter, Mitsuhiro Moriyama

SV TCL KK, JAPAN

June 2-5, 2019

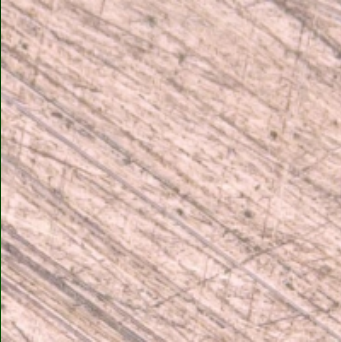
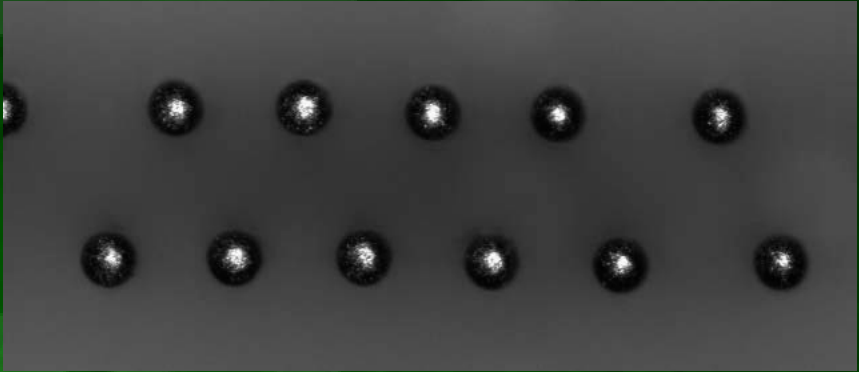
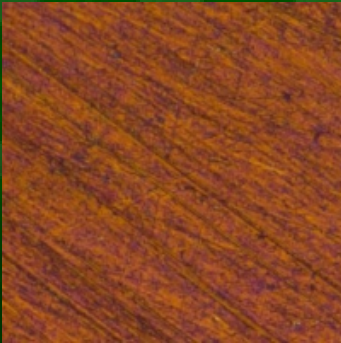
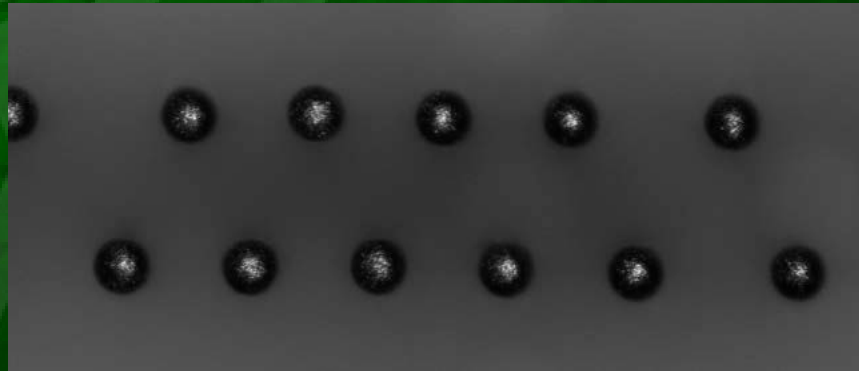
First test at 200°C

Wire sample	Probe tip as viewed on the prober
<u>STD</u> Initial

After heating

Probe tip discoloration.

The darker tip results in prober alignment errors!

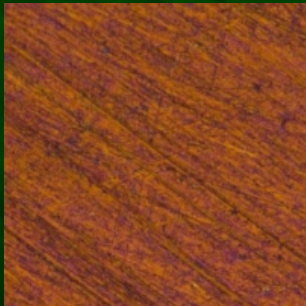
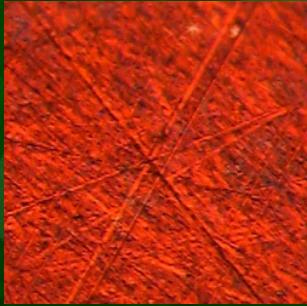
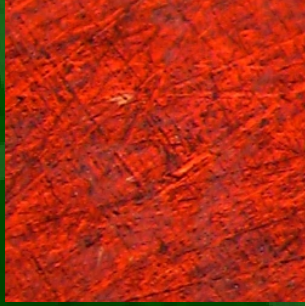
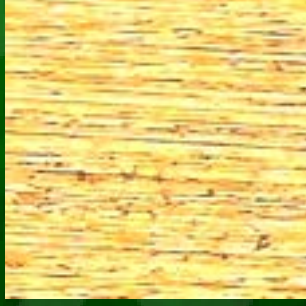
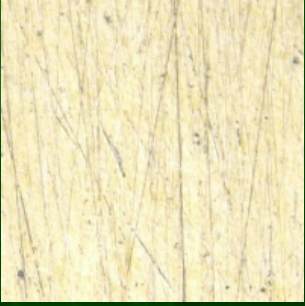
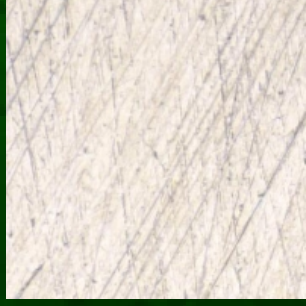
Improvement for discoloration at 200°C

We after several composition changes we resolved the discoloration problem

STD	Composition changes				
	Test1	Test2	Test3	Test4	Test5

Acceptable

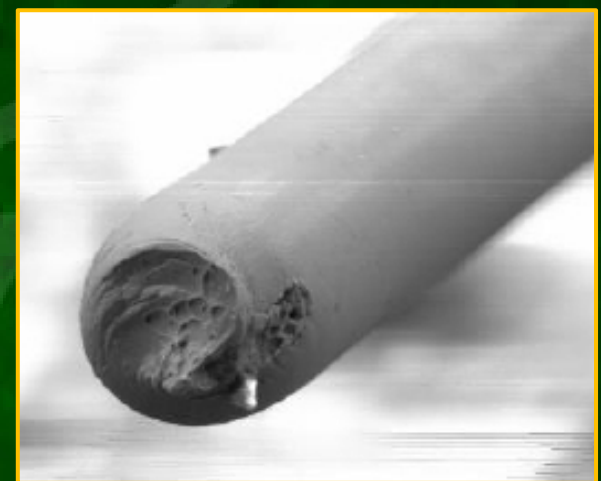
Broken wire in drawing process

Impurity defect

Wire drawing

Probe processing

After several attempts and process improvement breaking wire issues were solved

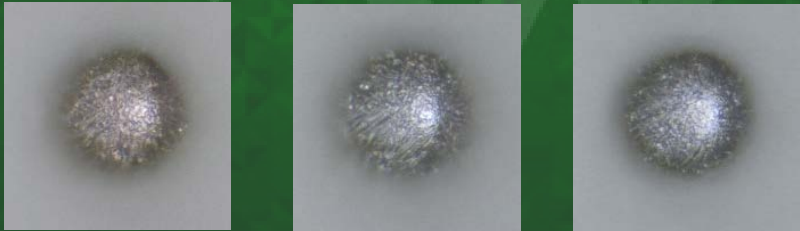
Specification of evaluation probe head

unit	EH	STD	AgPdCu
Probe diameter	um	35	35	35
Wire length	mm	50	50	50
Probe force	gf	2.2	2.7	2.4
Tip shape	-	Round	Round	Round
Probe Tip
