# Process analysis for thermal expansion matching between wafer and large array probe card

Woo Young Han  
Onto Innovation

Aug. 30 – Sep. 1, 2021

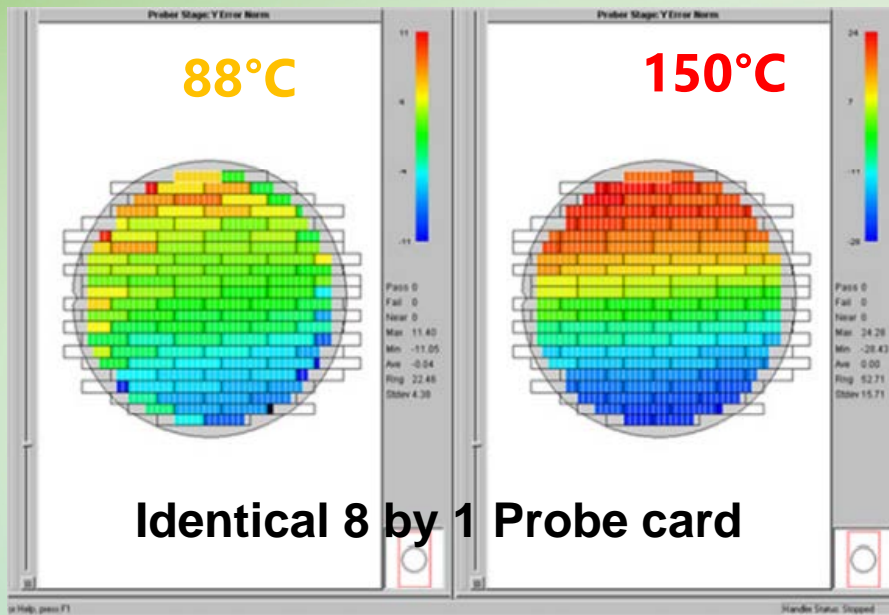
Scrub alignment error in Y direction shown at two different temperature

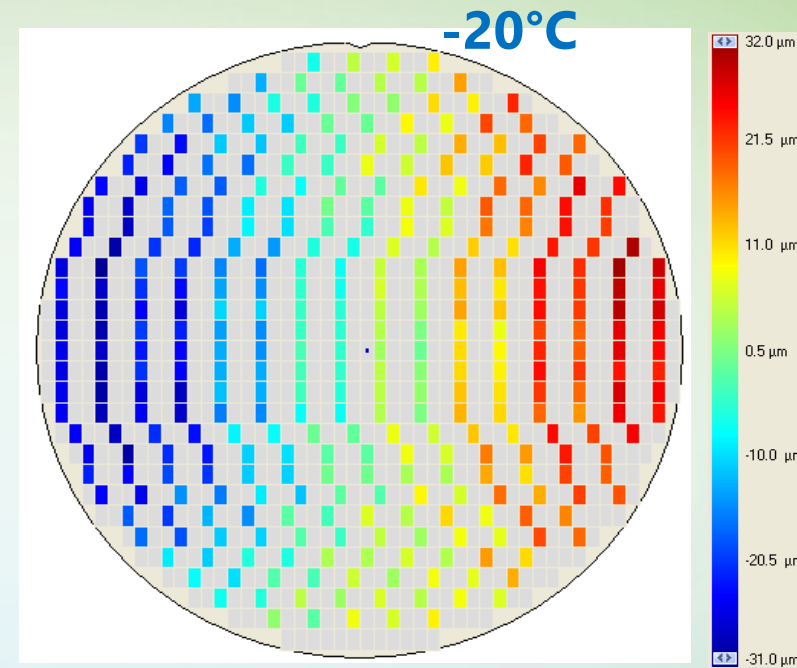
Scrub X Alignment at Cold Testing

~30um of probe card shrinkage mismatch found on wafer edge for the freeze test

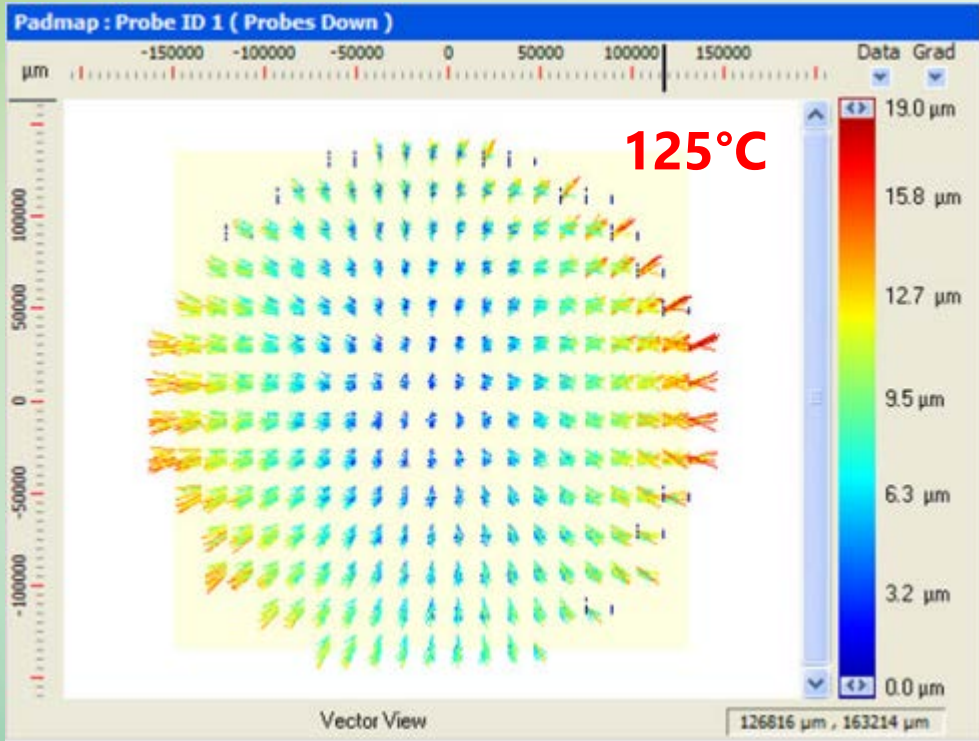
Vector View of Scrub X,Y Alignment

**The scrub analysis is showing that up to 20µm of thermal mis-match was found on wafer edge.**

**The new card was tested on 300mm bare silicon wafer at hot temperature (125°C).**

**This probe card did not pass incoming inspection and returned back to the vendor.**

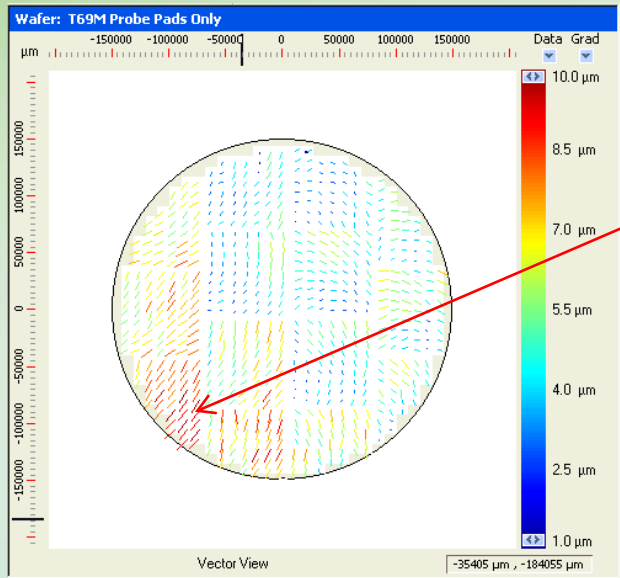
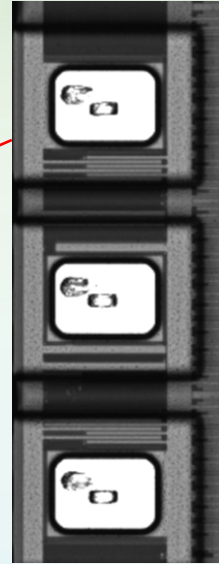
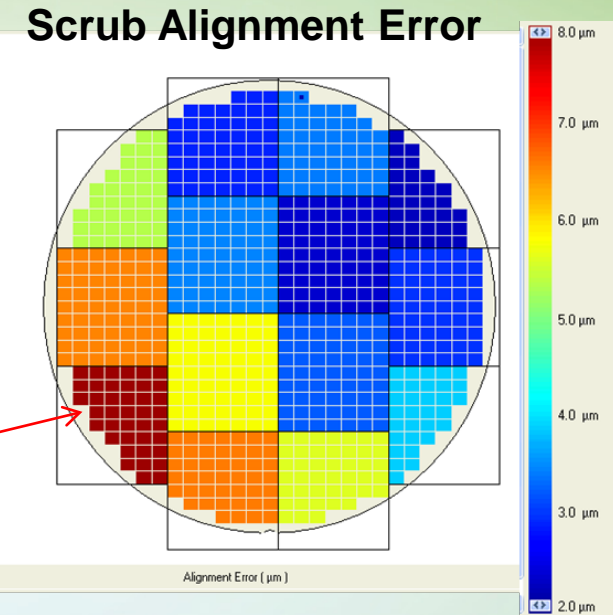
Scrub marks too close to pad edge.

Temperature scaling causing shift in needle location on pad during cold testing.

Prober not optimized for wafer scaling and chuck flatness at cold temperature. Combination of chuck tilt and stepping error resulting in a shift in the probe location.

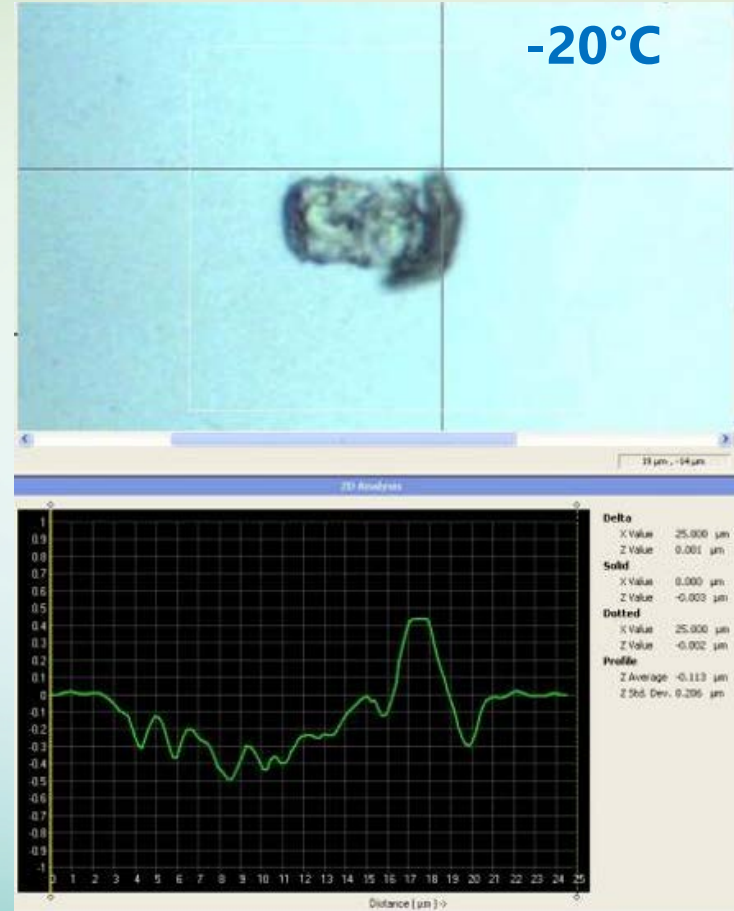
Scrub mark depth measured 0.5μm from Cold temperature test

- Scrub marks get larger and deeper as testing temperature increase.
- Need to monitor scrub mark depth on wafer to control prober chuck over drive distance for temperature tests.
- Need to ensure needles do not punch through bond pads during higher temperature testing and needles penetrate deep enough during cold temperature tests.
