**IEEE SW Test Workshop**  
Semiconductor Wafer Test Workshop

**Eddie McClanahan and Al Wegleitner**  
Texas Instruments

# **The Influences of Signal Matching During Multi-site Testing**

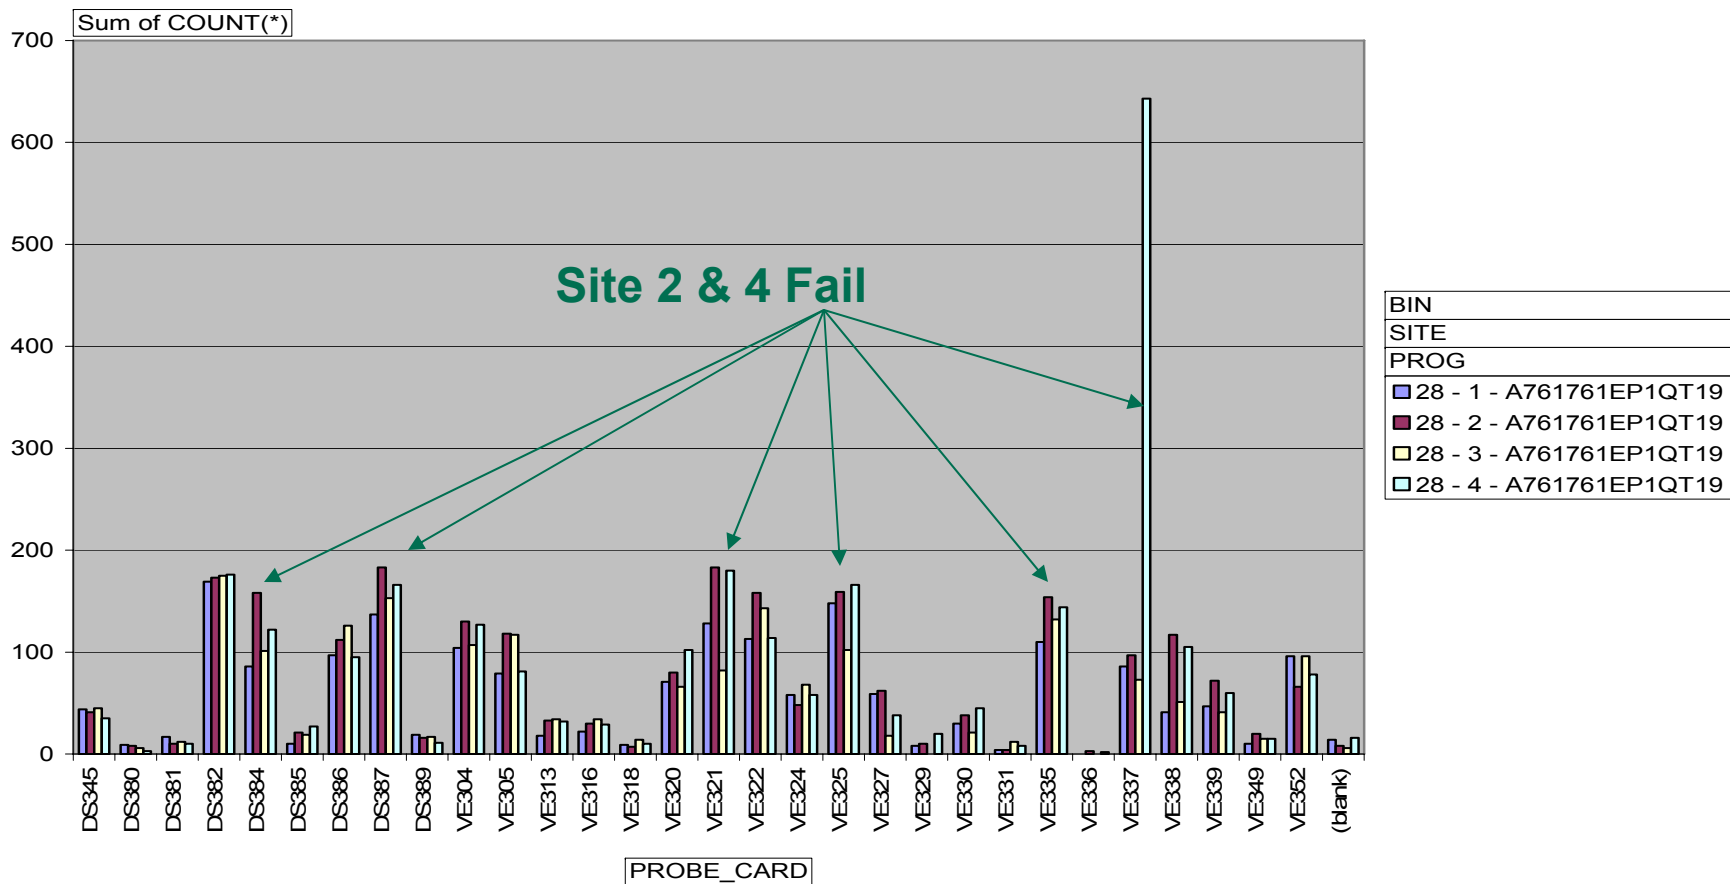
# S2S Yield Analysis

- Yield Variability
  - Site to site monitoring of this device indicate an increasing yield delta between sites. Average 2.95 %
  - Tester to tester yield performance data did not identify isolated tester issues but did support site to site failure mode

By Probe card

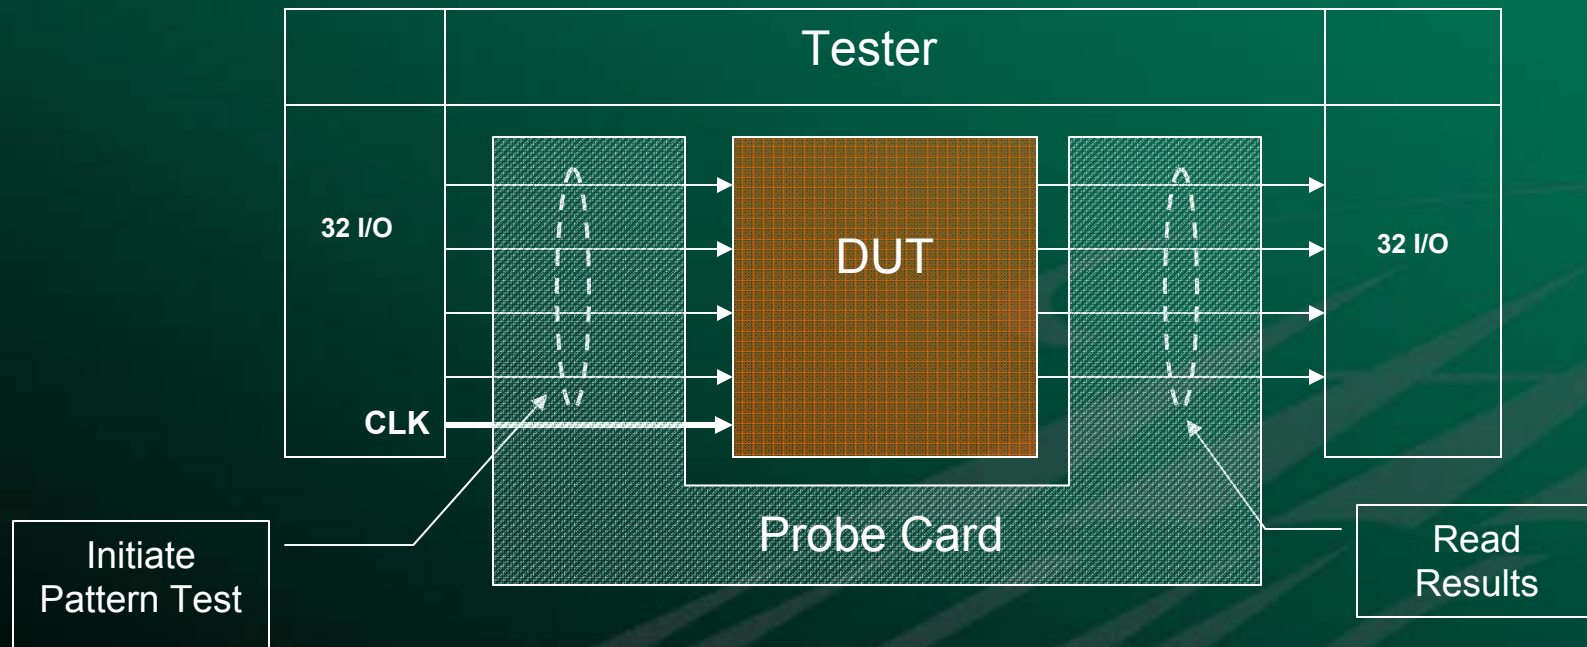
# Determining Cause Relationship

Critical Signals	
KEYIN4_N	GPIO05
ETX_TCK	GPIO06
TDI	GPIO07
TDO	GPIO43
TCK	PDID03

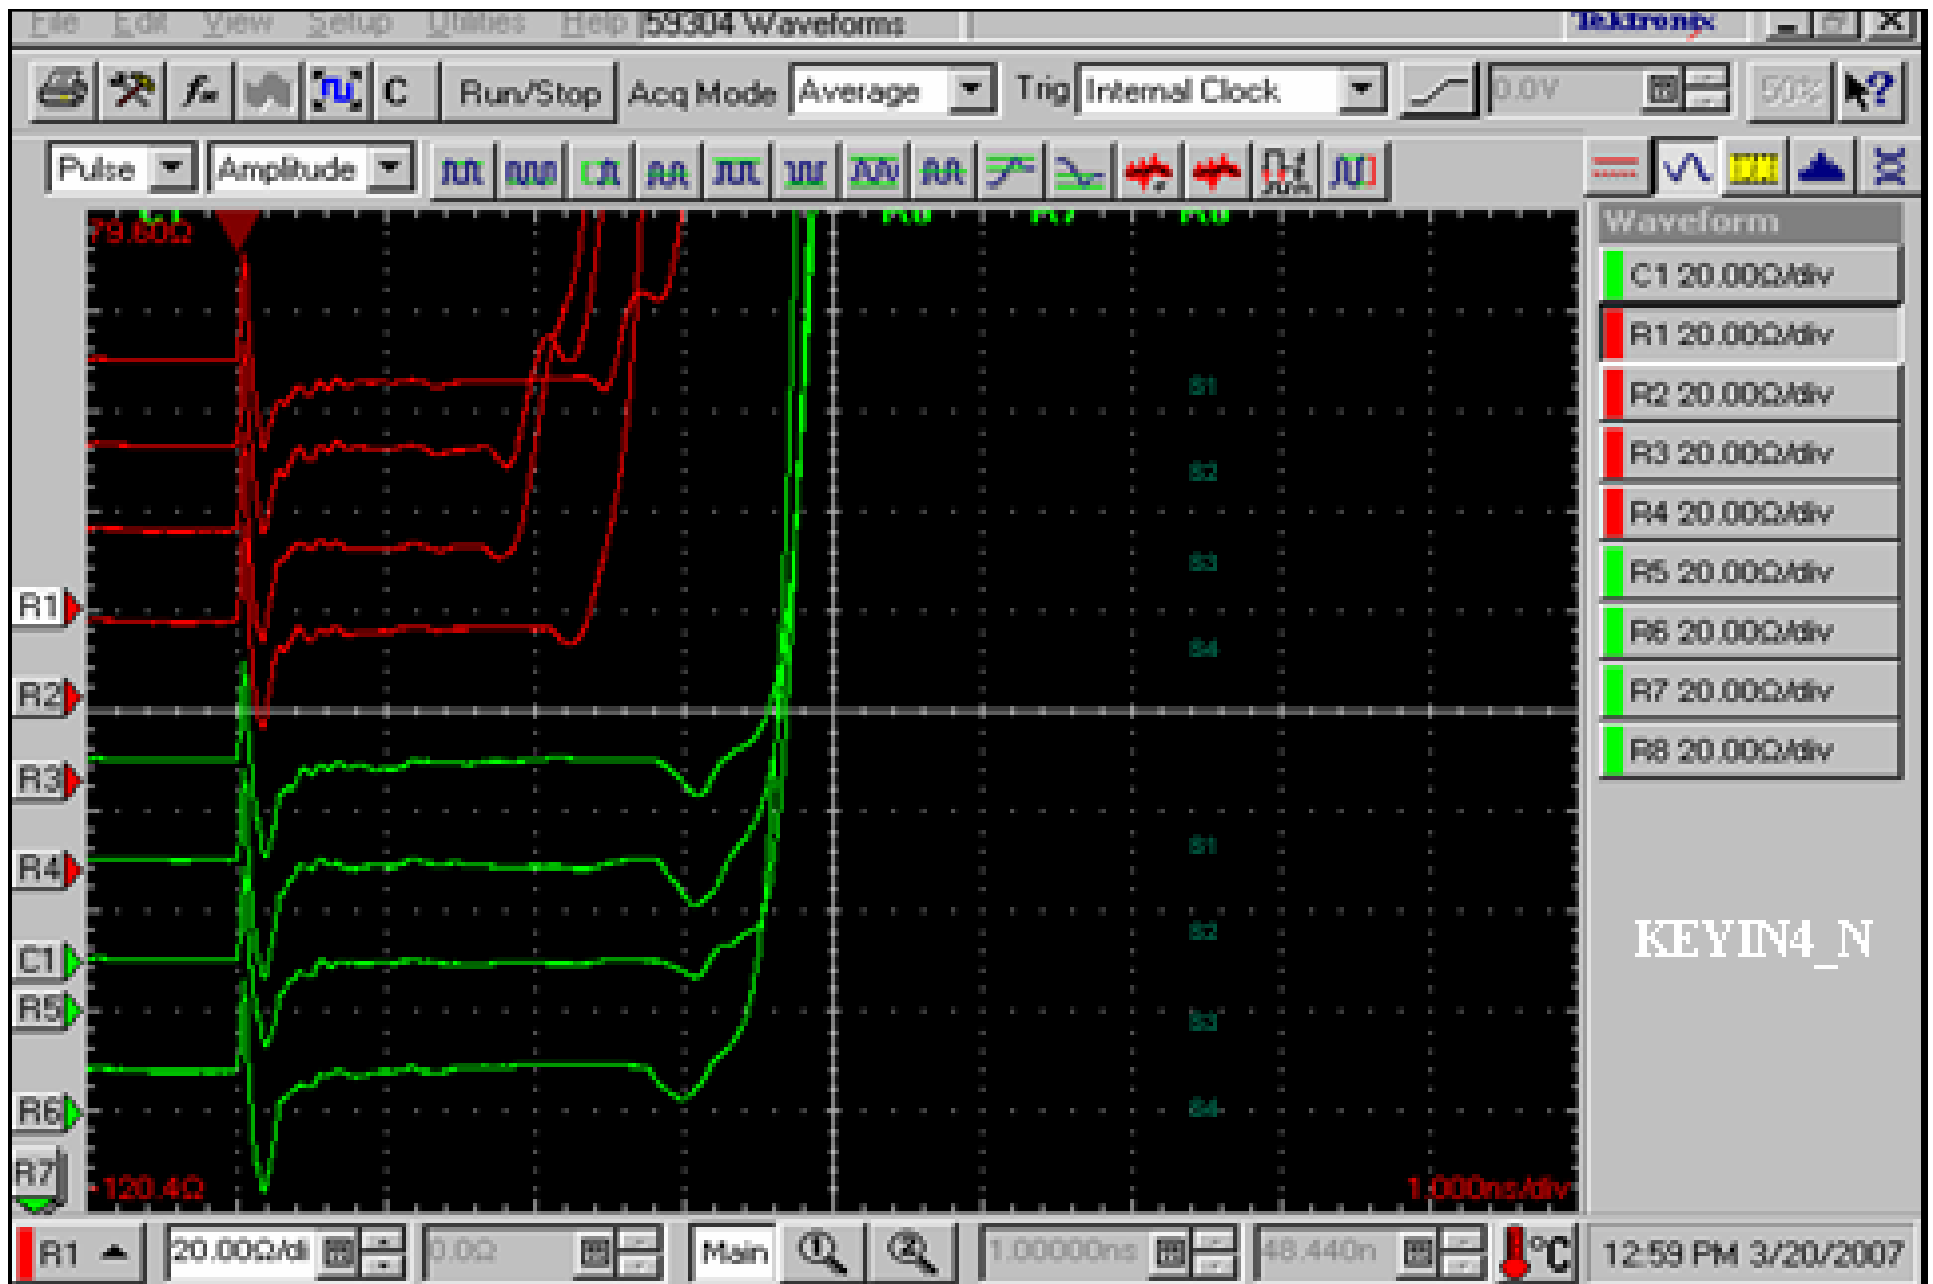
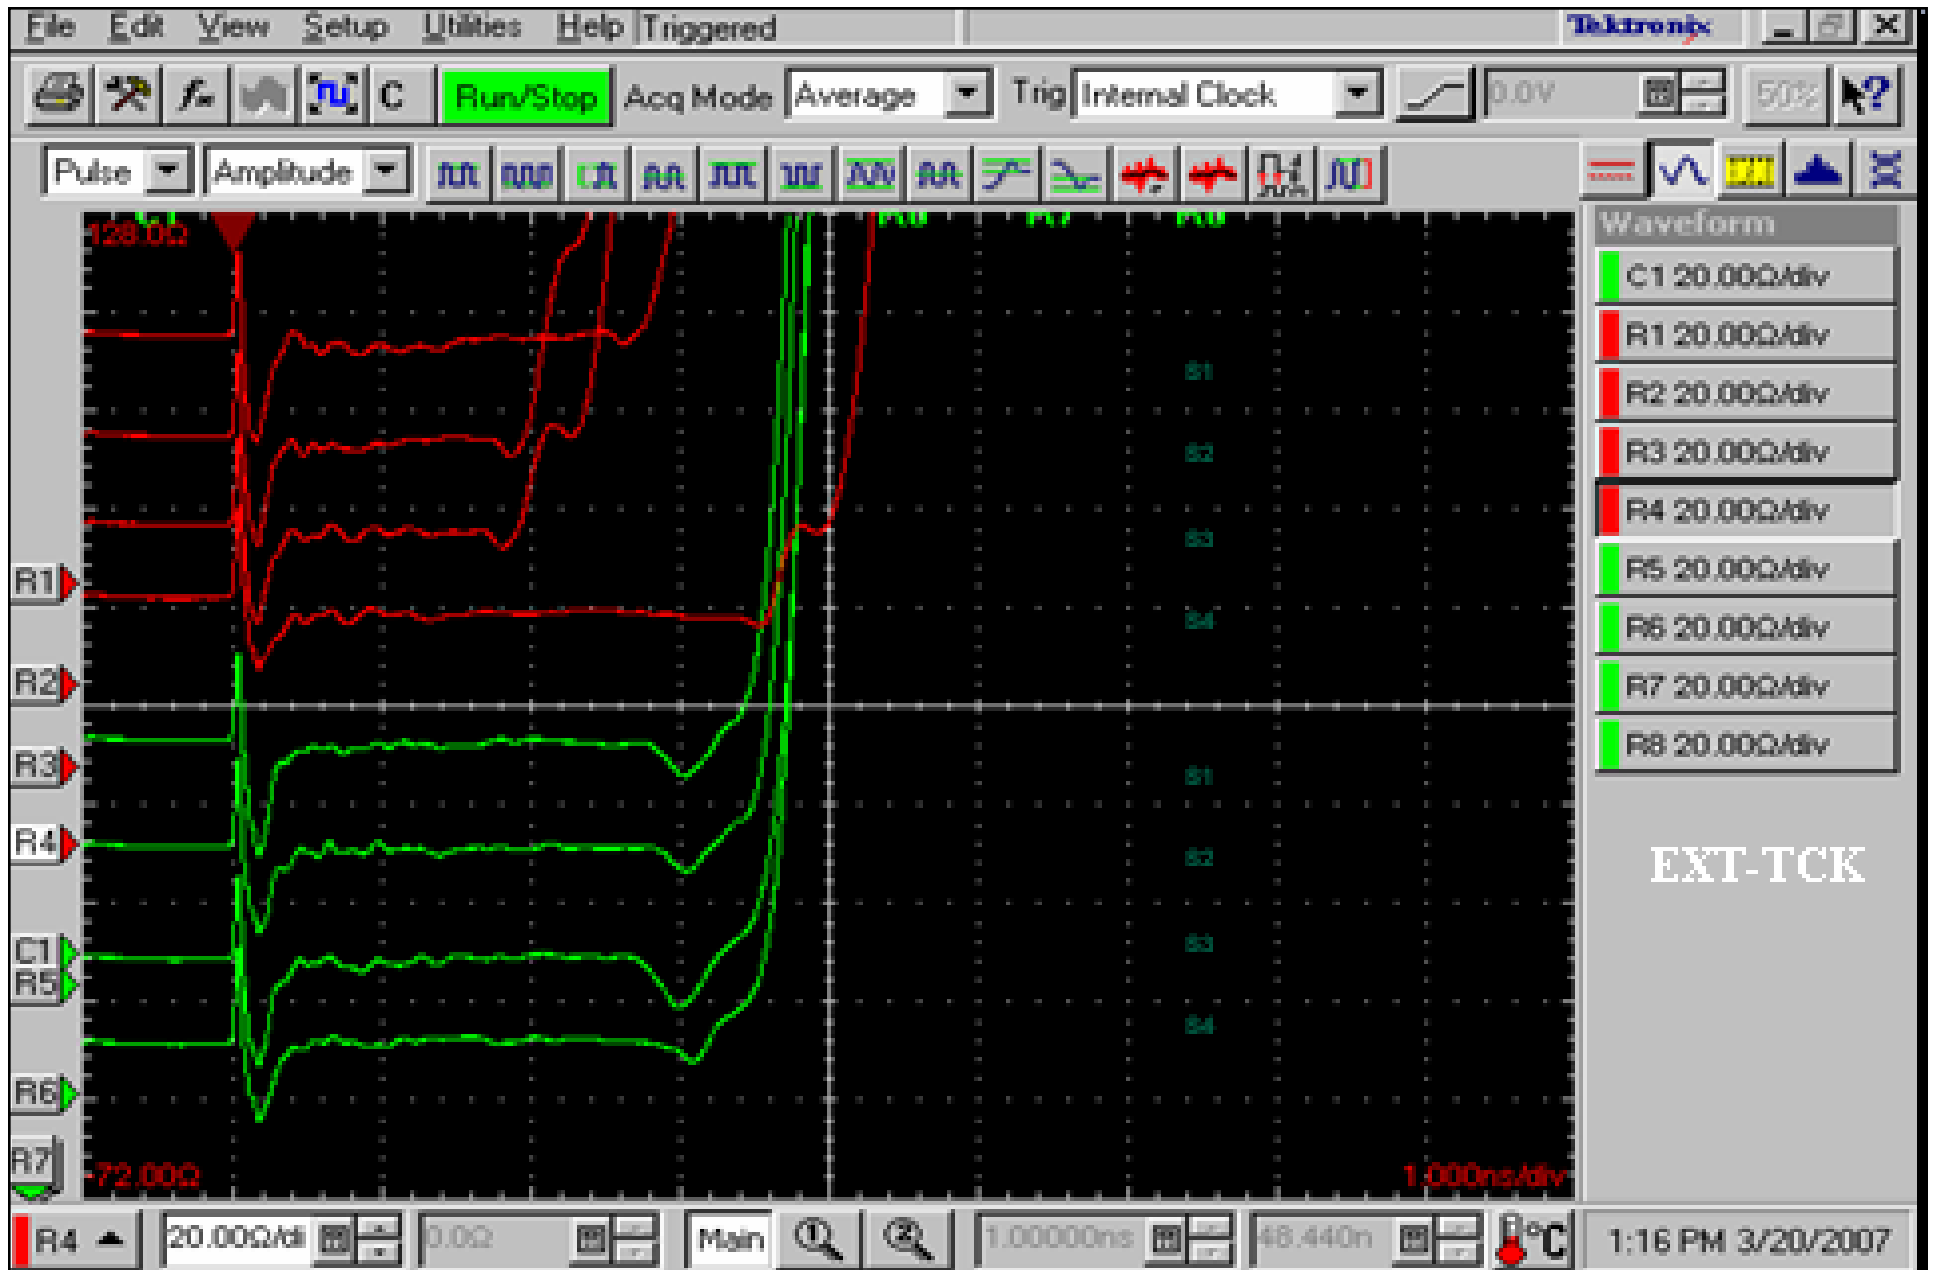
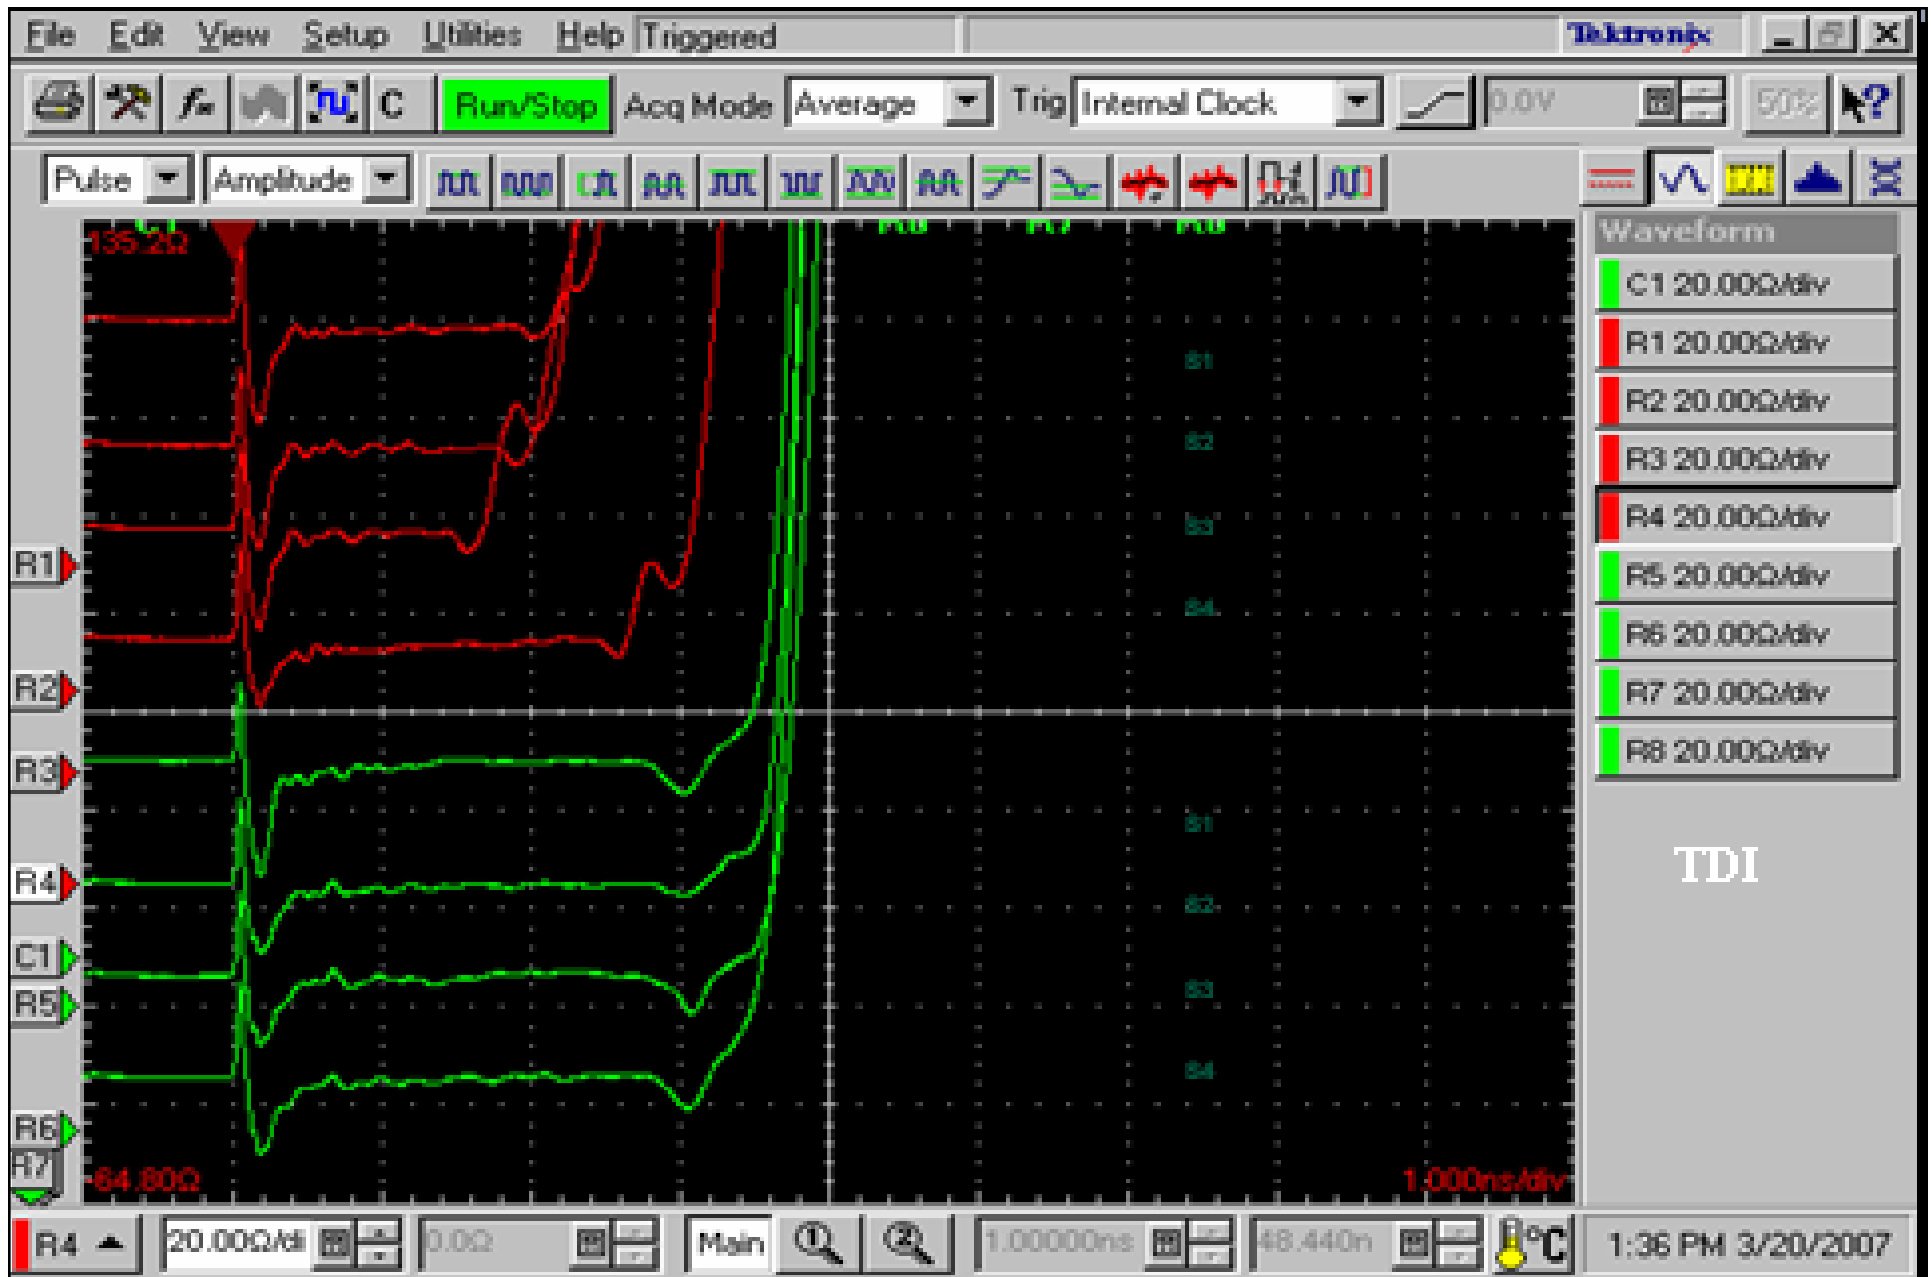
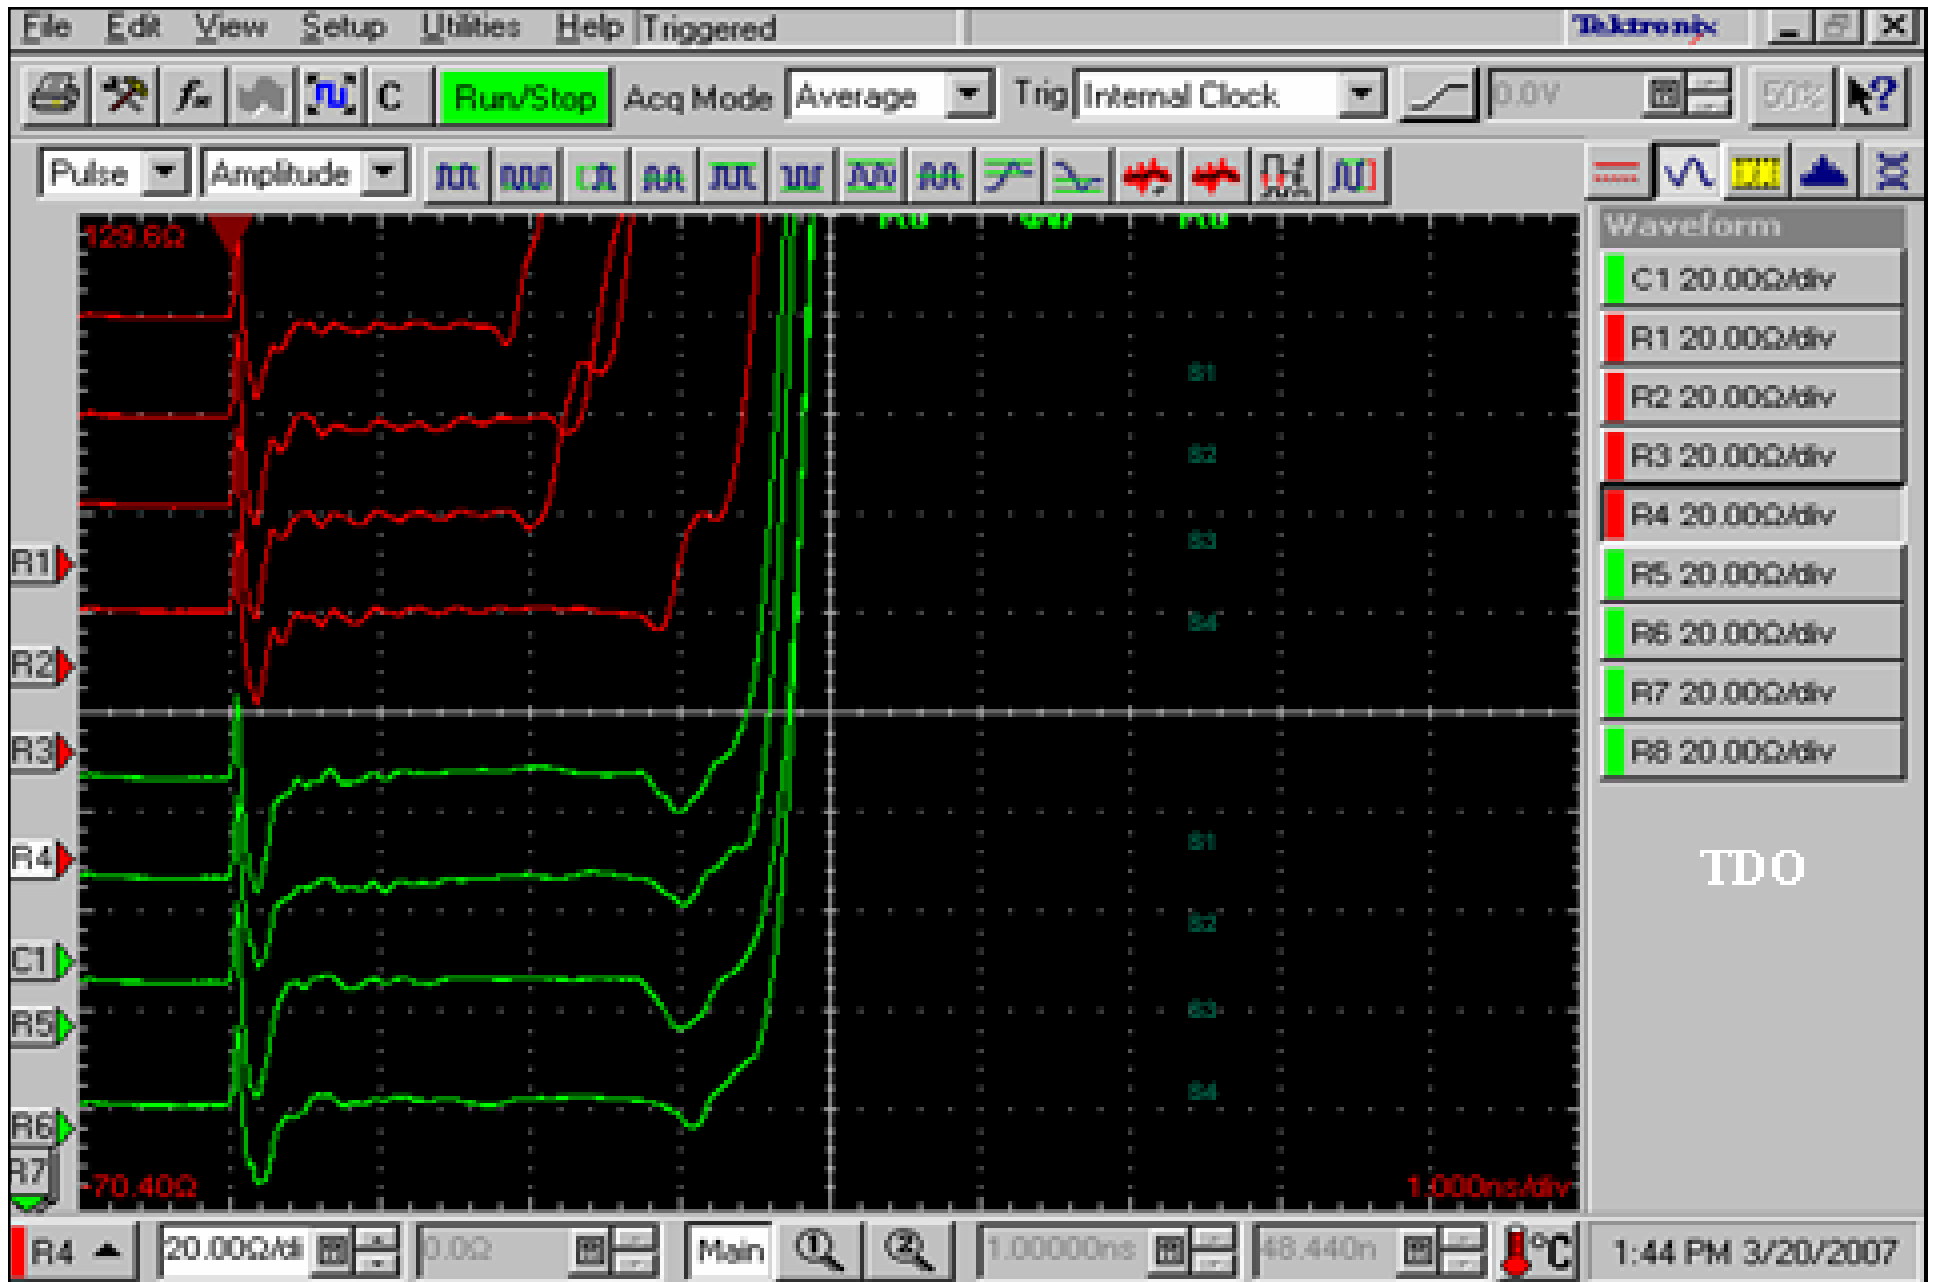
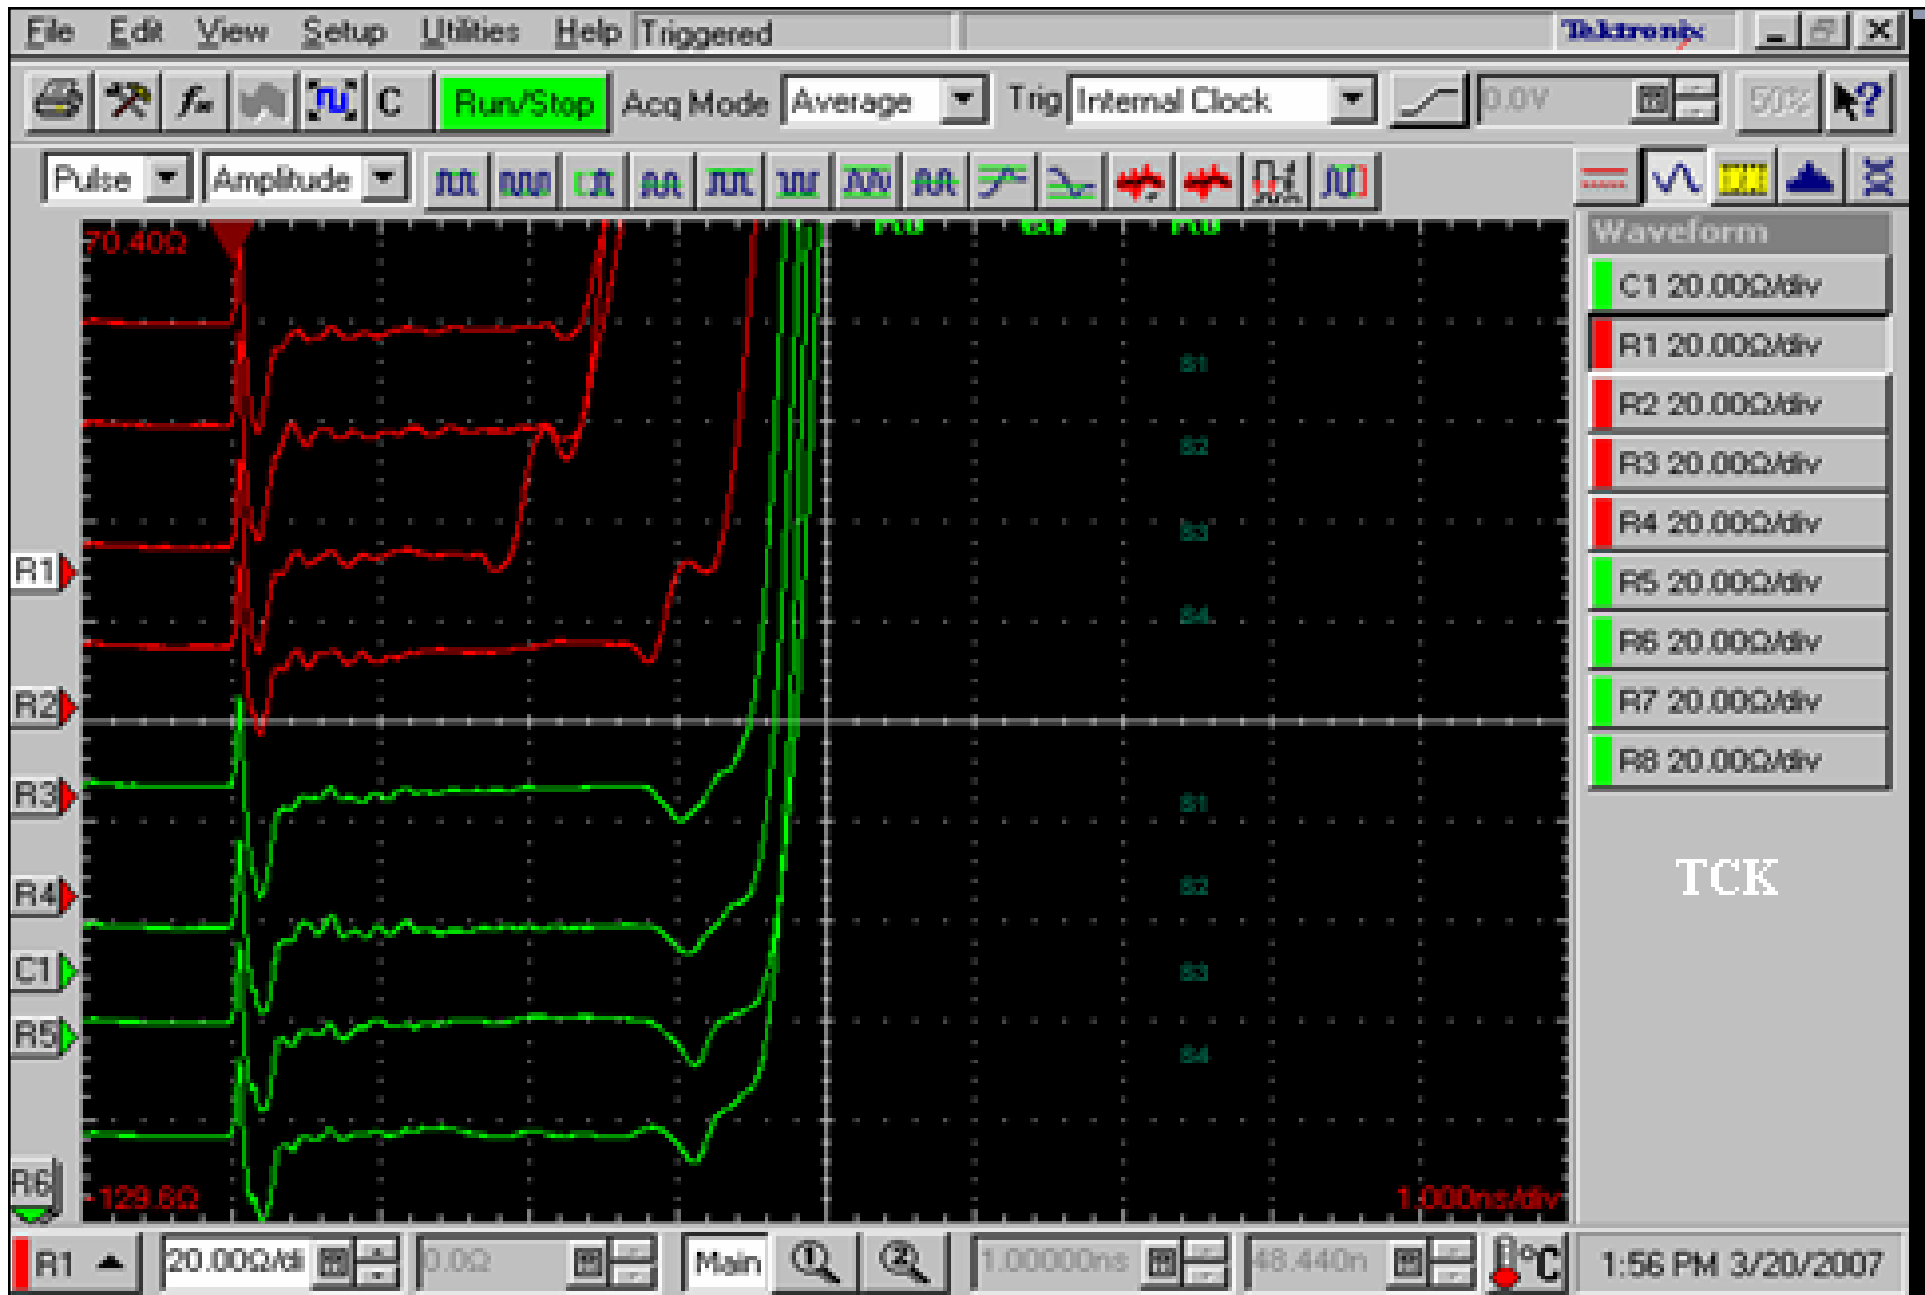
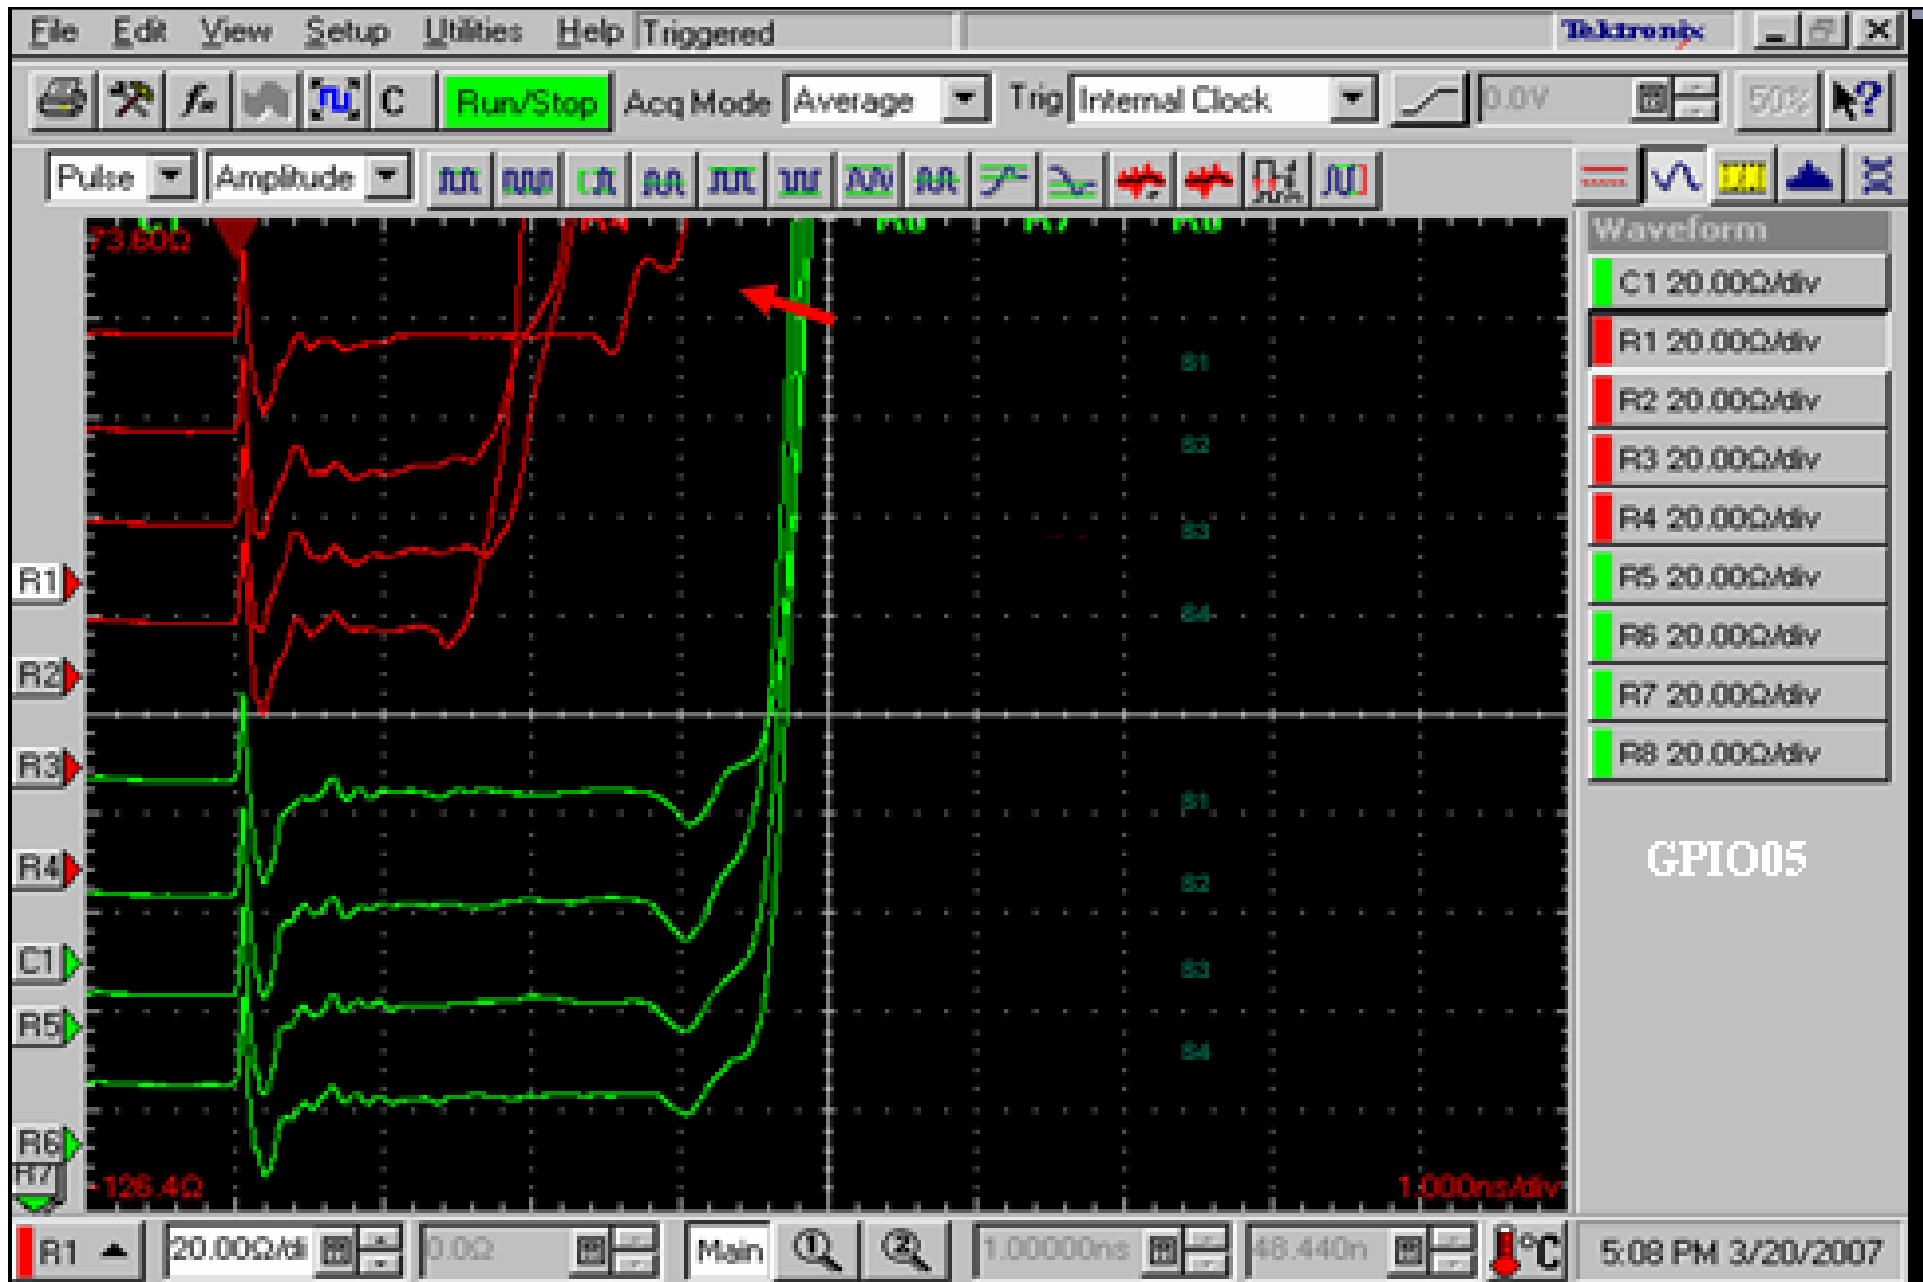
# Measurement Details

- The following slides are screen captures of comparison TDR measure between probe cards. **PC 1** standard build and component lay out, **PC 2** build with consideration to maintain site to site trace uniformity.

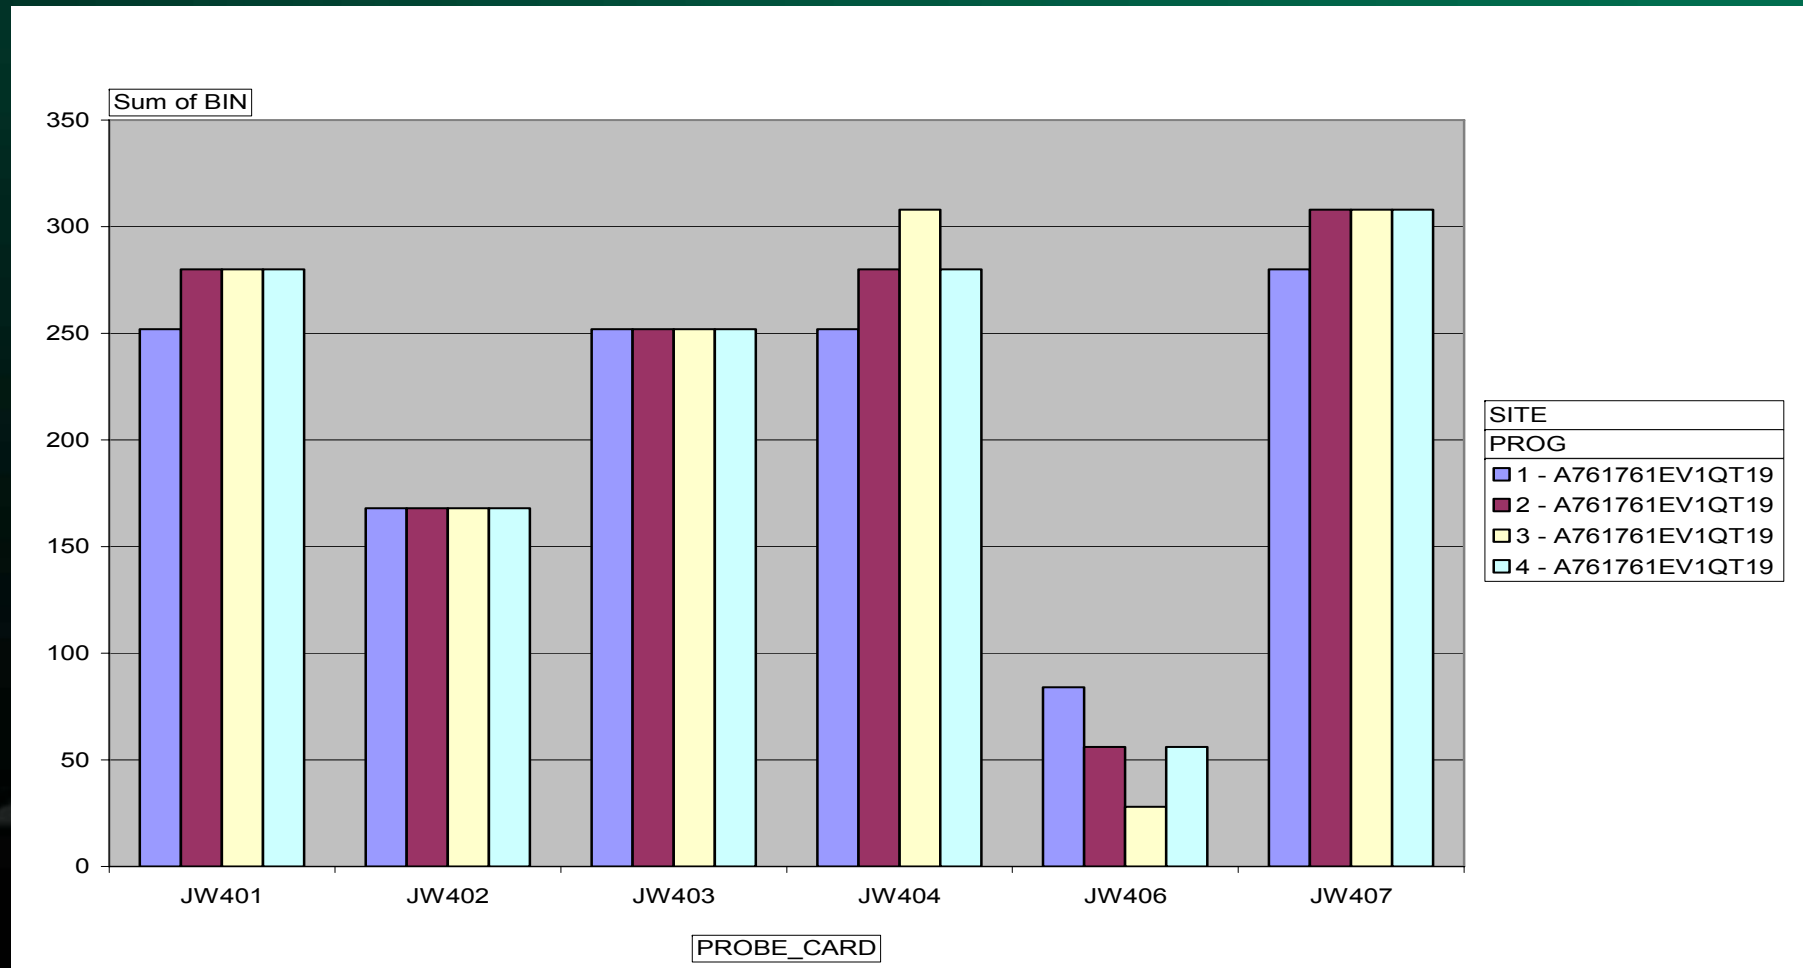
# S2S Yield Analysis

By Probe card W/ site match trace length (PC#2)

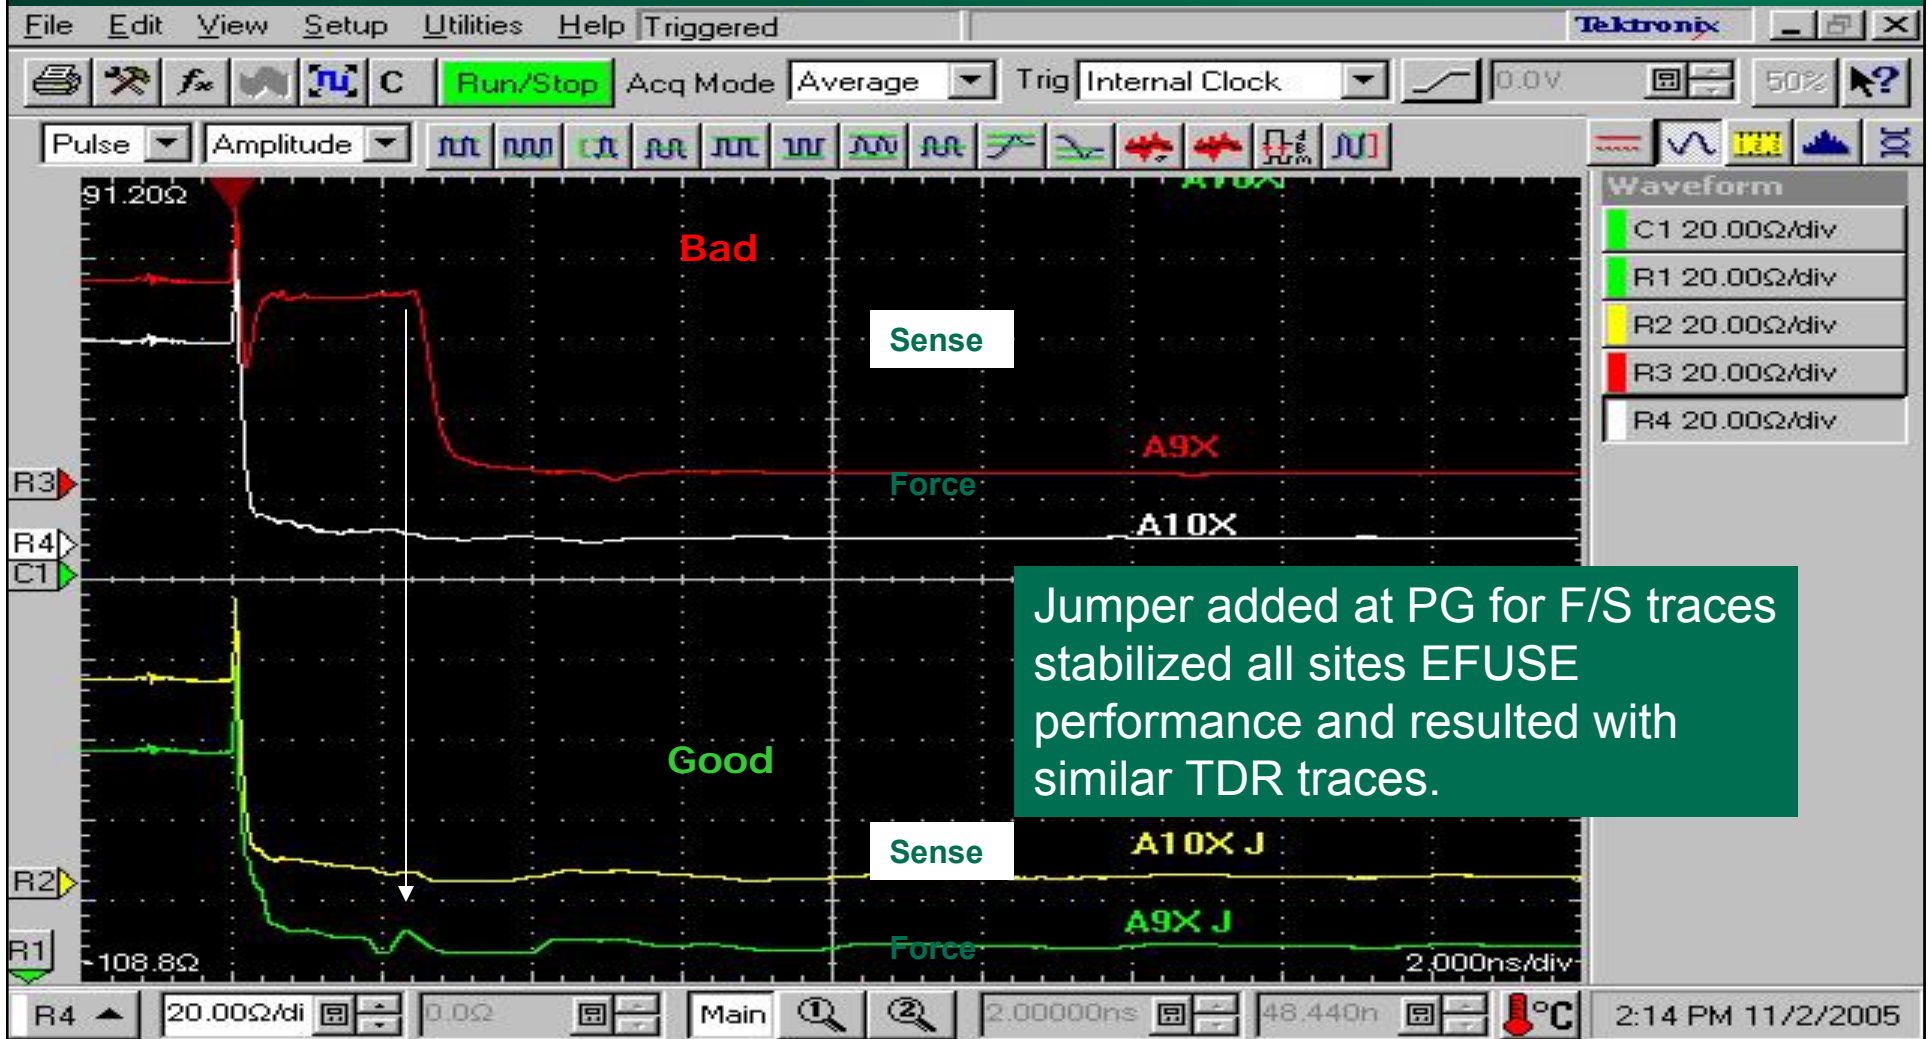
# TDR Analysis

- Suspect contact issue at contact pads or traces resistance and length (capacitive coupling) causing reduced current on fuse blow pulse.
- TDR trace comparisons of both VPP Power and Sense indicated an additional length between sense and power trace different than sites 1 thru 3.
- Fuse blow test performed after adding a jumper between the force and sense traces eliminated issue.

1. Original designer of the test program and probe card identify critical signal paths. Establish delta length limits as guides for signal types.
2. Probe card vendors implement TDR analysis as part of the standard probe card post build analysis. Trace information as well as analyzer data given as part of standard build specifications. If site / component complexity cause too high delta, the vendor should discuss the issue with the original designer to see if program adjustment can off set the issue.
3. Execute automated TDR analysis on repaired probe cards to eliminate high resistance issues as a result of all repair procedures.
