# Analysis for Pre-Mature Worn-out of Vertical Probe Needle

**Wiljelm Carl K. Olalia**  
Process Engineer II  
Probe and Die Sales Department  
ON Semiconductor Philippines  
June 5-8, 2016

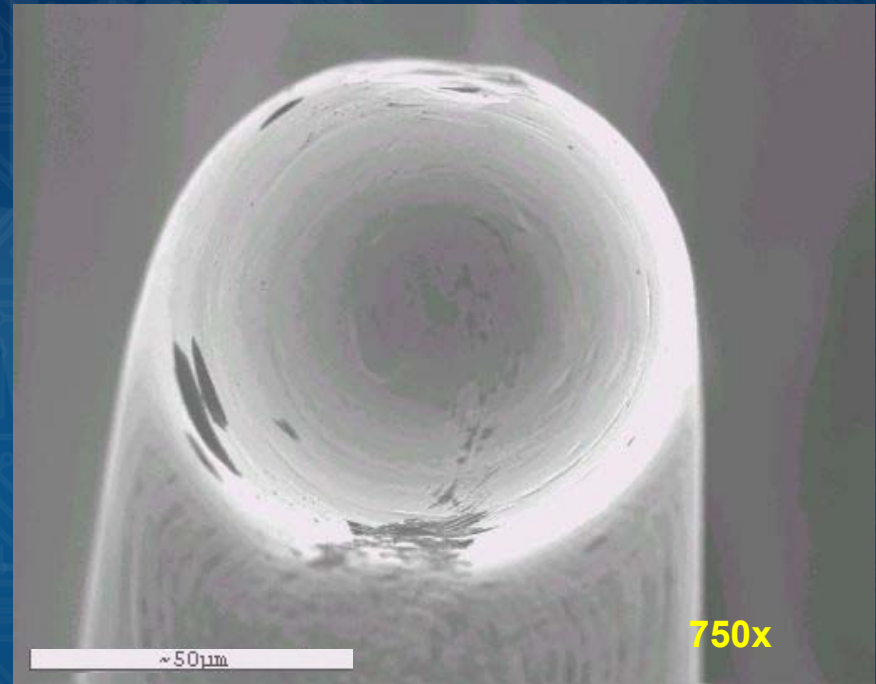
**New Probe Needle**

- Vertical needle verified to have a performance deterioration which is evident on the wafer yields.
- This deterioration is caused by needle tip deformation and debris accumulated on the needle tip which is not been removed by brush alone.
- Brush can only remove the cloudlike dirt but cannot re-shape and remove the debris on needle tip
- Yield deterioration is due to poor probe tip condition.

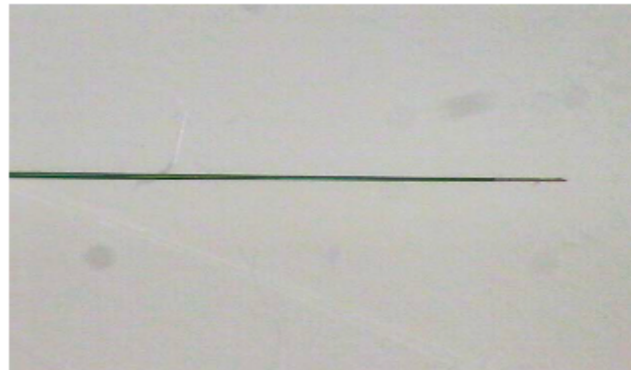
- The samples were analyzed using SEM+EDX. SEM morphologies showed no wearing problems on pin sites (4) and (7). EDX spectroscopy showed elemental composition of Silver (Ag), Palladium (Pd) and Copper (Cu) on all pins. Pins from Site (7) showed presence Aluminum (Al) w/c may actually coming from the Bonding pads of the die during testing. No Silicon (Si) were detected on Pins from sites (4) and (7) meaning the early wearing problem of pins from sites (1) and (2) were caused by the Silicon.

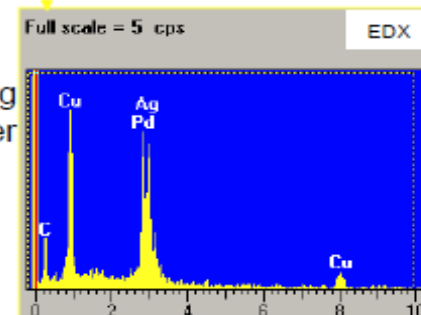
Figure 2. SEM+EDX results on Pin 4

SEM morphologies results on Pin site 4 showed no early wearing problem. EDX spectroscopy showed elemental composition of Copper (Cu), Palladium (Pd), Silver (Ag) and Carbon (C).

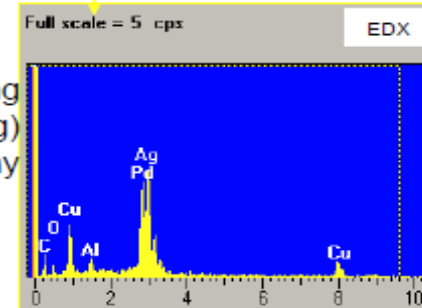
Figure 2. SEM+EDX results on Fresh Pin 7

SEM+EDX results on Pin site 7 also showed no early wearing problem. EDX detected also Copper (Cu), Palladium (Pd), Silver (Ag) and Carbon (C). Traces of Aluminum (Al) were also found w/c may come from the bonding pads.

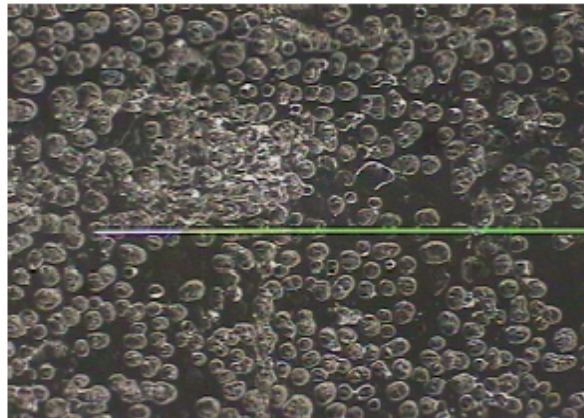
- Probe Pins were submitted to the Material Analysis and Evaluation Laboratory for Scanning Electron Microscope + Energy Dispersive X-ray (SEM+EDX) Analysis. Pins from Site (1) and Site (2) were reported w/ early wearing problem. A fresh pin was also submitted for correlation. SEM+EDX will verify any difference between the pins thru morphological and elemental composition analyses.
- The samples were analyzed using SEM+EDX. EDX spectroscopy showed elemental composition of Silver (Ag), Palladium (Pd) and Copper (Cu) on all pins. Pins from Site (1) and (2) showed presence of Silicon (Si) and Aluminum (Al) w/c may actually coming from the die during testing. Silicon in a form of glass or Silica ( $\text{SiO}_2$ ) is a harder material w/c can scratch the metallic pin during probe testing.

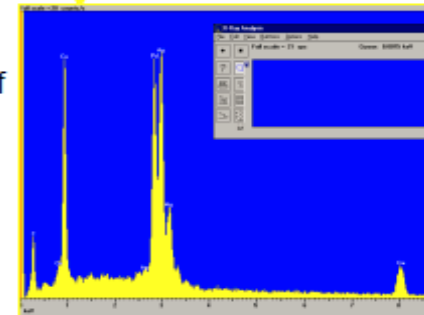
Figure 2. SEM+EDX results on Fresh Pin

SEM+EDX results on Fresh Pin showed elemental composition of Copper (Cu), Palladium (Pd), Silver (Ag) and Carbon.

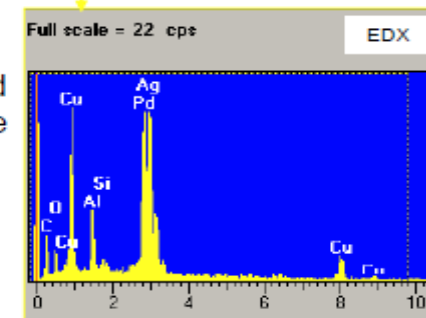
Figure 3. SEM+EDX results on Site 1 Pin

SEM+EDX results showed wear on Site (1) Pin. EDX detected presence of Aluminum (Al) and Silicon (Si) on the contact area of the pin.

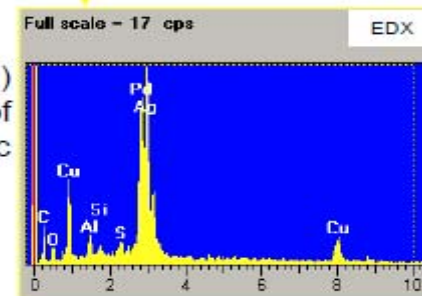
Figure 3. SEM+EDX results on Site 2 Pin

SEM+EDX results also showed wear on Site (1) Pin. Aluminum (Al) and Silicon (Si) are also present. Silicon in the form of passivation/glass ( $\text{SiO}_2$ ) is a harder material comparing to the metallic pins. The passivation can cause wear on the pins during contact.
