Practical Method For Detecting Hot-Stepping, Micro-Arcing Or Hot-Switching During Wafer Probe

Enrique Guerra (Author) Imran Ahmed (Presenter) Texas Instruments Inc.

June 2-5,2019

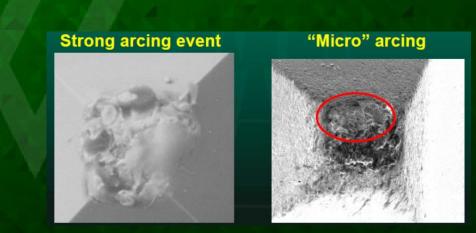
Probe Tip SEM pictures from Huebner et al, FFI

Effect produced at the contact point(s) such as probe tips during a Hot-stepping or Hot-switching event. It's arcing at a micron level with varying degrees of severity.

Per Studnicki et al, "arcing caused by the electric field will melt the surface of the tip and will create miniature craters"..."is an electrical breakdown of gas which produces an ongoing plasma discharge and results in a current flow". For gaps <5-7um, the breakdown is caused by "field emission and electrons tunneling" rather than gas and this "will happen at voltage differences below 1V at nm gaps" [Studnicki et al].

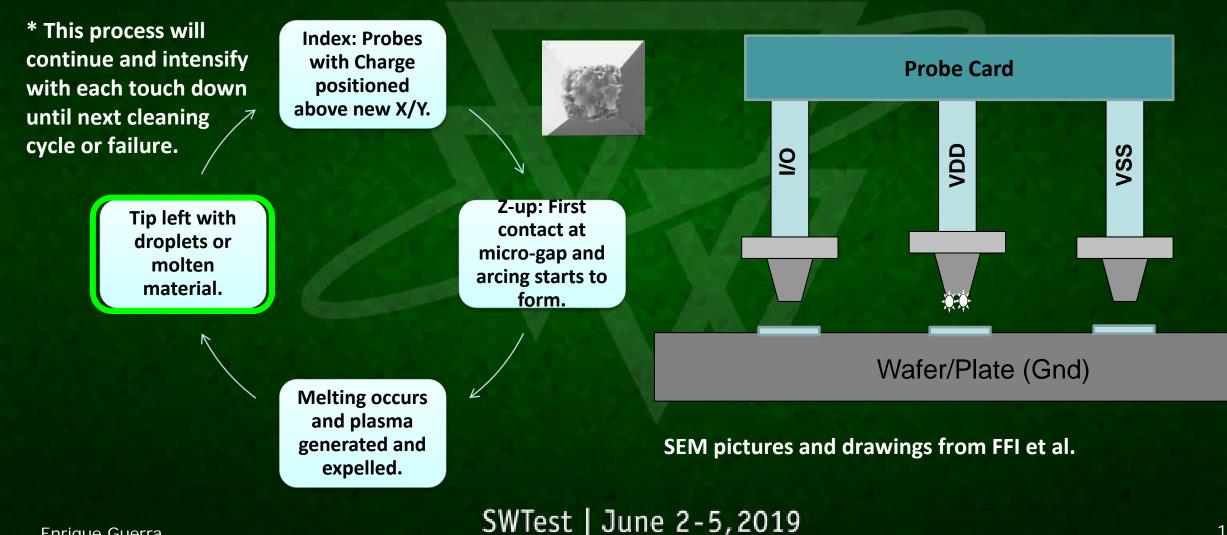
Stages of micro-arcing during a hot-stepping event:

- Initially, yield loss and damage may not be apparent or easy to detect specially on high pin count probe card designs.
- Damage is accumulative and depending on frequency and severity noticeable effects may require a considerable amount of events.
- First noticeable effects will typically correlate with functional and/or Cres sensitive failures.
- After many repeated events and damage, gross Cres and/or continuity failures will start to appear.
- Ultimate accumulative damage will likely require probe tip replacement or probe card rebuild.
