On Membrane Attenuators for 60 GHz Loopback

Transceiver Testing

Herve Pozin-Roux - ST Nicolas Falcot - ST Philippe Tribolo - ST Benoit Gubert - ST Ernie McReynolds - FormFactor Gabriele Vittori - FormFactor Andrew Nelson - FormFactor

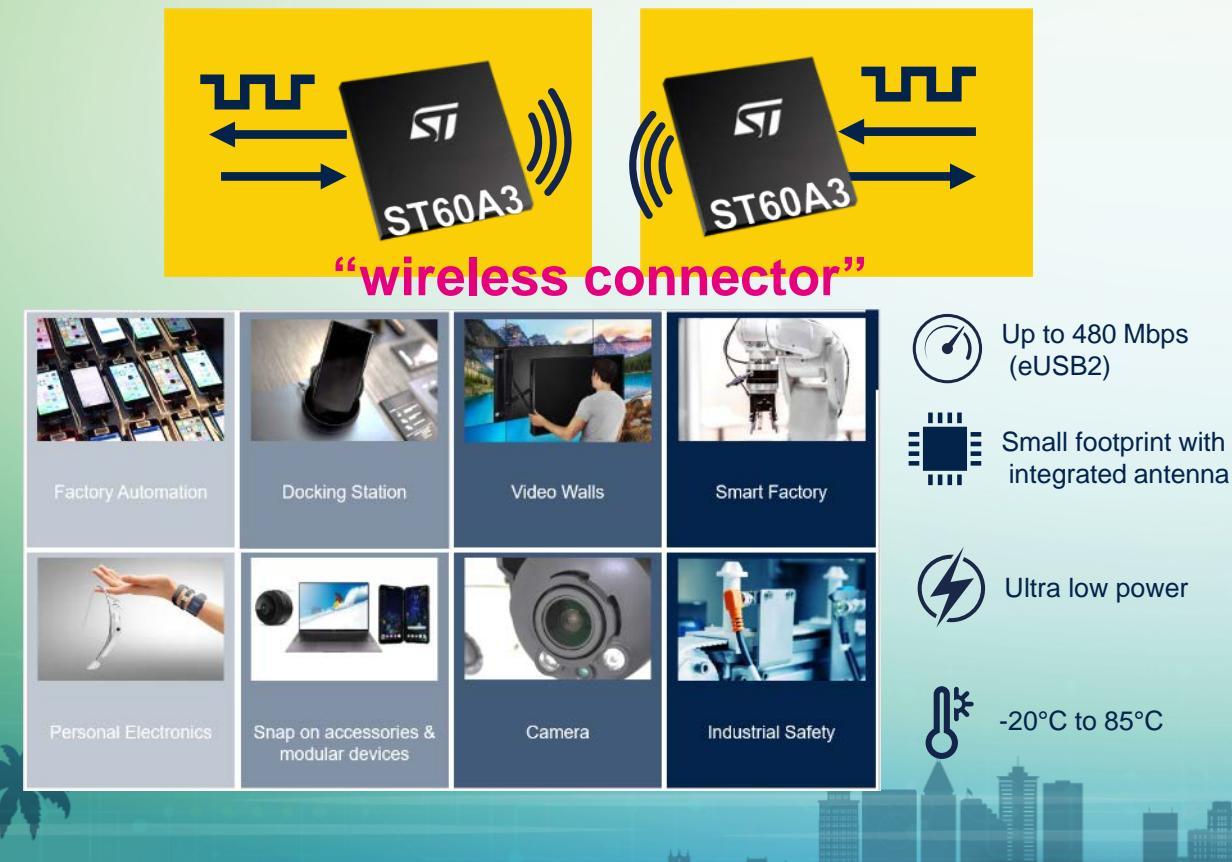
STMicroelectronics ST60A3

60 GHz V-Band transceiver for contactless connectivity up to 480 Mbps

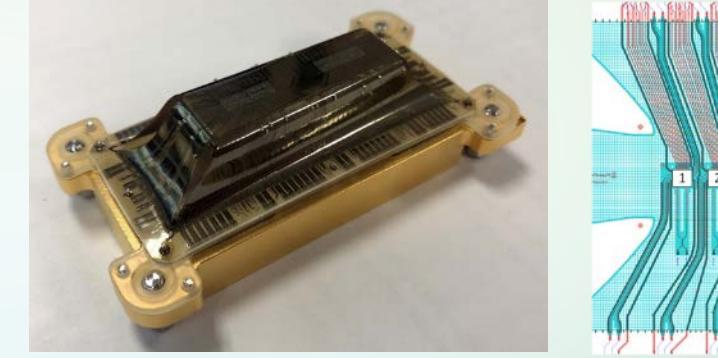
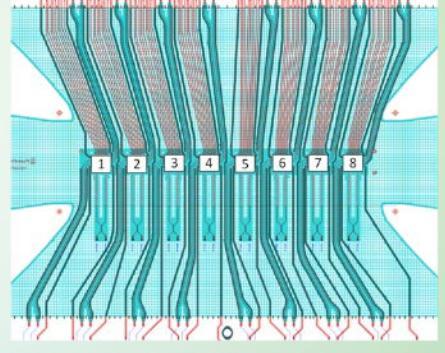
FormFactor Pyramid Probe P800s

Most widely qualified wafer test solution for production test

- Frequency range to 67 GHz with better than -10 dB Return Loss (RL) to maximize test accuracy out to specified frequency
- Multi-site 5G antenna and RFFE die testing
- Probe geometries engineered for low contact resistance on pads and solder

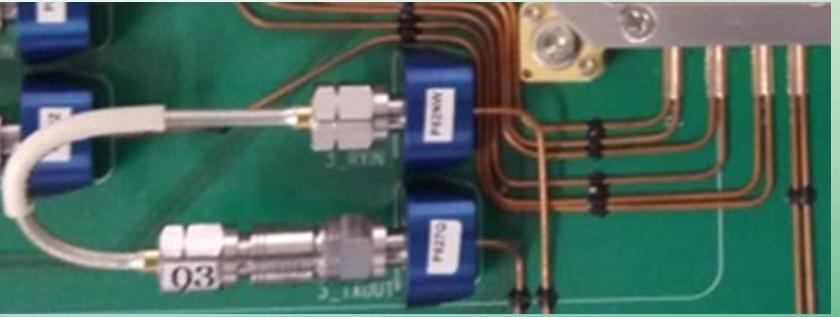
- Loopback path needs a high level of attenuation to ensure the transmitter (Tx) doesn't saturate the receiver (Rx).
- Wafer on bump testing
- Use x8 parallelism

Tx and Rx blocks are tested by looping one to the other:

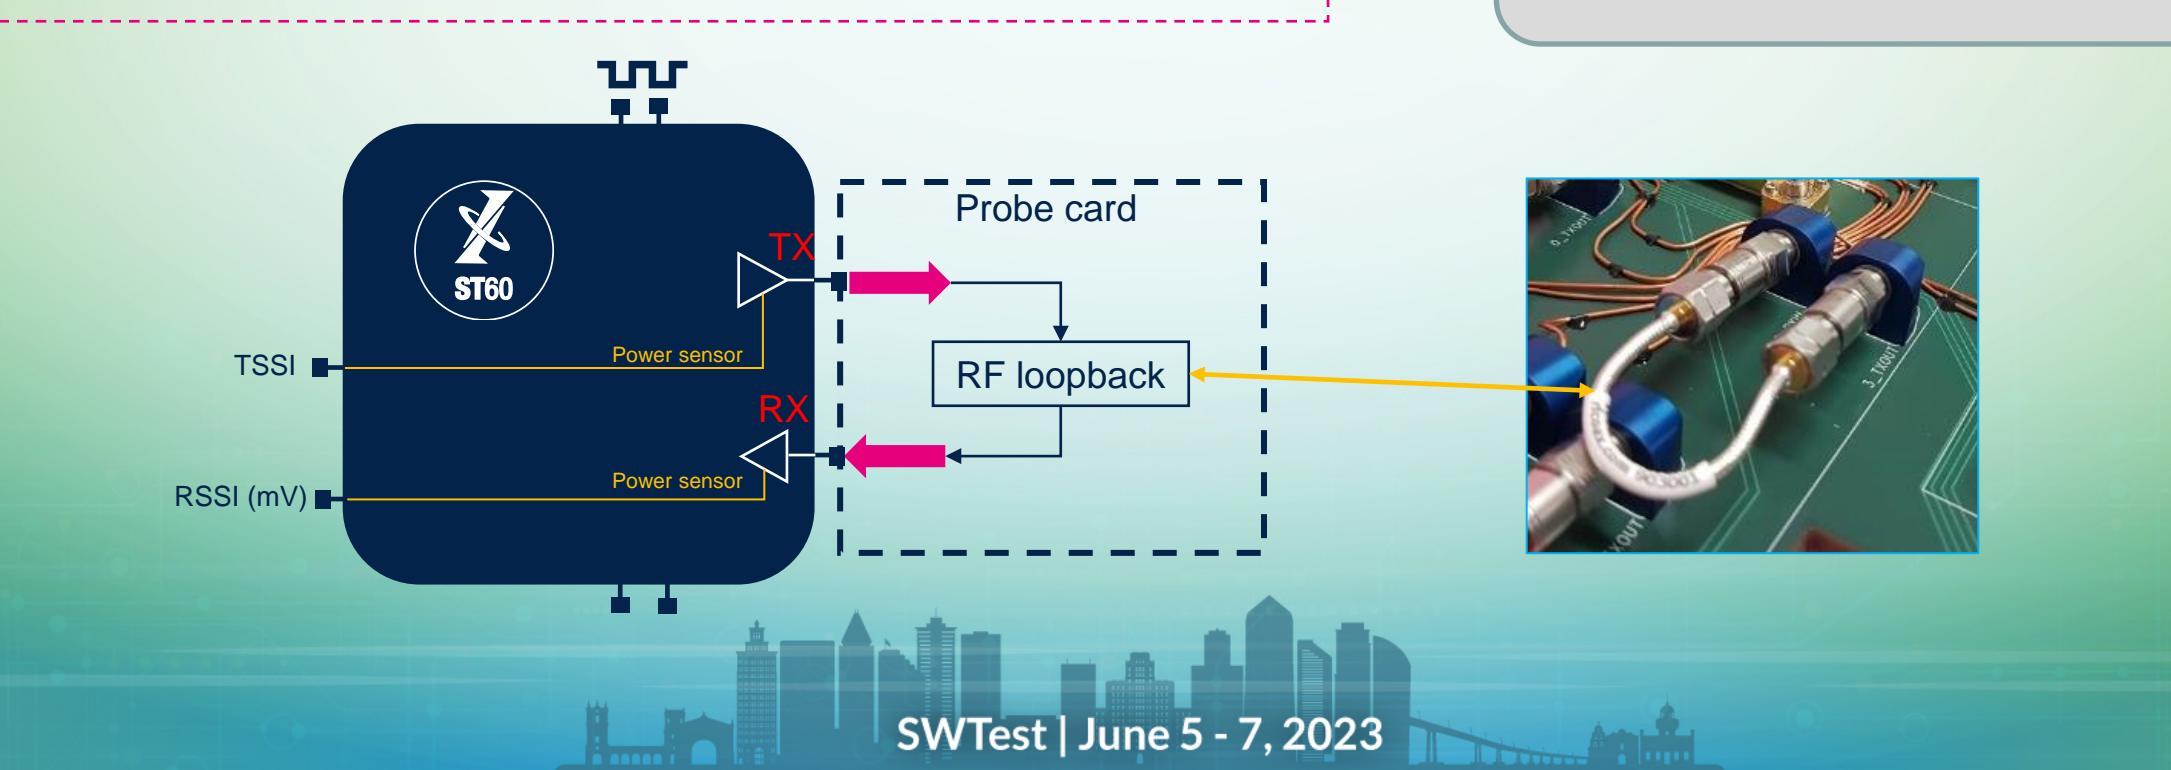
• Output power at TX

- P_{OUT} calibrated at fixed level and verified through TSSI (Transmitter signal strength indicator)
- Input power at RX
 - P_{IN} at RX is evaluated from RSSI (Receiver signal strength indicator) measurement on ATE (in mV)

This presentation focuses on RSSI data collection

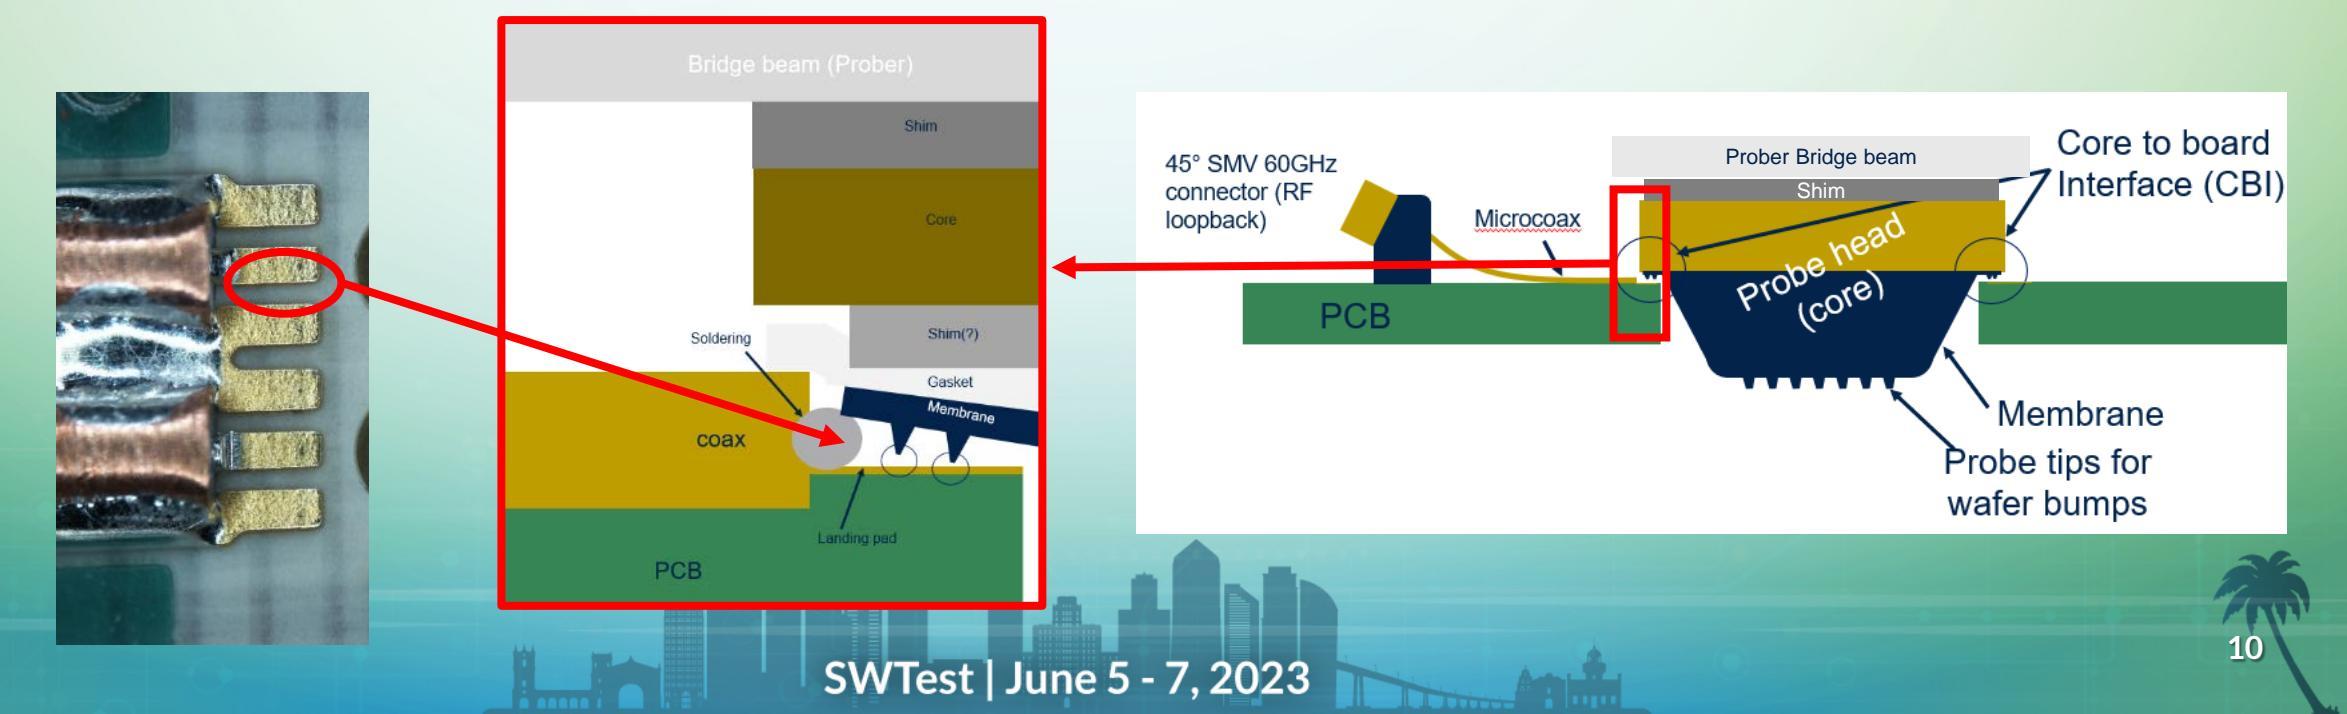
Core + PCB Testing

Observation: Not all bumps at the CBI make contact with the PCB pad.

Hypothesis: Interference between membrane & coax makes only 1 contact/imprint at CBI.

- Built a model to study bump & pad.
- Model shows no significant difference with 1 or both bumps touching down on PCB
- Kapton tape is 30 um thick and produced a 3 dB effect. (similar difference in RSSI)

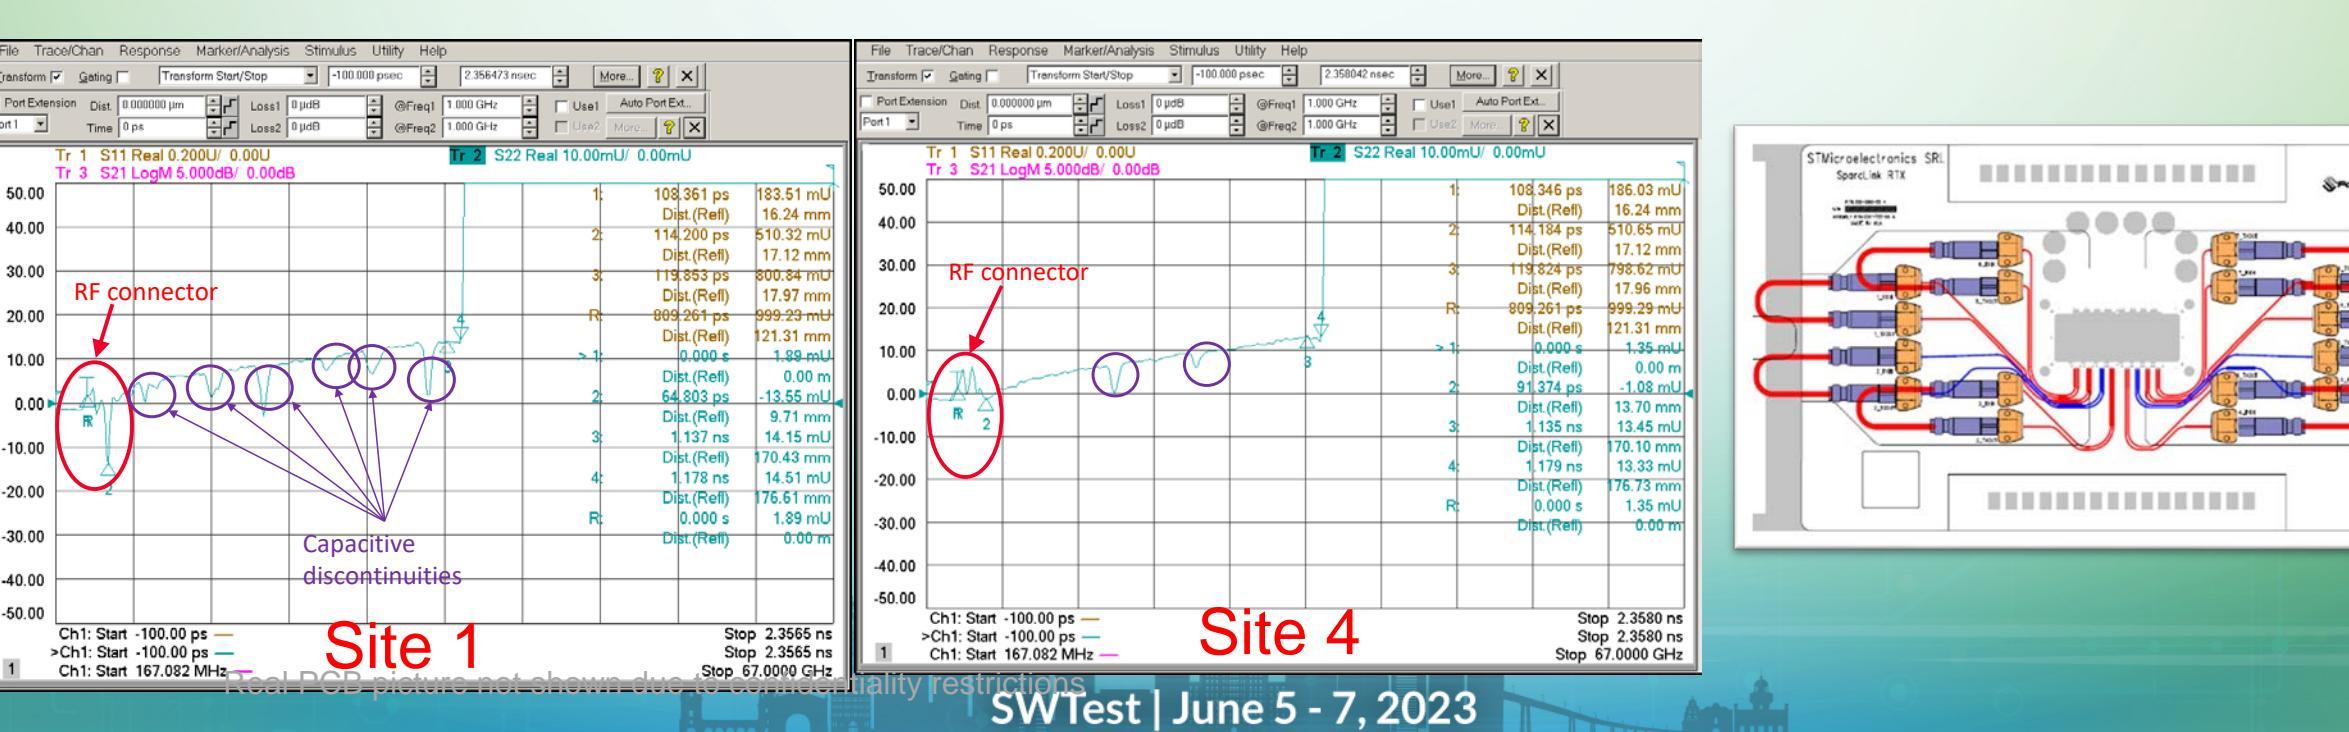
Semi Rigid Cable

Observation: Semi rigid cable was length matched (600 ps +/- 2.5 ps) but some had more bends than others.

Hypothesis: Bends in cable causing discontinuities that are leading to attenuation issues.

- Minimum on sites 4 & 5 and most on 1 & 8. (also max number of cable bends)
- It's known that there is about 3 dB difference between site 1 and site 4.
- IL measurements of site 1 & 4 show < 0.2 dB difference.

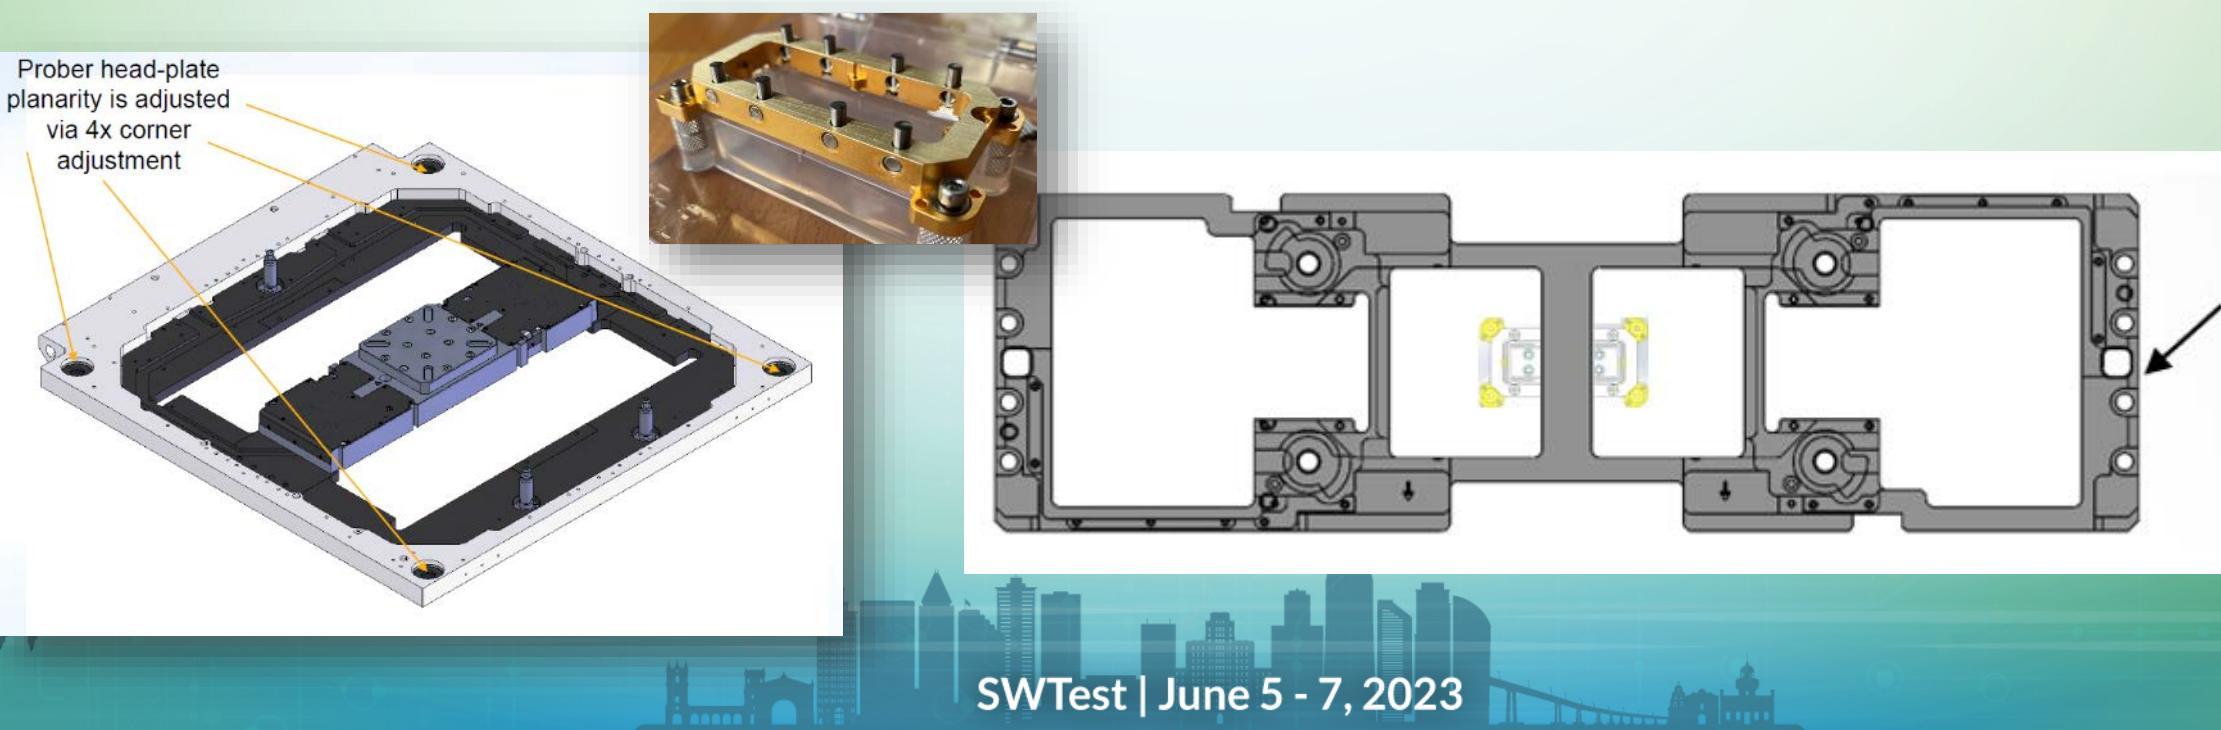
Bridge Beam vs Core Interference

Observation: Different test cells were producing different results for the same Probe Card (PC)

Hypothesis: Lack of planarity and uniform pressure of the bridge beam and core was causing attenuation issues.

- Special fixture was designed and manufactured to measure the interference
- It was found that the planarity and interference was within spec for the test setup

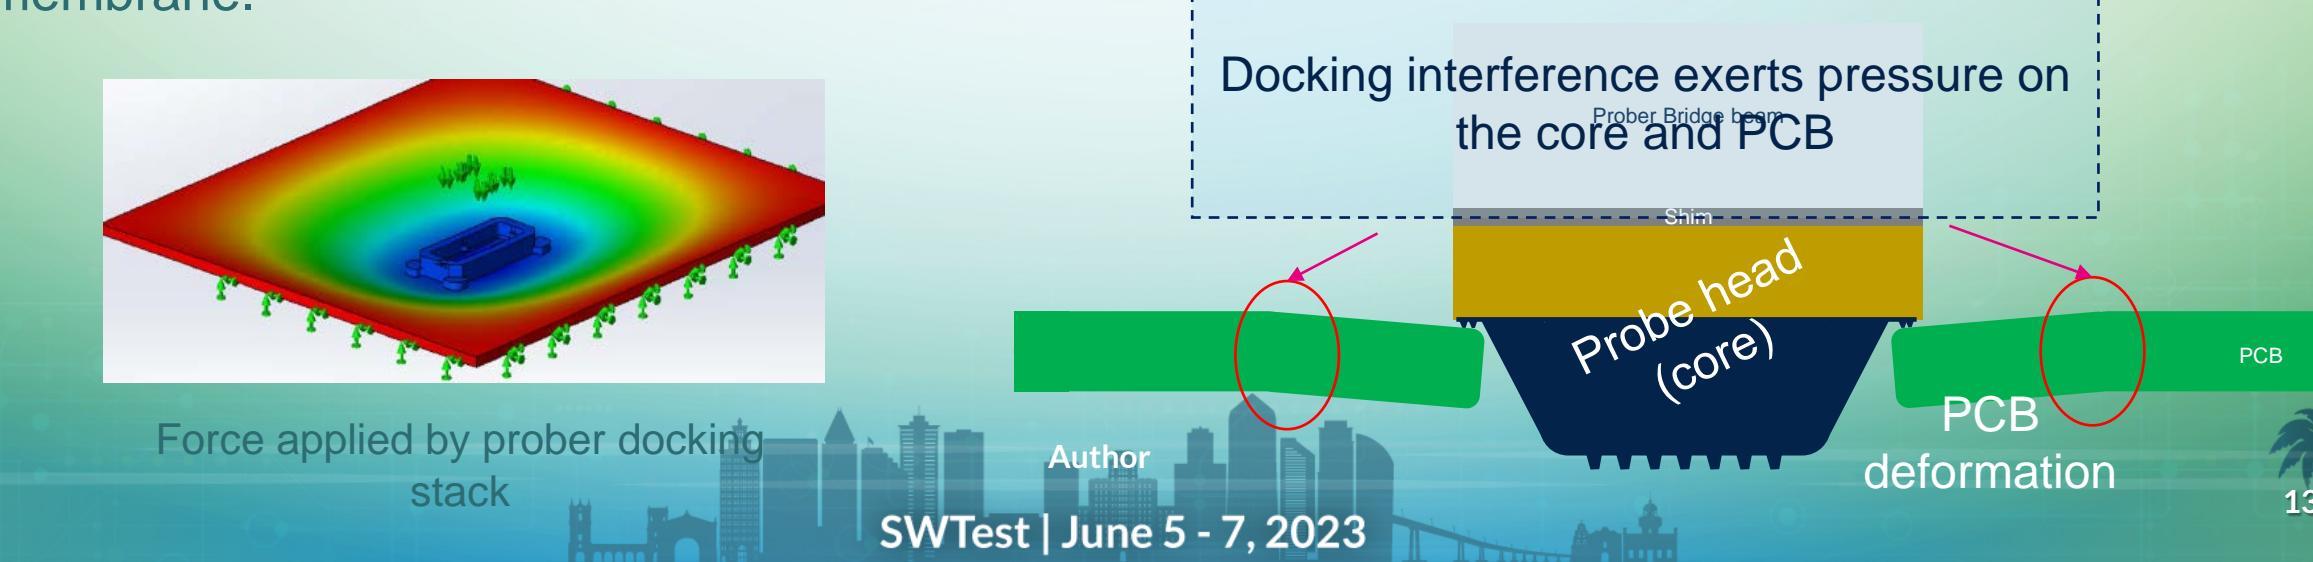
Bridge Beam Interaction

Observation: Numerous configurations have shown that mechanical forces negatively impact the RSSI.

Hypothesis: There is a PCB + Core interaction that affects the RSSI measurements

- Using combinations of shims, docking and undocking, tape and Over Drive (OD) it was possible to affect the RSSI level measured.
- This effect was not seen on any other application. Was unique to this design.
- Bridge beam interaction effects were eliminated by moving all attenuators from the PCB to the membrane.

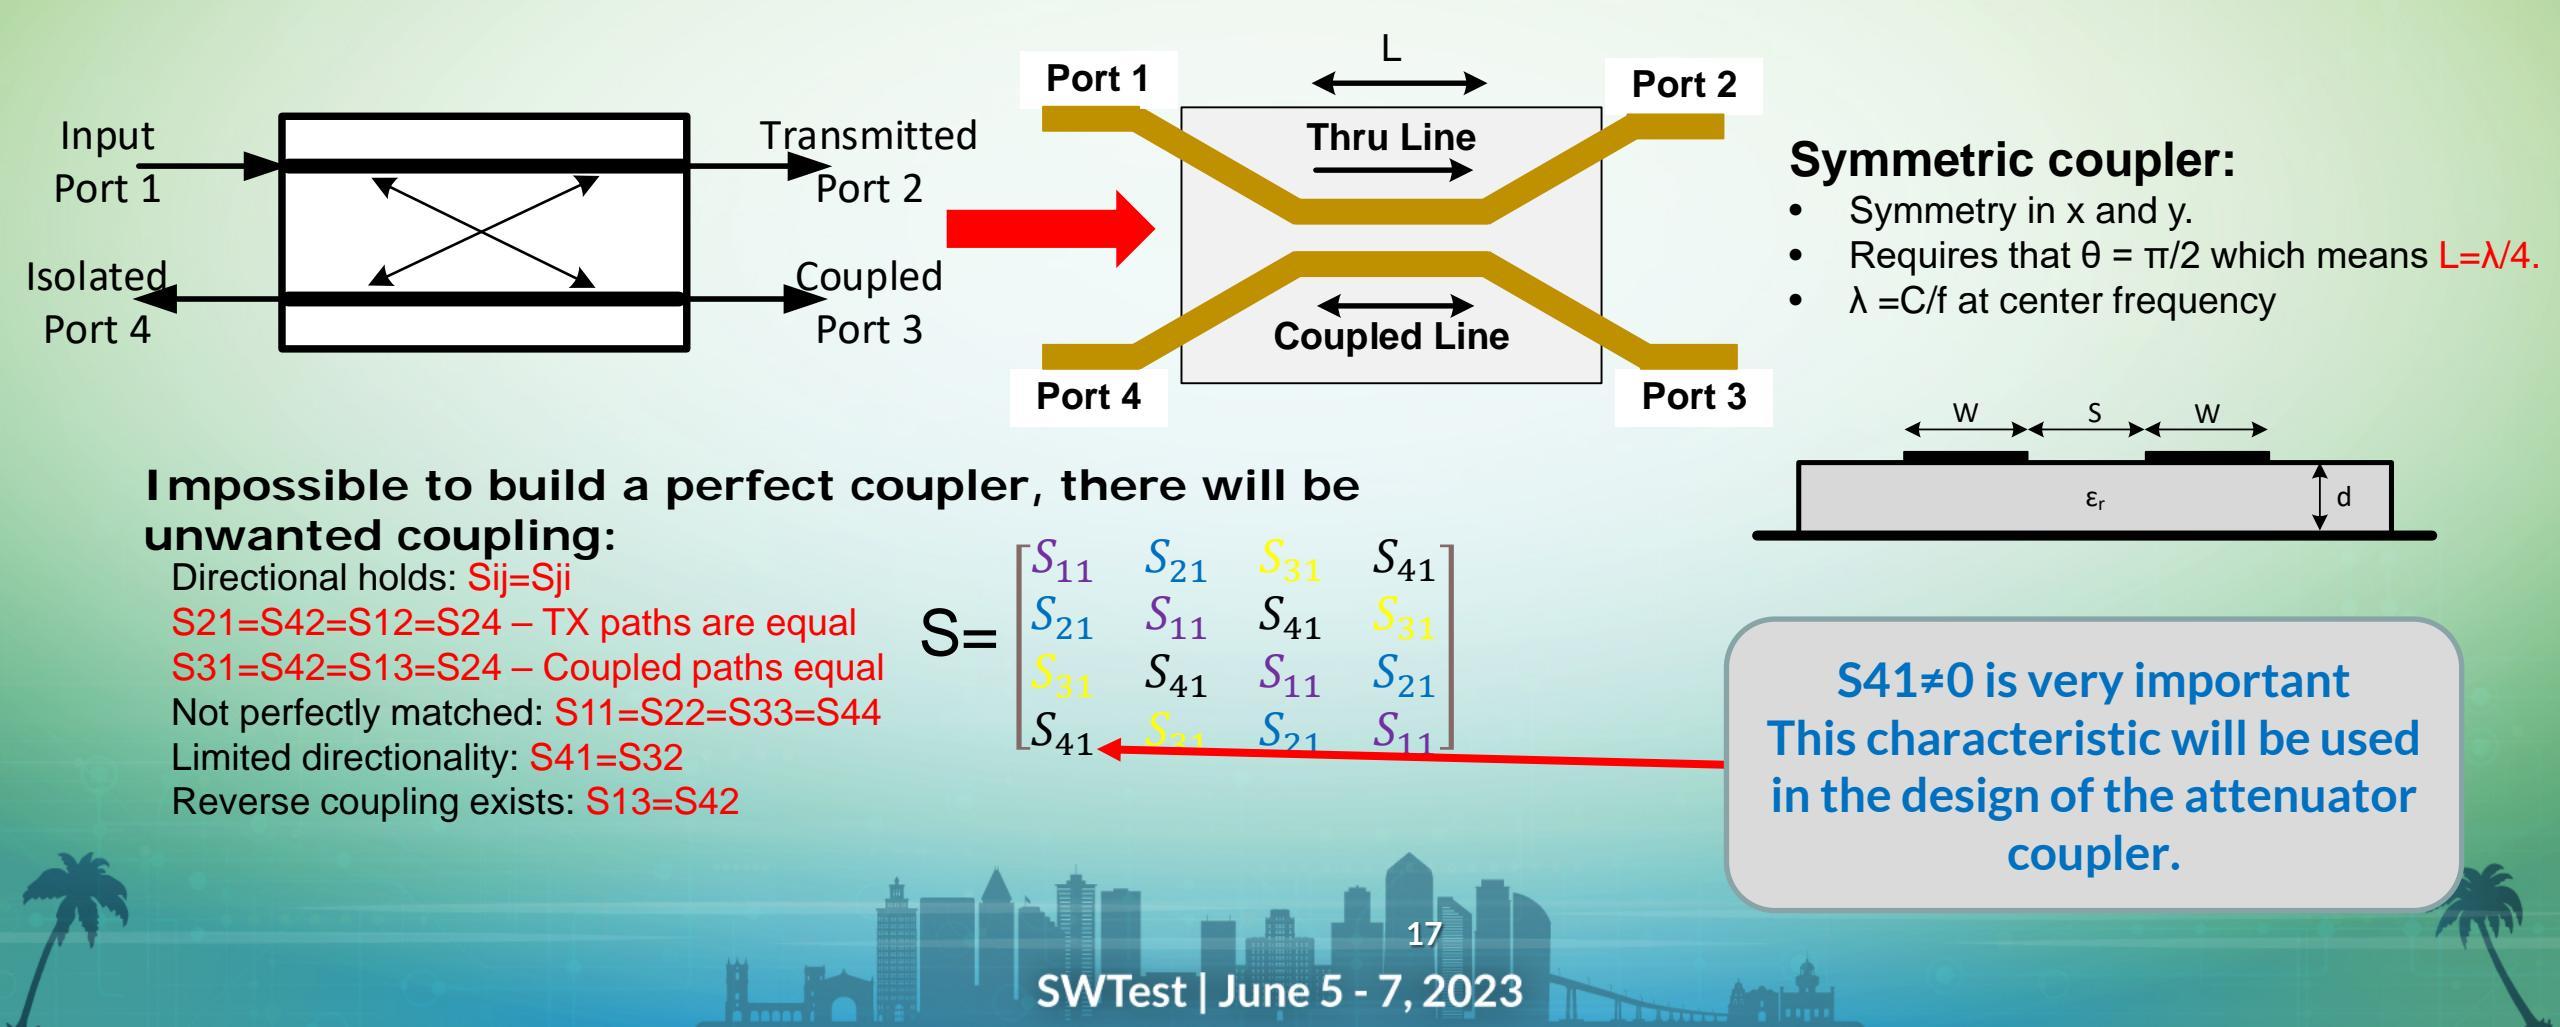
Coupler Theory

Coupler Definition (Ideal): Directional device where power suppled to port 1 (input) is coupled to port 3 (coupled port) while the remaining power is delivered to port 2 (transmitted port). <u>There is no power at port 4 (isolated port)</u>.

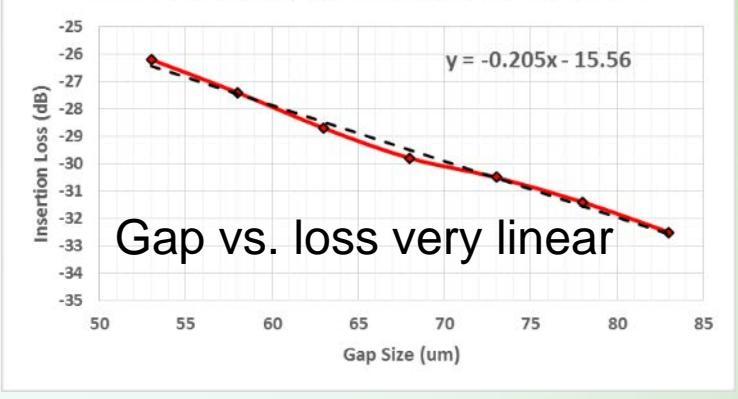
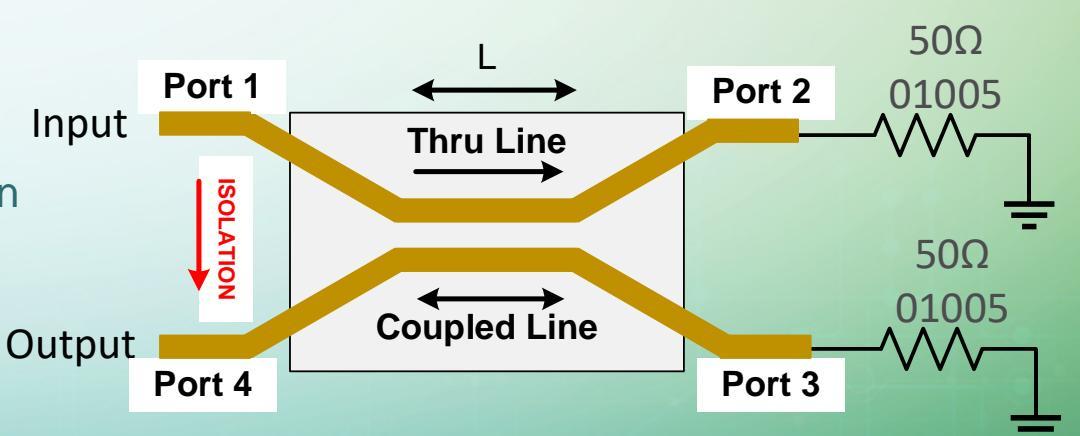
Attenuation (S21) vs. Gap Size @ 60 GHz R1005

- FFI membrane design rules provide excellent line width control for microwave circuits.
- With FAB variations of +/- 2 um allows us to hold the center attenuation to +/- 0.4 dB
- Designed on 2 metal layer membrane
- Coupler attenuator technology available for new membrane design.

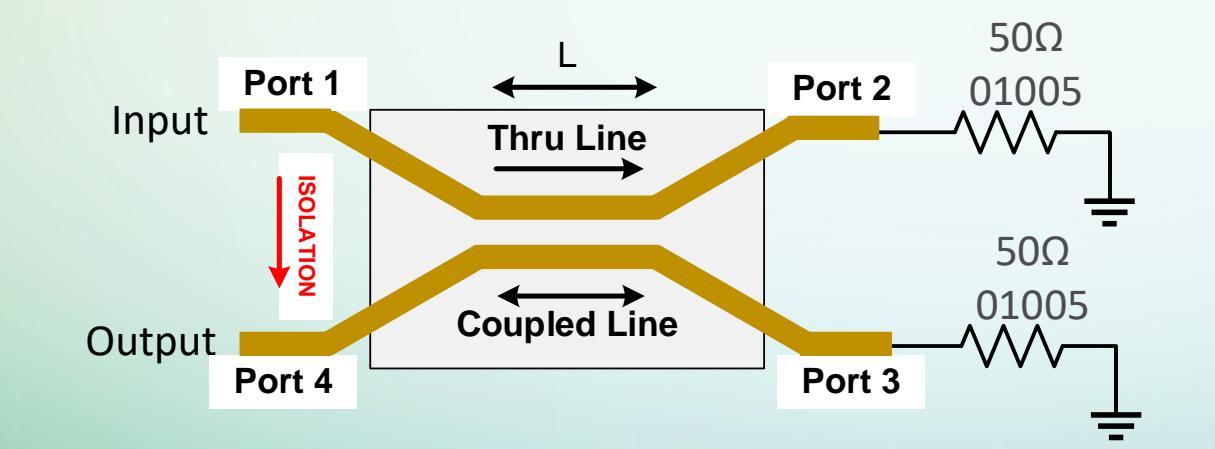
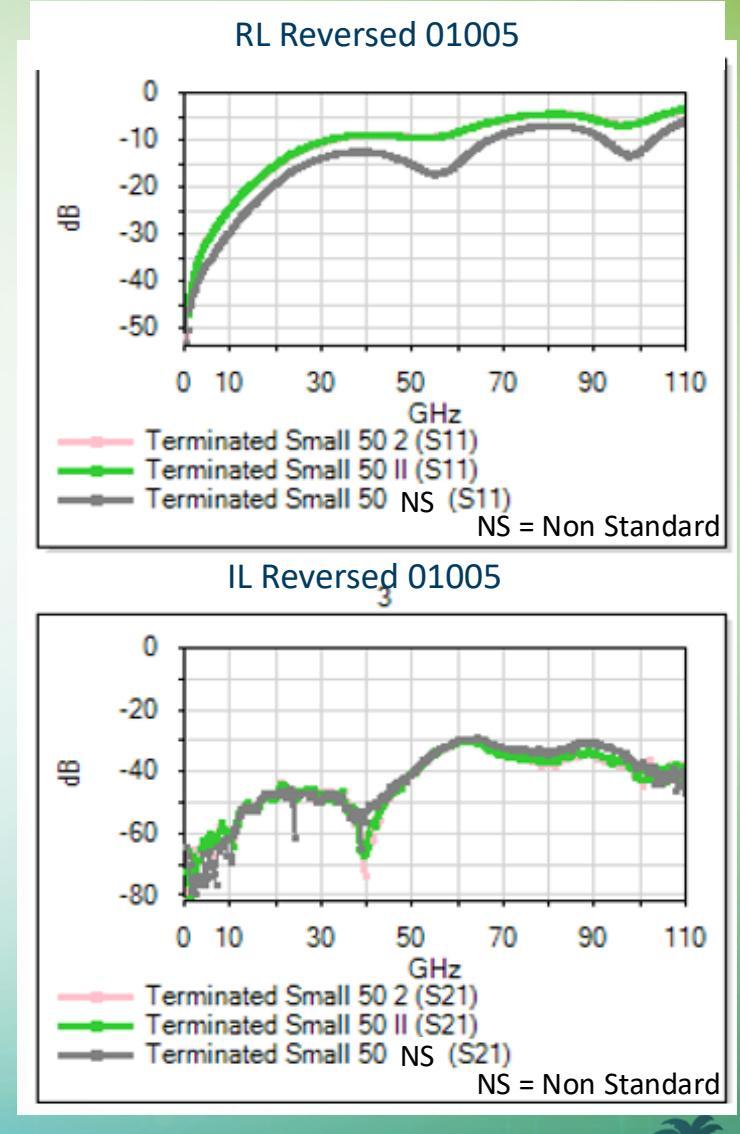
50 Ohm Trick

- Observed large improvement when the resistor is mounted in a non-standard configuration.
 - Normal: RL < -10 dB @ ~30 GHz
 - Non-standard: RL < -10 dB @ ~65 GHz
 - Best used with 60 GHz coupler

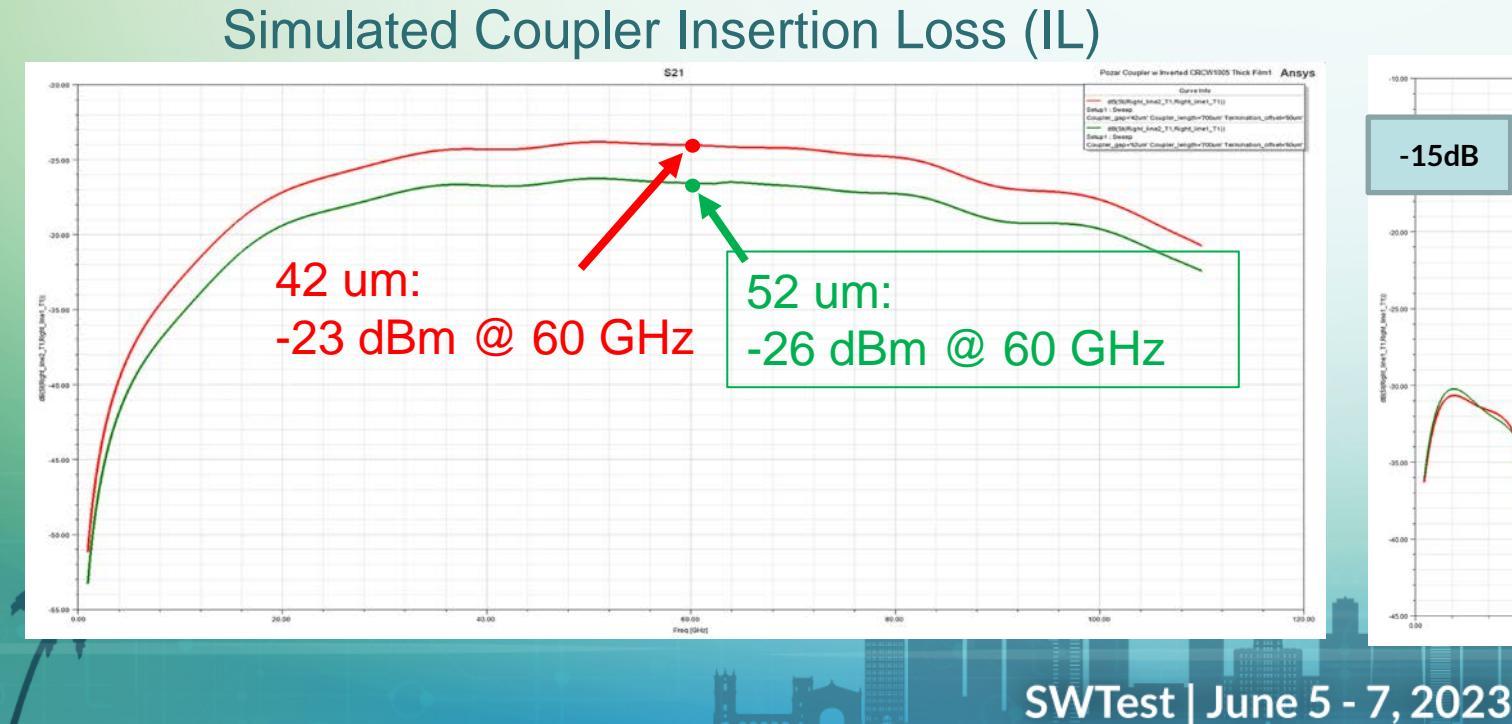
HFSS Simulation

- The coupler design was simulated in HFSS
- The red trace is a gap of 42 um and green trace is for 52 um. Insertion Loss (IL):
- The simulated IL at 60 GHz is reasonable.
- Model predicted 52 um achieves the required 26 dB of attenuation. **Return Loss (RL):**
- RL=-25 dB at 60 GHz is acceptable.

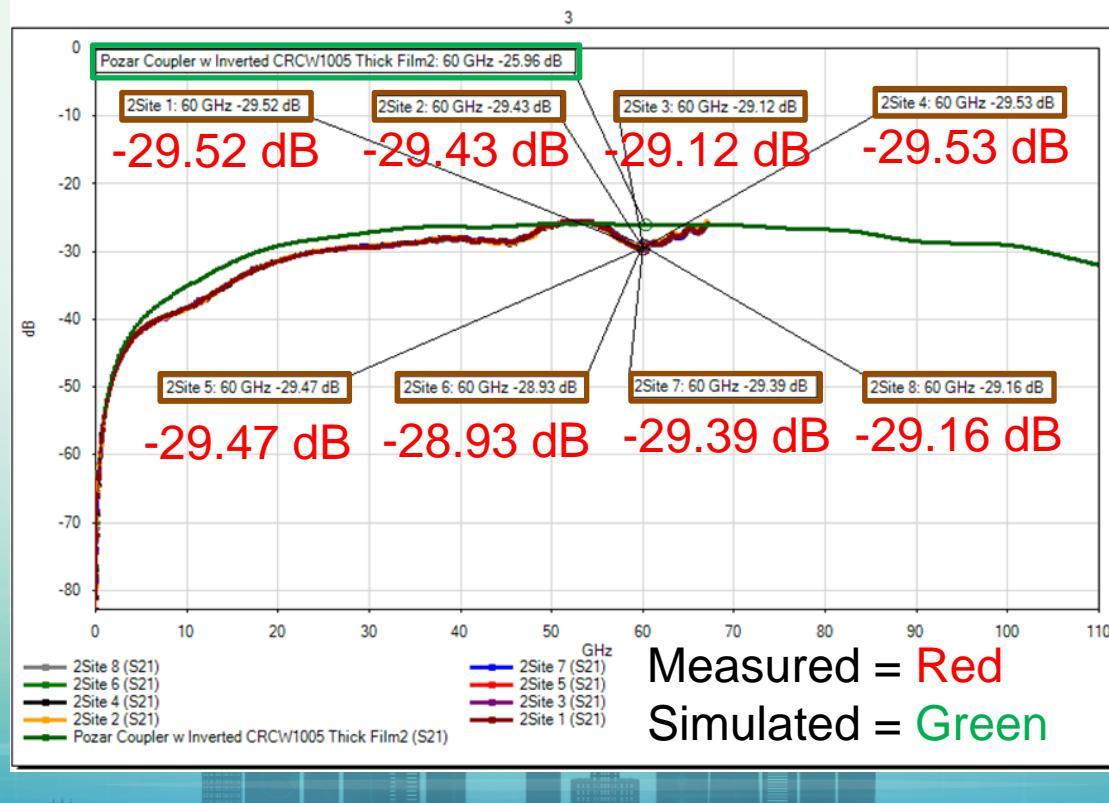
IL For Sites 1-8 + HFSS Simulation (green)

- All 8 sites have an IL of approximately 29 dB. This is 3 dB below the simulated IL of 26 dB.
- Future work to perform additional work to identify why there is a 3 dB delta
- 3 dB more of IL is a benefit. It moves the receiver into a more linear region of operation.

Data is fc = 60 GHz for 8 sites on a core.

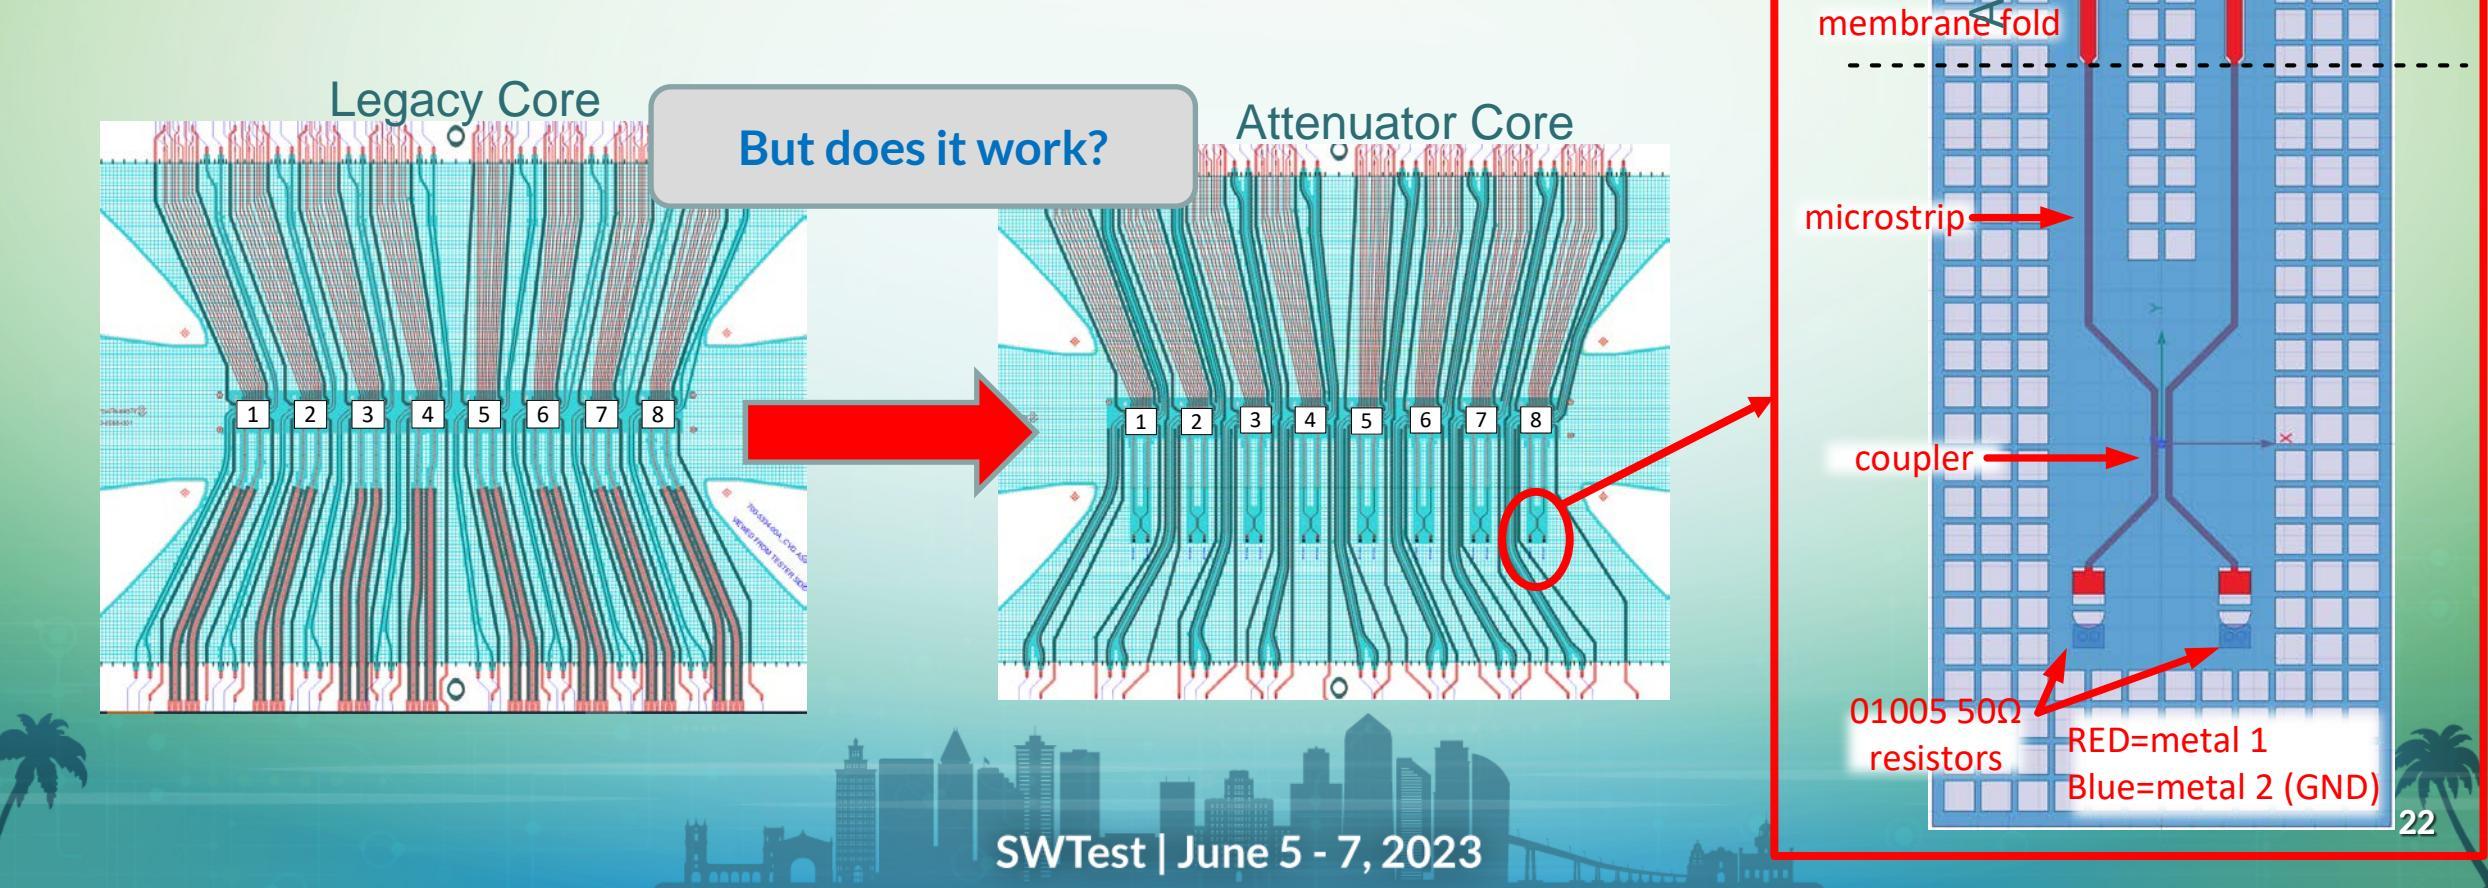
The final membrane (Attenuator Core):

- x8 design with no RF traces routed off the membrane
- 8 couplers (attenuator) designed into the south wing of the membrane
- final attenuator design results in 29 dB of attenuation

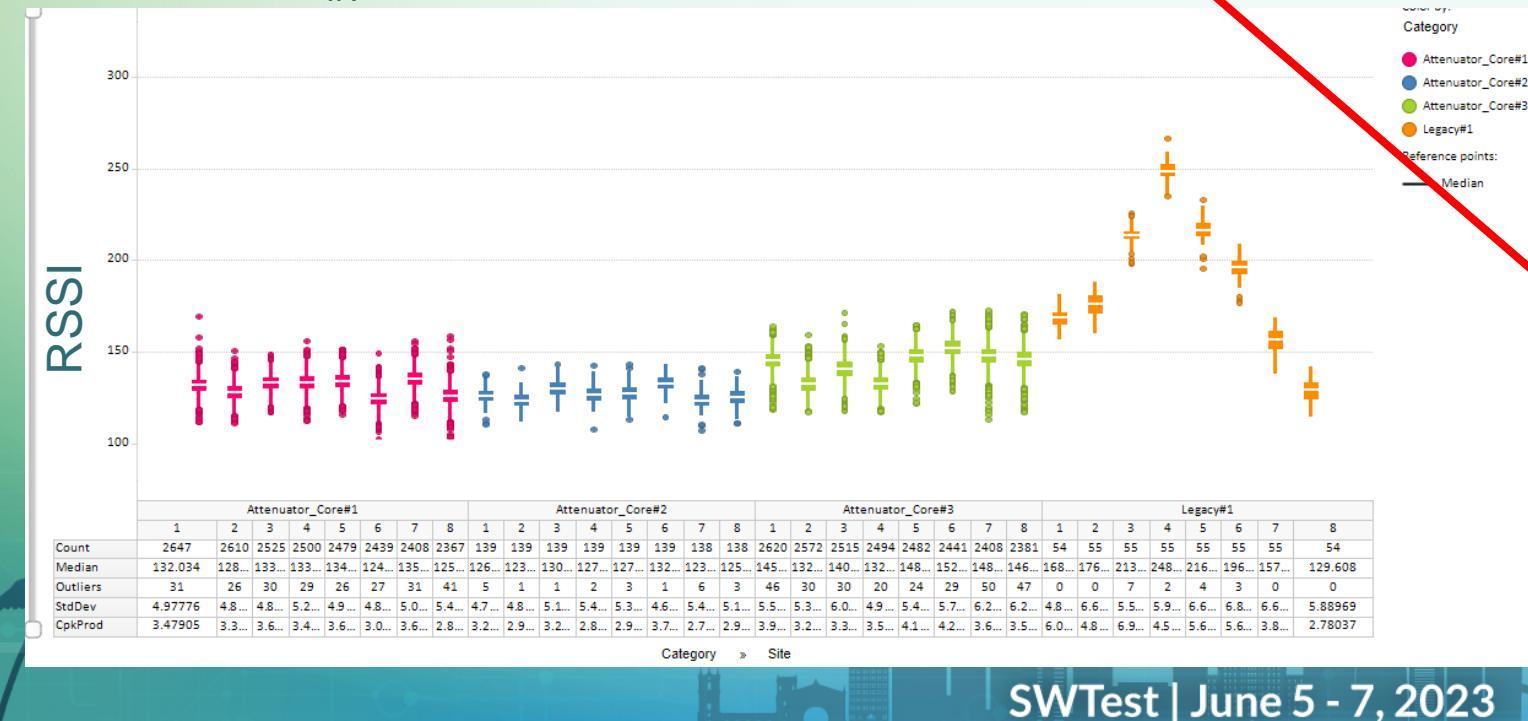
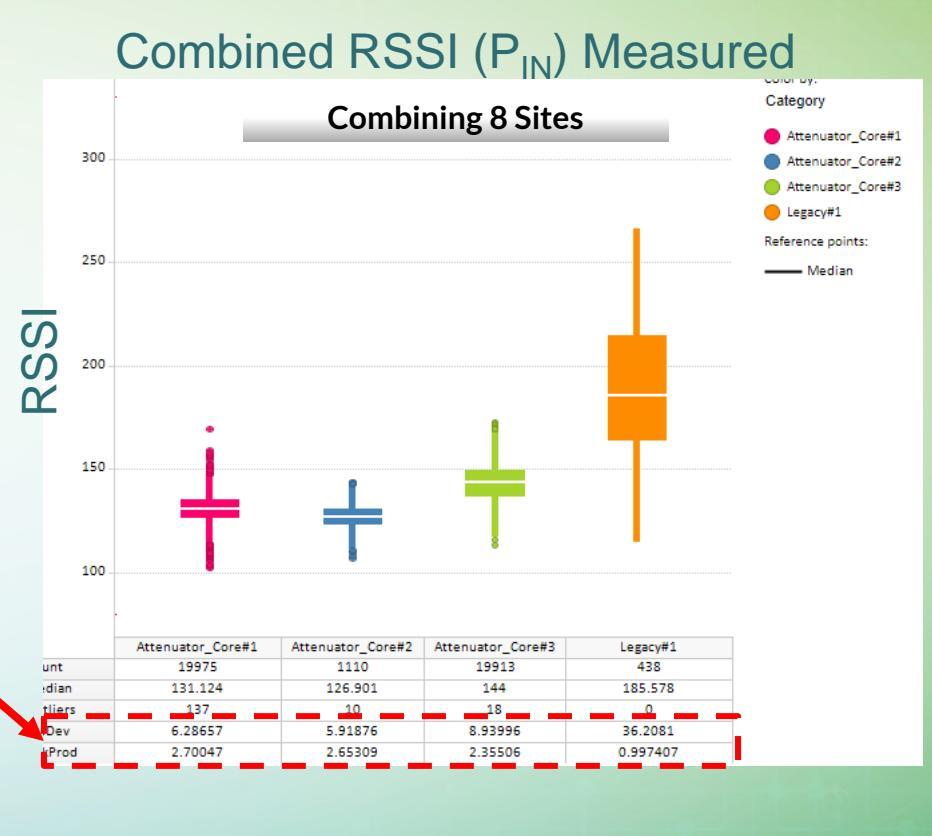
RSSI (P_{IN}) Measured for Complete Wafer Using x8 P800s

Comparing legacy and attenuator core:

- StdDev of legacy core is 5x that of attenuator core (36 mV to 6 ~ 9 mV)
- CpK of attenuator core is above 2 (now passing)
- Initially 20k die tested (small sample)
- These results are a MAJOR achievement
