Cu-Pillar Bump Probing: Utilizing a 50 μ m Pitch Fine Pitch Vertical Probe Card Technology

IEEE SW Test Workshop
Semiconductor Wafer Test Workshop

June 10 - 13, 2012 | San Diego, California

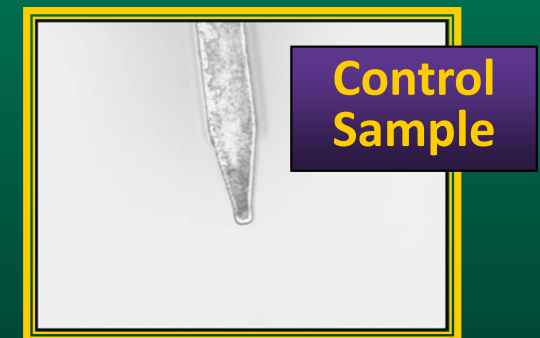
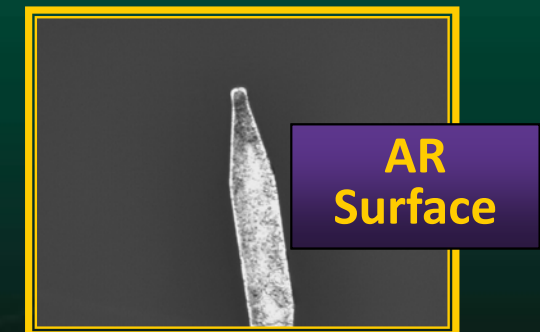
P-12 Prober Pictures: High Mag, Light Level 120, Focused 7-8 mils above Die Surface

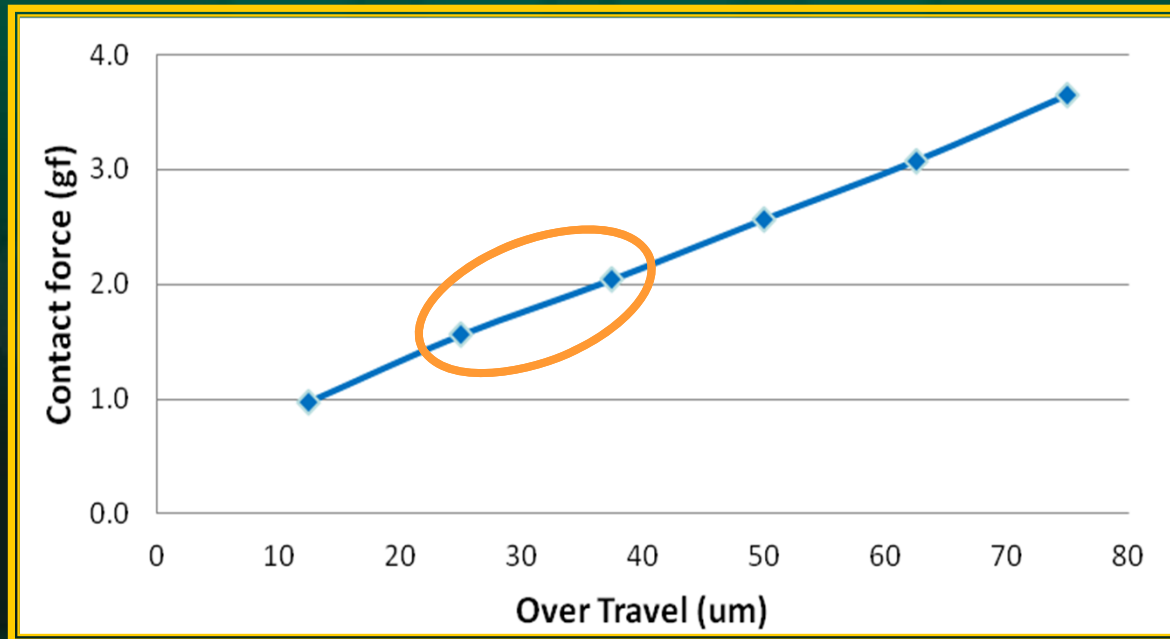
Probe Force

- **Contact Force of 2.5 gf @ 50 μ m OT**
- **Preferred Bump Probing OT \rightarrow 25 to 40 μ m**
 - Minimize Bump Damage
 - Accommodate Bump Co-planarity Across Wafer

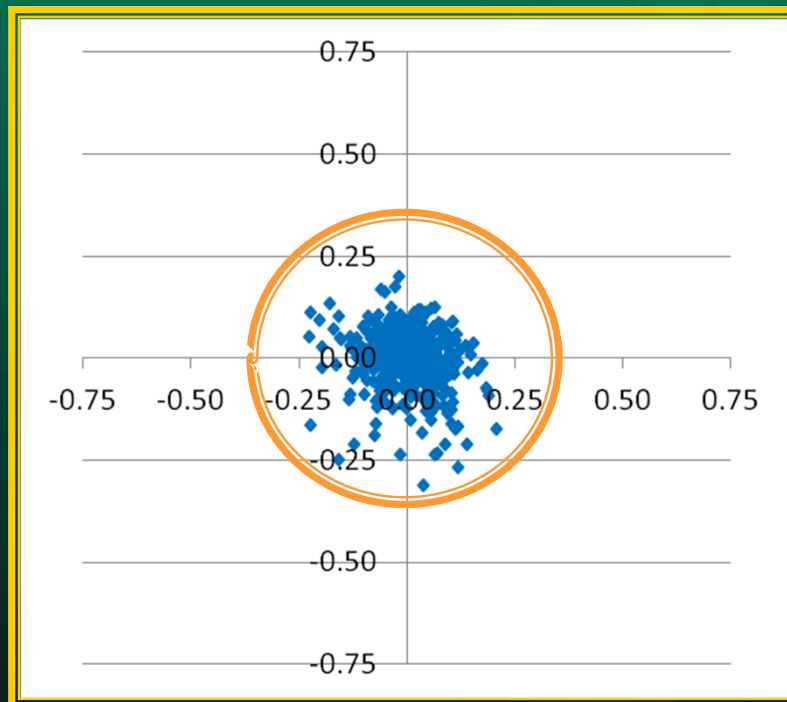
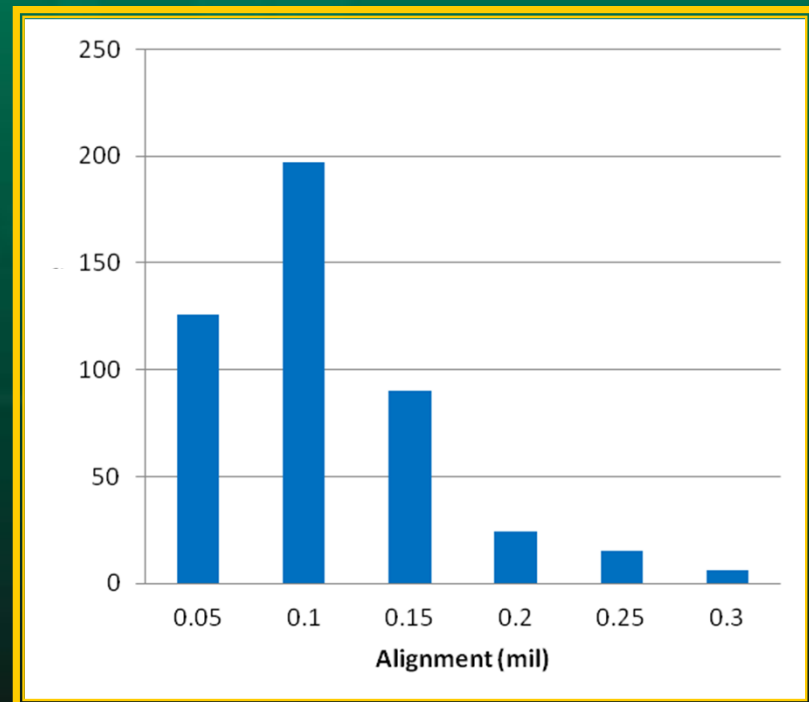
- Probe Tip Alignment – 0.3 mil Radial

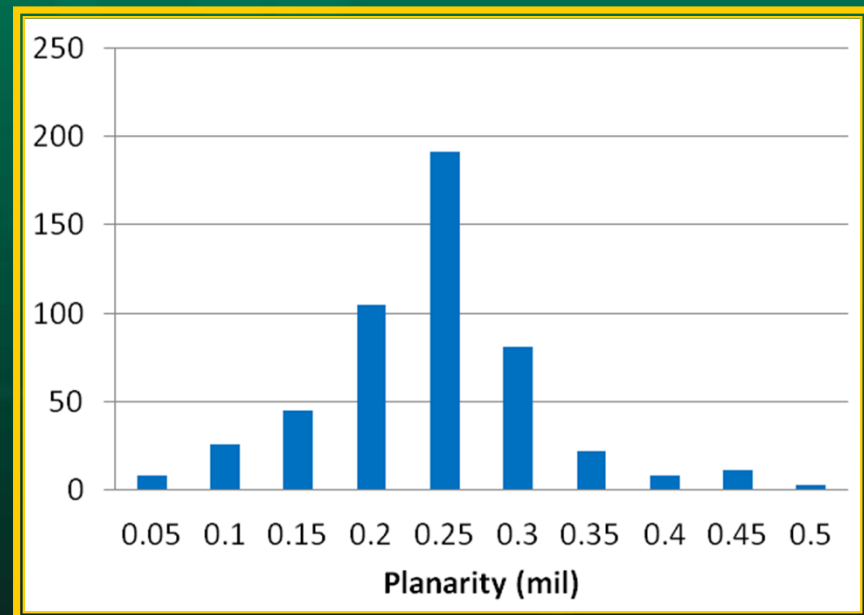
- Probe Planarity < 0.5 mil (12 μ m)

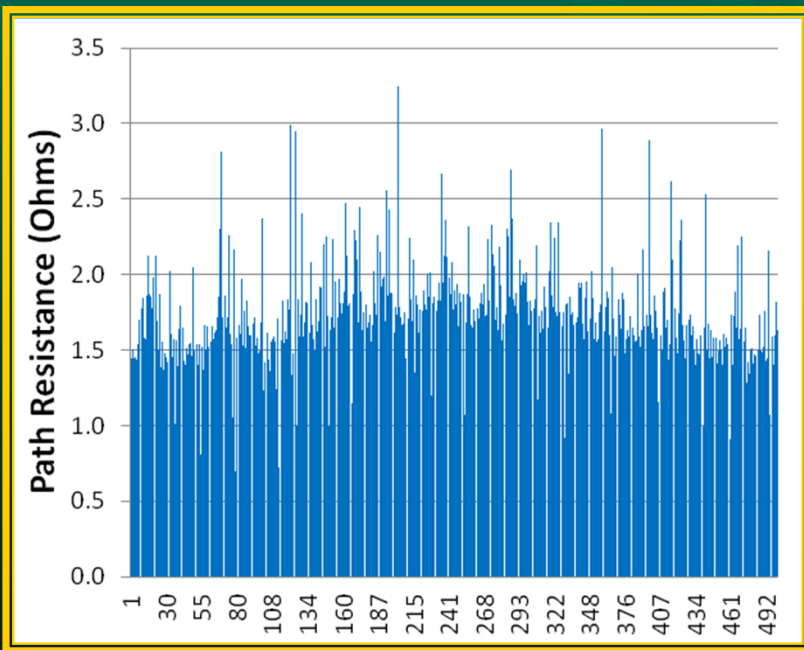
Resistance on Gold

- Max Total Resistance is 3.2 Ohms (includes Cres & Path Resistance through PH, ST & PCB)

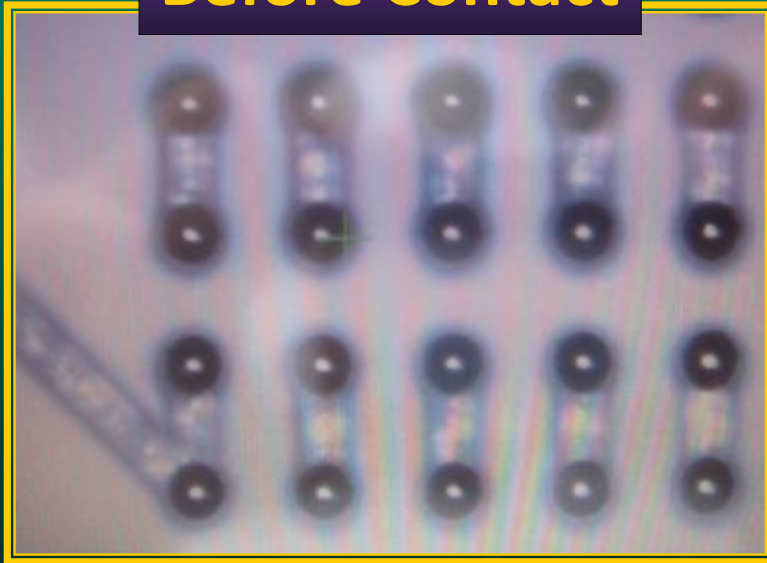
Before Contact

Probe Mark
